Evaluation of the Corrosion Resistance of Epoxy Coated Dowel Bars

Nebraska Department of Roads

**Research Project Number:
R-2004-02**

**I-80 Cozad (Built 1989)
I-80 Goehner (Built 1997)
Hwy 2 Syracuse (Built 2000)**

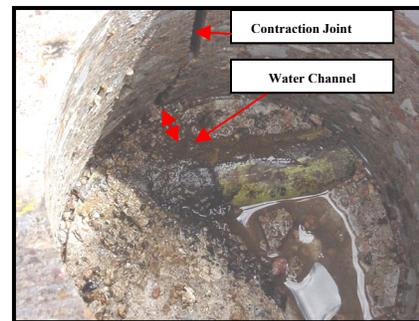
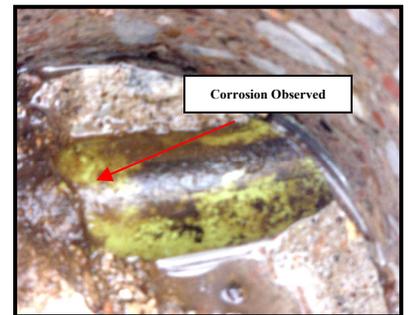
Investigation of I-80 Eastbound near Cozad (Built 1989):

Field Investigation:

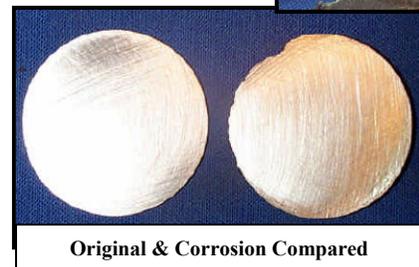
Laboratory Investigation:

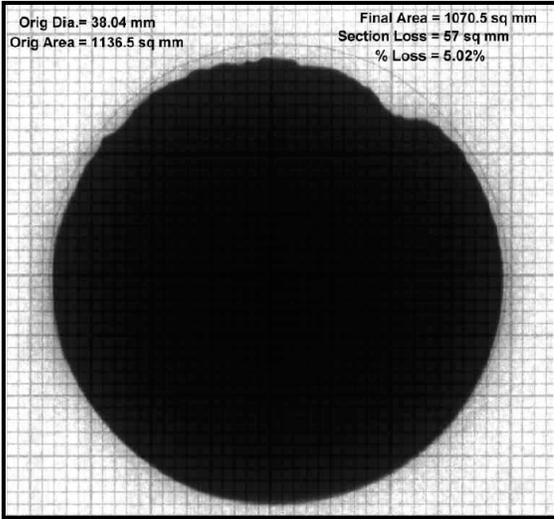
Dowel Bar Corrosion at the joints

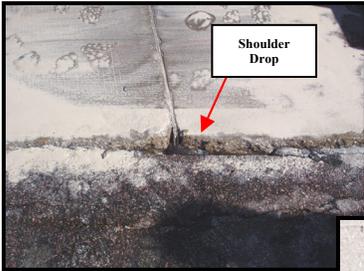
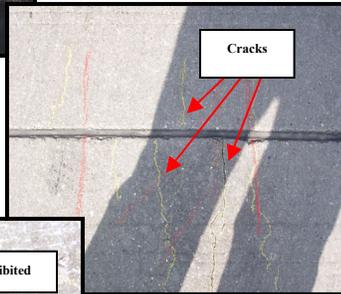
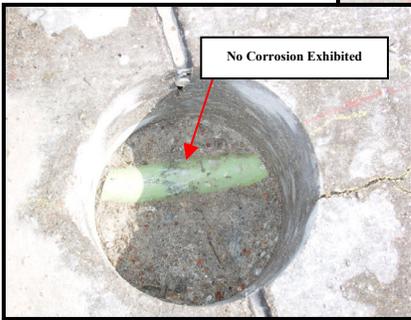
Investigation I-80 Eastbound near Goehner Built 1997:

Field Investigation:

Laboratory investigation was not necessary, because the dowel bar did not show any corrosion.

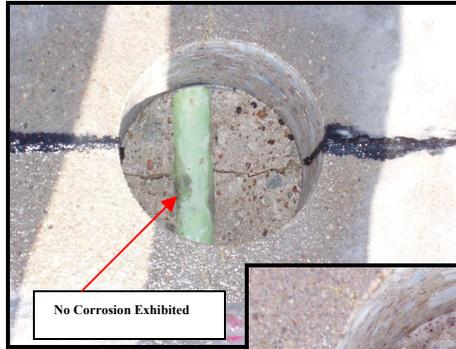
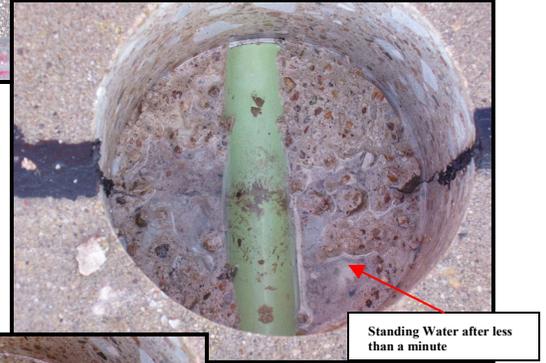
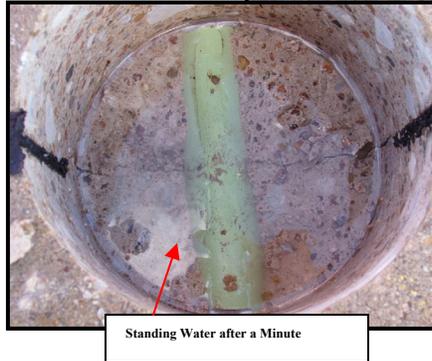
Investigation HYW 2 Westbound near Syracuse (Built 2000)

Field Investigation:

Laboratory investigation was not necessary, because the dowel bar did not show any corrosion.
