Pavement Quality Indicators Study

Five Year Report

Construction Management Department
University of Nebraska
Lincoln, NE 68588-0500

1. Report No SPR - 1 P563	2. Government Accession No.	3. Recipient's Catalog No.	
4. Title and Subtitle Pavement Quality Indicators		5. Report Date June 6, 2008

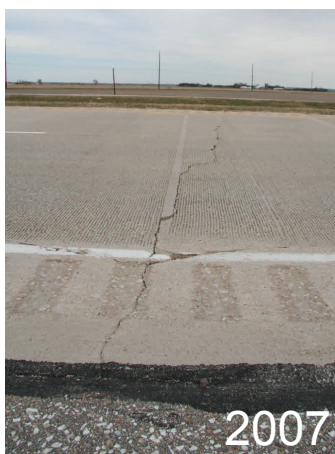
Location: MM 158

- High structural cracking with visible displacement, caused by undermining of pavement for utilities.

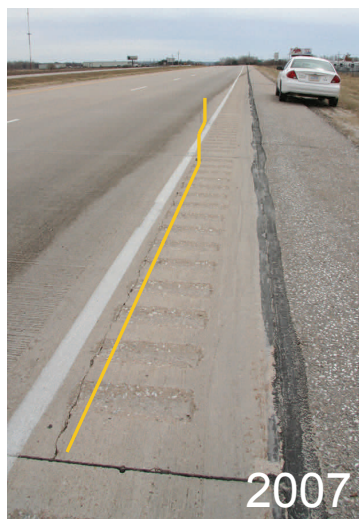
Location: MM 165.5

- Longitudinal crack starting along edge of rumble strips.
- Crack extends four pavement panels in length.
- Located along a gentle curve.

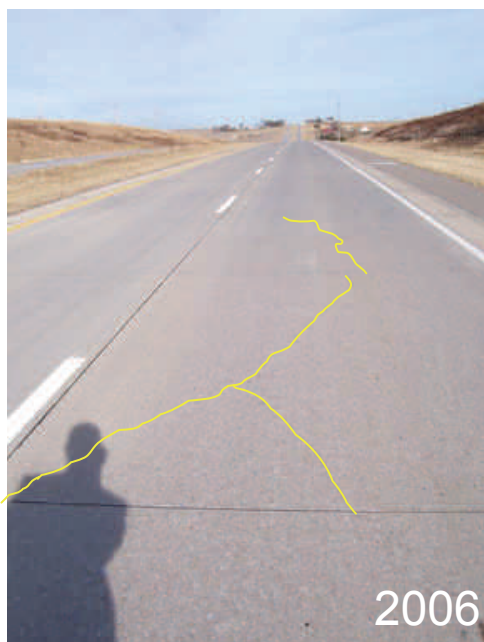
Locations: MM 44.9

- Perpendicular edge cracking along centerline.
- 2”– 8” transverse cracks approximately every four feet along centerline.
- High placement of tie bars across longitudinal joint caused surface cracking shown at left.

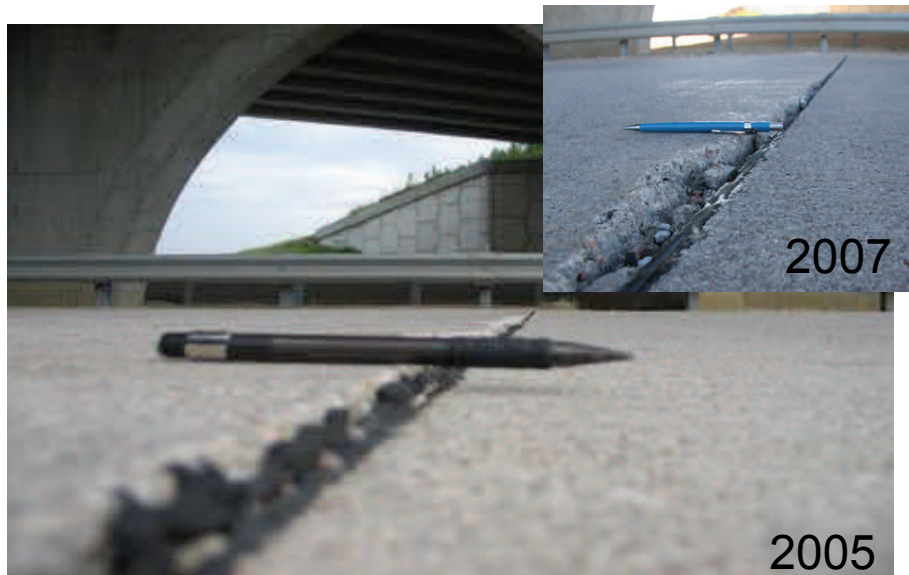
Location: MM 58.01

Faulting 6mm or greater.
Severity of faulting varies with changes in temperature and soil moisture content.
Image from 2005 shows more severe level of faulting.

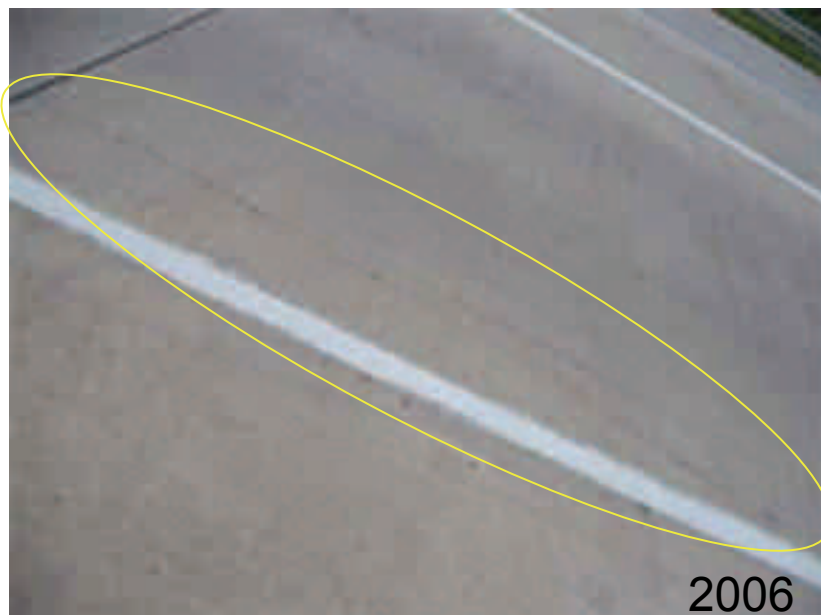
Location: MM 59

Distresses Shown: Longitudinal crack shown is about 10 feet long .

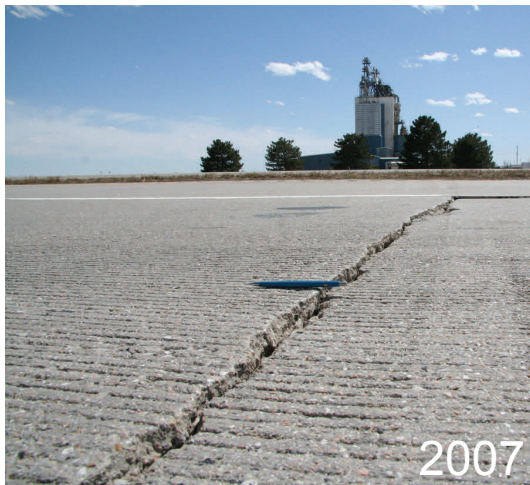
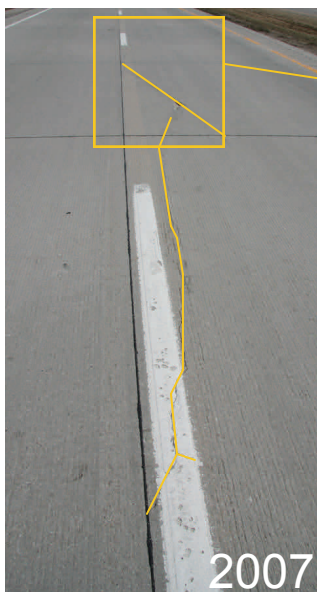
- Transverse cracking near the end of the study section.
- Faulting greater than 3 mm.

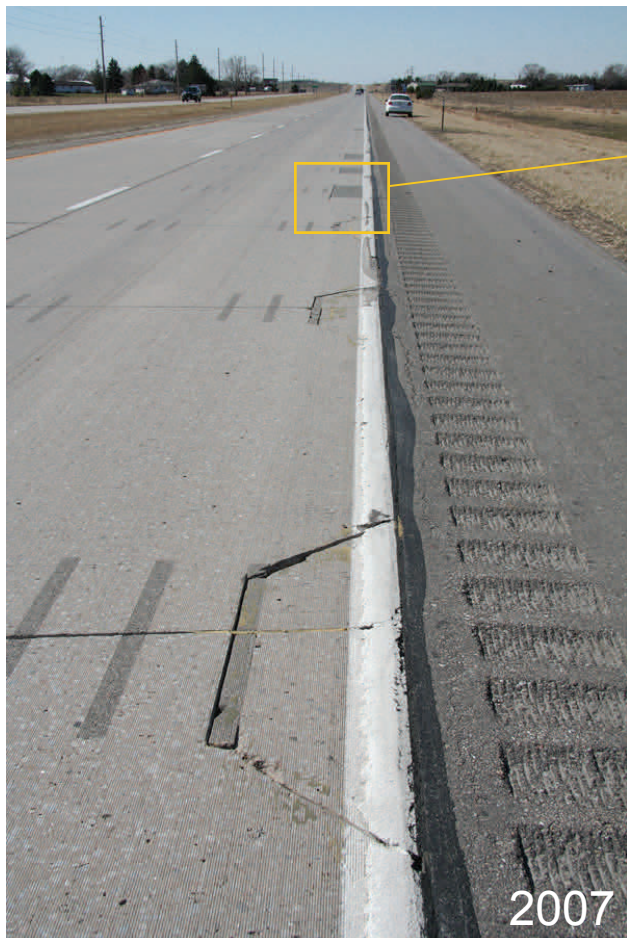
Location: MM 115.9

- Cracking along shoulder where dowel bars were retrofitted is common throughout the study section.
- Euroteck foam was used to prevent additional settling and to raise cracked panels.
- Retrofitted dowel bars placed too close to edge of pavement caused the cracking.
- Retrofitted dowel bars are now placed 6” closer to the centerline to prevent cracking of this type.

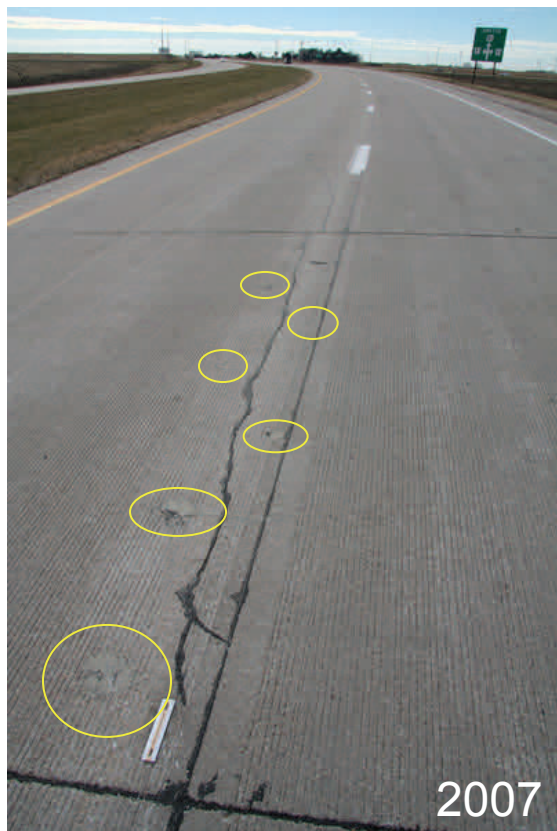
Location: MM 40

- Longitudinal cracking.
- Stitching with deformed bar to prevent further expansion of the cracks.

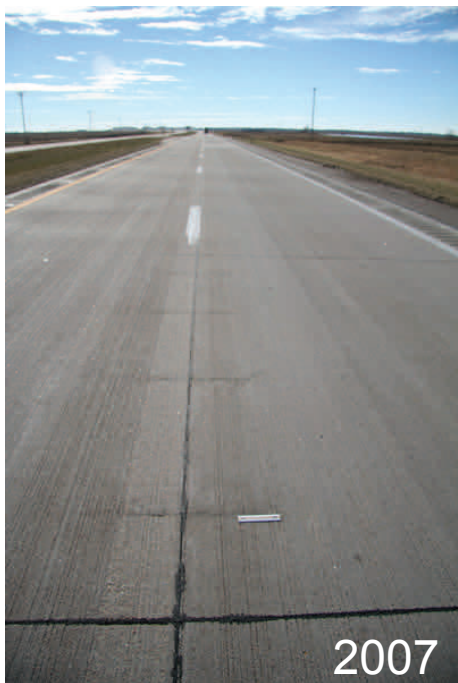
Location: MM 40.8

- Surface cracking extending through 11 to 12 panels along longitudinal joint.
- 2'8" cracks above tie bars across longitudinal joints.

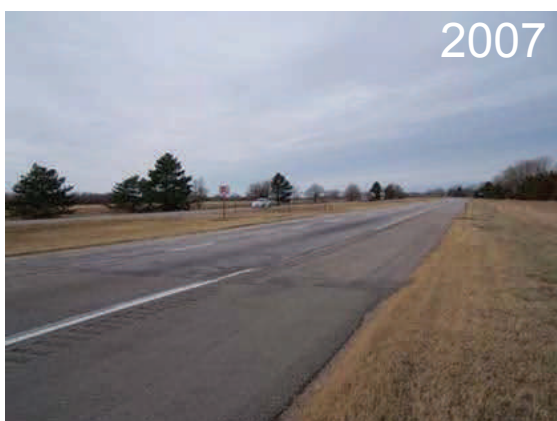
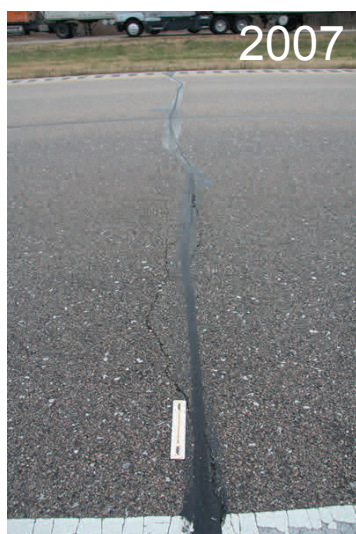
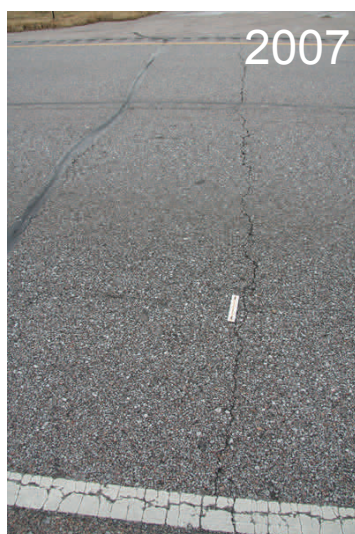
Location: MM 290.94

- Transverse cracking is common throughout the study section.

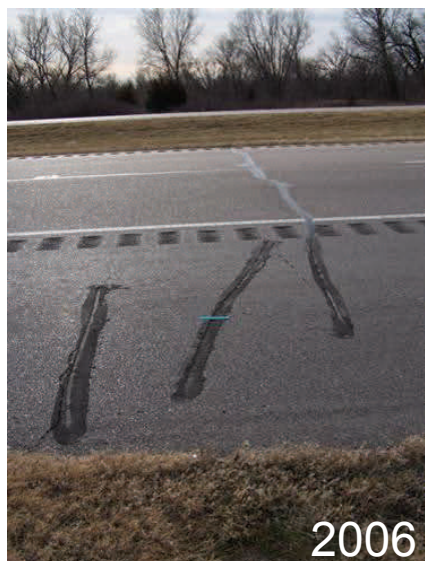
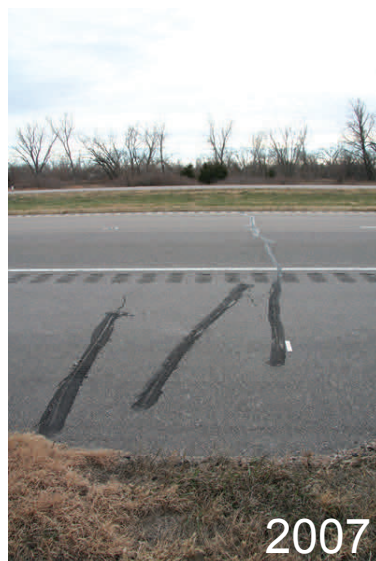
Location: MM 282

- High severity transverse cracking.
- High severity centerline cracking.

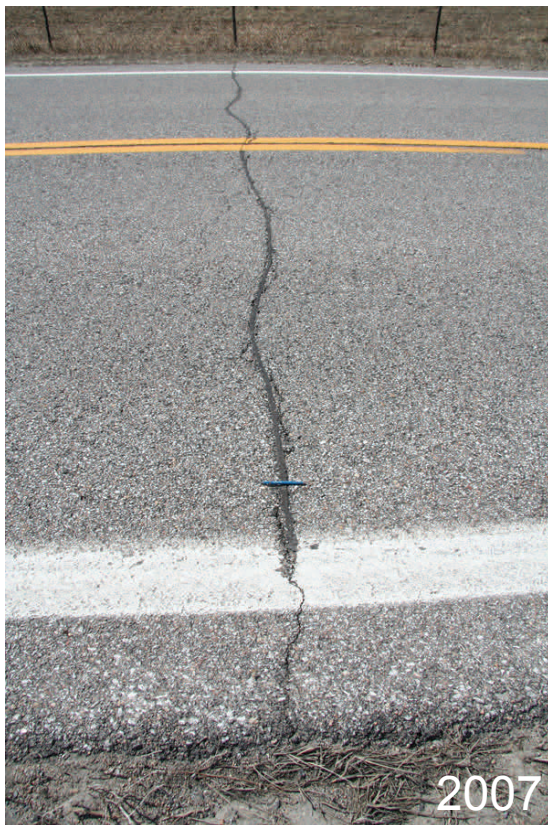
Location: MM 172.6

- Transverse cracking across both lanes and shoulder.

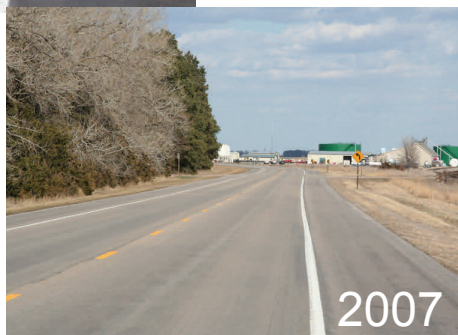
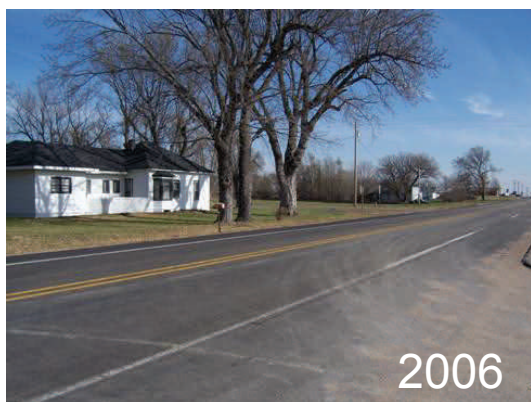
Location: MM 337.58

- New wearing course in 2006.
- Minor surface distortion; some appearance of wear in 2007.

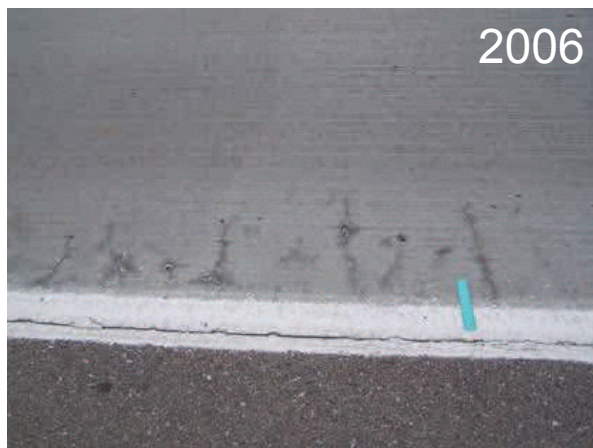
Location: MM 299.2

- Edge cracking adjacent to shoulder.

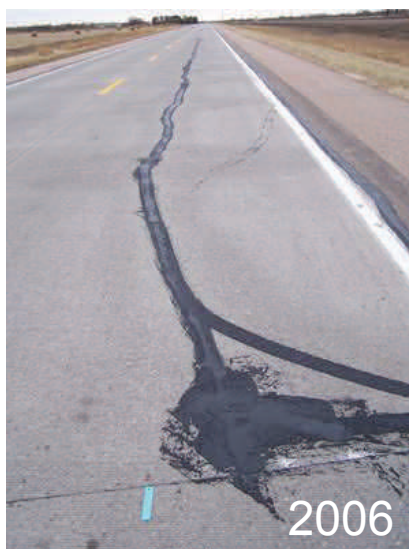
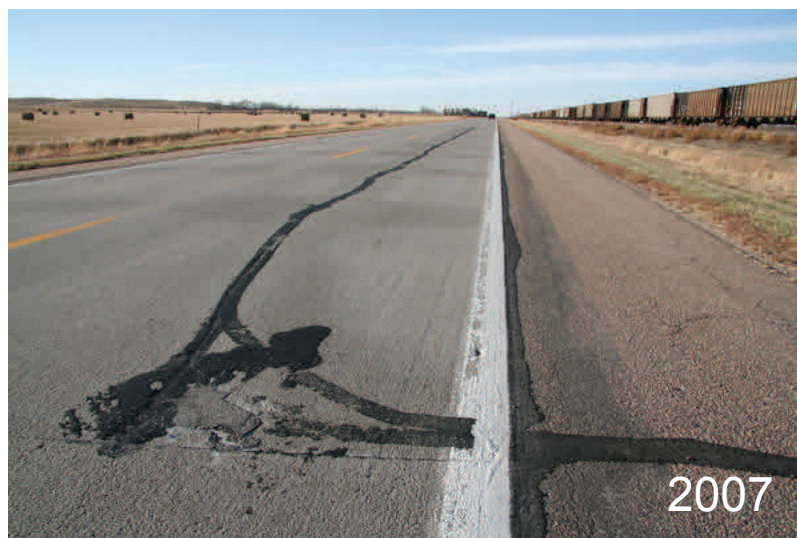
Location: MM 298.6

- High severity longitudinal cracking.
- Low pavement wear in wheel paths.
- ASR cracking at joints and cracks was less visible in 2007 than in 2006.

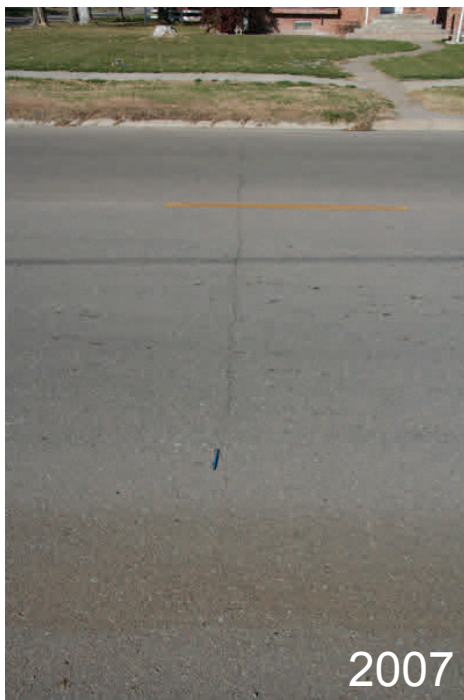
- Only visible crack was in Republican City near end of the study section.

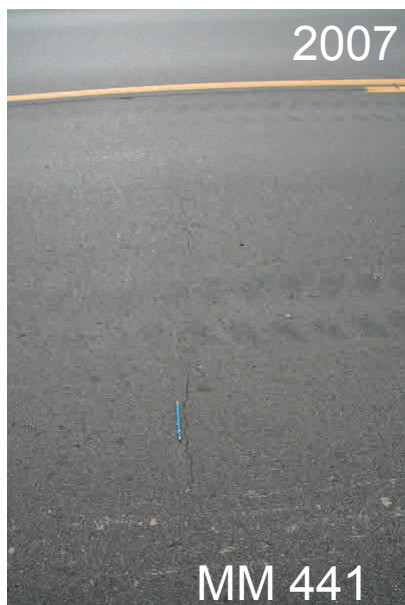
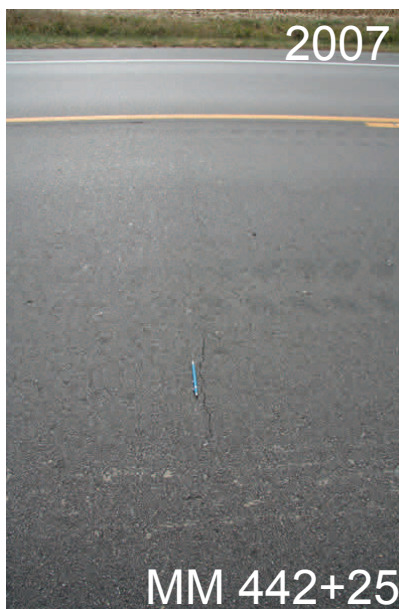
Location: MM 441 and 442+25

- Thin and short transverse cracking.
