**Detection of Multiple Flaws in Concrete Bridge Decks Using
Ultrasonic Wave Propagation**

M066

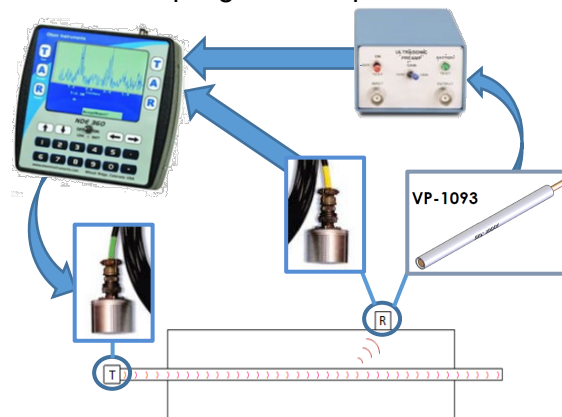
The experimental set-up (Figure 1) includes a transmitter (T), which is a standard 54 kHz transducer. For receivers (R), we used either a 2-inch diameter transducer, a 1-inch diameter transducer, or pinducers (miniature transducer) from CTS Valpey corporation. A low noise preamplifier was used to amplify the signals detected by pinducers. However, despite the amplifier, signals were too low and coupling was too problematic.

Figure 1 - Ultrasonic experimental set-up

The UGWL test arrangement investigated, illustrated in Figure 1, transmits a guided wave through a steel reinforcing bar and detects the bulk waves leaked into the surrounding material. This test arrangement monitors the ultrasonic guided wave leakage, theoretically allowing the steel reinforcement, the steel-concrete interface, and the concrete to be inspected with one system. Two sets of equipment was used in this project:

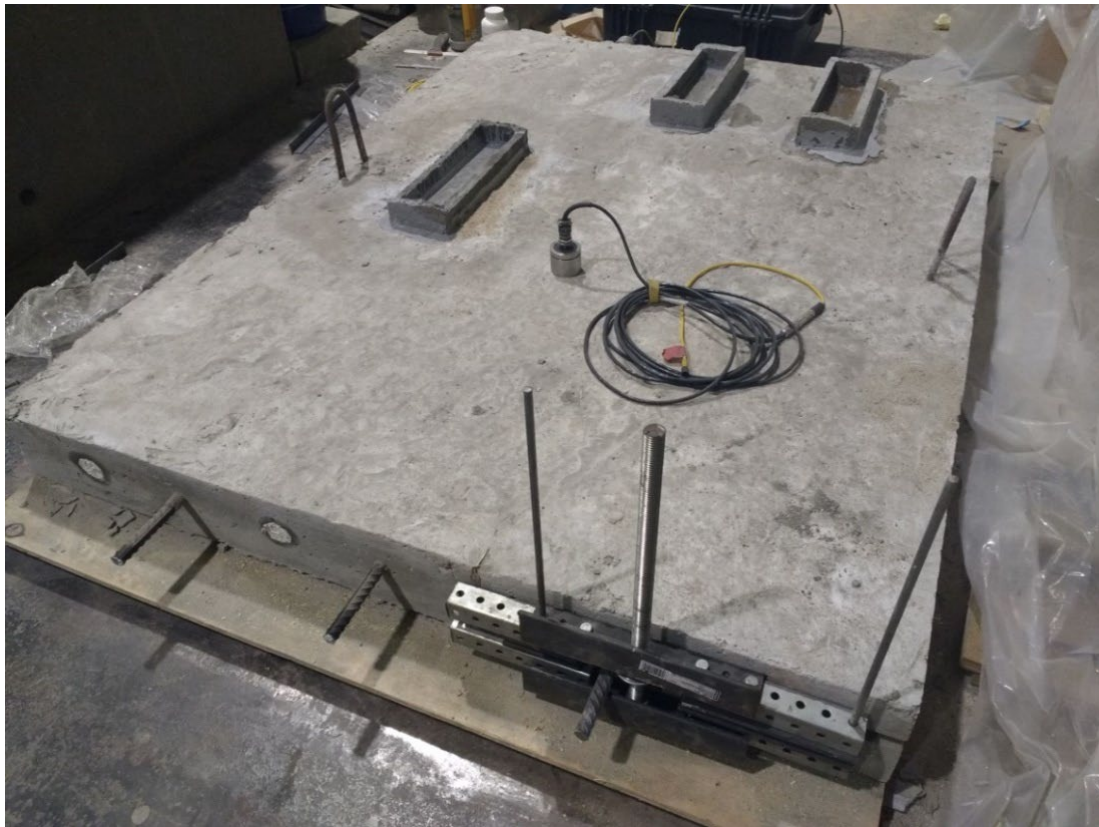
B. **Specimen Set 1B: One 60inch x 48 inch x 5 inch concrete slab** with three No.5 steel reinforcing bars spaced at 12inches (Figure 3): The purpose of this specimen was to: 1) investigate whether it is possible to detect the onset of corrosion in a larger and more complex specimen, 2) Whether it is possible to detect corrosion and delamination simultaneously. Certain regions of the slab were cast using 5% NaCl solution (salt water) rather than regular water to localize the corrosive environment. Further, to accelerate the corrosion in these regions, concrete basins of 12 inches x 3 inches x 2 inches were cast in those regions above the reinforcing bar (Figure 3). These were filled with 5% NaCl solution to accelerate the corrosion process. The solution inevitably gets absorbed and evaporates, so the basin was refilled with water every six days. The third steel reinforcing bar in this specimen was used to monitor simultaneous development of corrosion and delamination. This test is referred to as the “corrosion-delamination test”. The bar was exposed to corrosive conditions for 24 days, while simultaneously delaminated slowly over the same time period.

Figure 3- Specimen Set 1B (Corrosion-delamination Specimens)

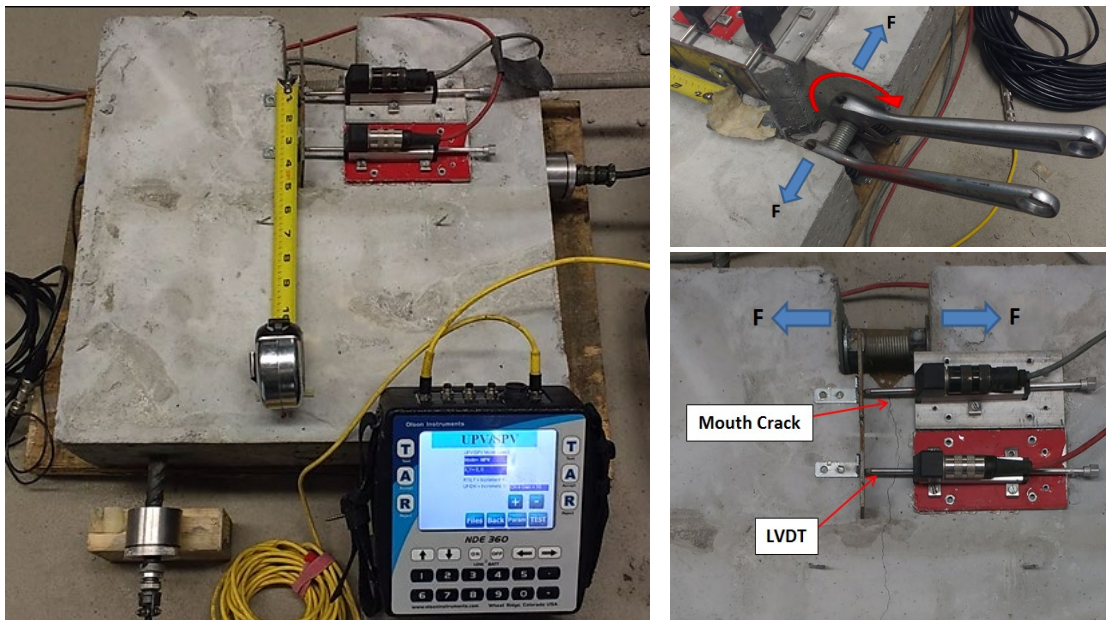
Specimen Set 2 comprised of two concrete test specimens with the dimensions of 18 inch x 18 inch x 5 inch, which were cast with a No.5 steel reinforcing bar embedded at the center height and three inches away from one edge of the cross-section. The purpose of this set of specimens was to look at the ability of using the UGWL method to identify the onset of cracks in concrete independent from rebar delamination (rebar delamination was studied in previous project M029). As such, an initial crack was created in the specimen and gradually opened further mechanically, as shown in Figure 4.

Figure 4 – Specimen Set 2: Cracking Specimen and the detail of the cracking mechanism

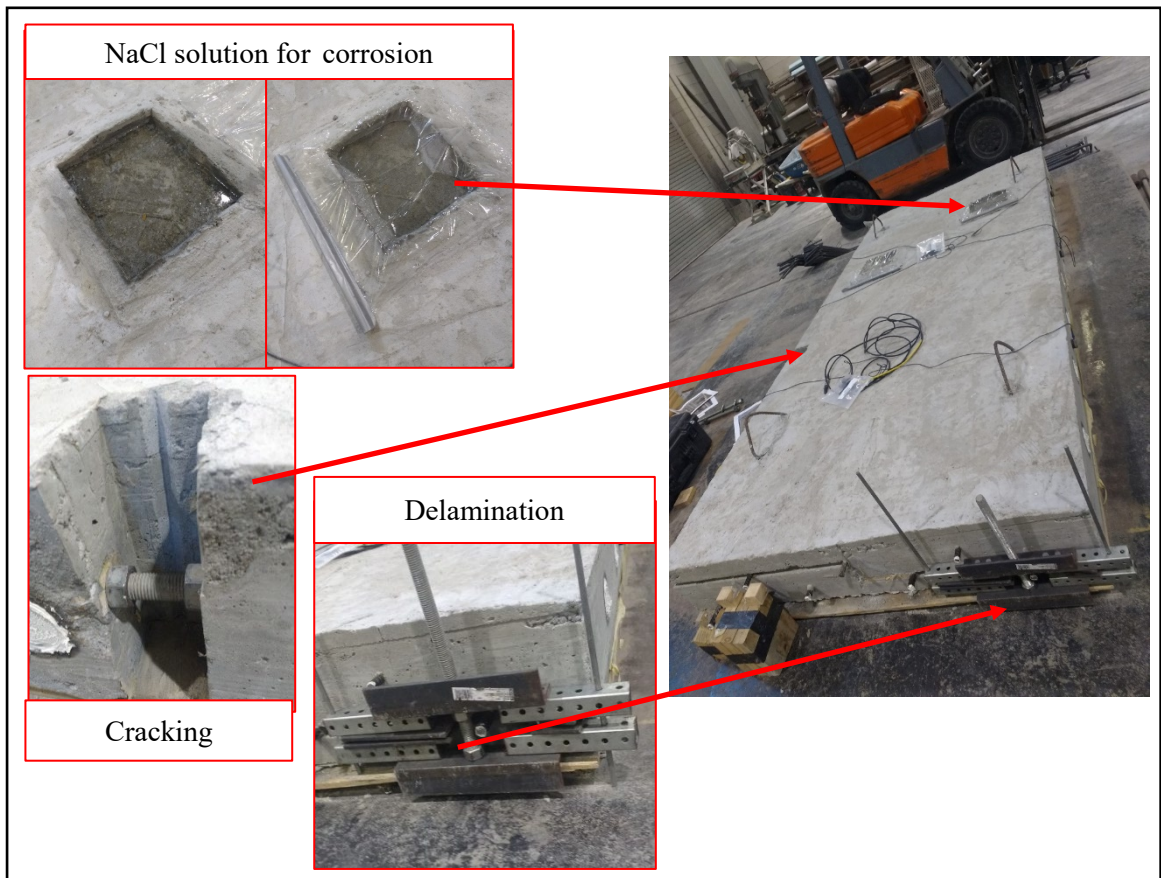
Figure 6- Specimen Set 3 and various areas of artificially introduced flaws

Specimen set 3 was a larger reinforced concrete slab (10 feet long, 4 feet wide, and 8 inches thick), which was cast to examine the influence of multiple layers and direction of reinforcement on the UGWL method, as well to test farther distances between the transmitter and receivers than we tested before (Figure 5). Each layer of reinforcement had a cover of 2.5 inch and, consequently, 3 inches between them. The specimen contained known areas with delamination, corrosion and cracks as shown in Figure 6. An array of sensor locations were marked on the side of the slab as shown in Figure 7.

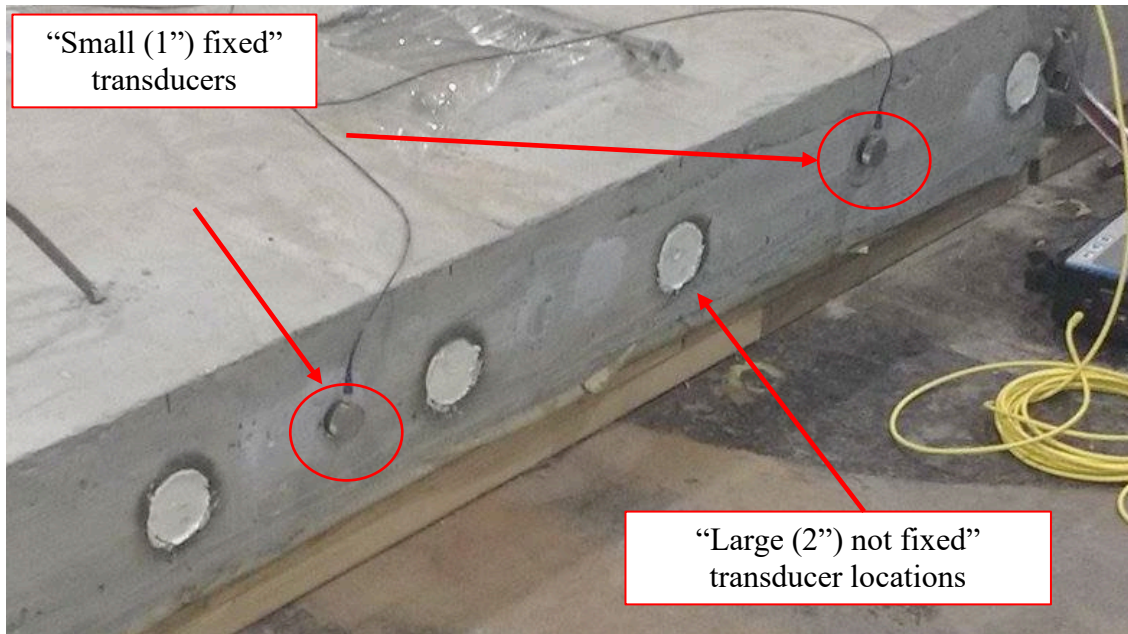
Figure 7- Specimen Set 3 Sensor locations

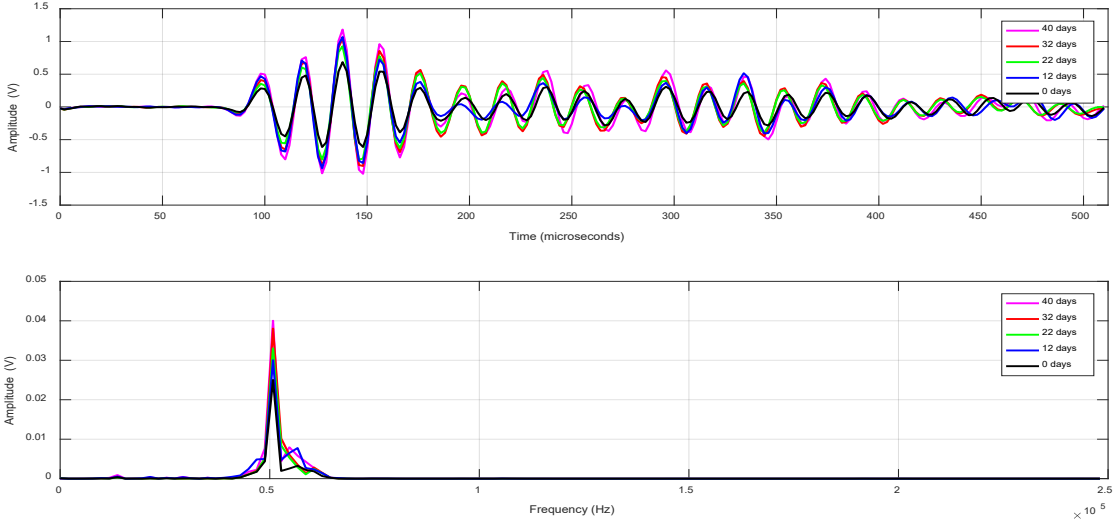
Figure 8- Velocity (top) and Amplitude (bottom) readings as the corrosion progressed up to 40 days

Specimen Set 1A comprised of two 18inch x 12inch x 5 inch concrete slabs with a No.5 steel reinforcing bar embedded at the center level (Figure 2). The purpose of the experiment was to investigate whether the proposed method can detect the start of corrosion. Figure 8 shows the velocity measurement results (time domain) on top and the amplitude measurement results (frequency domain) on the bottom. As discussed before, velocity measurements represent the current industry standard, while amplitude measurement is part of the methodology proposed by our team. Figure 9 shows a larger view of the peak amplitudes in frequency domain that clearly shows the change in amplitude as the corrosion progressed; while it is more difficult to see this change by velocity measurements (Figure 8). These figures represent the average of five measurements each. Figure 10 shows mean and standard deviation of each data set in a plot of percent change in energy (or peak amplitude) versus days (or progression of corrosion).

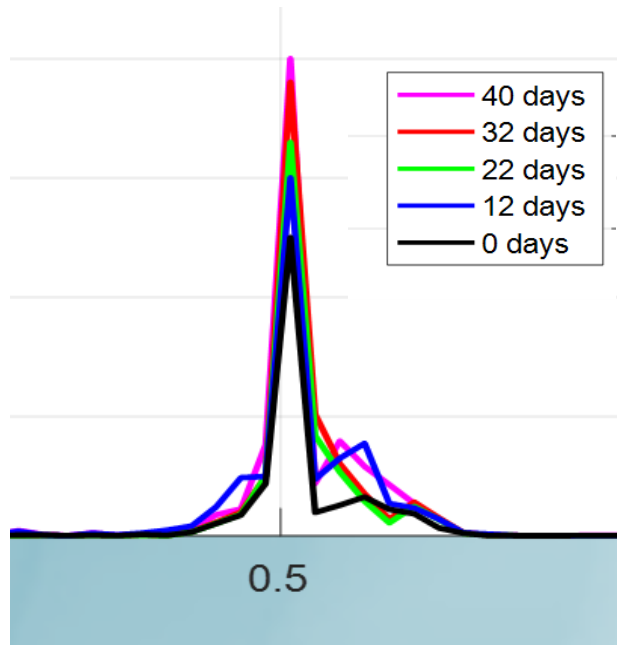
Figure 9- Larger view of the peak amplitude readings as the corrosion progressed in the specimens up to 40 days

It can be concluded from this set of experiments that onset of corrosion, even as early as 5 days, is detectable with this method; and the percent difference increases as the corrosion builds up.

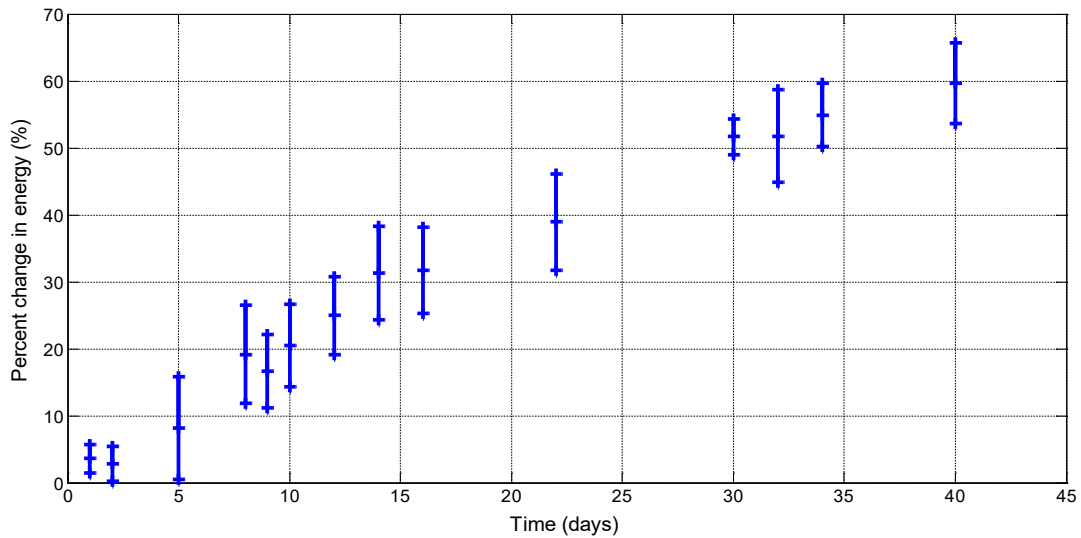
Figure 10- Mean and standard deviation of each data set

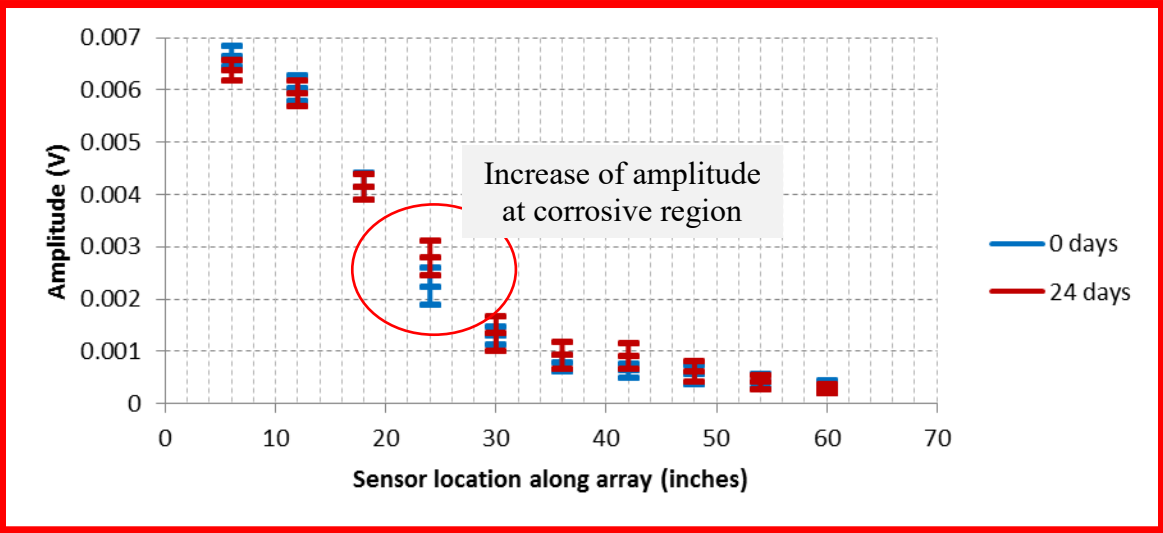
Specimen Set 1B comprised of one 60 inch x 48 inch x 5 inch concrete slab with three No.5 steel reinforcing bars spaced at 12 inches (Figure 4). Figure 11 shows the amplitude of leaked waves detected from the array of sensors located along the edge of the concrete slab at the beginning and after 24 days of corrosion progression. In this test, the transmitter is on bar 1a (shown in Figure 12), and sensors are located on the near edge of the slab, i.e. 1 foot away from the bar (denoted by the red line in Figure 12). As expected, the energy attenuates as the sensors are farther away from the transmitter location at the end of the rebar. Further, while the no-corrosion data (0 days) follows an exponential curve as expected from theoretical equations after 24 days, the sensors corresponding to the corrosion region show an increase in amplitude. Finally, based on the leakage angles demonstrated in Figure 13, it is expected to have the exponential decay of the amplitude start around 13.5 inches.

Figure 11- Amplitude of leaked waves versus sensor location plot for Specimen 1B, Transmitter on corroded bar (bar 1a) and Receivers 1 foot away from the bar

As expected, sensors located closer to the corroded bar with signals transmitted through this wave guide detect stronger signals/higher amplitudes compared to an array located farther out. However, whether tested at 1 foot or 3 feet away from the corroded bar, the onset of corrosion could be detected as early as 5 days.

It should also be noted that the corrosion is detected as an increase in the amplitude of the leaked signals in either case (Figures 11 and 14). The initial stages of corrosion improves the bond between steel and concrete until the delamination occurs, increasing the amount of energy absorbed into concrete.

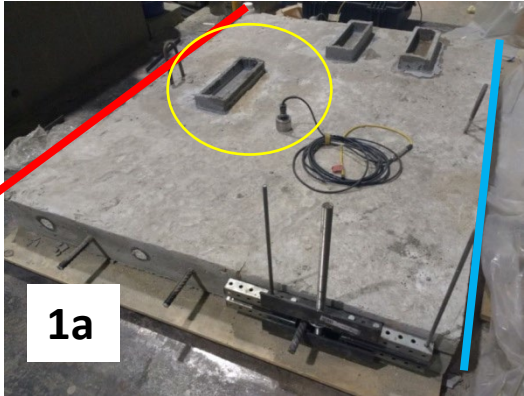
Figure 12- Red line denotes the sensor array for data displayed in Figure 11, and blue line denotes the sensor array for data displayed in Figure 14.

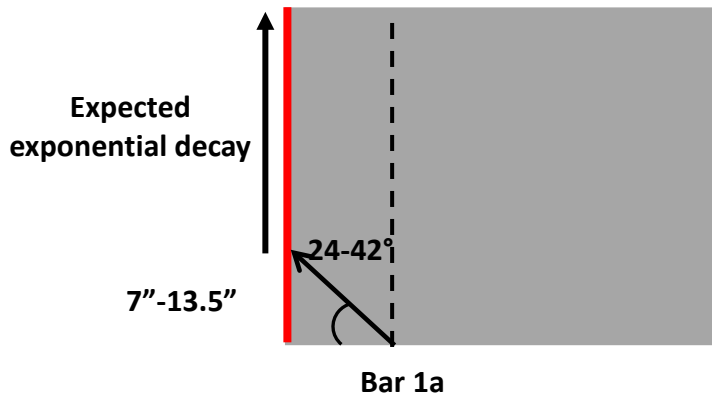
Figure 13- Schematic illustration of leakage angles with respect to the location of the sensor array shown in red line (1 foot away from bar 1a)

Finally, it should be noted that, when interpreting test results, leakage angle should be considered in order to calculate the location of the flaw.

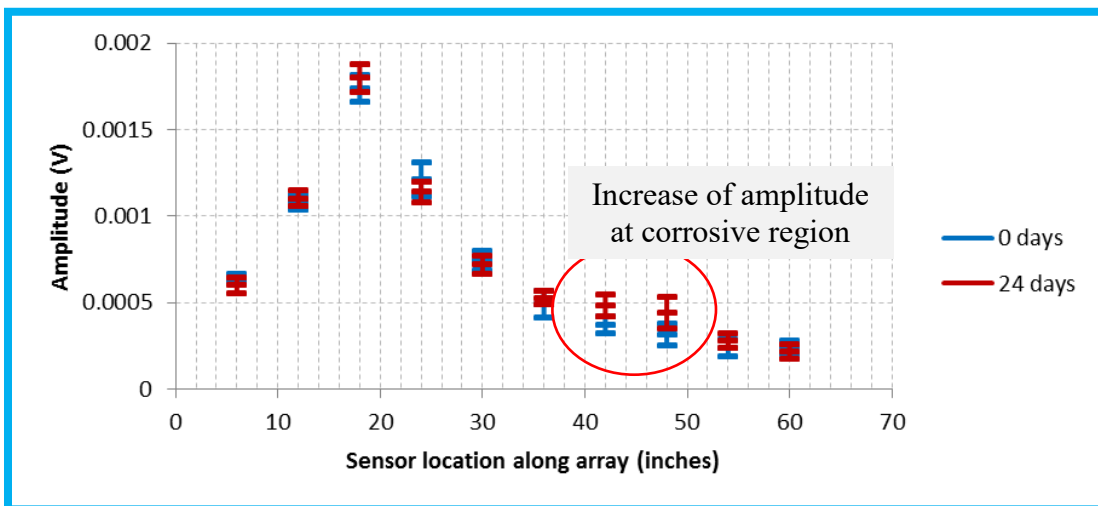
Figure 14 shows data from the sensor array on the other edge of the specimen (blue line in Figure 12) and Figure 15 illustrates the consequences of the leakage angle in this case.

Figure 14- Amplitude of leaked waves versus sensor location plot for Specimen 1B, Transmitter on corroded bar (bar 1a) and Receivers 3 foot away from the bar (blue line)

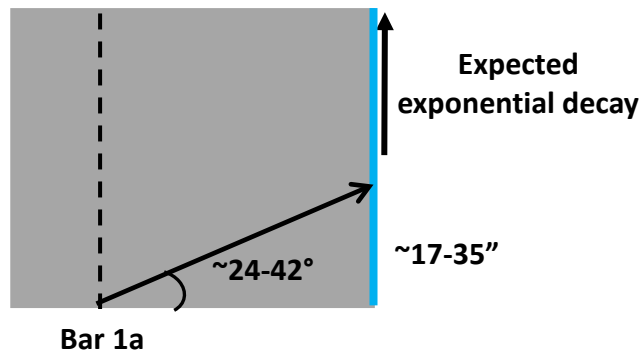
Figure 15- Schematic illustration of leakage angles with respect to the location of the sensor array shown with blue line (3 feet away from bar 1a)

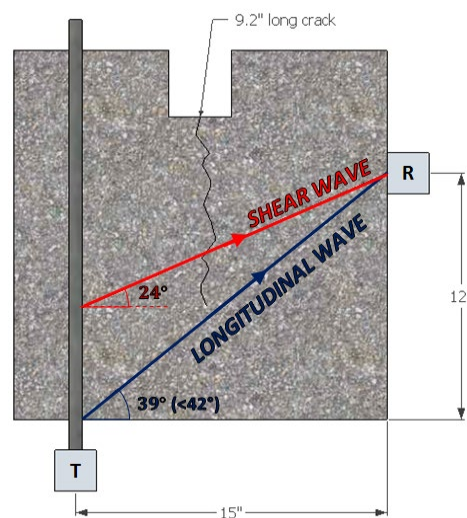
In one of these specimens, the crack was created parallel to the steel rebar that was used as the wave guide with direction of wave crossing the crack nearly perpendicular (see Figure 16). This results in the amplitude graphs shown in Figure 17, as the as the crack in concrete progressed from not existent to 11.6 inches long. The drop in the amplitude is very clear when these graphs are inspected together, indicating a flaw that is getting worse.

Figure 16- Plan view of the relationship between the transmitter, the receiver, and the cracking in concrete for the first specimen in Set 2.

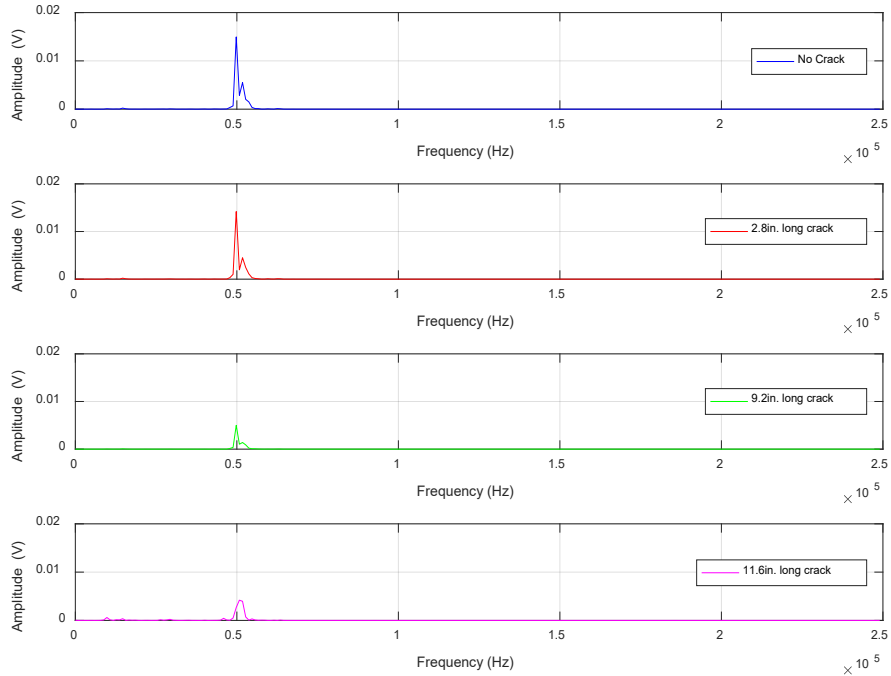
Figure 17- Amplitude of the leaked energy measured as shown in Figure 16.

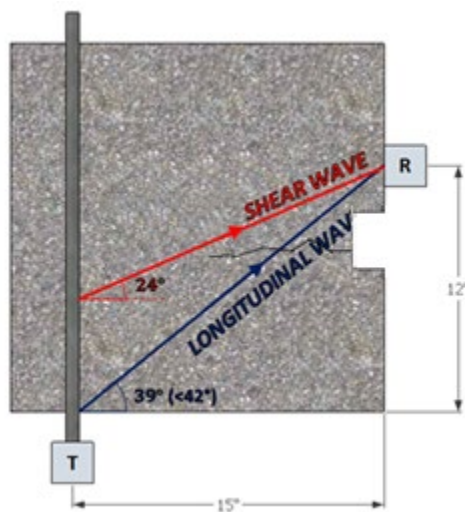
Figure 18 shows the other specimen in plan view, with the location of the crack, transmitter (on bar), and receiver (on concrete). As can be seen, in this case, the direction of the wave crossing the crack is nearly parallel. Figure 19 shows the amplitude graphs for this specimen, as the crack in concrete progressed from not existent to 11.9 inches long. It should be noted that there is still a drop in the amplitude and it is noticeable, but as not clear as the previous case. As the crack disturbs the travel of the leaked waves, the amplitude of the energy received decreases, but because the crack is nearly parallel to the wave, the decrease is smaller.

Figure 18- Plan view of the relationship between the transmitter, the receiver, and the cracking in concrete for the 2nd specimen in Set 2.

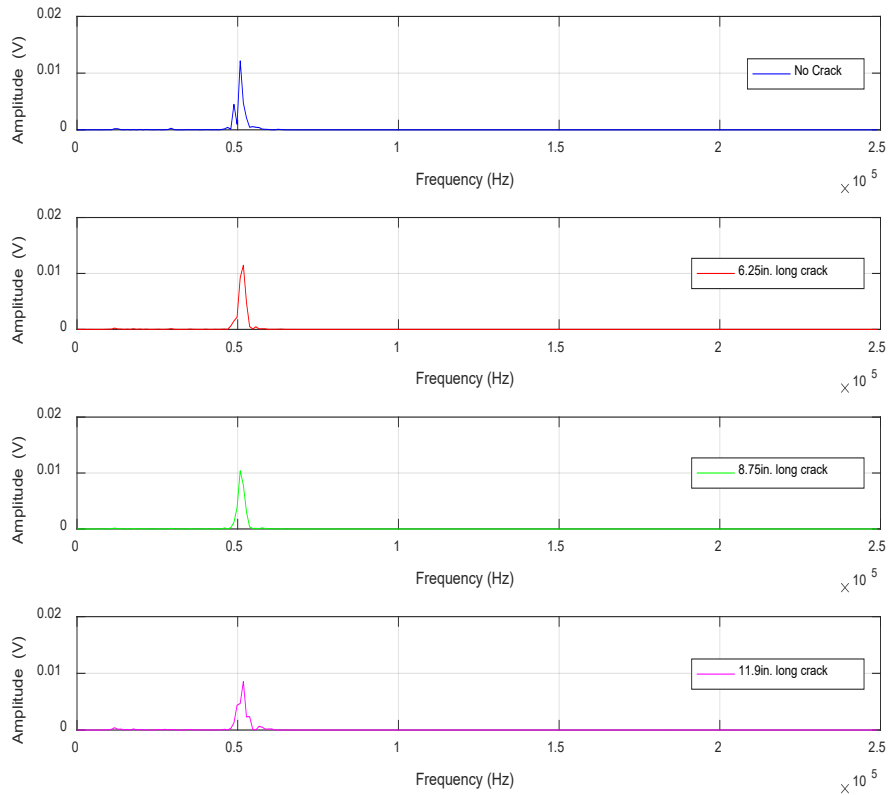
Figure 19- Amplitude of the leaked energy measured as shown in Figure 18.

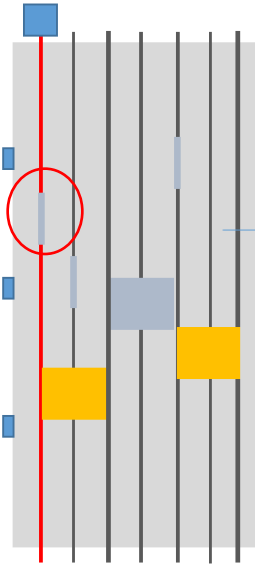
First, a delamination is introduced around some parts of the bars with laminates placed around while casting and the existence of this flaw was detected by several sensors along the length of the specimen as shown in Figure 20. The results in this test (Figure 21) showed that the amplitude of the leaked wave increased after the delamination region as expected.

Figure 20- Schematic of the setup for the testing for delamination around the bar (see circled area of inserted delamination)

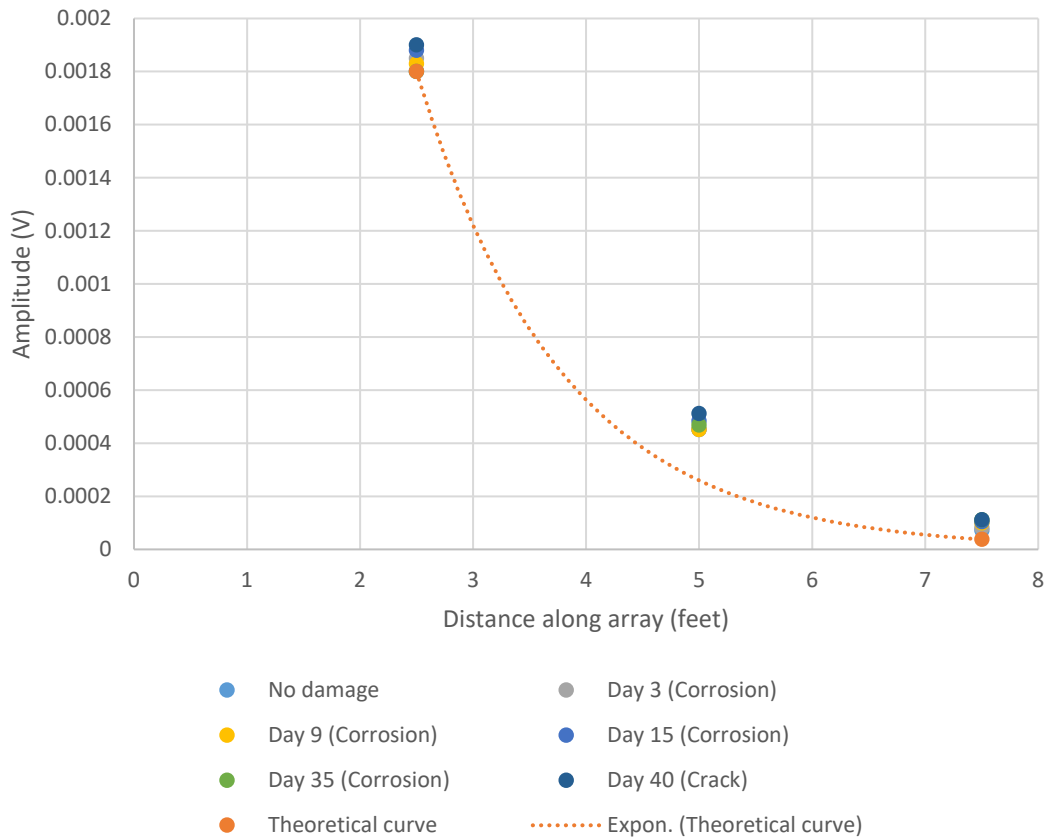
Figure 21- Amplitude versus distance plot for Specimen 3, 1st bar (as shown in Figure 20).

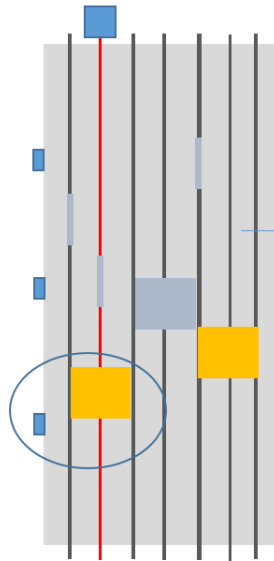
In the second test, the second bar (shown in red on Figure 22), was the one where the signals were transmitted and the purpose was to detect the corrosion. As shown in Figure 23, the amplitude increases after the corrosion zone.

Figure 22- Schematic of the setup for the testing for corrosion around the second bar (see circled area of corrosion)

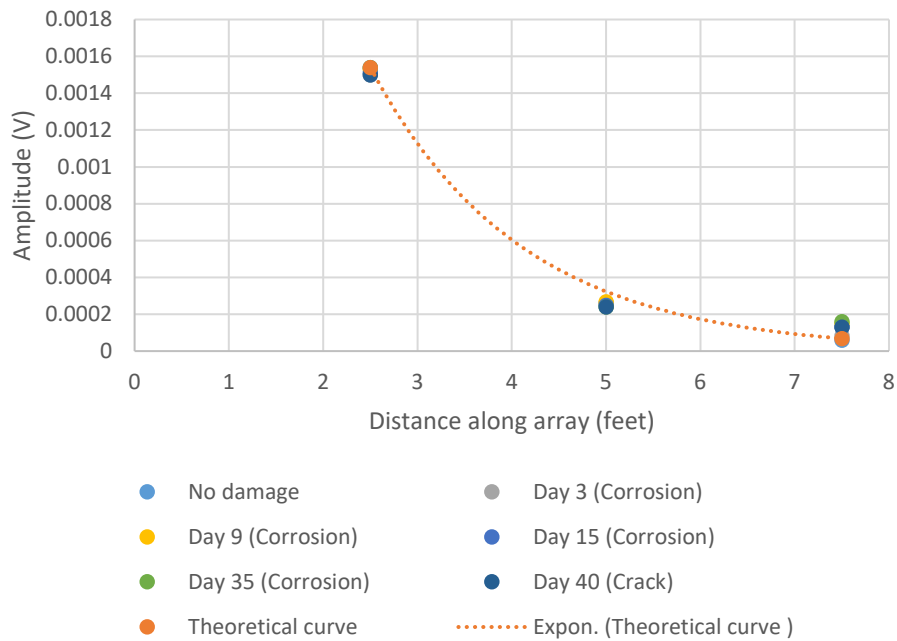
Figure 23- Amplitude versus distance plot for Specimen 3, 2nd bar (as shown in Figure 22).

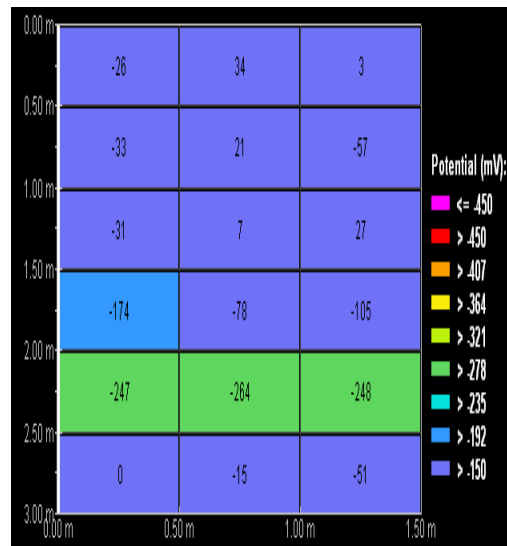
We used Specimen Set 3 to benchmark with GPR and HCP to compare the competencies of our method to these well known methods, specifically for corrosion detection. Figures 24 and 25 show a course scan and a finer scan with the HCP, respectively. This confirms, as expected, that the HCP can also detect the corrosion once it is formed at the same locations as our method. On hindsight, we realized that we should have tested with HCP continuously from the start in order to compare sensitivities of the two methods to very early corrosion detection and to quantify the amount of corrosion.

Figure 24- Course half-cell potential scan of the test slab for corrosion

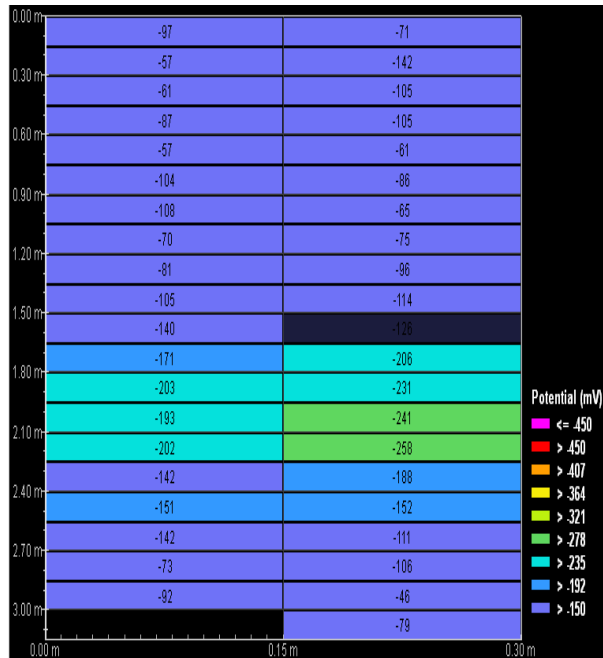
Figure 25- Fine HCP scan of the slab for corrosion detection

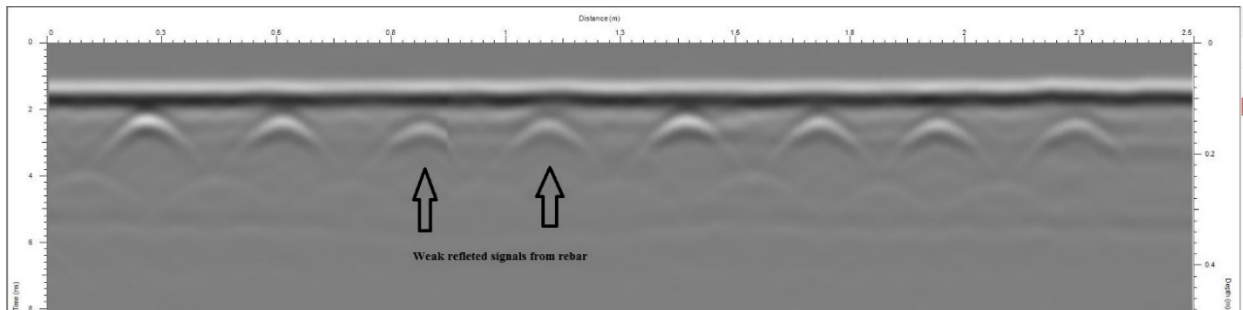
Finally, we also scanned the slab with GPR, and the results are shown in Figure 26. However, the results are inconclusive from GPR as expected. There seems to be a slight change in the hyperbolas indicating anomalies in the rebar reflections at the locations of corrosion, but they are not too different from reflections from the clean rebar regions. On the field, this type of result would be considered inconclusive and subject to a final call based on the operator’s judgment and expertise.

Figure 26- GPR results from the attempt to detect the corrosion areas on the rebar
