1. Report No P309	2. Government Accession No.	3. Recipient's Catalog No.	
4. Title and Subtitle Infrared Thermography-Driven Flaw Detection and Evaluation of Hot Mix Asphalt Pavements		5. Report Date January 2010

6. Performing Organization Code	
7. Author/s Yong K. Cho, Thaddaeus Bode, Yong-Rak Kim		8. Performing Organization Report No.	
9. Performing Organization Name and Address Peter kiewit Institute 1110 South 67th Street Omaha, Nebraska 68182-0176		10. Work Unit No. (TRAIS)

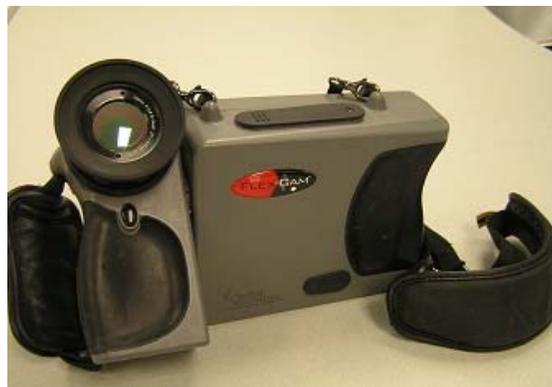
Figure 3.1 Infrared Camera

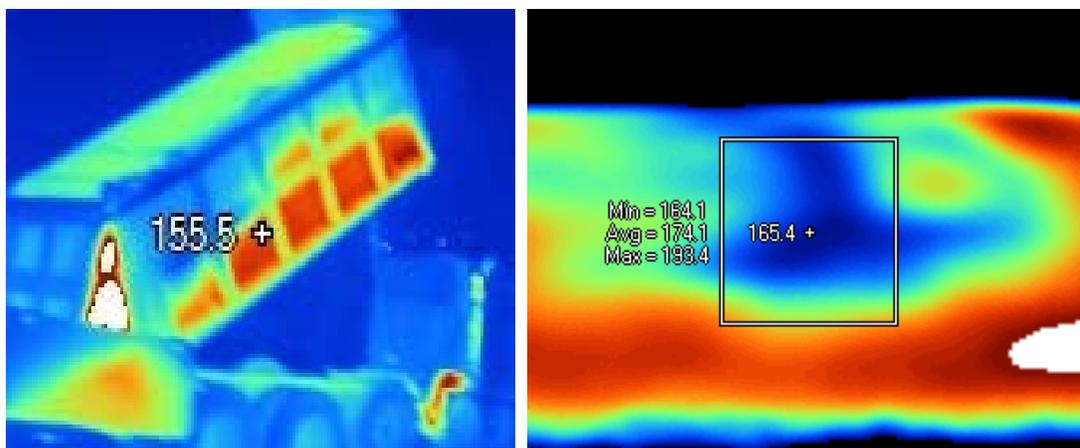
Figure 3.2 Heat loss from a truck (left) and temperature differential from a HMA mat (right) (temperatures shown in °F.)

For verification of the use of thermal image data in HMA applications, temperature readings were initially taken on the surface of the HMA as well as internally using a temperature probe. The internal and external temperature readings were compared to those obtained by the infrared camera. This was also done to ensure the specific infrared camera used in this study provided an accurate representation of temperature differentials. The accuracy of infrared cameras in general has already been proven in HMA applications from the University of Washington study, noting that both temperature probes and infrared cameras are adequate tools for proving temperature differentials (Willoughby & Kim, 2001). Figure 3.1 shows a Flex Cam XR2, the infrared camera used in this research. Figure 3.2 shows infrared images taken from Nebraska paving sites.

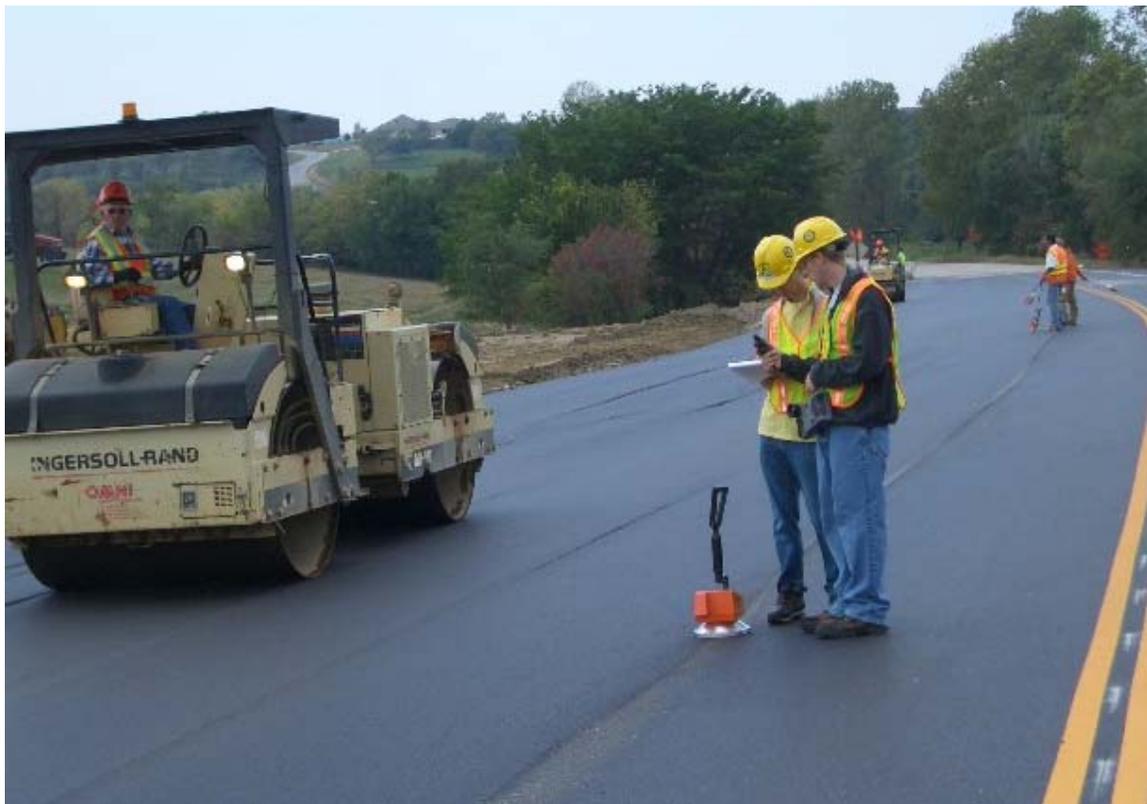
Figure 3.3 Taking PQI density readings onsite

The onboard electronics in the PQI then convert the field signals into material density. Once calibrated, direct density readings can be consistently obtained (TransTech, 2008). In this study, the PQI is calibrated by comparing PQI's density measurements with core samples (Bulk Specific Gravity) at each site. A Maximum Theoretical Density (MTD) value (RICE# or Maximum Specific Gravity) is required for the initial device calibration which can be provided from the asphalt mix designer. Then, the offset is adjusted after PQI calibration readings have been taken (Figure 3.3) and cores have been obtained from those same reading areas (Figure 3.4). An alternative method is also available by using a calibrated nuclear gauge to generate the offset needed by the PQI to accurately read densities. The use of nuclear gauge for calibration is especially useful when a paving job is fast-tracked to quickly open the road to public traffic. For this calibration process a nuclear density gauge is simply used rather than taking core samples. Using a nuclear gauge to calibrate the PQI has been validated by the Wisconsin DOT (Schmitt, 2006). Both methods were used as part of this study.

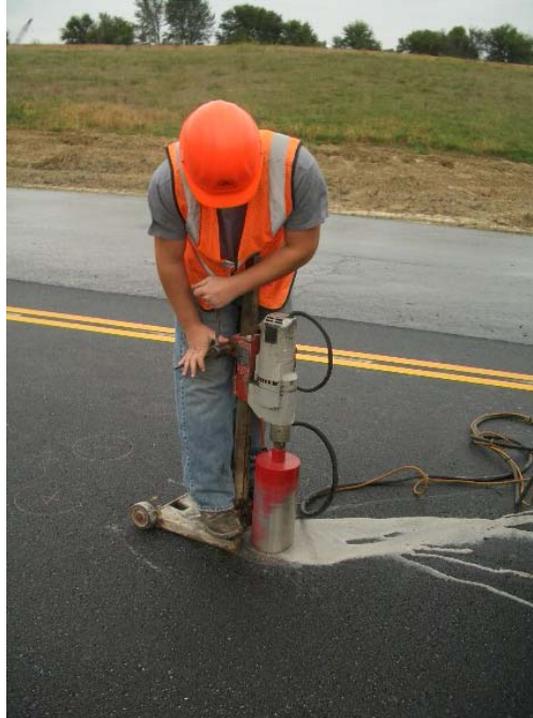
Figure 3.4 Taking cores for PQI calibration

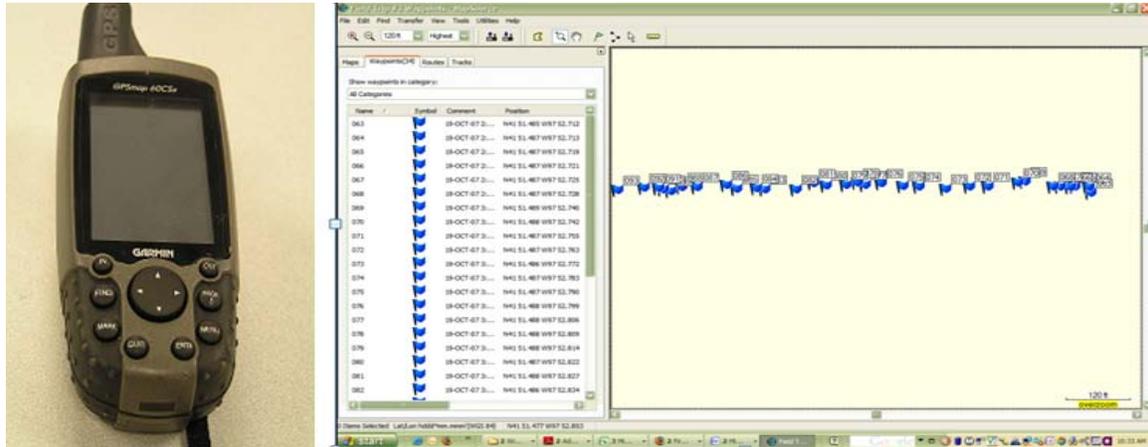
Figure 3.5 Handheld GPS Device and Jobsite Location Tags

readings within about 3 meters of the exact location (Garmin, 2007). By using GPS tags for each location, data was easily sorted during analysis and tied to digital maps which will be discussed later. It also allowed for the navigation back to selected locations, streamlining site re-visitation.

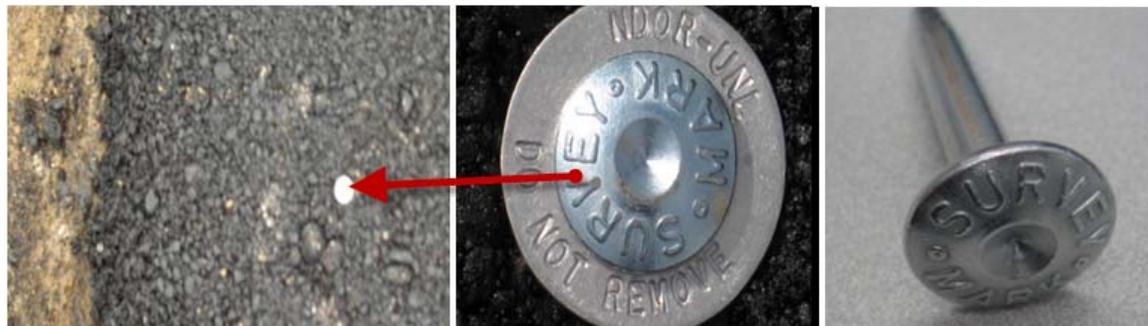
Figure 3.6 Physical Location Markers

In addition to digital markers, physical markers were used to mark the exact location of points of particular interest to the research team. These markers were specially designed pavement marking nails similar to surveyor markers shown in Figure 3.6. The physical markers were driven into the shoulder pavement while still malleable and a distance directly across from the marker to the location was recorded.

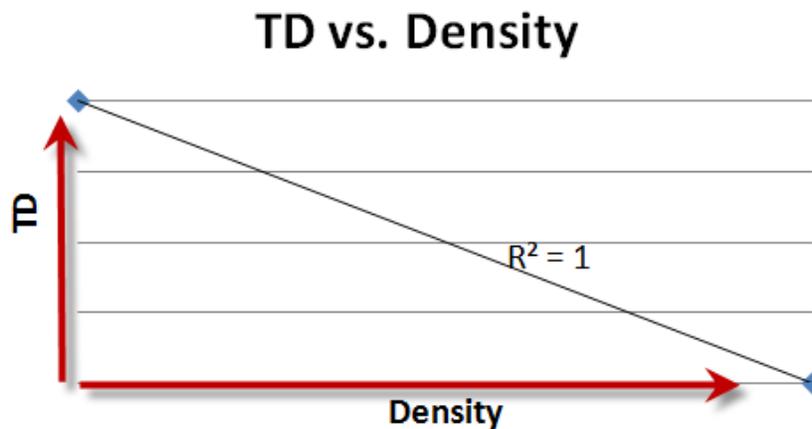
Figure 4.1 Theoretical relationship between temperature differential (TD) and pavement density

Throughout this project, 304 unique locations have been evaluated with the primary intention of investigating the effect that temperature differentials (TD) have within the HMA paving process. As found from earlier studies, the areas possessing increased temperature differentials after final compaction are expected to yield lower densities (Figure 4.1).

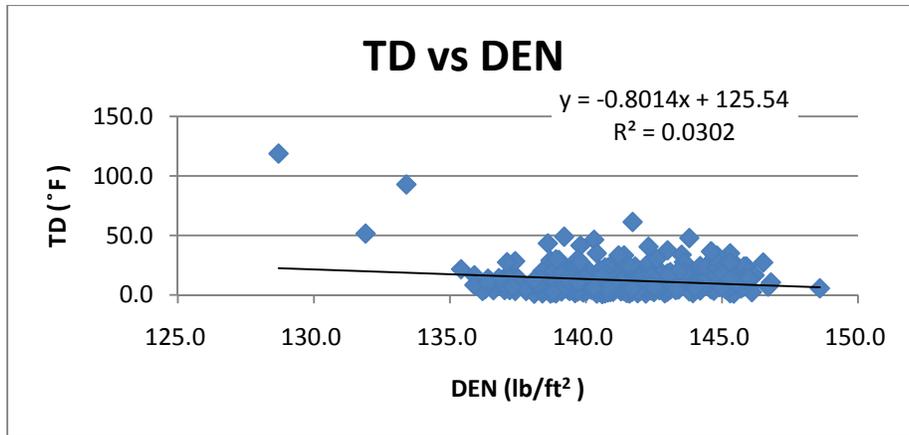
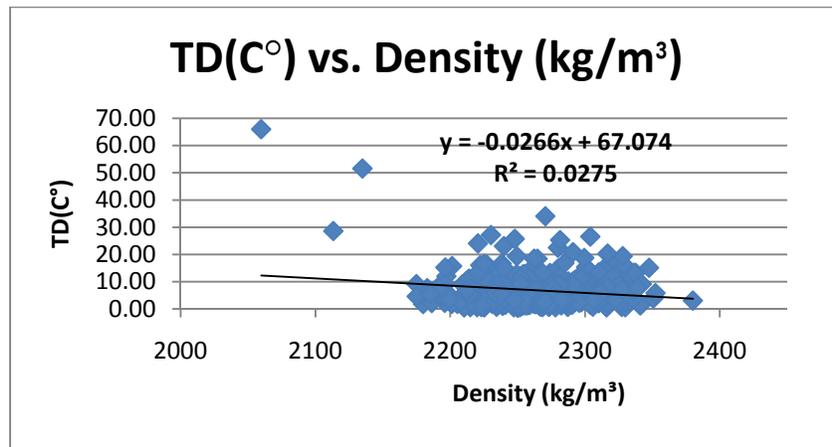
Figure 4.2 Relationship for All Collected Data Between temperature differential (TD) and density (DEN)

Although a negative relationship was found, the general analysis between temperature differentials (TD) after compaction and pavement density (DEN) showed the relationship between the two variables not to be significant (Figure 4.2). This analysis included all 304 density readings obtained throughout the project and charting them against their corresponding temperature differential.

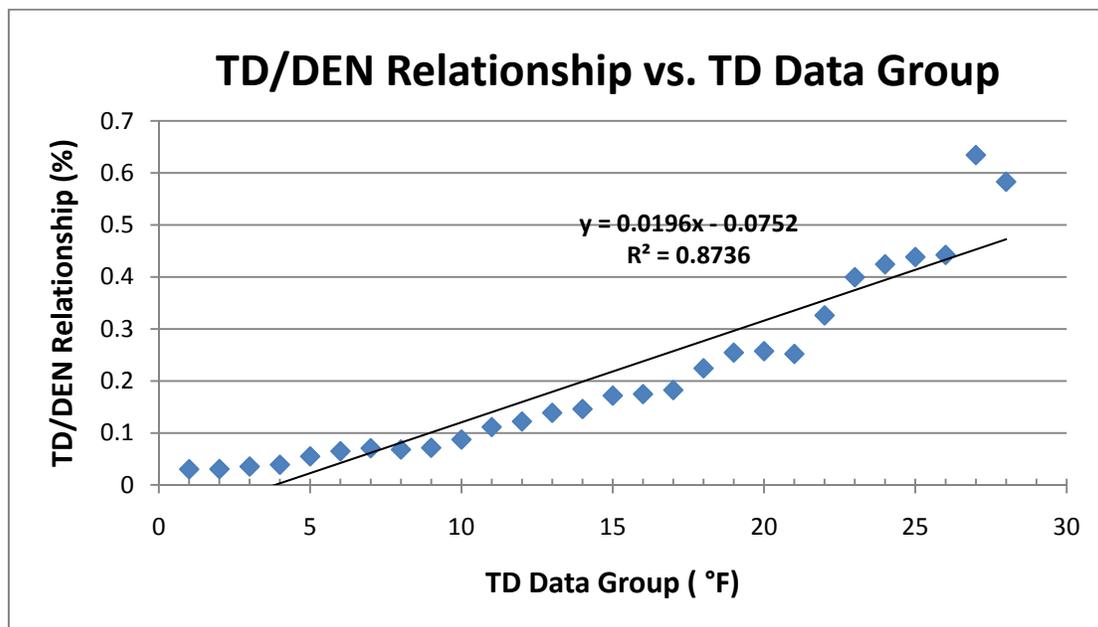
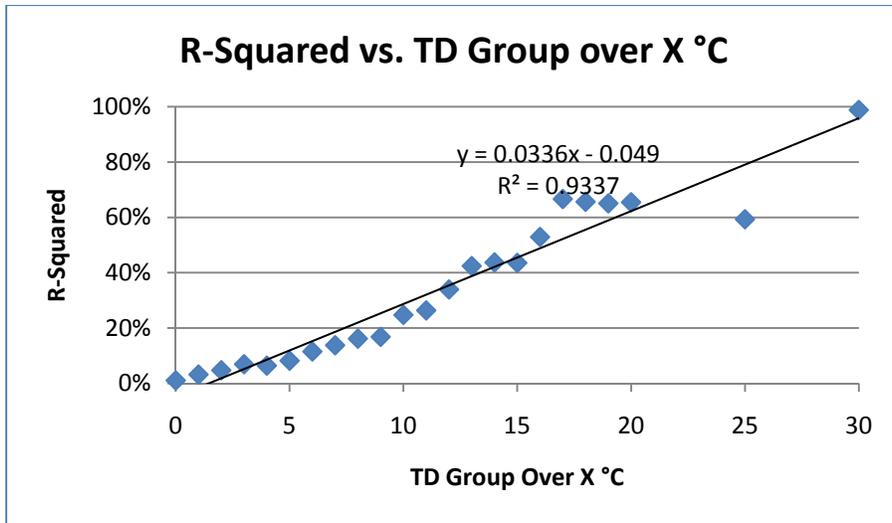
Figure 4.3 A graphical representation of the relationship between individual temperature groups and TD and DEN

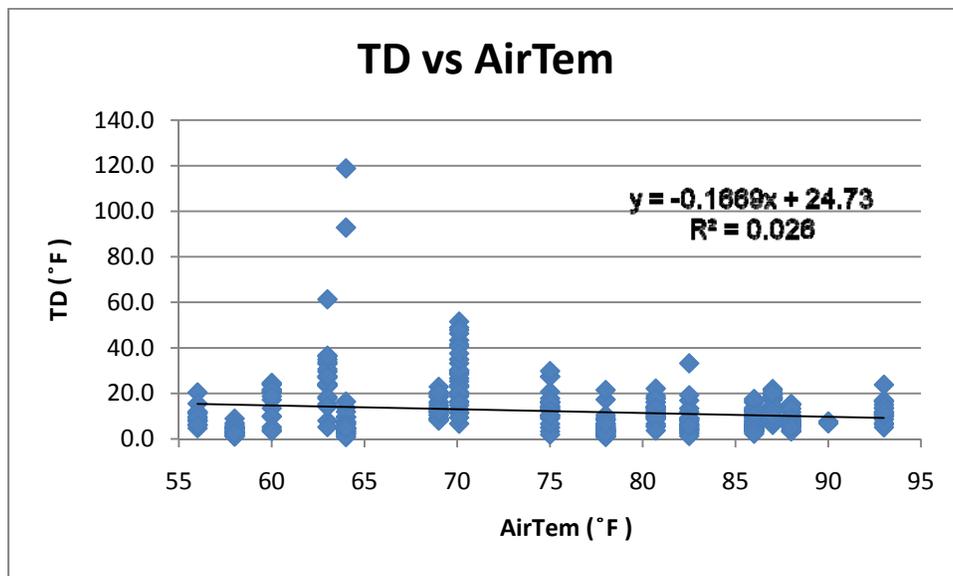
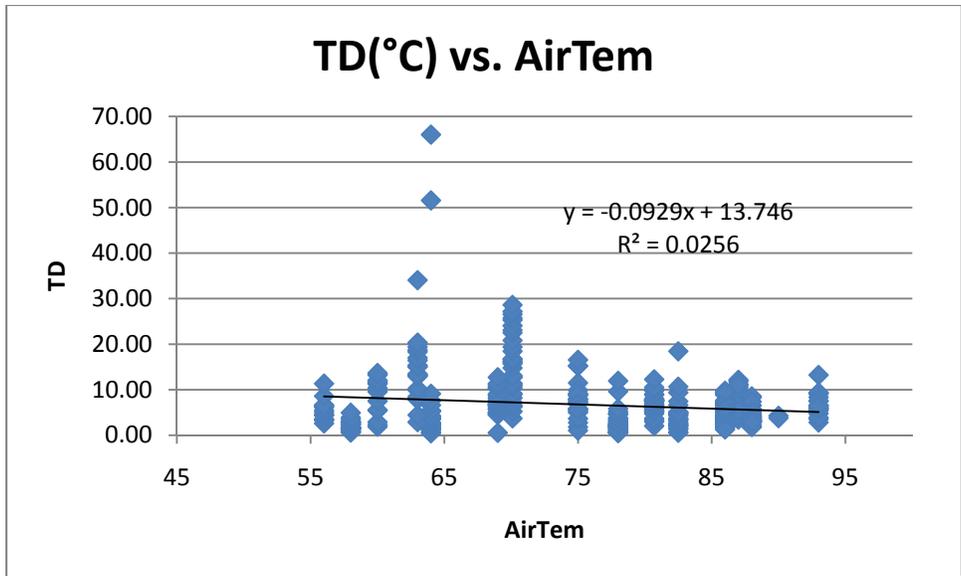
Figure 4.4 Relationship between ambient jobsite air temperature and temperature differential

The 18 site visits carried out during this project occurred at varied times throughout the paving season across Nebraska. Sites were visited in early spring, the middle of summer, as well as far into the fall paving season. By visiting at varied times of the year, the affect outside air temperature has on the instances of temperature differentials (TD) was able to be studied. It is a common practice for mix types to compensate for cold weather. Essentially boosting the mix temperature during manufacturing gives the laydown crew adequate time to use the material before it reaches its cessation point. It is still important however to investigate if these changes are sufficient at reducing temperature segregation. As can be seen in Figure 4.4 there was no statistically significant relationship ($r^2 = 0.026$) between the outside air temperature (AirTem) and the occurrence of temperature differentials (TD) during the typical paving seasons in Nebraska (between 50°F and 95°F).

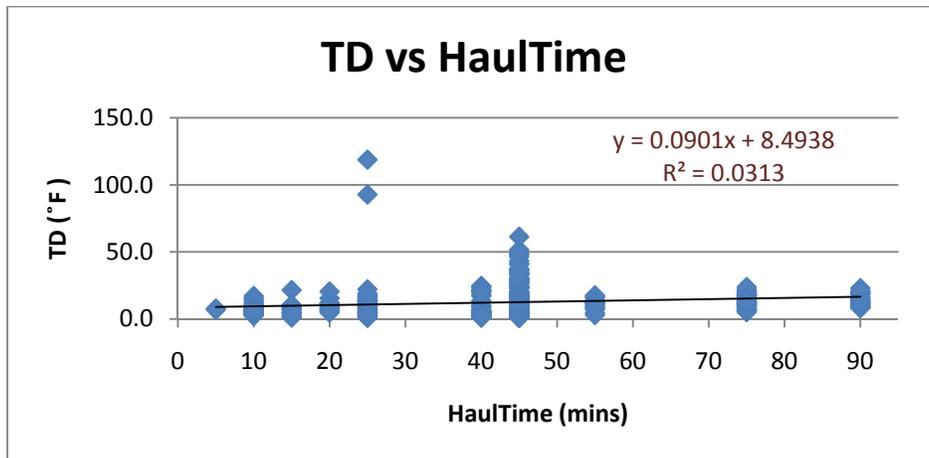
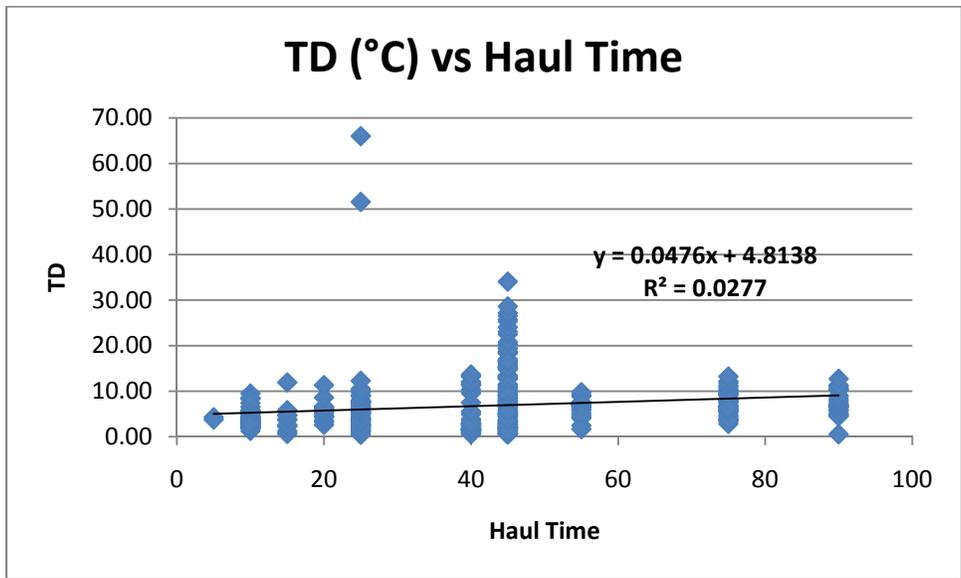
Figure 4.5 Relationship between Haul Time and Temperature Differentials

The effect of haul time in generating temperature segregations was investigated in this study. Increased effort was placed on visiting sites with longer haul distances. It was thought that increased haul times would translate to a thicker crust being generated during transportation. The thicker crust is generated because the periphery of the material cools faster in the truck bed than the interior material. Also, because of varied gradation and binder content in different mix types show variations in temperature differentials after transport. This point was proven throughout the data analysis of Site 13. Site 13 had the longest material transport time at 90 minutes (Figure 4.5); however, it exhibited decreased signs of temperature segregation. This is likely due to the gap graded crumb rubber modified binder used in the mix. These rubber modified mixes are manufactured at higher temperatures which extends their allowable transport time. Overall the relationship between haul time and temperature differentials was calculated at 3% (Figure 4.5). Greater than a 90 minute haul time may be required to see significant impacts on temperature differentials; longer haul distances could not be found to include as part of this study. A brief investigation of the mix types Nebraska uses and their allowable haul time would be a very appropriate study to further identify which mixes can be used for sites that are at risk of developing temperature differentials due to increased haul times. Overall, this investigation indicates that current remixing practices carried out onsite are sufficient at preventing temperature segregated material.

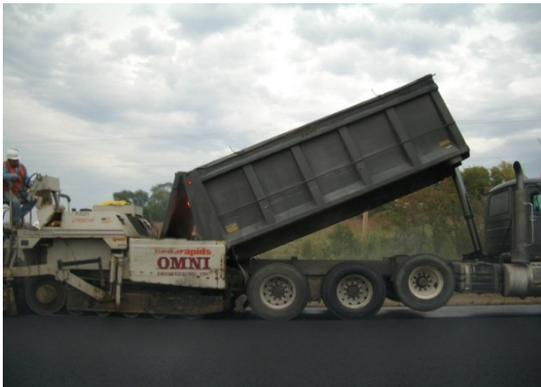
Figure 4.6 Direct dump between truck and paver

There are two types of material feeding processes from a delivery truck to a paver in Nebraska. Either HMA trucks directly dump delivered HMA into the hopper of a paver (Figure 4.6), or belly dump trucks and live belly dump trucks deposit the material ahead of a pickup machine which scoops up the HMA and transfers it into the hopper of a paving machine (Figure 4.7). Unlike a material transfer vehicle (MTV), such as RoadTec Inc.'s Shuttle Buggy MTV, the pick-up machine does not have a special remixing auger or chute.

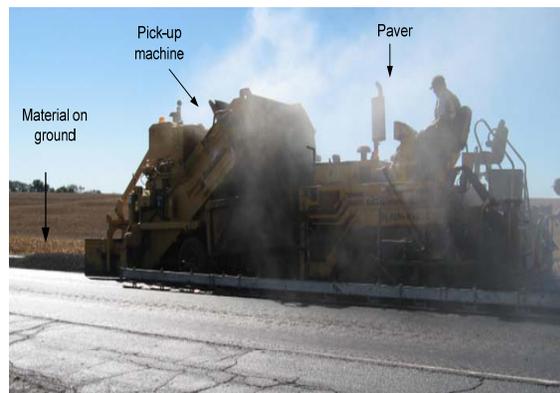
Figure 4.7 Pick-up machine with paver

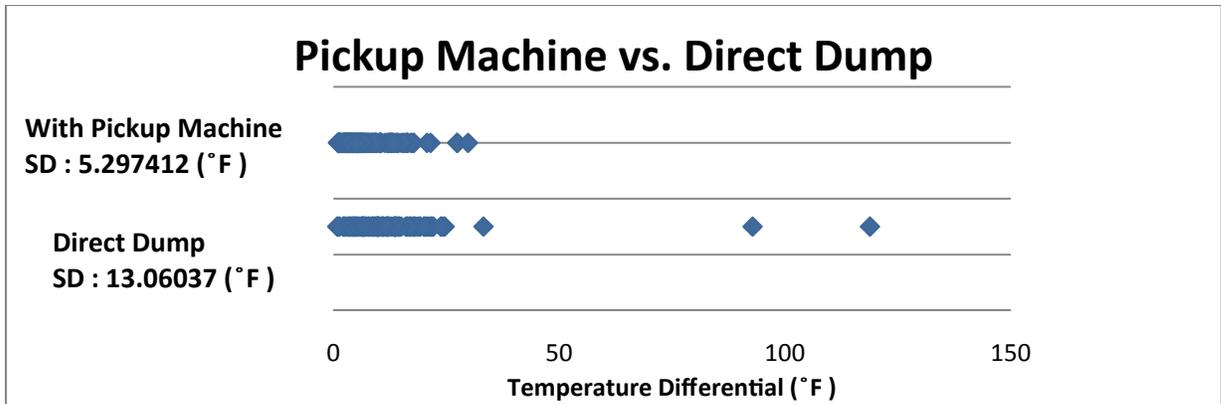
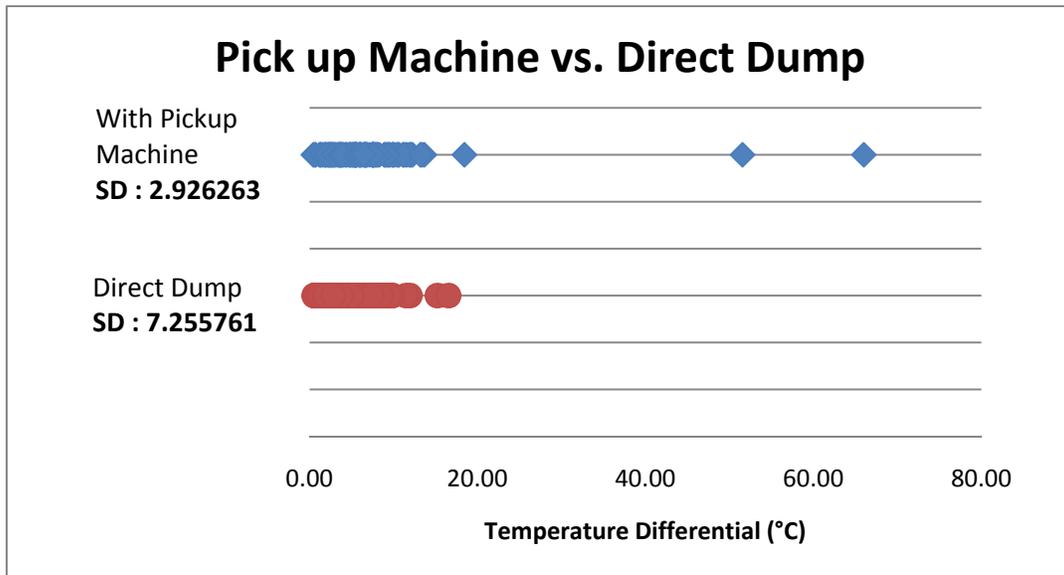
Figure 4.8 Temperature Differential based on feeding types

Figure 4.8 shows the temperature differential variation for each material feeding process. When a pick-up machine is used between a belly dump truck and a paver, the completed material shows a more consistent temperature profile (standard deviation=5.3°F) than when a truck directly dumps HMA material into a road paver's hopper (standard deviation=13.1°F). The significantly smaller standard deviation demonstrates how a pickup machine is a very cost-effective solution to reduce temperature differential of delivered HMA without using expensive MTVs.

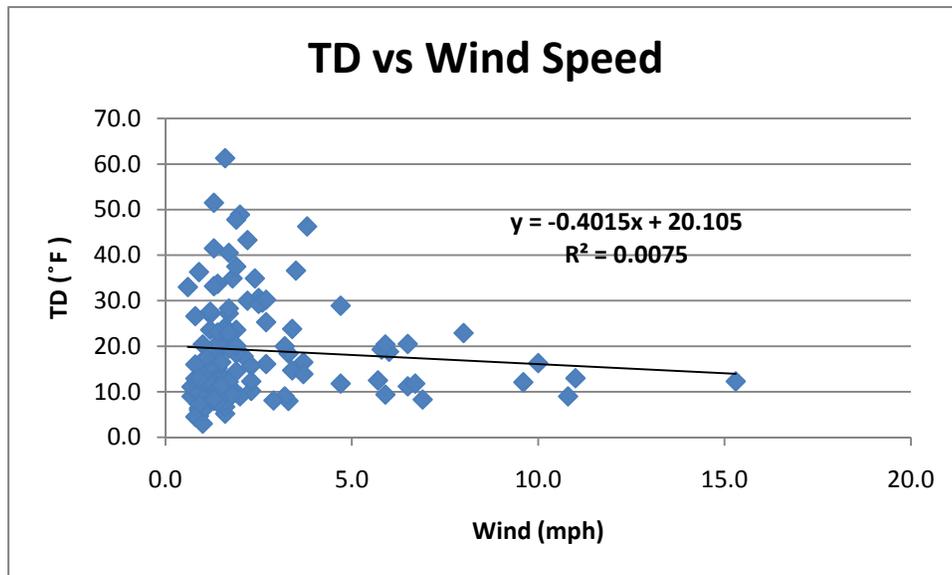
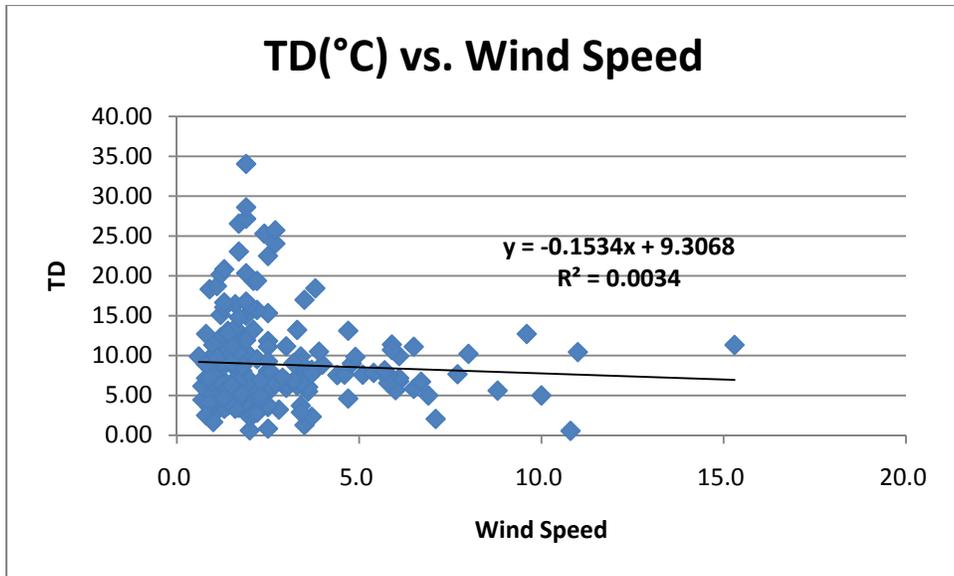
Figure 4.9 Relationship between wind speed and temperature differentials (TD)

Wind speed was collected at each location for Sites 11-15 with a hypothesis that its effects could lead to HMA temperature segregation (Figure 4.9). The data suggests that wind speed has a negligible effect on temperature segregation, showing less than a 1% relationship. This is because the wind is likely affecting the pavement overall, rather than focalized areas.

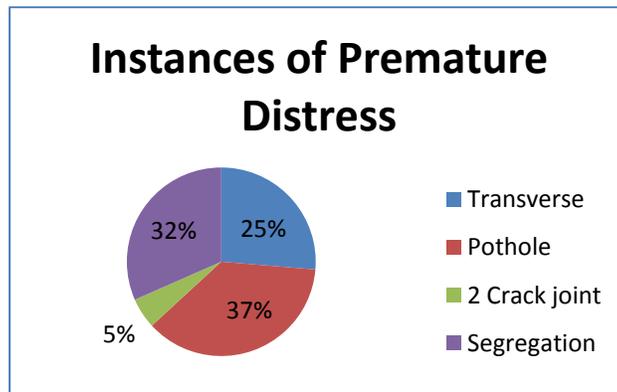
Figure 5.1 Instances of Premature Distress

Total Instances of Premature Distress by Type				
Total	Transverse	Void	Multi-Crack joint	Segregation
76	19	28	5	24
100.00%	25.00%	36.84%	6.58%	31.58%

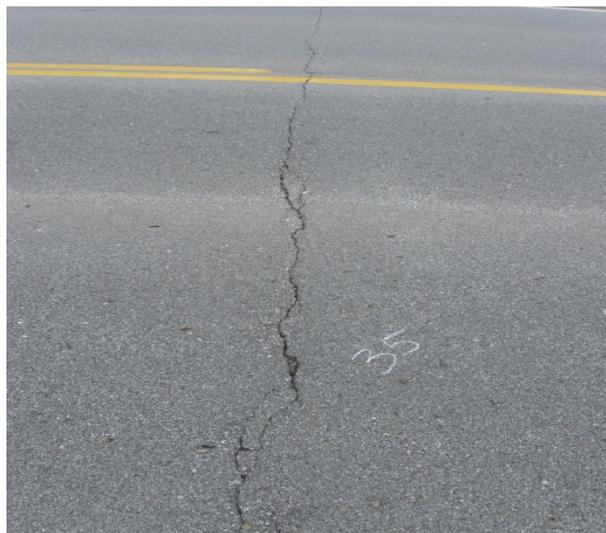
Figure 5.2 Observed Transverse Crack

The picture below is indicative of a transverse crack (Figure 5.2). Transverse cracks are formed perpendicular to the direction the asphalt paver, and are often the result of asphalt shrinkage. Because areas of different temperature expand and contract at different rates, transverse cracks are of particular interest in this investigation. Cracks of this type also often occur as reflective cracks which will be discussed later.

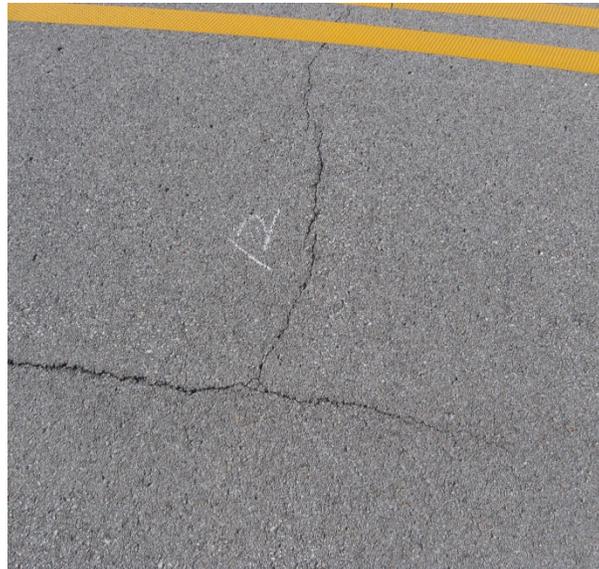
Figure 5.3 Observed Multi Crack Joint

In referencing the Asphalt Institute’s article on *Understanding Asphalt Pavement Distresses-Five Distresses Explained* (Walker, 2009), it was found that there was no singular designation for the type of flaw shown below in Figure 5.3. Because this flaw appears to be a meeting of one longitudinal crack and one transverse, it will be further identified as a multi-crack joint. The primary reasons these multi-crack flaws are formed can be assumed to be a combination of the reasons for transverse cracks and longitudinal cracks. Longitudinal cracks are often formed due to shrinkage, reflective cracking, and longitudinal segregation caused by poor paver operation. The reason transverse cracks are formed have been stated previously (Walker, 2009).

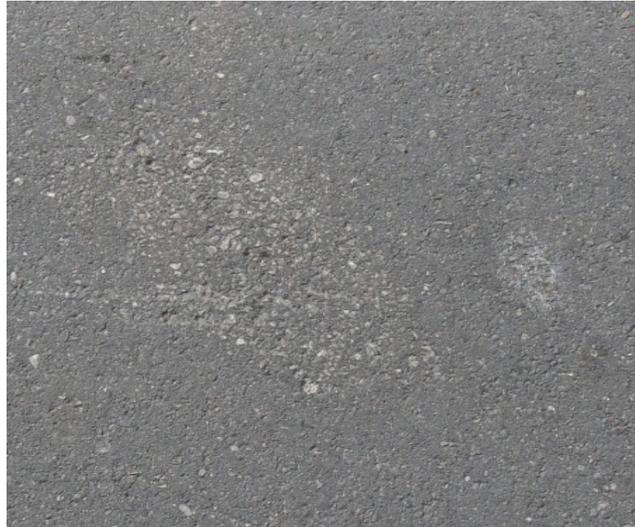
Figure 5.4 Observed Material Segregation

to fine aggregate as well as low asphalt content (Williams et. al 1996). Aggregate segregation in HMA can be caused by improper mixing. Aggregate segregation leads to flaws like: accelerated rutting, fatigue failure, and potholes (Williams et. al 1996; Walker, 2009).

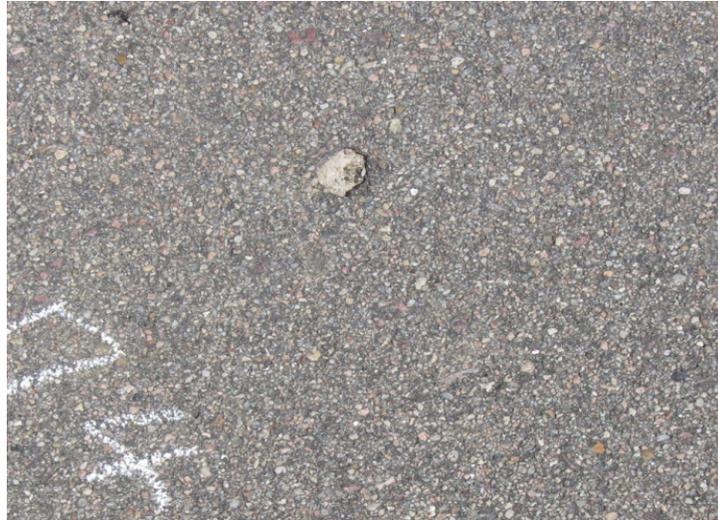
Figure 5.5 Observed Surface Void

An example of an early pothole is shown below in Figure 5.5. To be clear, for purposes of the first year's revisit report, a pothole was taken to be any small void larger than a quarter sized coin. These identified surface voids have not become detrimental to overall pavement quality yet, however, it was important for the research team to tag these locations, as these small surface voids have the potential of developing into major problems. It is the team's hypothesis that these small potholes have developed from large pieces of aggregate cracking or popping out of the surface of the pavement during the freeze- thaw cycle. Because these potholes have not degenerated pavement qualities to date, later data analysis deals with their inclusion at certain times.

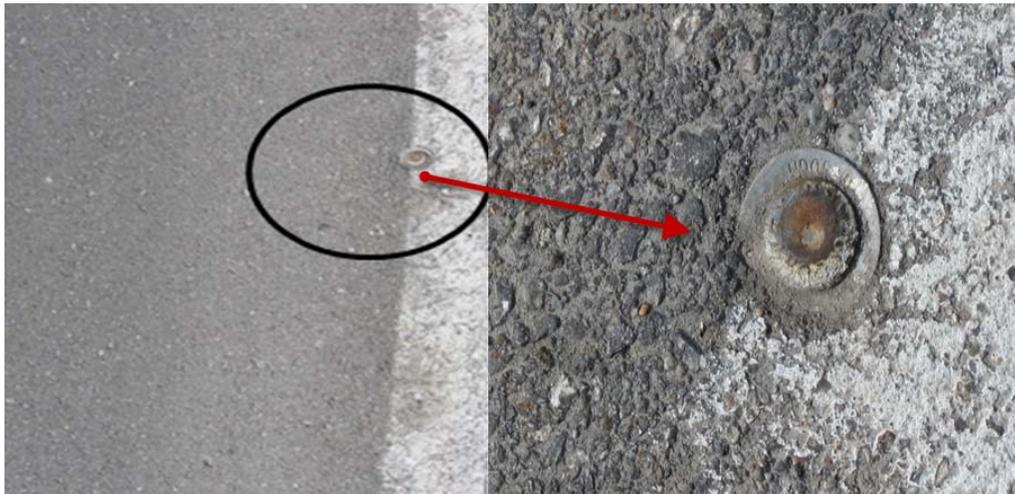
Figure 5.6 Observed Marker After One Freeze Thaw Cycle

The site revisits for all fourteen sites were conducted between eight and eighteen months after the initial site visit. At each site, a handheld GPS unit was used to locate each location that was investigated at the time of paving. Additionally, some exact locations were found based on survey markers placed along the shoulder of the road. Figure 5.6 shows what these markers looked like after one freeze thaw cycle.

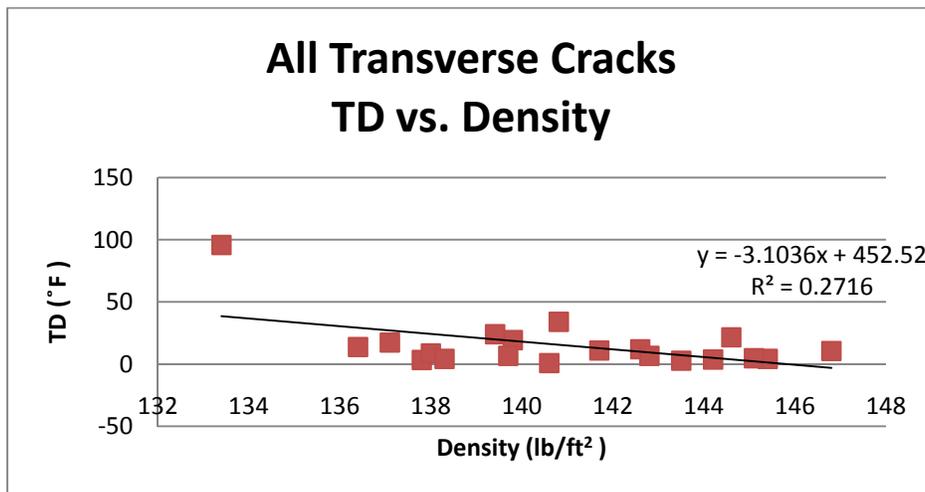
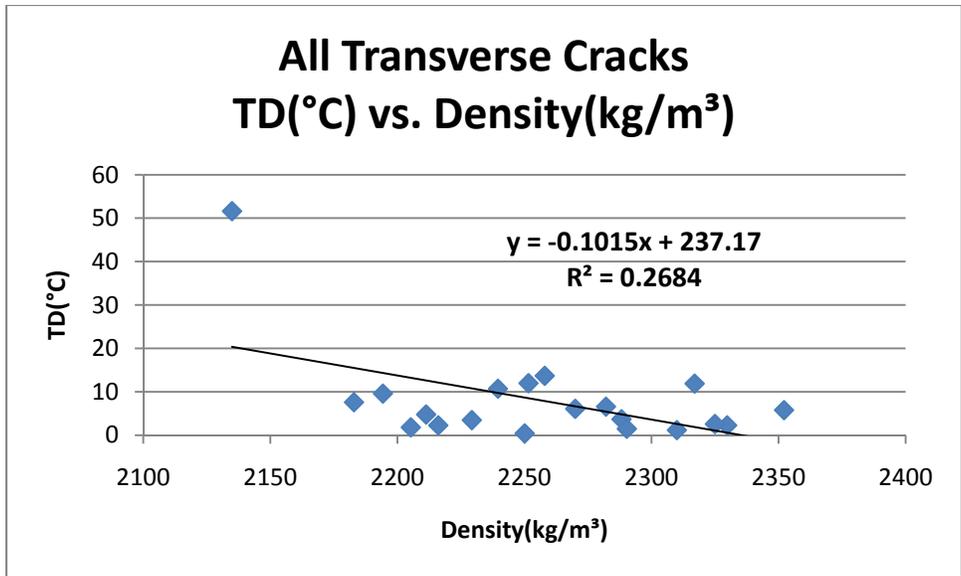
Figure 5.7 Relationship of TD and Density among Transverse Cracks

Twenty instances of transverse cracks were noted during the first year's re-visitation. As this research is primarily concerned with the overall relationship between temperature differentials and density, all twenty locations were evaluated based on that criteria. After calculating their relationship, a correlation of just over 27% was obtained (Figure 5.7). This correlation was lower than expected because the collected data includes reflective cracks which were not affected by temperature differential.

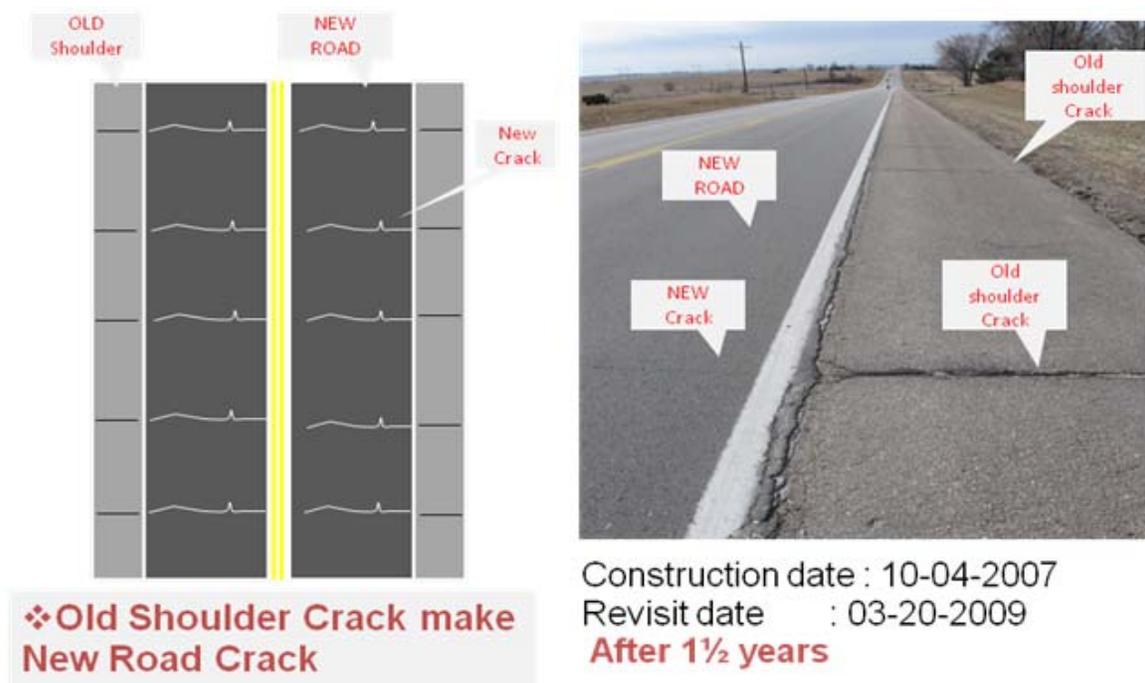
Figure 5.8 Plan view of roadway exhibiting reflective cracks (Left) Observed reflective cracking (Right)

After collecting individual location data and preliminary analyses were conducted, each site was considered as a whole. It was during this second phase of data analysis that the research team decided it was important to take a closer look at the instances of repetitive transverse cracks because some were suspected of being reflective. Reflective cracks occur when cracks in older asphalt or concrete joints are reflected upon the new asphalt overlay. A series of graphics depicts what reflective cracking looks like in Figure 5.8.

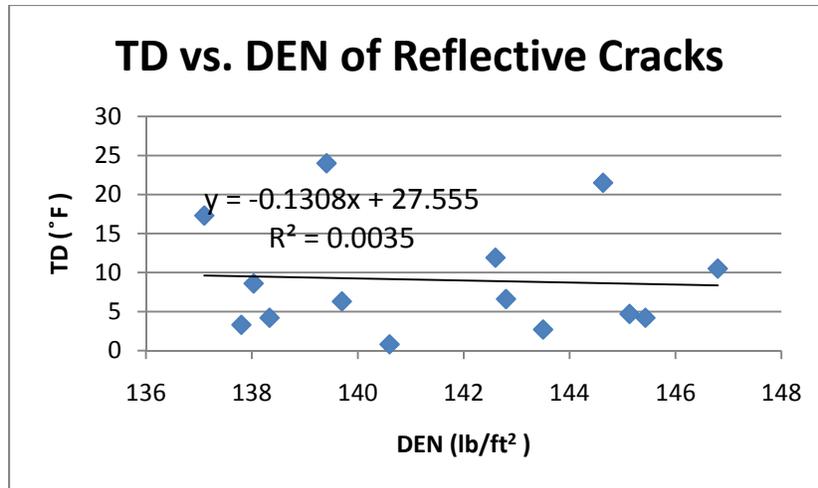
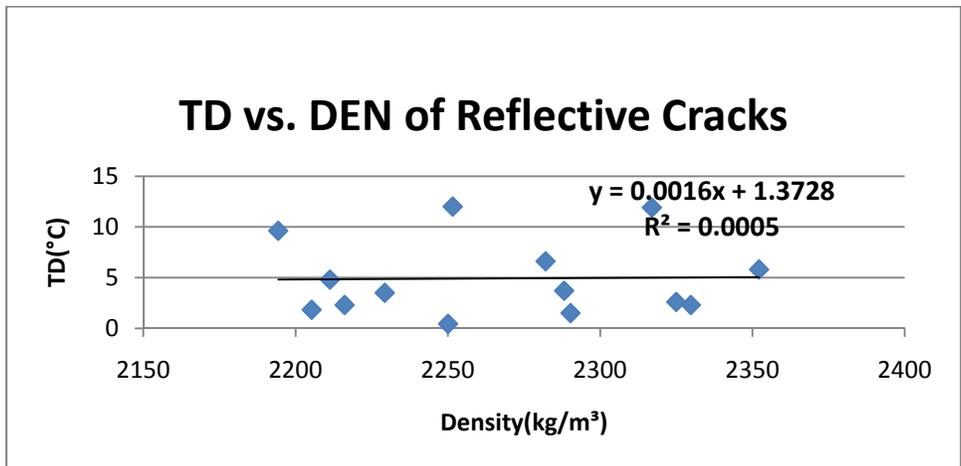
Figure 5.9 Temperature Differentials and Density Relationship Among Reflective Cracks

From the 20 observed instances of transverse cracking, 14 were found to exhibit signs of reflective cracking. When analyzing the 14 locations alone, a relationship of less than 1% was found between temperature segregation and density. This analysis further solidifies the researcher's assumption that these locations were caused by cracks permeating up through old layers of material (Figure 5.9).

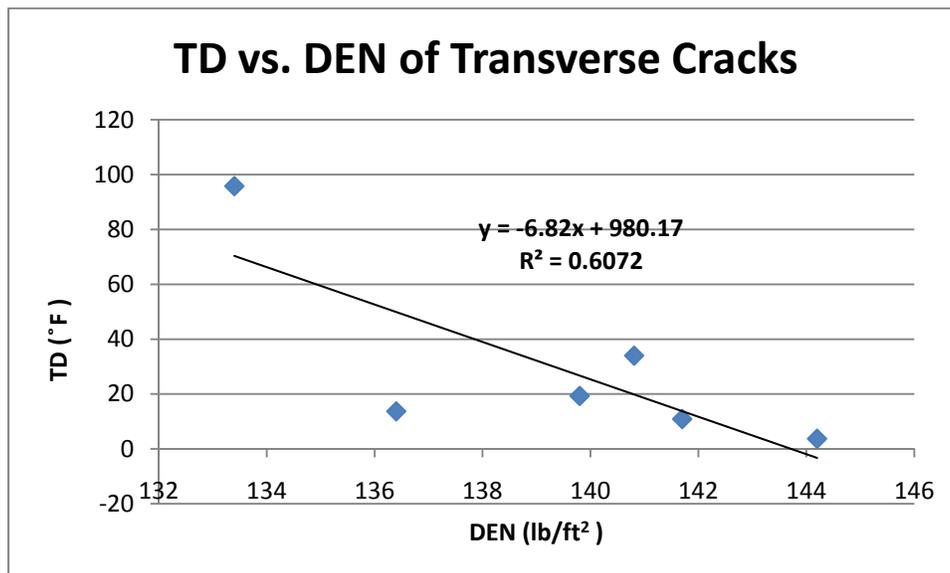
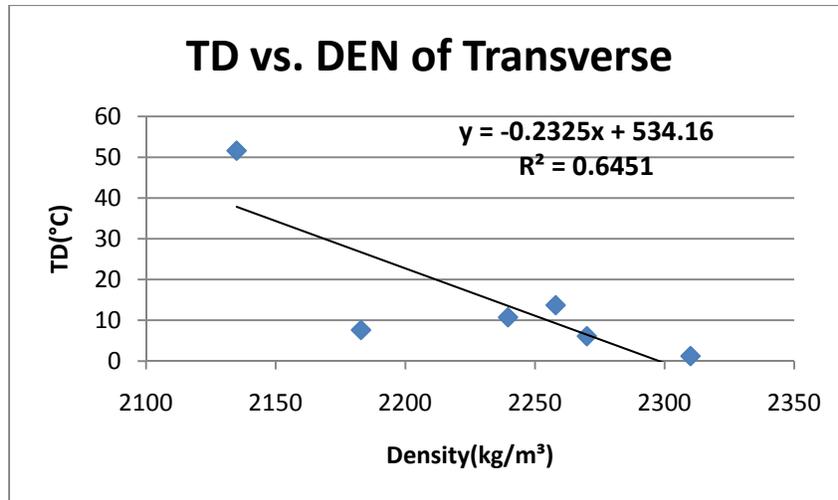
Figure 5.10 Relationship between temperature differentials (TD) and density (DEN) excluding reflective cracks

The 14 locations were not further included in data analysis as these locations were almost certainly influenced primarily by the previous pavement underlayments. After excluding the suspected reflective cracks, the remaining six transverse cracks that had developed were found to pose an increased relationship (60.7%) between temperature differentials and density (Figure 5.10).

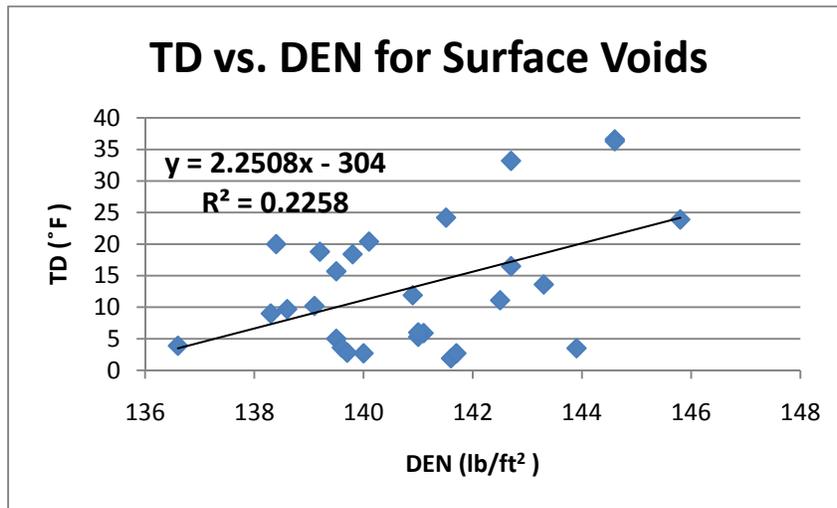
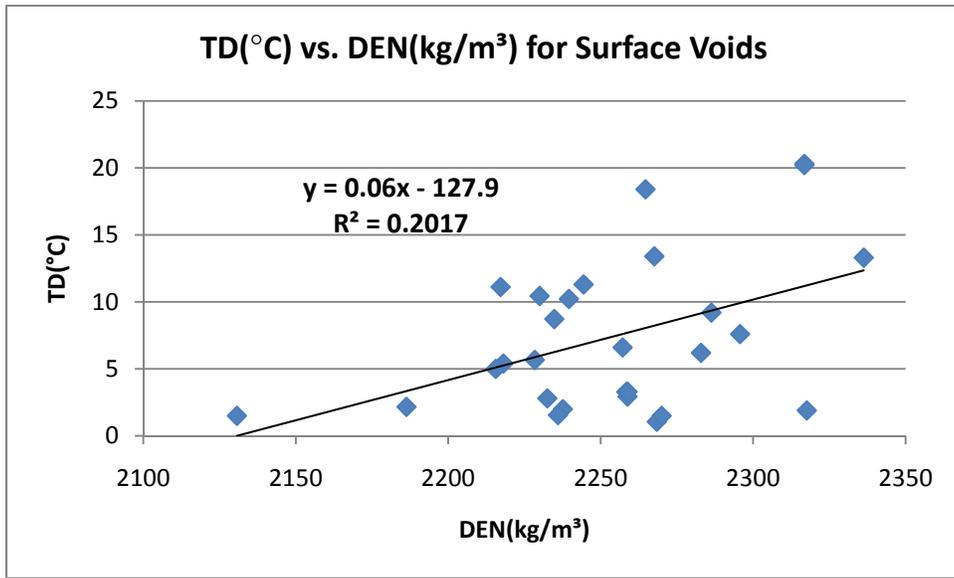
Figure 5.11 Relationship Between Temperature Differentials (TD) and Density (DEN) Among Surface Voids

Small surface voids, or “potholes” for purposes of this report, have proven to be a counter-intuitive flaw. It is assumed that the surface voids in the material will begin to develop at specific locations because of inadequate densities. One primary cause of inadequate density, and the focus of this research, is due to temperature segregation, namely cold spots. It is assumed that these cold spots would “set up” faster than the surrounding warmer temperatures, thereby increasing its ability to resist compaction. However, when analyzing locations classified as a surface void (or pothole), a positive relationship was found between temperature differentials and pavement density. This positive relationship follows counter to the assumed negative relationship where high temperature differentials would translate to low densities. This is more easily explained by referencing Figure 5.11 below.

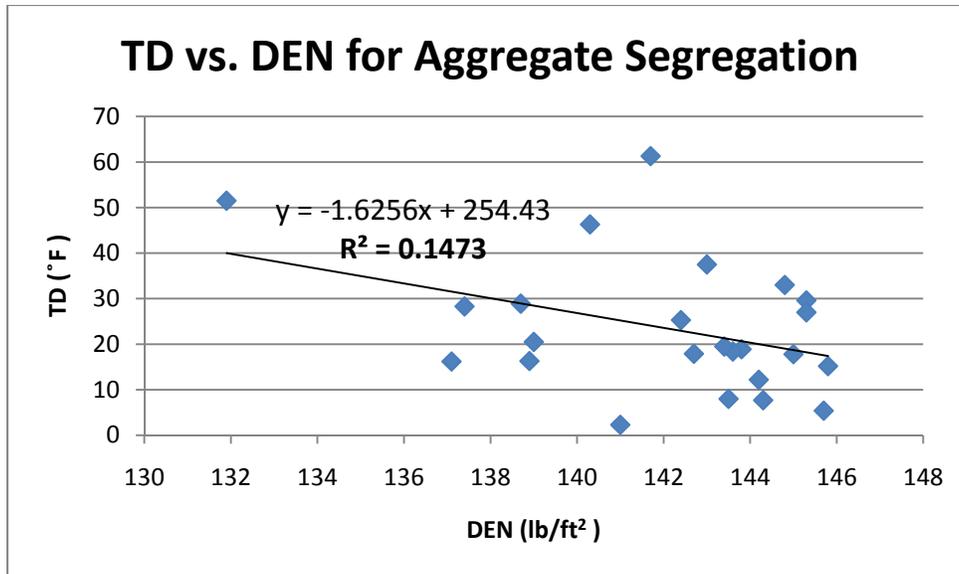
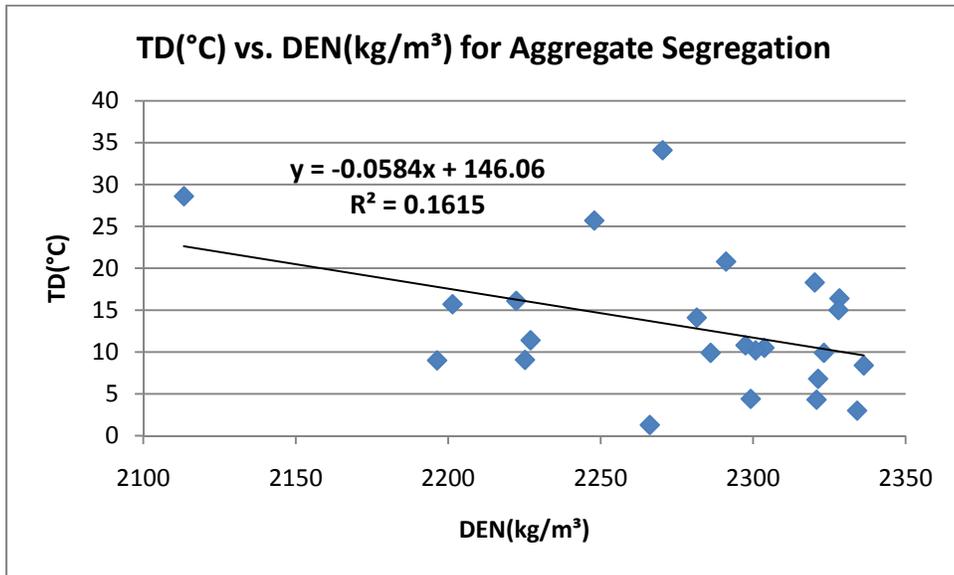
Figure 5.12 Relationship Between Temperature Differentials (TD) among Aggregate Segregation

Of the 24 locations with visible material segregation, a 15% negative relationship was found between temperature differential (TD) and density (DEN).

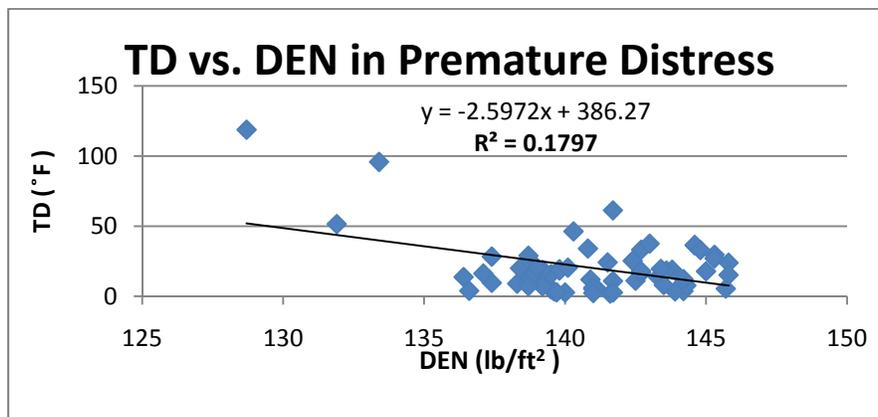
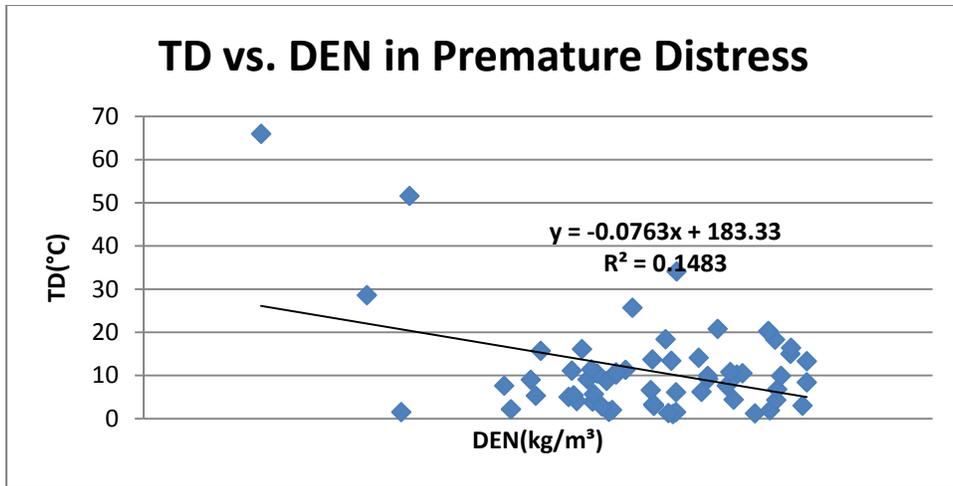
Figure 5.13 Relationship Between Temperature Differentials and Density Among Total Instances of Observed Premature Distresses
