1. Report No P309	2. Government Accession No.	3. Recipient's Catalog No.	
4. Title and Subtitle Infrared Thermography-Driven Flaw Detection and Evaluation of Hot Mix Asphalt Pavements		5. Report Date January 2010

6. Performing Organization Code	
7. Author/s Yong K. Cho, Thaddaeus Bode, Yong-Rak Kim		8. Performing Organization Report No.	
9. Performing Organization Name and Address Peter kiewit Institute 1110 South 67th Street Omaha, Nebraska 68182-0176		10. Work Unit No. (TRAIS)

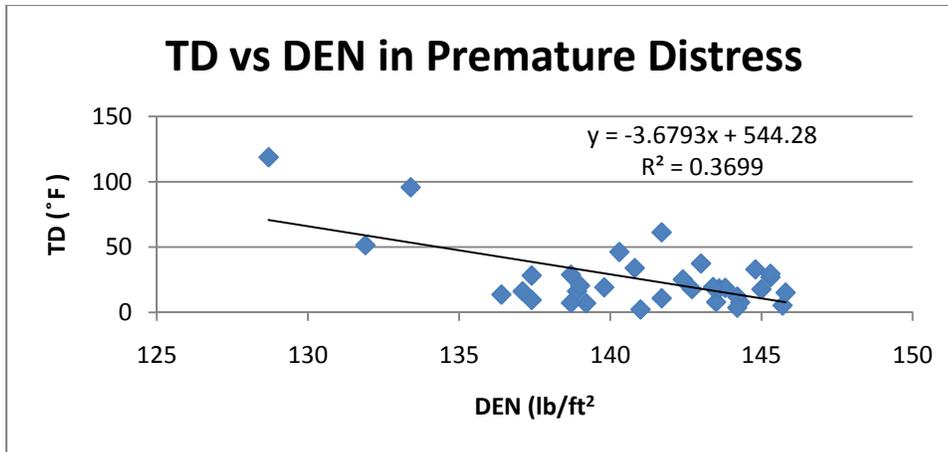
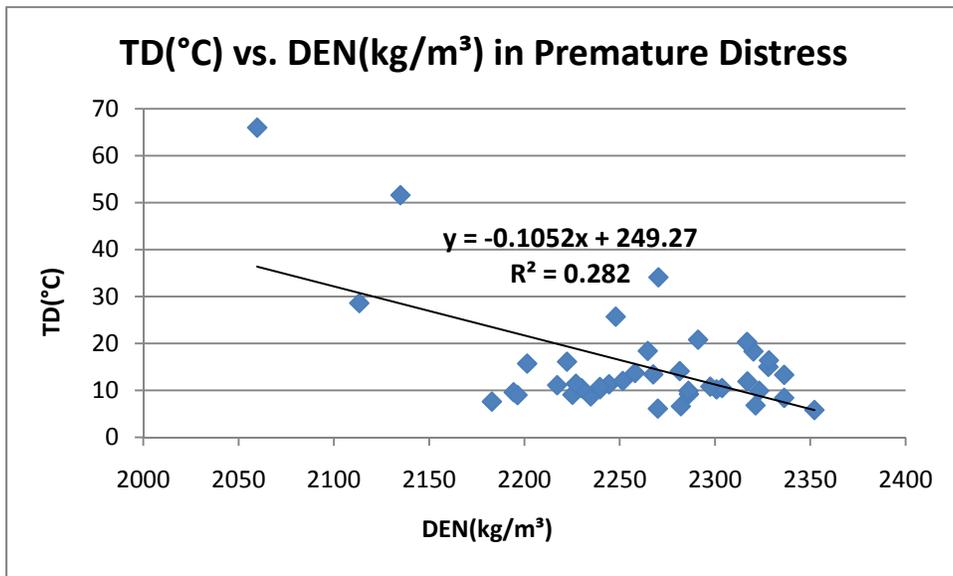
Figure 5.14 Relationship Between Temperature Differentials and Premature Distresses, Excluding Small Surface Voids

Recall, however, that when analyzed individually the pothole type of flaw exhibited a positive relationship between TD and density. Because all other flaw types show signs of being affected by temperature differentials in regard to their corresponding densities, while the locations with small voids do not, they were removed from the data set. The remaining 34 premature distresses or flaw locations were analyzed with regards to TD and density, and found to have a relationship of 37% (Figure 5.14); an improvement of 19% over the inclusion of small voids.

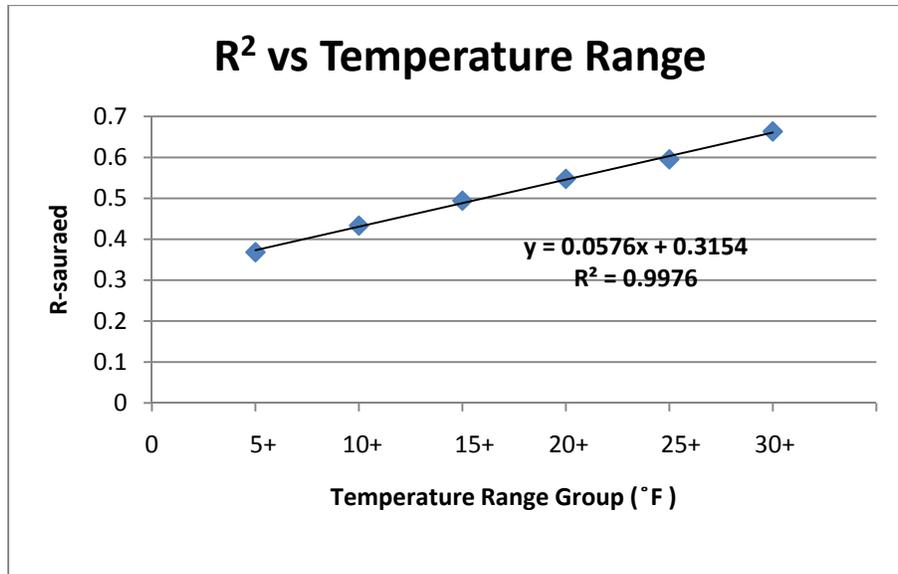
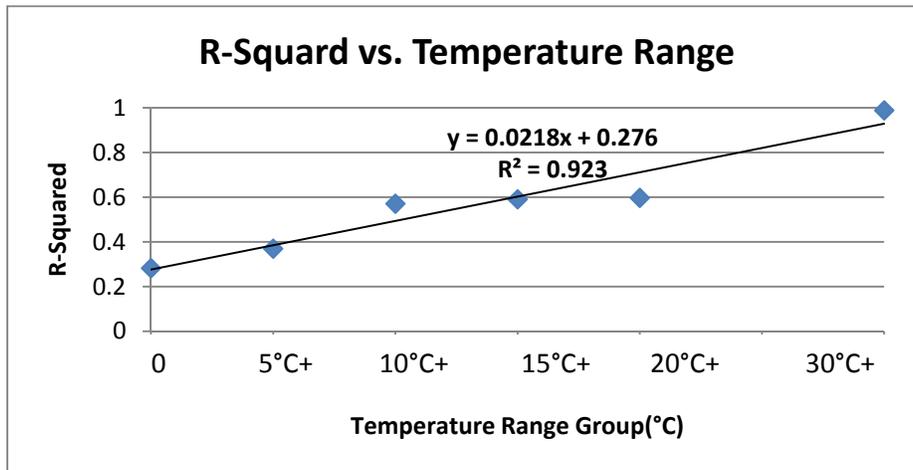
Figure 5.15 Relationship between the correlation of TD and DEN for a given temperature range and the temperature range group

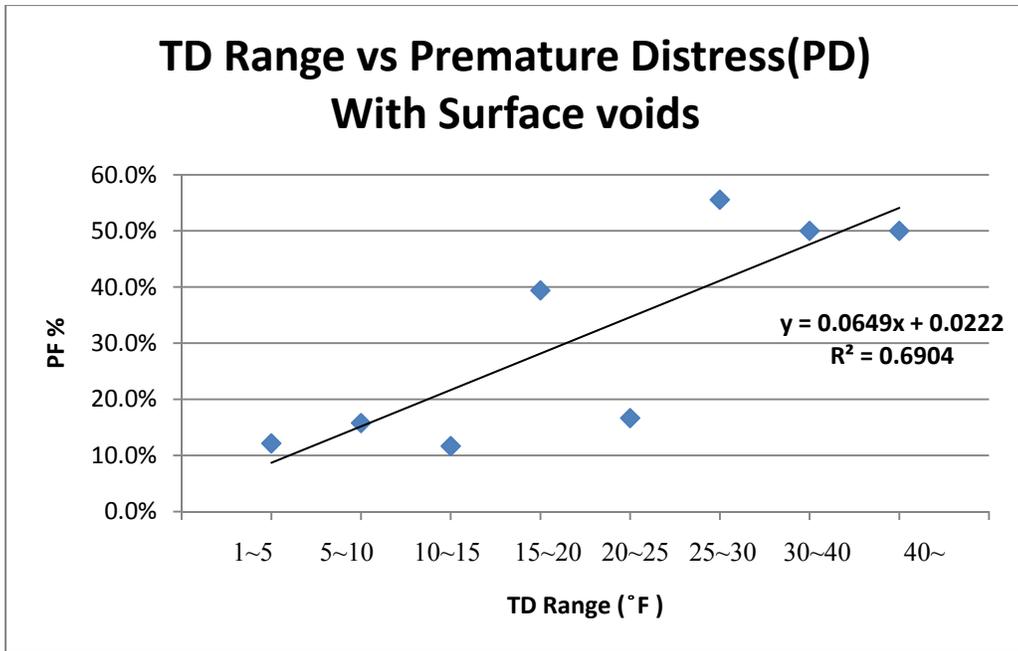
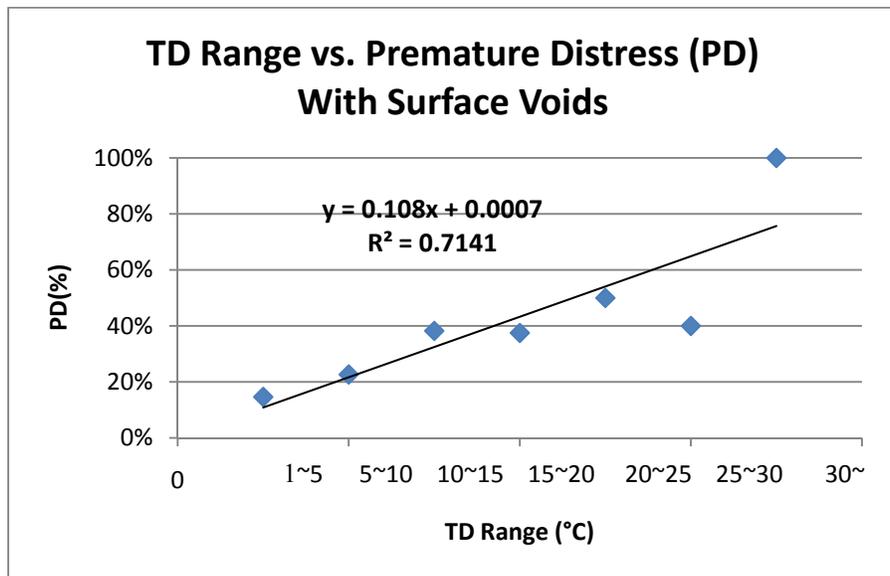
Figure 5.16 Correlation between the percentages of premature distresses, including surface voids, found within a specified temperature range

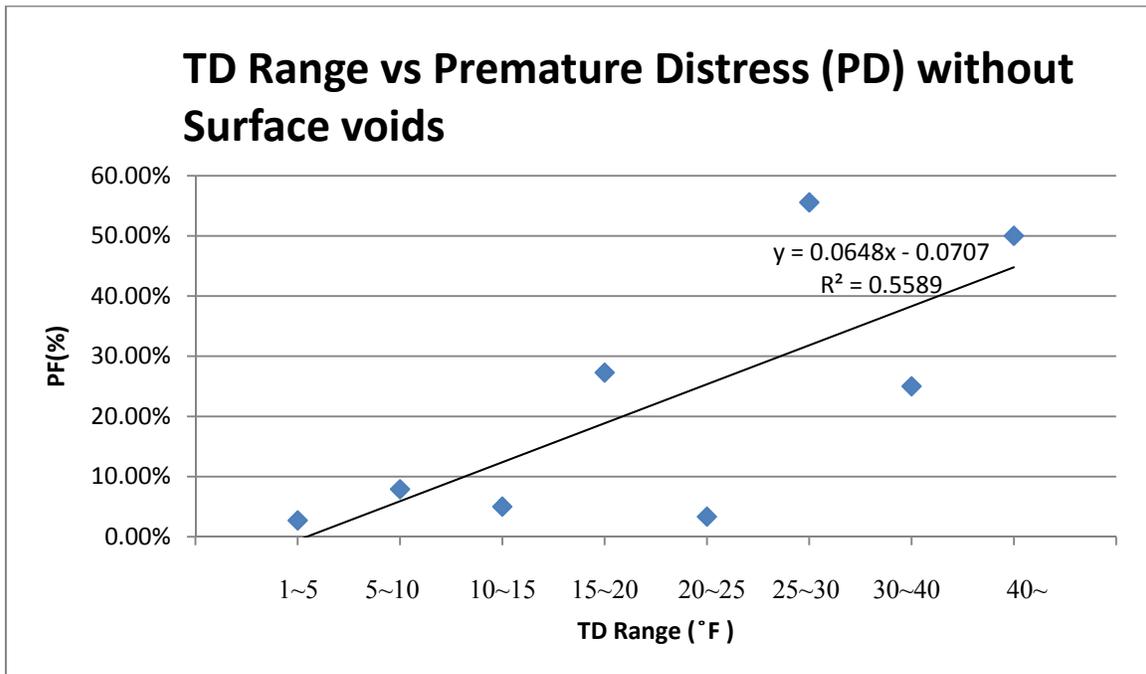
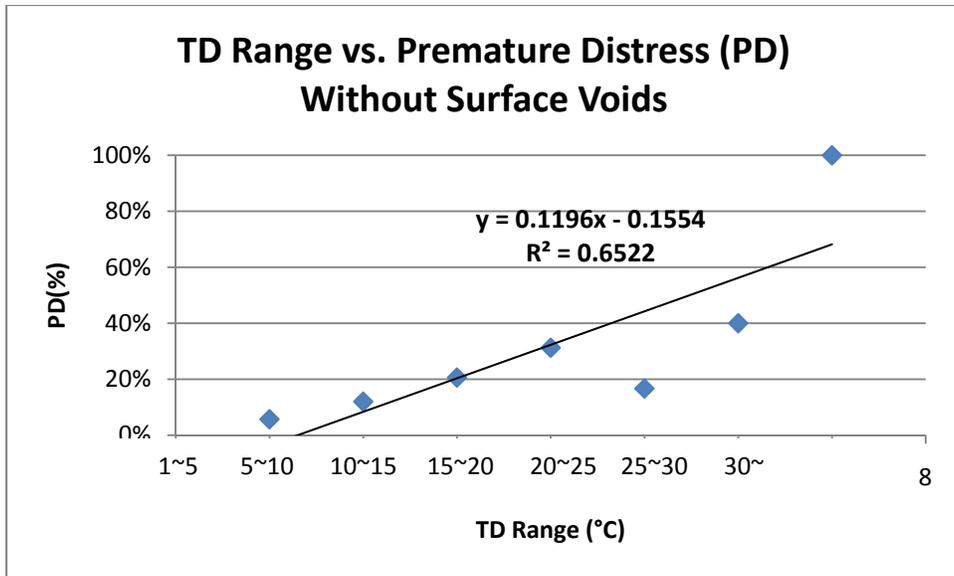
Figure 5.17 Correlation between the percentages of premature flaws, excluding surface voids, found within a specified temperature range

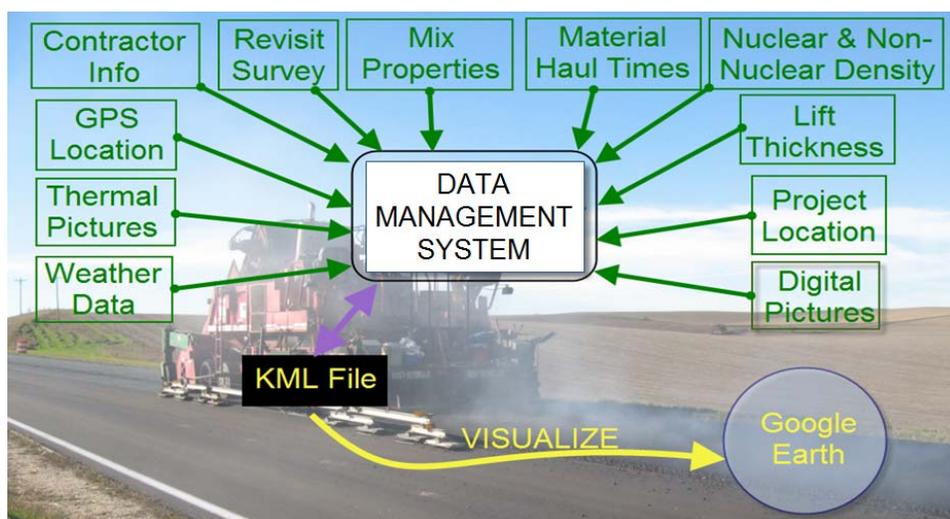
Figure 6.1 Developed Data Management System

In order to perform this investigation, a number of devices were utilized, those devices included: 1) a portable anemometer to record current weather conditions, 2) portable GPS unit to digitally mark areas of interest for later revisit, 3) a thermal imaging camera to locate areas of HMA temperature segregation, 4) a penetrating thermometer to validate the thermal camera, 5) a digital camera to record site conditions and procedures, and 6) nuclear and non-nuclear pavement density devices to measure the compacted density of the material. In addition to data collected via portable devices, site specific information was collected that included: 1) pavement or mix type, 2) lift thickness, 3) haul time, 4) equipment used, and 5) location.
