NDOR Research Project Number P568

F  
I  
N  
A  
L

R  
E  
P  
O  
R  
T

# Steel Box System Monitoring of N-2 over I-80 Bridge

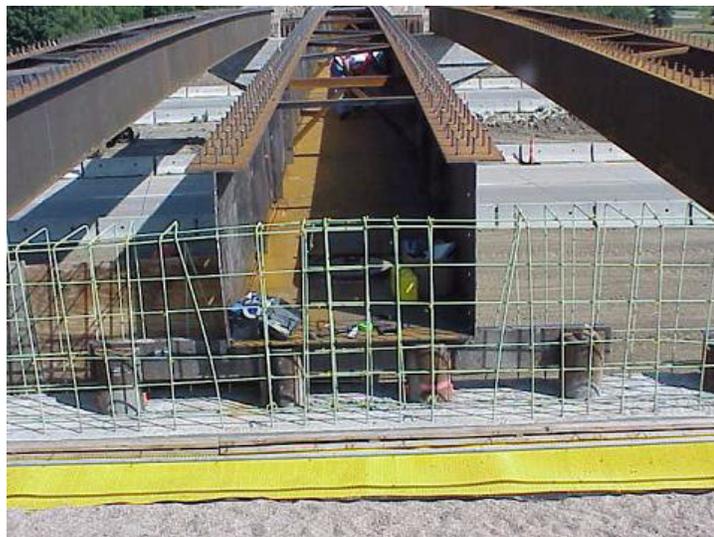
Next, the pilings for the south abutment were driven. These piles were driven between July 7 and July 10, 2003. Twelve pipe piles were driven at each abutment, to a depth of approximately 66 feet. Three sets of four piles were connected at the top with a steel channel, which the girders would bear on. This can be seen in Figure 3-1.

**Figure 3-1. Girder bearing on channel across piles**

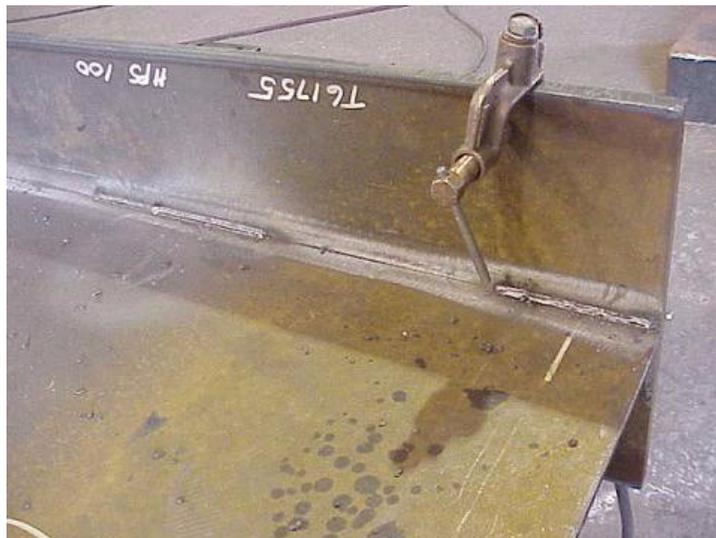
Once all the plates were welded up for the first girder, the webs and top flanges were tacked together, as shown in Figure 3-4. Once the flange and web were tacked together, they were flipped over and wire-fed welded together, as shown in Figure 3-5. They were flipped back over, and the tack welds were ground out. Then the other side was wire-fed welded.

**Figure 3-4. Top flange tack-welded to web**

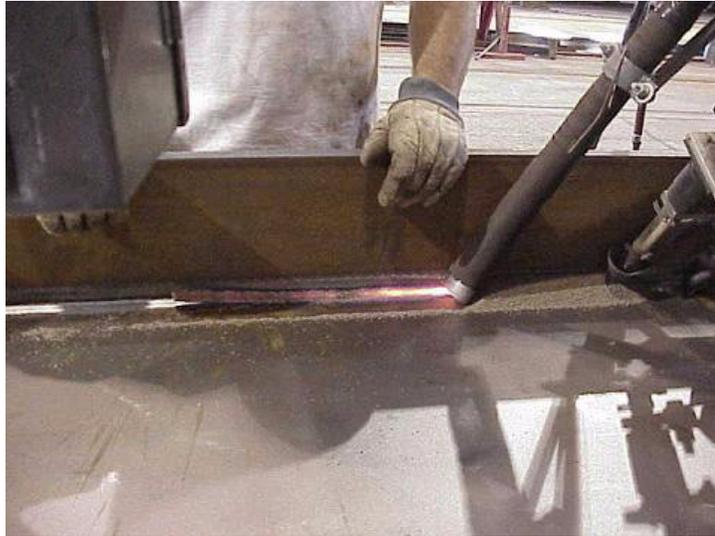
**Figure 3-5. Top flange being wire welded to web**

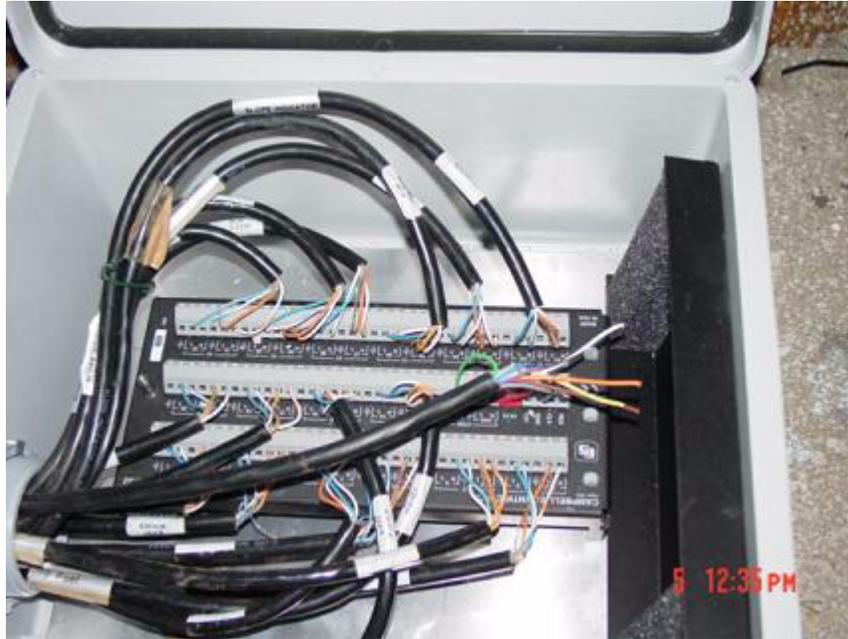
The next component in the system is the AM16/32 Relay Multiplexer. The AM16/32, shown in Figure 4-1, is the wiring hub for the gages. These act as switches allowing each gage to be individually sampled. The AVW100 modules are used for reading the vibrating wire type gages.

**Figure 4-1. AM 16/32 Relay Multiplexer**

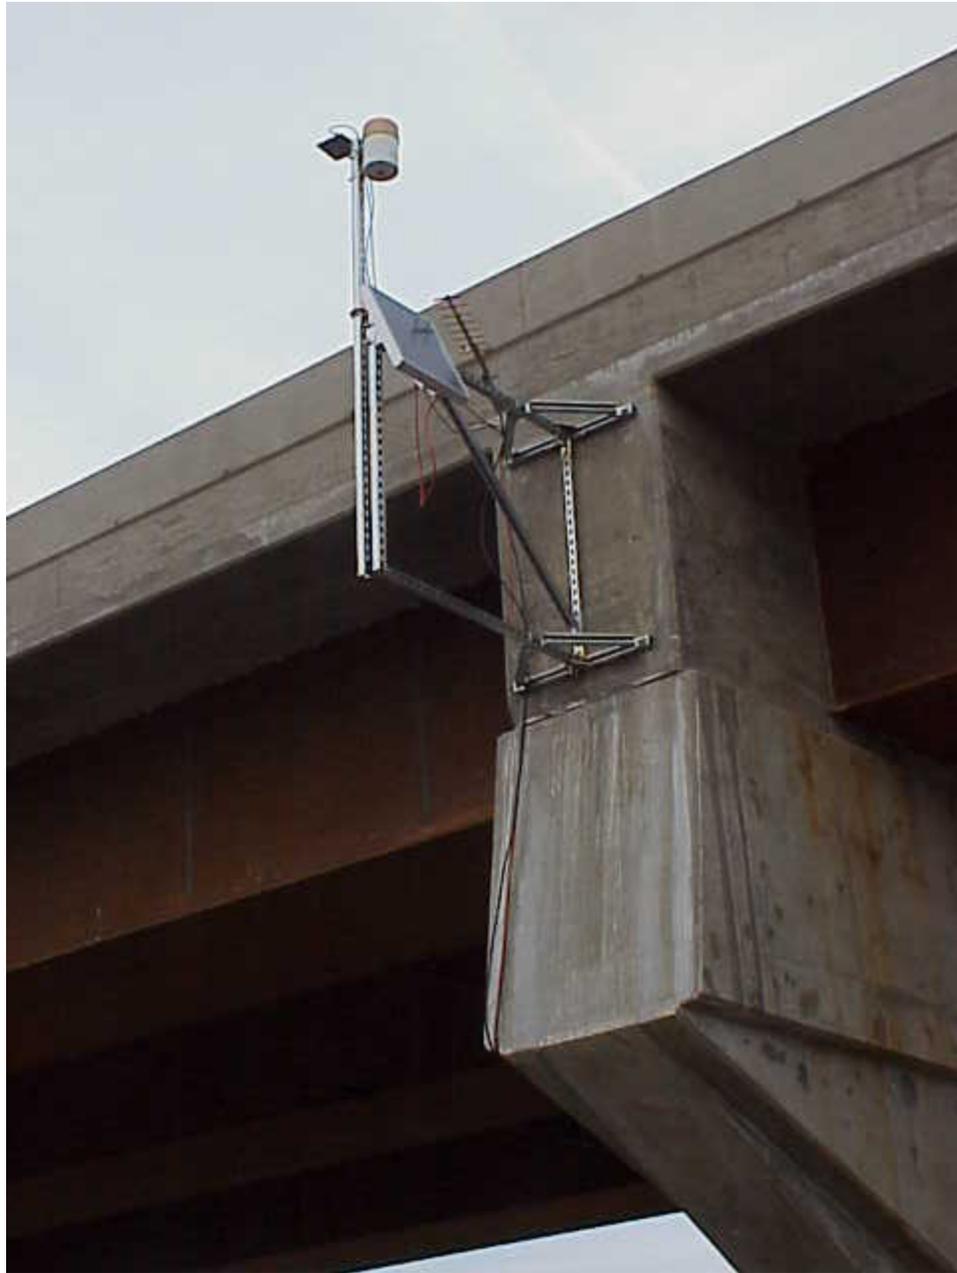
Other components in the system include a PS12LA battery/charger. This provides the system with power. A solar panel, produced by Solarex of Frederick, MD, is connected to the PS12LA to run the system and charge the battery during the day so that the system can run on battery power at night. The solar panel can be seen in Figure 4-2. An SC32B Optically Isolated RS232 serial interface allows the system to be linked to a PC so that data can be retrieved or a new program can be uploaded to the CR10X locally. To do this remotely from the office, a COM 100 Cellular Phone Package and a COM 210 Telephone Modem can be installed. An ASP-962 yagi antenna, produced by Allen Telecom Inc., of Dallas, TX, is used with the COM100 to improve cellular signal strength.

**Figure 4-2. Solar Panel**

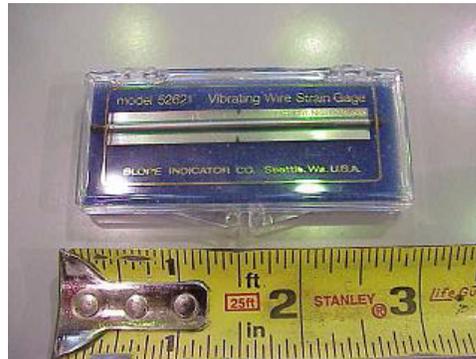
to the top of it. The reader "plucks" the tensioned wire and causes it to vibrate. The frequency is read and recorded by the DAS. The frequency can then be converted to strain. Control and frequency measurement are provided by the AVW100 modules.

Figure 4-6. Spot welded vibrating wire strain gage

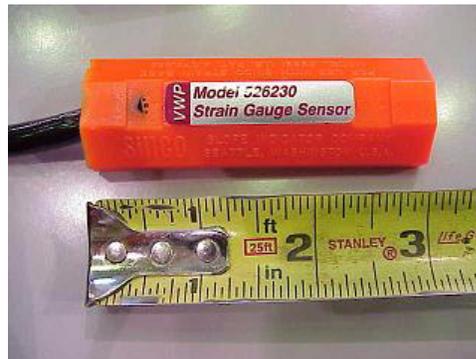
To monitor steel strains, spot weldable vibrating wire strain gauges made by Slope Indicator Co. are used. The gage, shown in Figure 4-6, consists of a small wire held in tension inside a small tube that has a flange on it so that it can be spot welded to the girder. After the gage is attached to the girder, a reader, shown in Figure 4-7, is attached

Figure 4-7. Strain gage reader

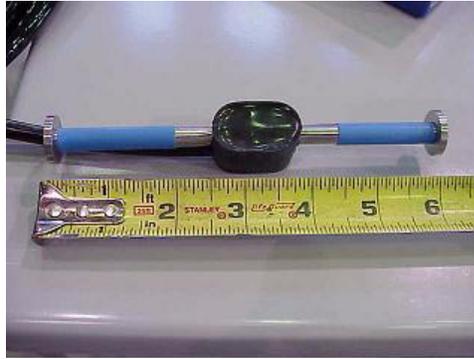
To monitor concrete strains, two different things are done. To monitor compressive strains, vibrating wire embedment gauges made by Slope Indicator Co. are used. This gage, shown in Figure 4-8, works similarly to the spot weldable gage by reading the frequency of a vibrating wire held in tension. To monitor the tensile strains in the concrete, spot weldable gages are attached to pieces of reinforcing steel to create "sister bars". These bars are placed in the concrete deck along side the longitudinal reinforcement. See Figure 4-9 and Figure 4-10.

Figure 4-8. Vibrating wire embedment gage

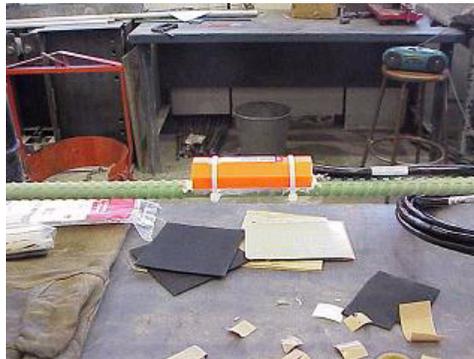
Figure 4-9. Sister bar prior to completion

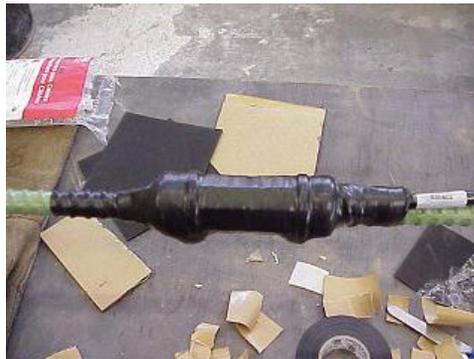
Figure 4-10. Completed sister bar

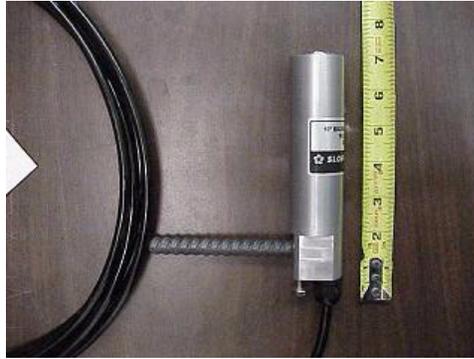
To monitor movements of the abutments and pier, Monopod EL Tiltmeters made by Slope Indicator Co. were used. As indicated in the name, this gage measures change in tilt. This gauge has a rebar stud on it that is epoxied into a hole in concrete. Once the epoxy has set up, the gauge is then leveled using the bubble level on top. The gauge is capable of detecting rotations in two planes. See Figure 4-11.

**Figure 4-11. Tiltmeter**

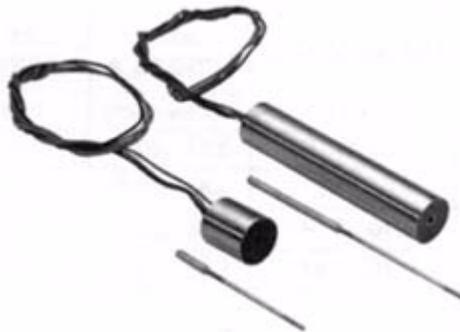
To measure deflections in the girders, linearly variable displacement transformers (LVDTs) made by Trans-Tek, Inc., of Ellington, Connecticut were used. These LVDTs, similar to what is shown in Figure 4-12, detect movement of a rod that slides through the middle of the device. Voltage is applied to the device, and depending on the position of the rod in the middle, the output voltage varies. Knowing the input and output voltages, and a gage calibration factor, the change in displacement can be found.

**Figure 4-12. Linearly Variable Displacement Transducer (LVDT)**

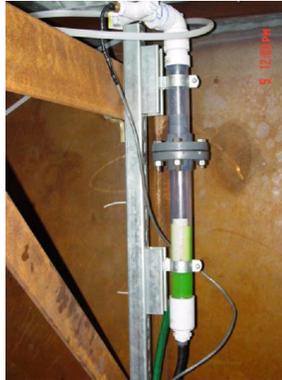
A water-level system was built in conjunction with the LVDTs to monitor the deflections. For each span, a PVC tube was placed at the pier, and at midspan. The tube at the pier is considered a reference point. Each mid-span tube was connected to its corresponding reference tube at the pier with plastic hose. Bobbers with the LVDT rods inserted into them were placed in the PVC tubes. The system was then filled with water and antifreeze so that the bobbers would float. The LVDTs were placed over the rods, and then the pipes were adjusted so that the bobbers were at approximately the middle of their strokes. Since the device at the pier is the reference, the water levels of the other gages are assumed to change with respect to that one, while the pier device is assumed to not move. The change in water level represents the deflection of the girder at the point where the instrument is located. One of these units can be seen in Figure 4-13.

Figure 4-13. Water Level

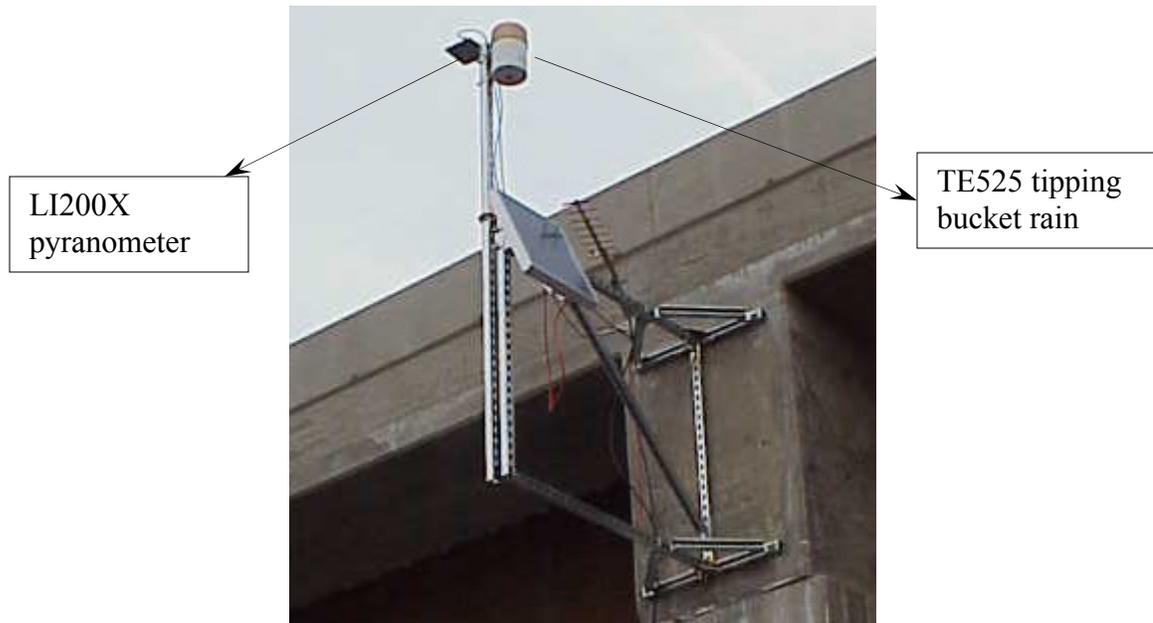
The TE525 tipping bucket rain gage and the LI200X pyranometer were attached to a frame that was installed on the west side of the diaphragm (Figure 4-22). The CS500 temperature and humidity probe was installed near the pier underneath the bridge deck in order to shield it from direct sunlight or rain.

Figure 4-22. Weather instrumentation

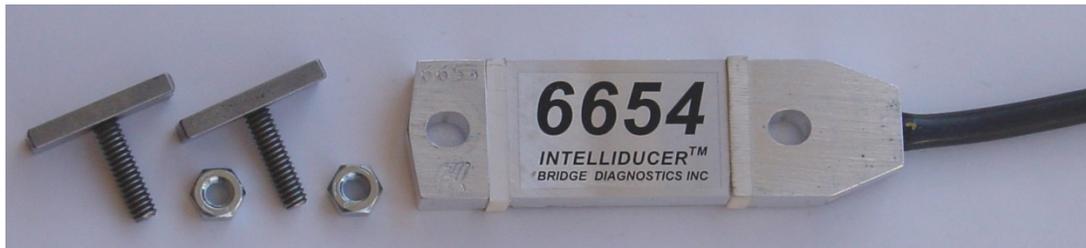
Additional testing equipment was supplied by Bridge Diagnostics Inc. and is referred to as BDI. The strain transducers contain a full wheatstone bridge with 4 active 350 foil gages. The range of these 3" gages is approximately  $\pm 1000 \mu\epsilon$  for steel. Extensions to increase the gage length were used for the concrete tension gages on the bridge deck. These transducers, shown in Figure 6-1, were attached to the steel and concrete using loctite adhesive. The steel surface in contact with the metal tabs was smoothed using a wire grinding wheel. Similar preparation was done to the concrete surfaces using a concrete grinding disc. The gages were connected to the STS control box in series with military-style connections allowing quick assembly and relocation.

**Figure 6-1. Intelliducer**

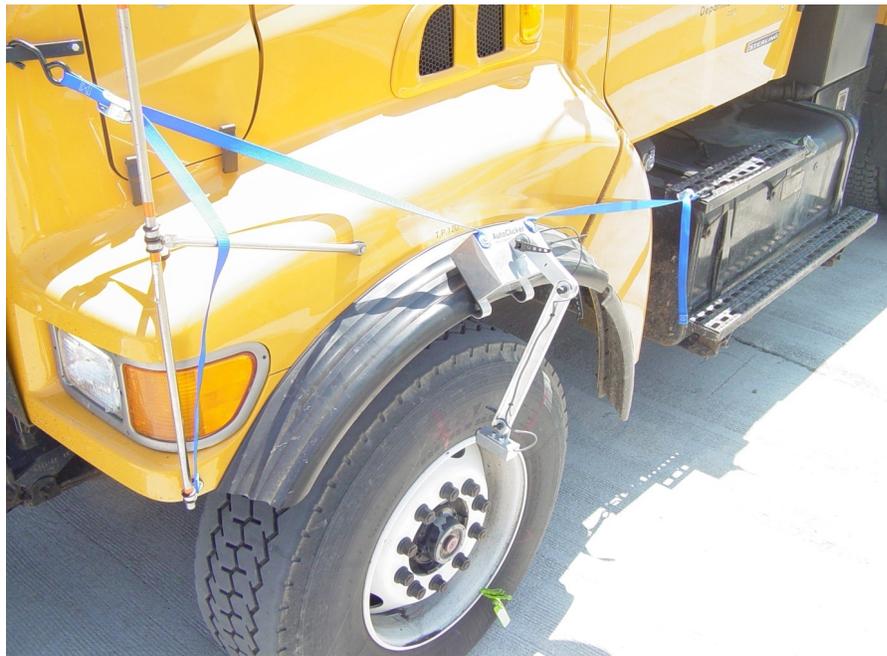
The longitudinal position of the truck on the bridge was measured using the BDI Autoclicker. The time of each revolution is recorded using this contraption. A picture of the Autoclicker is shown in Figure 6-8.

**Figure 6-8. Autoclicker**

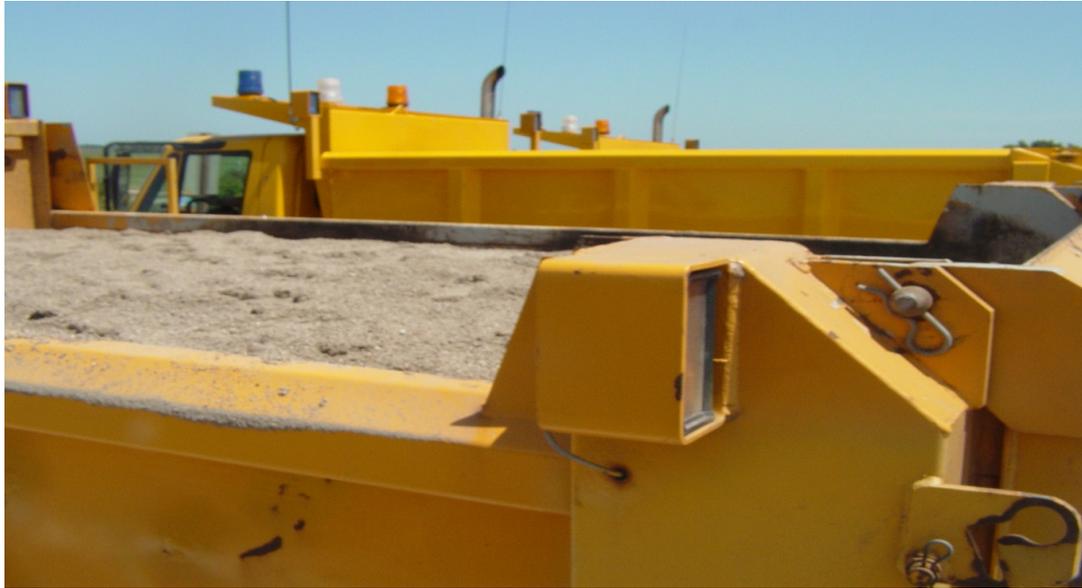
Figure 6-9. Gravel in Trucks

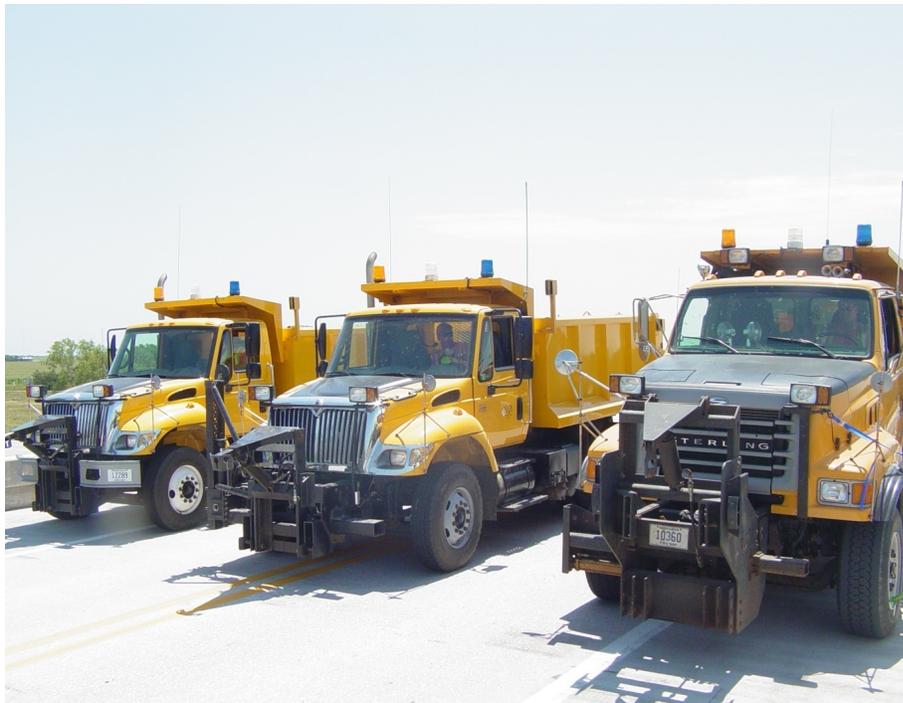
Figure 6-10. Three Trucks on Bridge
