Comprehensive Evaluation of Fracture Critical Bridges

**Department of Civil and Environmental Engineering
Florida International University
Miami, Florida**

Sponsored By
Nebraska Department of Roads

February, 2014

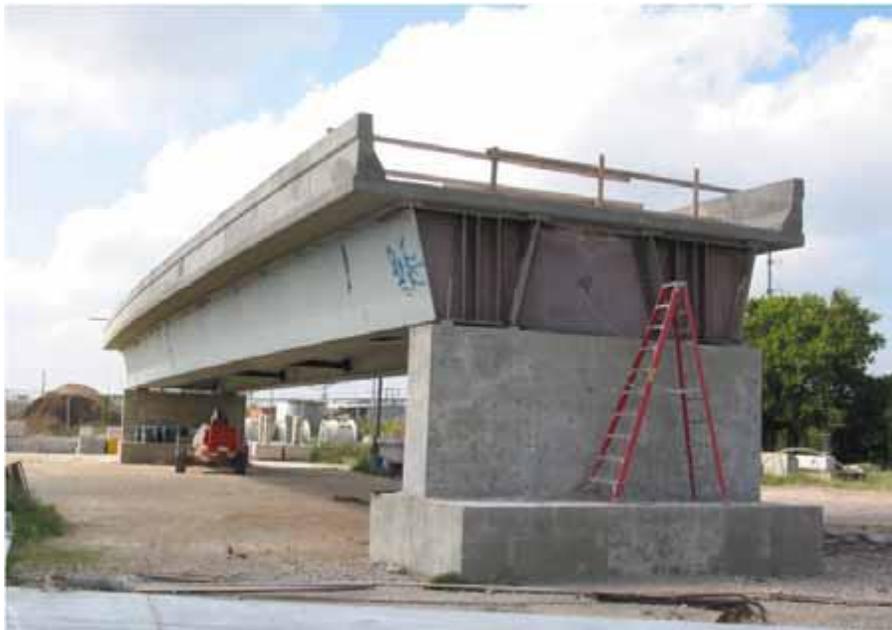
Figure 1-1. FSEL Twin Box-Girder Bridge [Source: FHWA Report No.: FHWA/TX-10/9-5498-1]

The full scale bridge test of this research project revealed the intrinsic redundant behavior of twin box girder bridges, despite the test was conducted in the worst case scenario from the redundancy point of view. The tested bridge was a simple-span one and therefore it had no redundancy due to continuity of its superstructure. In addition, all external diaphragms of this bridge were removed. Besides, the railings of the bridge were constructed with expansion joints. This limits the effectiveness of the contribution of the railing to the load carrying capacity of the bridge. And finally the bridge had a horizontal curvature and the fractured girder was the outside girder which has the maximum internal forces. Therefore, it is observed that the situation of a real-life bridge cannot be worse than this bridge from redundancy standpoint. Figure 1-1 shows a picture of this test bridge before conducting the tests.

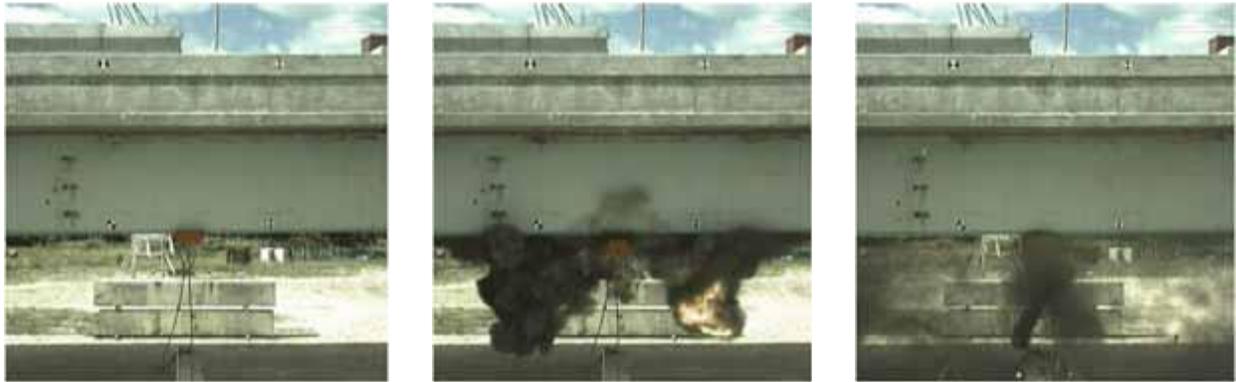
Figure 1-2. FSEL First Bridge Fracture Test [Source: FHWA Report No.: FHWA/TX-10/9-5498-1]

Three different tests have been done on this bridge. In the first test, the bottom flange of the exterior girder was rapidly cut by an explosive to simulate a sudden fracture while an equivalent HS-20 load was positioned above the fractured girder and in the worst possible location. Figure 1-2 illustrates the bridge during the explosion and Figure 1-3 shows the bottom flange cut after the explosion. The response of the bridge during and after this test was satisfactory and its maximum deflection was less than one inch.

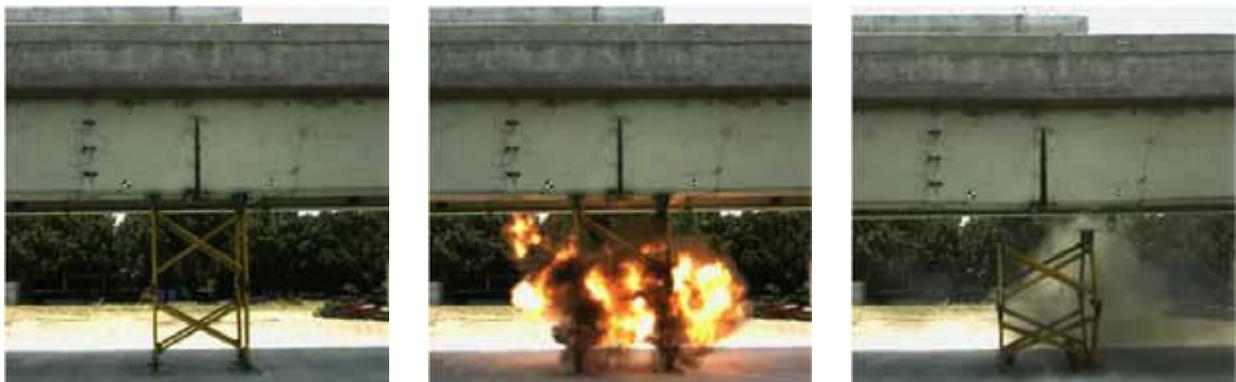
Figure 1-4. FSEL Second Bridge Fracture Test [Source: FHWA Report No.: FHWA/TX-10/9-5498-1]

In the second test, the bridge was supported by means of a scissor jack while about 83% of the webs of the cracked girder were cut manually and then the scissor jack was removed suddenly using an explosive acting on the jack. This way the sudden nature of the crack was simulated. Figure 1-4 shows the supporting scissor jack before, during and after the explosion. Again, the bridge showed a well performance with a maximum deflection of seven inches.

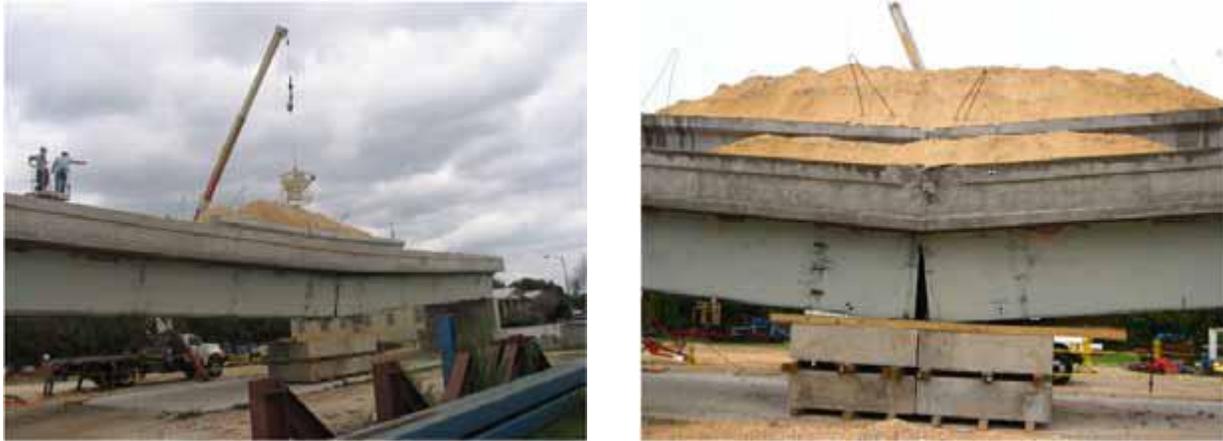
Figure 1-5. FSEL Third Bridge Fracture Test [Source: FHWA Report No.: FHWA/TX-10/9-5498-1]

loads. In this test, the bridge carried 363 kips of load which, considering the extent of the damage, was a remarkable capacity. Figure 1-5 shows the incremental loading of the bridge and also the bridge in its collapsed mode.

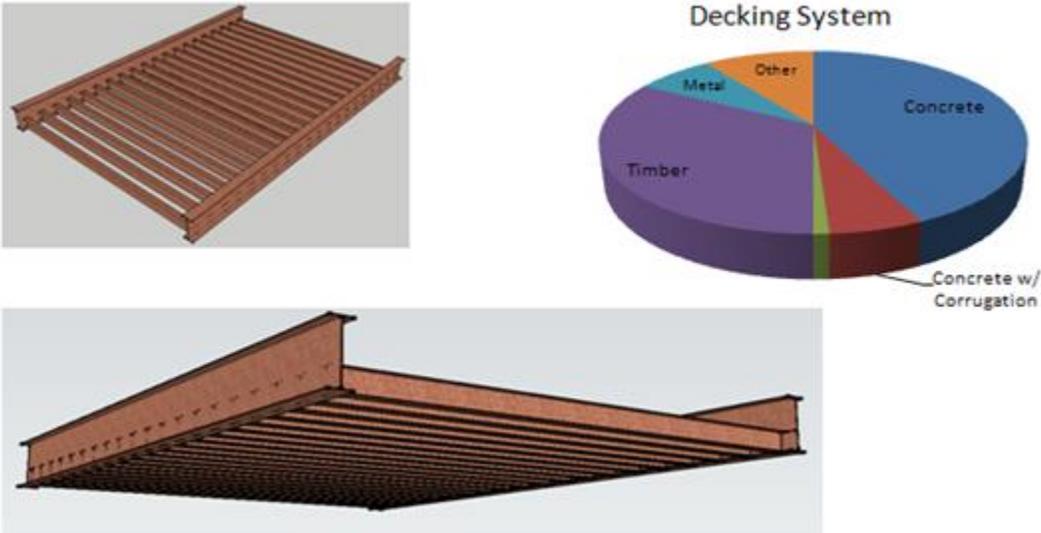
Figure 2-1. Two-girder Bridge Type 1, 144 Bridges, 46%

Figure 2-1 through Figure 2-6 illustrate these structural systems of two-girder bridges.

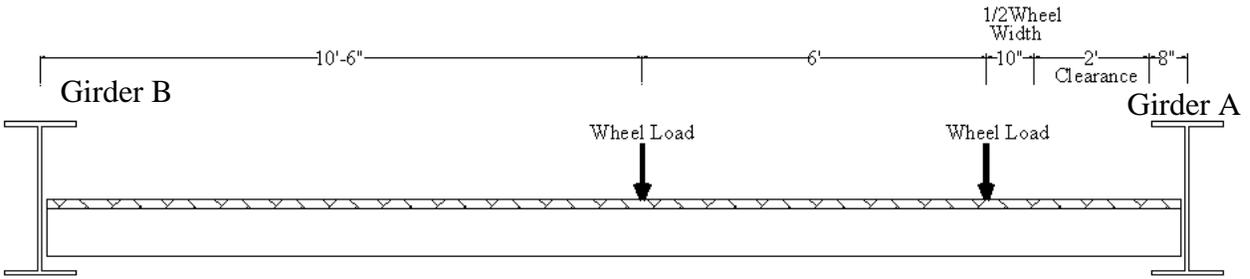
Figure 3-3. Loading Configuration

The loads are applied to the bridges in two steps. In the first step, the self-weight of components is applied to the models. Then, when the stresses are in the self-weight condition, the point loads are applied. In order to simulate the eccentric loading and have the critical condition in only one of the girders, the point loads are placed closer to one girder (denoted as Girder A) compared to the other (denoted as Girder B). Figure 3-3 shows the eccentric loading configuration.

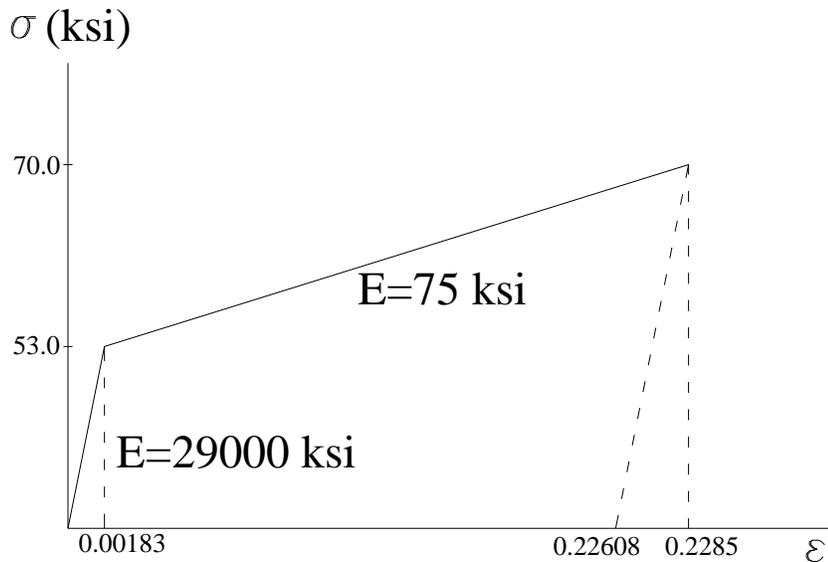
Figure 3-4. Stress-Strain relationship of Steel Components

The steel components (girders, floor beams and angles) have a bilinear stress-strain behavior with a Young's modulus of 29000 ksi for stresses up to 53 ksi and a Young's modulus of 75 ksi for stresses between 53 ksi and 70 ksi. This material ruptures at the stress level of 70 ksi. The unit weight of steel is 490 lb/ft³ and its Poisson's ratio is 0.3. Figure 3-10 shows the stress-strain relationship for the steel material. The considered timber material for deck has a Young's modulus of 1500 ksi, a unit weight of 50 lb/ft³ and a Poisson's ratio of 0.2.

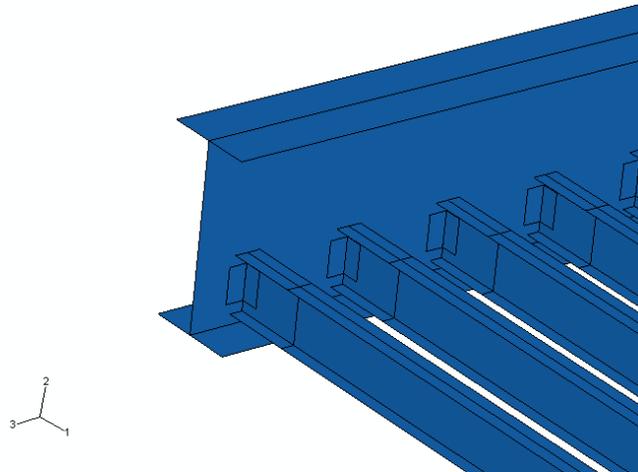
Figure 3-5. Typical Floor Beam to Girder Connection

In the models, the floor beams are connected to the girders by means of angles to provide flexibility similar to the actual connections. Figure 3-5 illustrates the typical floor beam to girder connection.

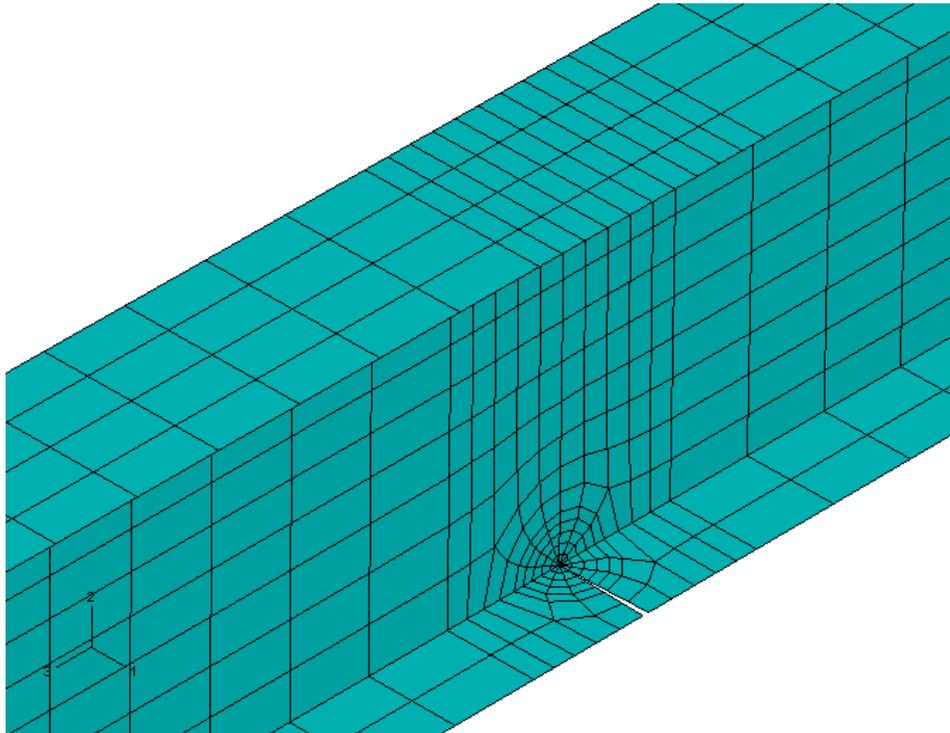
Figure 3-6. Bottom Flange Cracking Pattern

Each bridge is analyzed in three different states. In the first state, the bridge girders are uncracked. The second state has the bottom flange of the girder closer to the loading (Girder A) fully cracked. And the last state is the case where the lower half of the girder A is cracked. Figure 3-6 and Figure 3-7 illustrate these two cracking patterns.

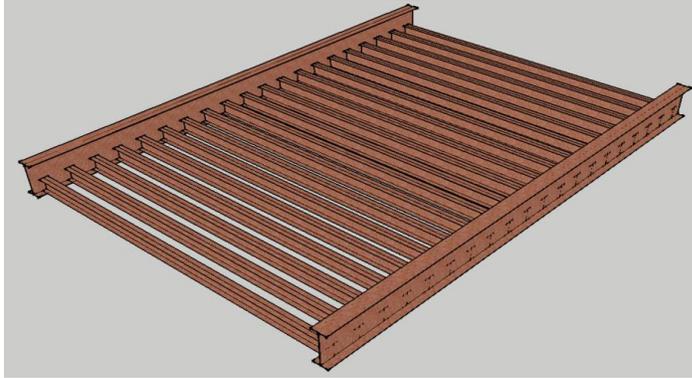
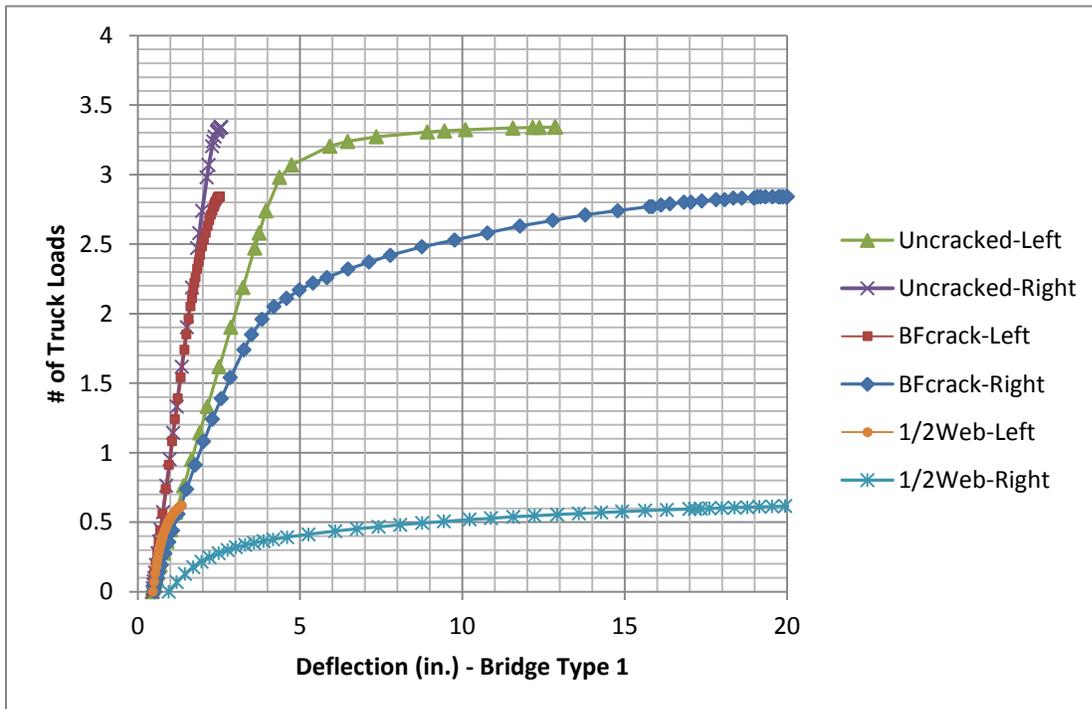
Figure 3-8. Two-girder Bridge Type 1 and its Load-Deflection Curve

Figure 3-8 shows the two-girder bridge Type 1 and its load deflection curves. The bridge was analyzed in its uncracked mode and also the two cracking patterns described earlier. The load capacity of the bridge is denoted by the number of the HS-20 trucks that the bridge could carry. The uncracked bridge was able to carry about 3.35 times HS-20 loads in its uncracked state. When it had the bottom flange of one of the girders cracked, the load decreased to about 2.85 trucks. And when the bridge was modeled with half the depth of one of its girders cracked, the load capacity of the bridge dropped to approximately 0.6 times the weight of a HS-20 truck. The deflections of both cracked and uncracked girders of the bridges are shown in Figure 3-8.

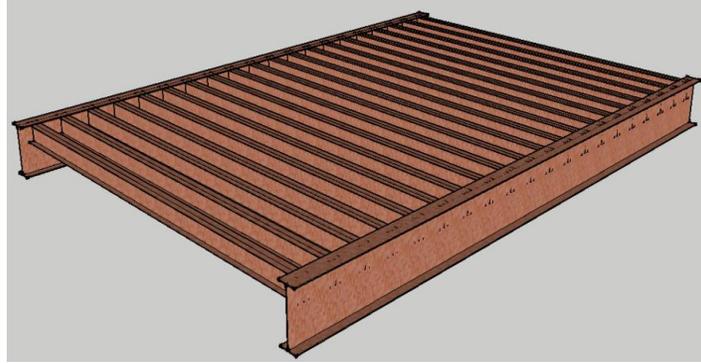
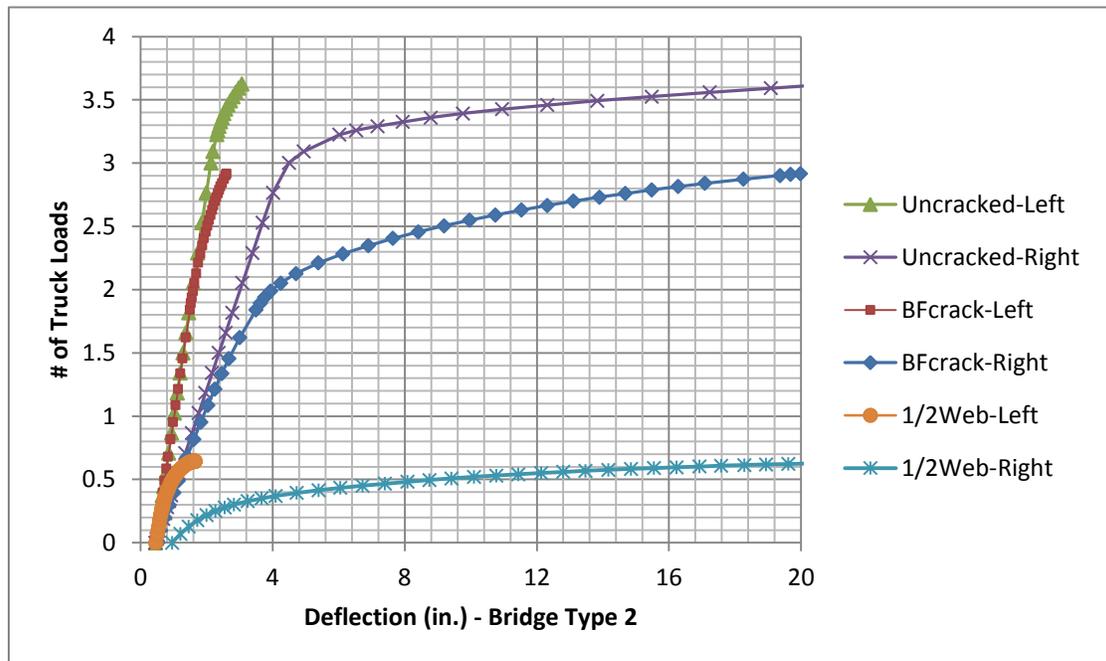
Figure 3-9. Two-girder Bridge Type 2 and its Load-Deflection Curve

The two-girder bridge Type 2 and its load deflection curves are illustrated in Figure 3-9. The bridge was analyzed in its uncracked mode and also the two described cracking patterns. The uncracked bridge was able to carry about 3.60 times HS-20 loads in its uncracked state. When it had the bottom flange of one of the girders cracked, the load reduced to about 2.90 times of HS-20 truck load. When the bridge had one half of the depth of one of its girders cracked, the load capacity of the bridge dropped to approximately 0.60 times of HS-20 load. The deflections of both cracked and uncracked girders of the bridges are shown in Figure 3-9.

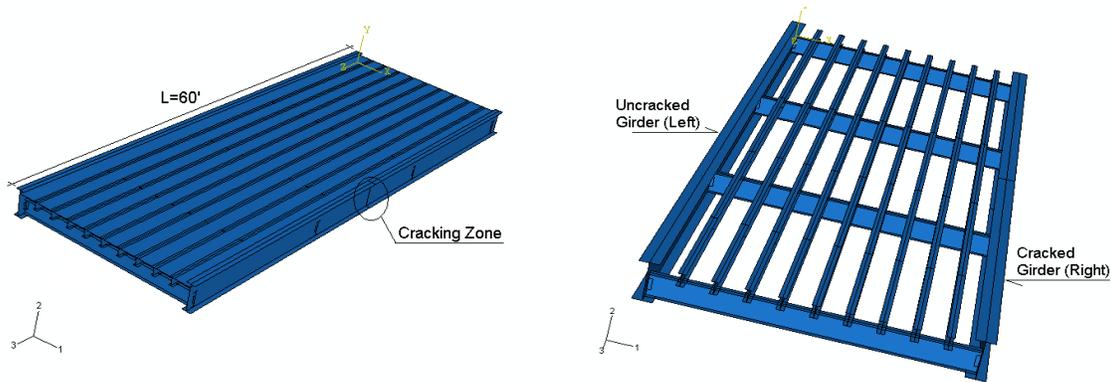
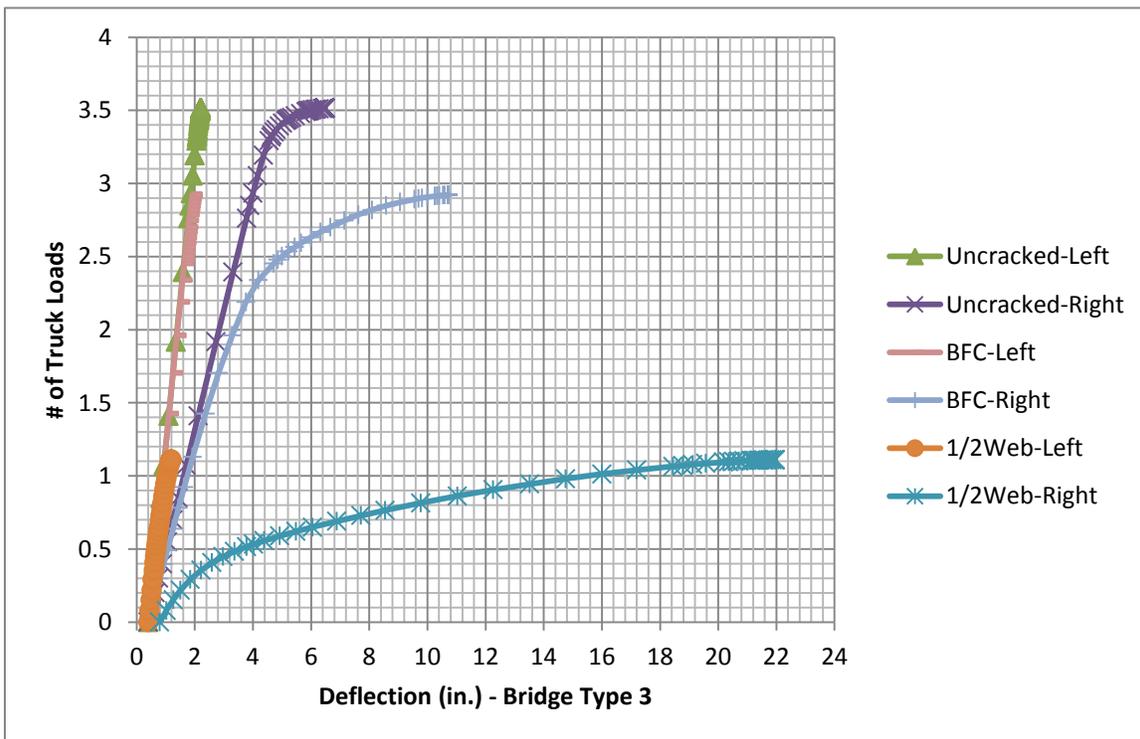
Figure 3-10. Two-girder Bridge Type 3 and its Load-Deflection Curve

Figure 3-10 displays the two-girder bridge Type 3 and its load deflection curves. The bridge was analyzed in its uncracked mode and also the two cracking patterns. The uncracked bridge was able to carry about 3.5 times of HS-20 load in its uncracked mode. When the bottom flange of one of the girders was cracked, the load decreased to about 2.9 trucks load. And when the bridge was modeled with half depth of one of its girders cracked, the capacity of the bridge reduced to approximately 1.1 times of the weight of HS-20 truck. The deflections of both cracked and uncracked girders of the bridges are shown in Figure 3-10.

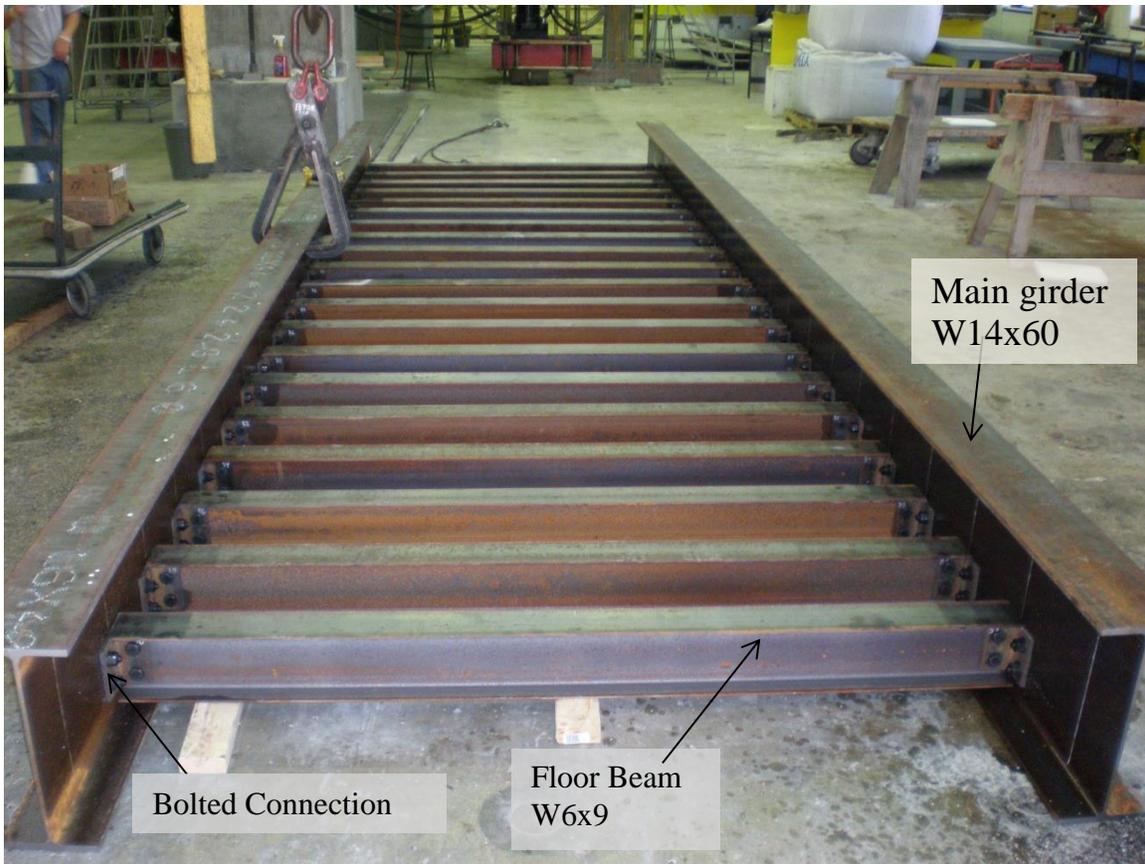
Figure 4-7. Complete Two-Girder Bridge Specimen.

The geometric characteristics of the test bridge are explained in this section. In this experiment, the main girders have a total length of 22 feet. The span length of the single span bridge is 21 feet so the girders extend 6 inches beyond the supports in the longitudinal direction. The girders have W16x40 sections and the floor beams have W6x9 section. Figure 4-7 shows a photo of the specimen and the connection. The main girders are 73 inches apart that allows for a half inch gap between the ends of the 6-foot long floor beams and the web of the girders. The ratio of girder height to floor beam height is approximately 2.3. The floor beams are connected to the web of the girders by means of L3x3x3/8 angles. The angles are 6 inches long. Each leg of the angles is attached to the webs of the floor beams or main girders by two ½ inch A325 high strength bolts. Four spreader beams were used to simulate 4-wheel vehicle loading for the test as illustrated in Figure 4-11. The distance between the front and back wheels was chosen to be 6 feet. The loading points (vehicle loading) are placed closer to one girder, Girder A (the one that later will be fractured) than the other. The final loading locations in both longitudinal and transverse views are illustrated in Figure 4-8 and Figure 4-9.

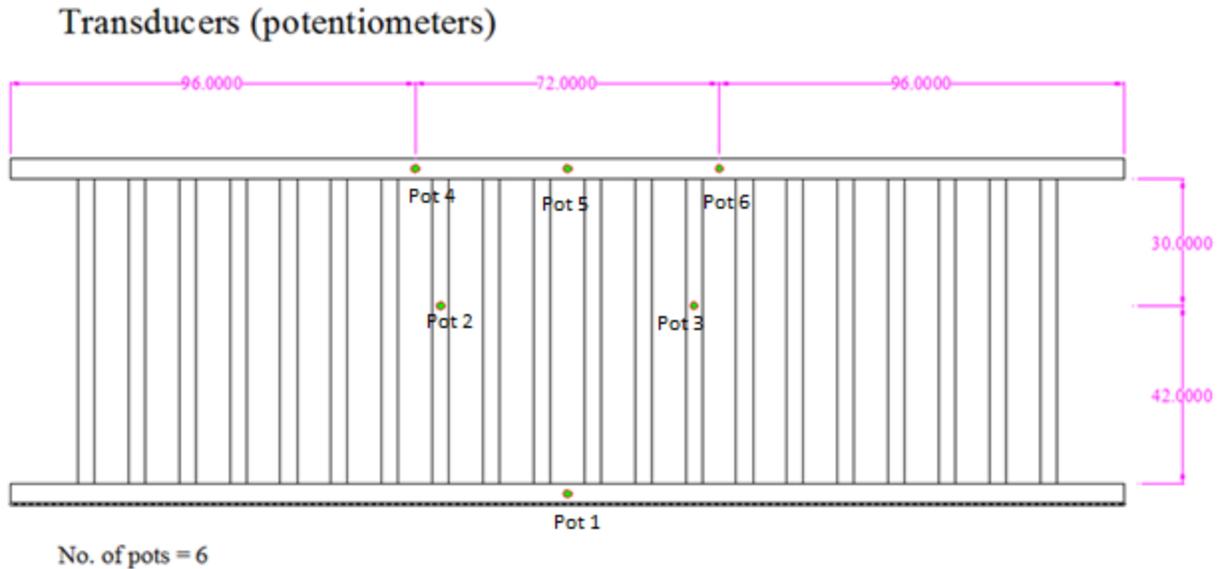
Figure 4-14. Location of Potentiometers.

For the first part of the test, which was the lateral torsional buckling capacity evaluation of the bridge, six potentiometers were provided; the positions of which are shown in Figure 4-14. The girder away from the loading points (Girder B) had one potentiometer located at its mid-span. The other girder has three potentiometers, one at each quarter point along the length of the girder. Two other potentiometers were located 30 inches away from the end of the two floor beams beside the loading rods.

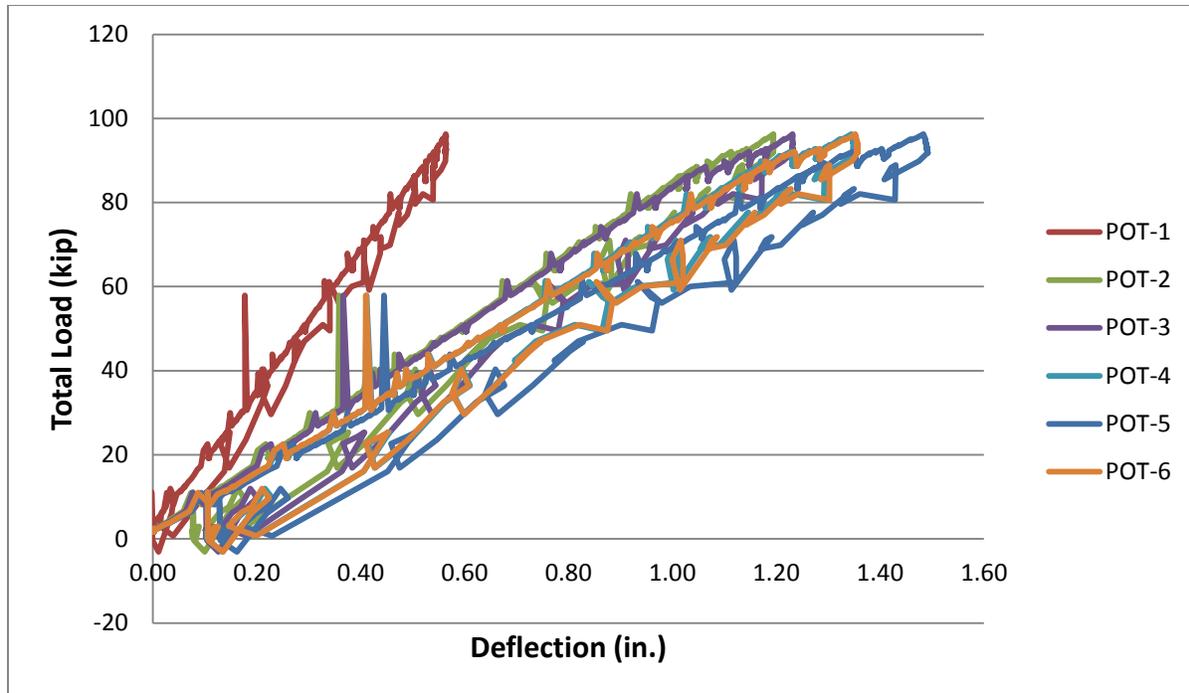
Figure 4-15. Load-Deflection Curves- Partial LTB Test

Figure 4-15 shows the vertical displacements obtained from the potentiometers during the loading. It was observed that the deflection of the girder further away from loading (Girder B) had a maximum of about 0.56 inch, which was the lowest maximum deflection recorded during the test. The deflection of the floor beams, which were measured by POT-2 and POT-3 were similar and have a maximum of about 1.23 inch. The other three potentiometers were attached to the mid-span section of the girder close to the loading. POT-4 and POT-6 were attached to the edges of the bottom flange of the girder near the loading point and are almost similar, with a maximum of 1.36 inch. But POT-5, which was attached to the outer edge of the top flange, had the largest deflection among the potentiometers approximately 1.49 inches. It also showed that the girder started to rotate about its bottom flange, which was why a larger displacement was observed in the top flange of the girder.

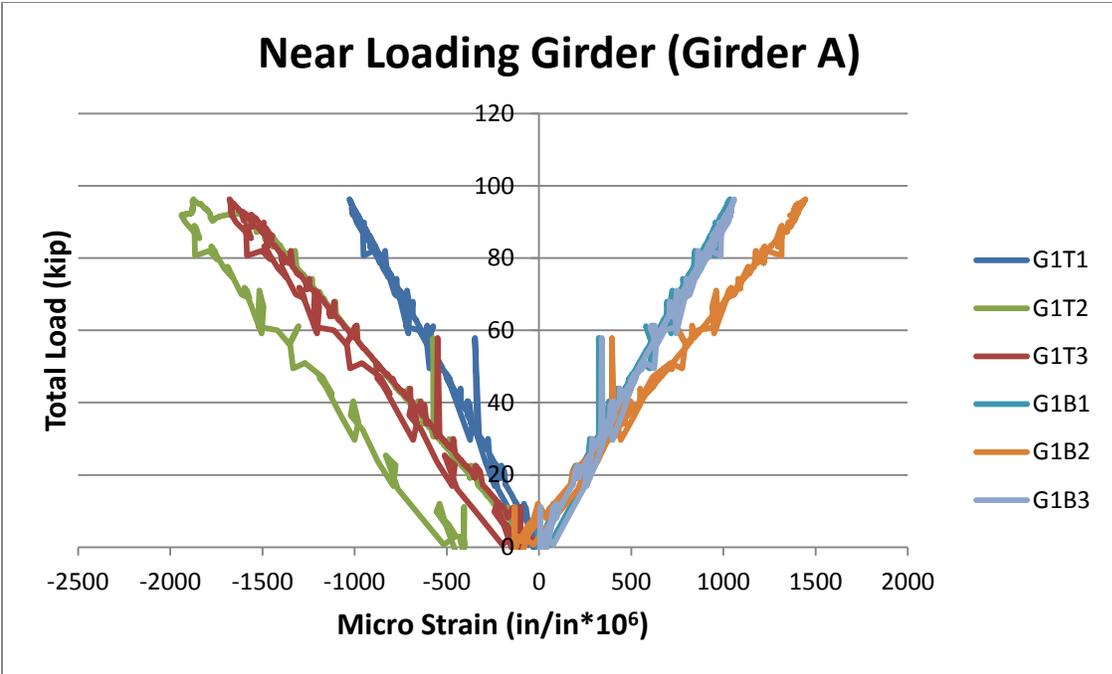
Figure 4-16. Main Girder Strains (με) vs. Applied Load (kip)- Partial LTB Test

The data obtained from strain gages are divided into two groups. The first group consists of the strain gages attached to floor beams, angles and the girder away from point of loading (Girder B). These strain gages showed values of strain between -1113 me and $+1228 \text{ me}$ which were less than the yielding strain of 1700 me for Grade50 steel material. The results from this group of gages followed from linear elastic predictions and were not shown. The more important data were acquired from strain gages of the main girder close to loading (Girder A). As shown in Figure 4-16, the strains in bottom flange of the girder at quarter length sections, named G1B1 and G1B3 showed positive values less than 1058 me . These tensile strains were less than the yielding strain of the steel material and restored to zero after unloading the test bridge. The strain gage of the bottom flange at mid-span section, G1B2, and strain gage of the quarter length of top flange, G1T1, showed similar but opposite responses with maximum values of $+1444 \text{ me}$ and -1028 me , respectively. However, the two strain gages attached to top flange of the girder at mid-span section had larger values of strain. The one attached to the inside edge of the top flange, G1T3, had a strain of $+1678 \text{ me}$ which was at the yielding threshold and the other one, G1T2, located at the outer edge of the top flange, had a strain of $+1941 \text{ me}$ which is greater than the yielding strain. It was observed in Figure 4-16 that the strains from these gages did not restore to zero after unloading the bridge.

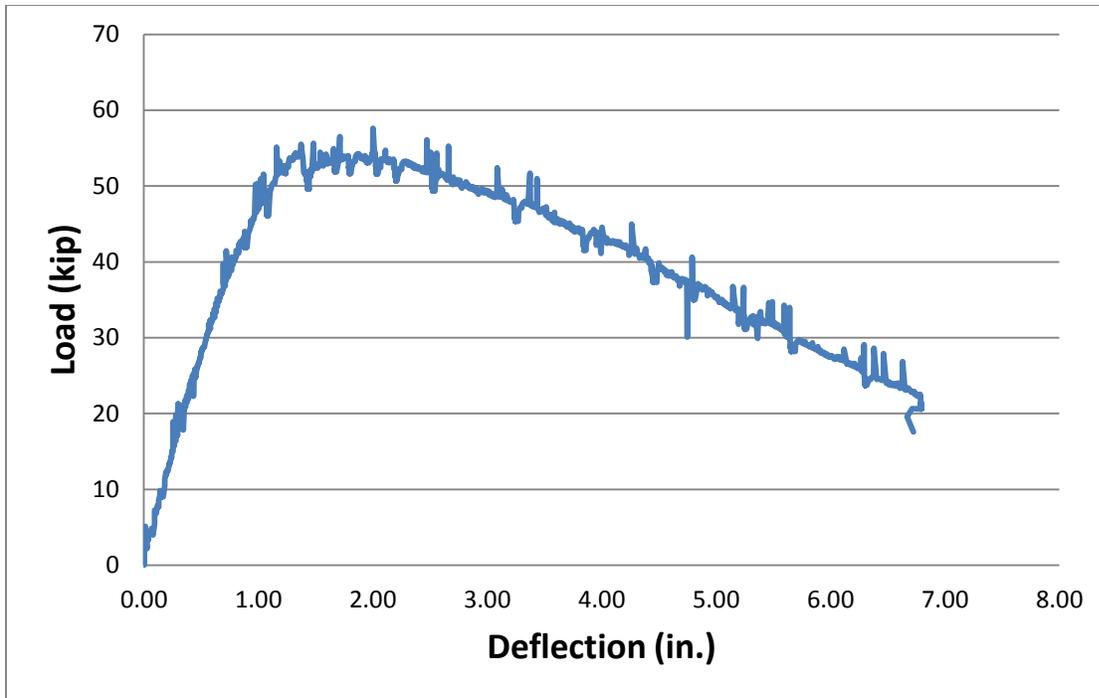
Figure 4-17. Load vs. Mid-Span Deflection of the Cracked Girder

This section presents the results of the loading of the pre-cracked bridge. In this stage, the bottom flange of one of the girders of the bridge (the girder closer to loading, Girder A) was cracked for the whole width at the mid-span section of the girder. Then, the bridge was loaded gradually with the hydraulic rams. Figure 4-17 shows that load-deflection curve of the cracked girder during the test. The load in the graph is the total load applied to the two-girder bridge and the deflection is the recorded deflection at the mid-span of the cracked girder. These deflections were recorded by the potentiometer connected to the girder immediately adjacent to the crack plane.

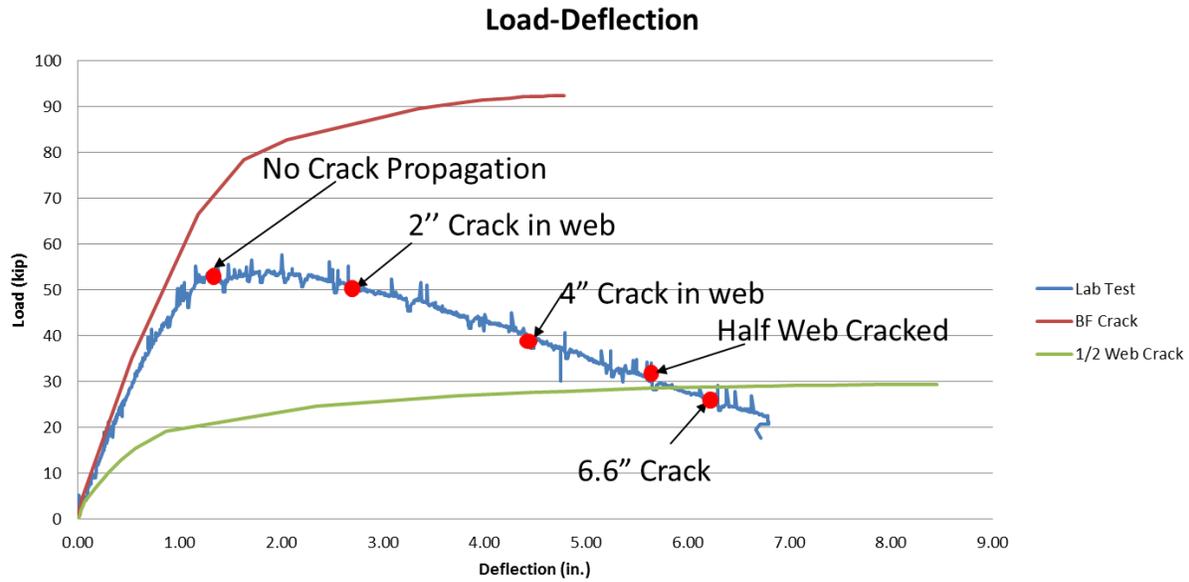
Figure 4-18. Comparison of Experimental and Analytical Load-Deflection Curves

In Figure 4-18, the load-deflection curve obtained from the experiment is compared to two analytical load-deflection curves obtained from Finite Element Analysis. The red curve is the load-deflection of the bridge with bottom flange crack and the green curve is for the bridge with bottom flange and half of the web cracked. It is observed that the test bridge response is very close to the curve of the bottom flange cracked bridge up to the point that the crack in the test bridge starts to propagate, which corresponds to a load of 51 kips with a deflection of 1.15 inches. Beyond that point, the deflections in the test bridge begin to increase noticeably with a minimal increase in the load. This relates to the lower moment of inertia and stiffness of the girder section at the cracked plane because of the propagation of the crack. The maximum load that the bridge was able to carry at this stage was equal to 54 kips corresponding to a deflection of 1.37 inches. More propagation of the crack yielded more deflection with lower load capacity. The test was stopped when the deflection of the bridge reached 6.80 inches with 21 kips of load on the bridge. The curve of the half web cracked bridge resulted from the finite element analysis intersects with the test bridge load-deflection curve at a point with 5.69 inches of deflection and 28.51 kips of load. That point is very close to the point that the girder crack reached half of the web height during the experiment. The drop in capacity of bridge versus the crack length is illustrated in Figure 4-19. It shows once the bottom flange crack propagated, a linear relationship was observed between reduction in capacity and growth in crack length.

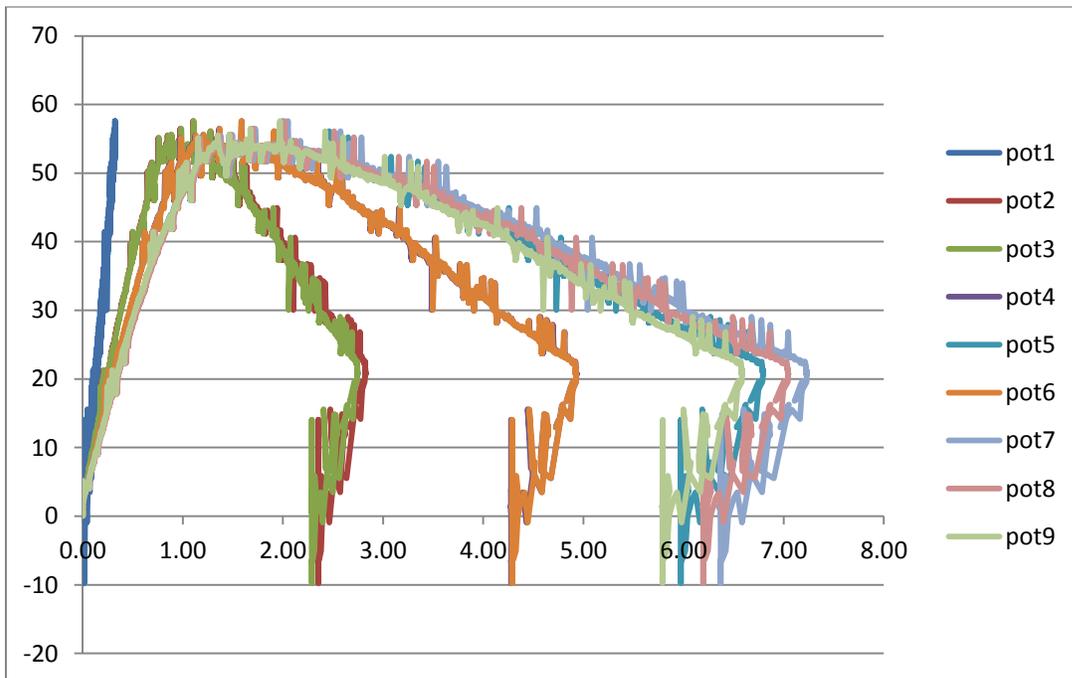
Figure 4-20. Load vs. Deflection of the Cracked Bridge- POT's 1 thru 9

rotation which caused the large deflections of about 2.82 inches at the points of potentiometers attachment. Pot4 and Pot6 were connected to the quarter points of the cracked girder length. It was observed that the experiment was symmetric about the mid-span plane of the bridge and the deflections at these two locations were exactly the same. Pot5, Pot7, Pot8 and Pot9 are the four potentiometers that are connected to the two sides of the crack plane of the cracked girder. Pot9, Pot5, and Pot8 were attached to the inner edge, mid- point and outer edge of the bottom flange at the cracked section, respectively. Pot7 was attached to the outer edge of the top flange at this section and showed more deflection due to addition of the vertical deflection and the vertical component of the torsional displacement of the top flange. For that reason, the deflection recorded at Pot7 was the maximum among the deflections recorded during this experiment.

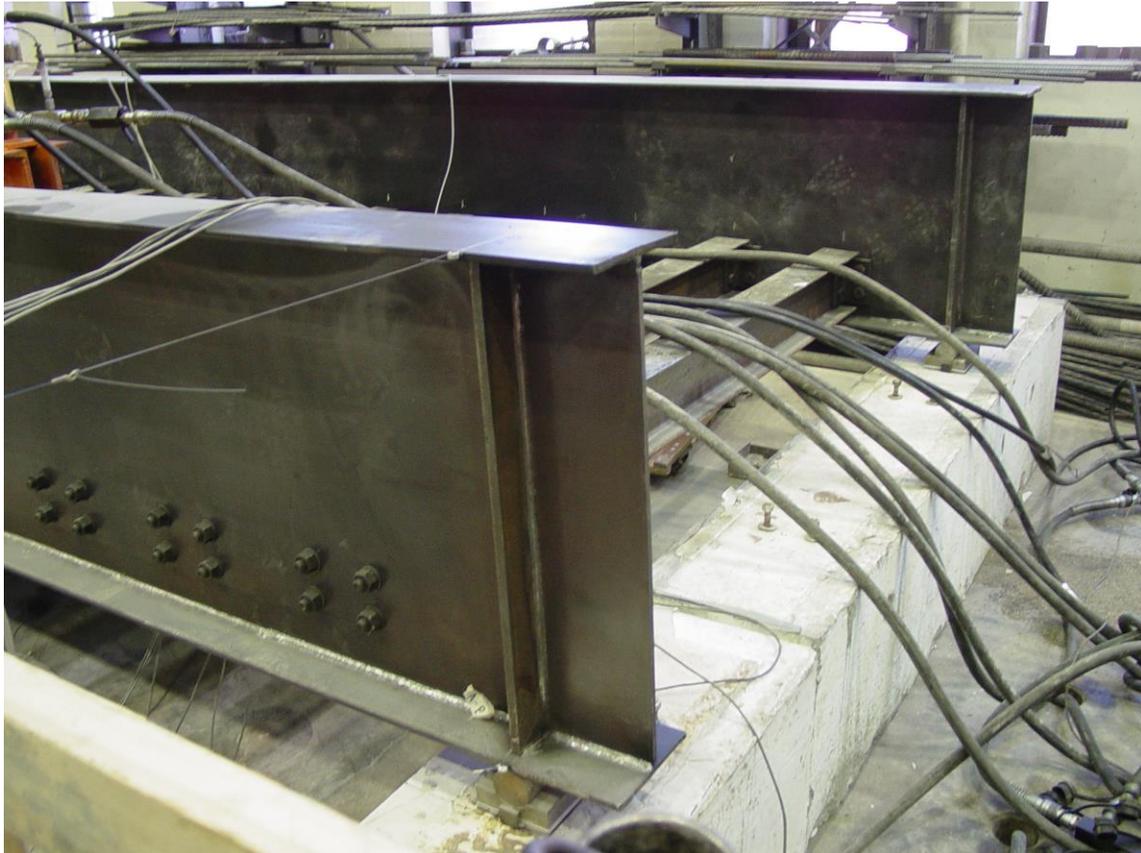
Figure 4-21. Two-Girder Bridge with Deep Girders

In the second experiment, a bridge with a built-up girder was chosen. The reason for not using rolled girders was to be able to perform the experiment on the maximum ratio that can be found in practice for the height of the girder to height of the floor beams. Figure 4-21 shows a photo of the two-girder bridge in which the ratio of the heights of the girders and floor beams can be seen. The geometrical configuration of the test bridge, loading position, instrumentation and different stages of loading in this experiment are explained in the following subsections.

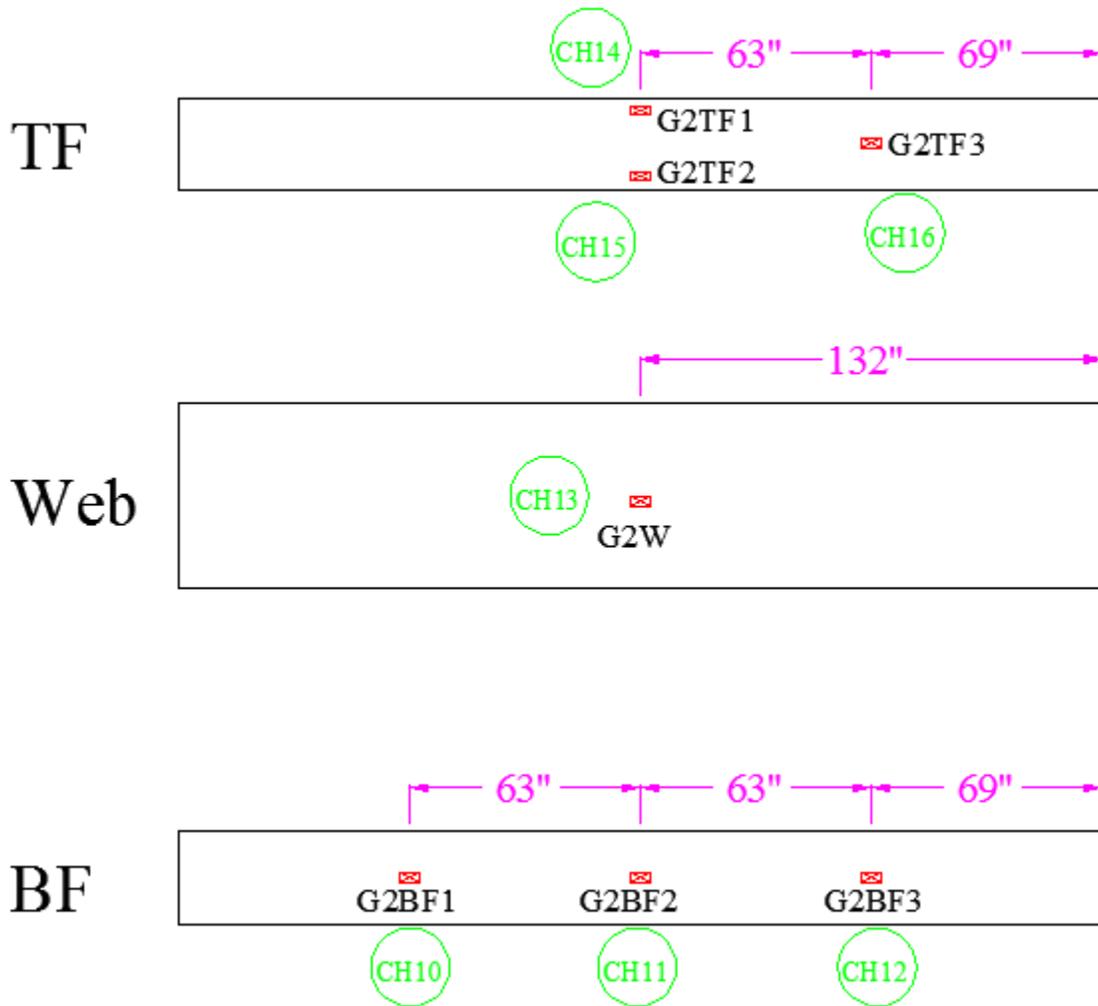
Figure 4-27. Strain Gauges in Girder far from Loading.

The girder that is farther from the loading points has three strain gages below its bottom flange each of them at the quarter points of the girder length. It also has one strain gage at the middle of the height of the mid-span section. On the top flange, the girder has three strain gages. One at the quarter point in the middle of the width of the flange and the other two at mid-span section, each of them one inch away from the edges of the top flange. The strain gauge locations on the girder far from loading points are shown in Figure 4-27.

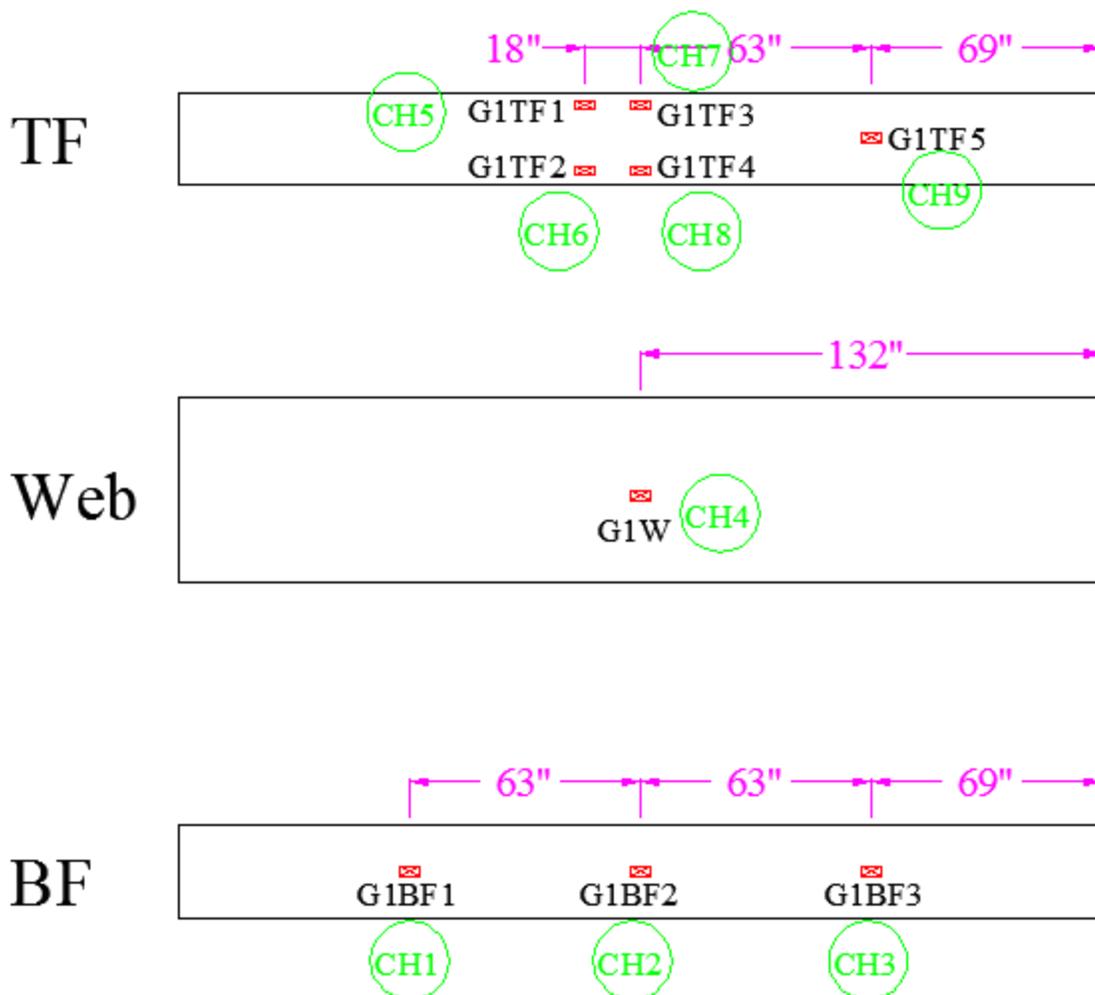
Figure 4-28. Strain Gauges in Girder Close to Loading.

The strain gages of the girder A has the same strain gage positions plus two more strain gages on the top flange at a section 1'-6" from the mid-span section, as illustrated in Figure 4-28. These two strain gages also have a distance of one inch from the edges of the top flange.

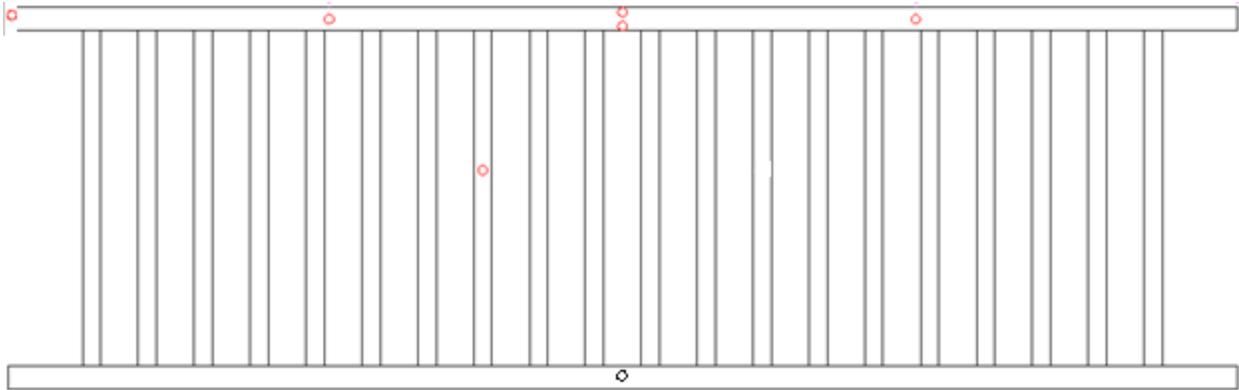
Figure 4-32. Vertical Potentiometers in Fractured Test.

In this stage of the experiment, the horizontal potentiometers were kept the same as in the LTB unfractured test above. However, one vertical potentiometer was added to the girder near the loading to record its vertical displacement and another potentiometer was used to measure the crack opening during the loading. One of the vertical potentiometer on the floor beam was removed due to the limitation on the number of potentiometer channels. The final setup of the potentiometers is shown in Figure 4-32 and Figure 4-33.

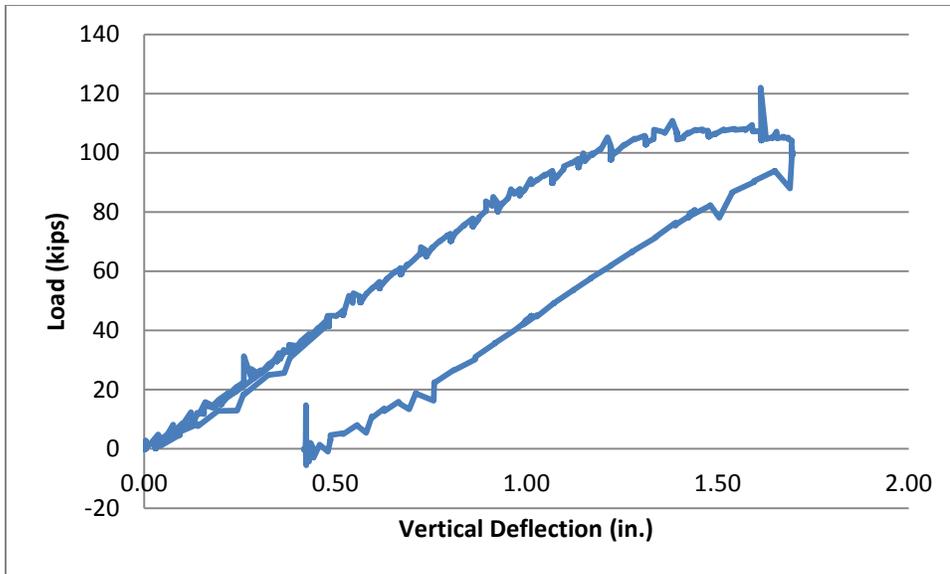
Figure 4-47. Load vs. Vertical Deflection at Mid-span of Loaded Girder

Figure 4-47 illustrates the applied load versus the vertical deflection of the girder closer to the loading (Girder A) at mid-span. It is observed that a maximum load of 106 kips was carried by the bridge with a maximum vertical displacement of 1.7 inches. It is also observed that the girder experienced a plastic vertical deformation of about 0.45 inch at the mid-span of the loaded girder.

In the second model, a bridge with a built-up girder was used to provide a taller specimen. This provided the maximum ratio found in practice for the height of the girder to height of the floor beams. In this experiment, the ratio was approximately 4.0. There were a total of five tests performed in on the second model. In the first test, the uncracked bridge system carried a maximum load of 106 kips with a maximum vertical displacement of 1.7 inches. After unloading, the girder closer to the loading point (Girder A) experienced a permanent vertical deformation of approximately 0.45 inch at mid-span.
