Comprehensive Evaluation of Fracture Critical Bridges

**Department of Civil and Environmental Engineering
Florida International University
Miami, Florida**

Sponsored By
Nebraska Department of Roads

February, 2014

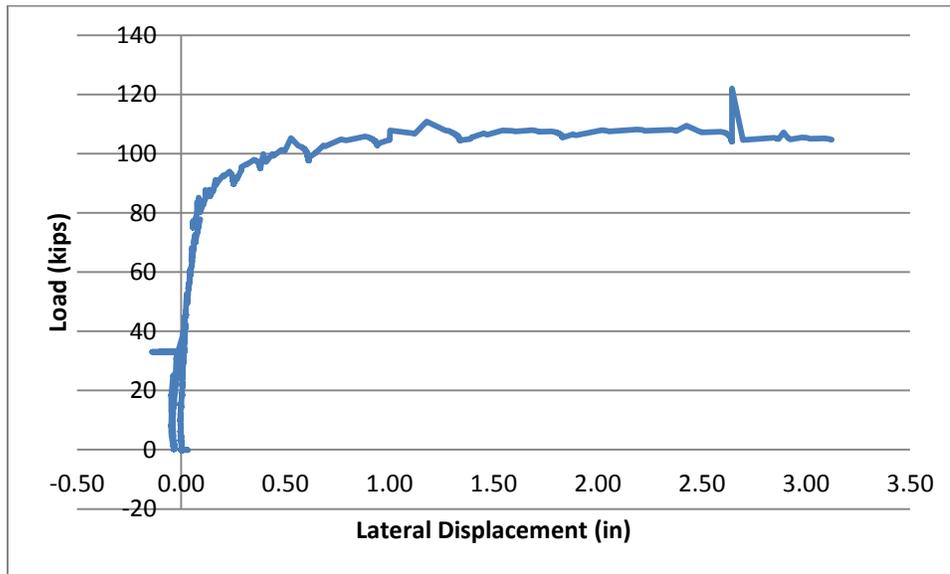
Figure 4-48. Load vs. Lateral Displacement of Flanges Loaded Girder at Mid-span

Load versus lateral displacement at mid span of the top flange of the girder near the loading is illustrated in Figure 4-48. Until 80 kip of applied load, lateral displacement of the top flange of the loaded girder was minimal. After that 80 kips of applied load, the lateral displacement increased drastically with a small increase in load.

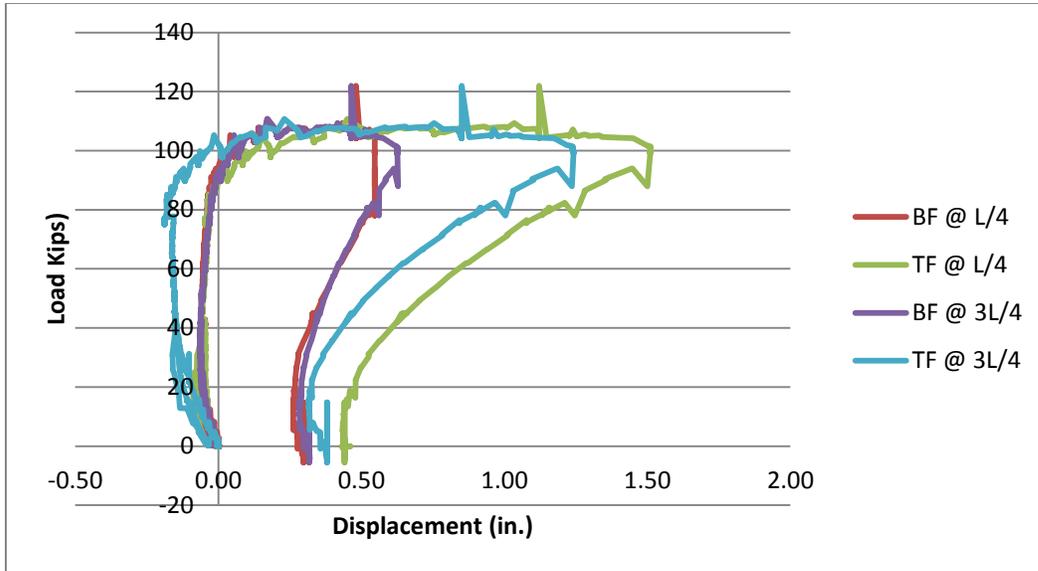
Figure 4-49. Load vs. Lateral Displacement of Top Flange Loaded Girder at Quarter Length

at the distance of $3L/4$. However, similar results were observed in these locations at the bottom flange.

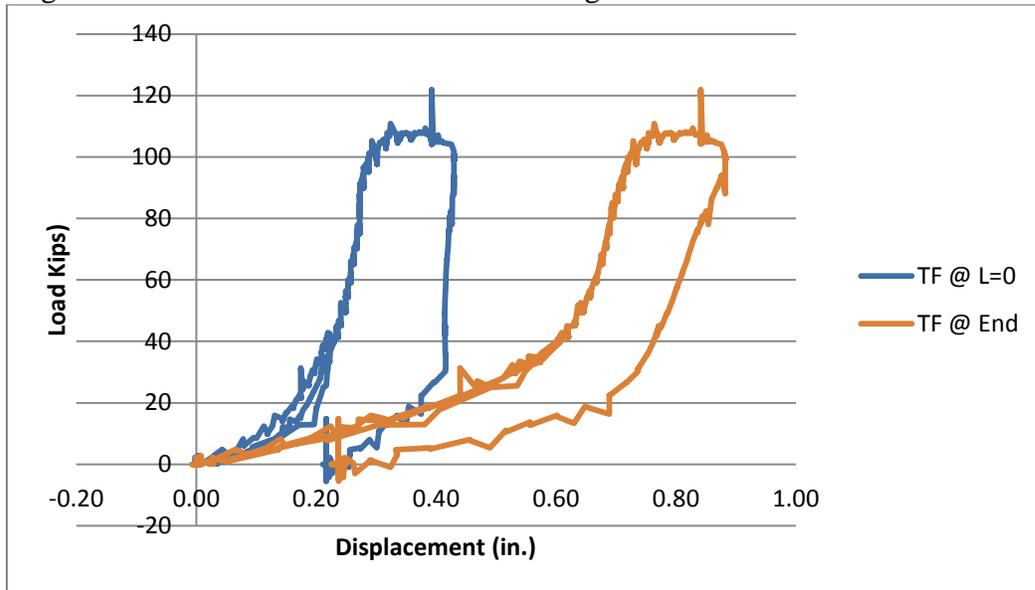
Figure 4-50. Load vs. Lateral Displacement of Top Flange at Ends Loaded Girder

In contrast to the quarter points, the lateral displacements at the ends of Girder A were observed increased quickly at small loading level (up to 40 kips); then they increased more slowly as the load increased. However, the overall magnitude at the ends is much less than observed at midspan. The lateral displacement in one end was observed to be larger than that of the other end. Figure 4-51 illustrates rotation of the loaded girder at its ends.
