Report SPR-P1(15) M027

Final Report
26-1121-4025-001

Performance Assessment of Deteriorated and Retrofitted Steel HP Piles

June 2016

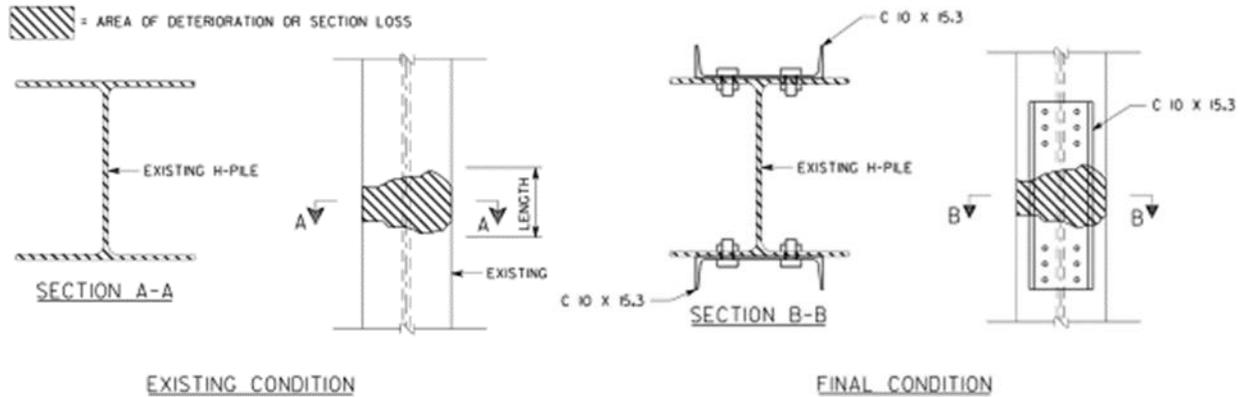
Figure 2.1 Steel channel retrofit details (GDOT, 2012)

IADOT (Wipf, 2003), GDOT (2012), and WisDOT (Wan, 2013) all describe a retrofit involving steel channels bolted to the exterior of the flange across the damaged area of the pile, as shown in figure 2.1 This retrofit's installation would require minimal effort and the design

GDOT also permits a welded alternative to the bolted channels.

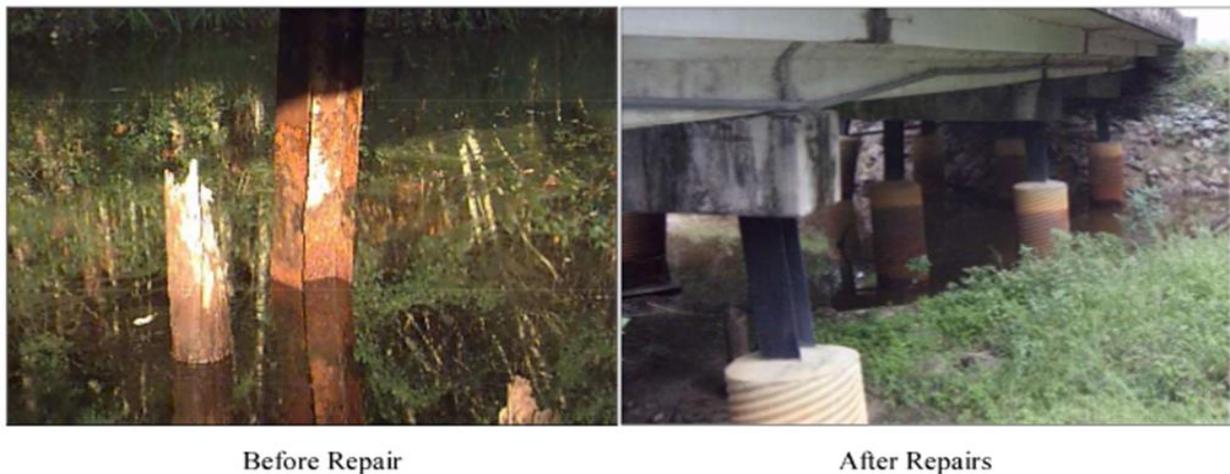
Figure 2.2 Repair before and after pictures (GDOT, 2012)

confinement to the concrete, as well as flexural strength. Georgia describes both a circular (see fig. 2.2) and square concrete encasement case. Florida does not prescribe a shape. Research performed for Wisconsin (Wan, 2013) used a square encasement detail similar to that used by Ohio DOT. The use of concrete provides the benefit of continuous bracing along the deteriorated section. Unfortunately, the concrete also prevents observation of the steel after the repair is made. FDOT discourages the use of jackets because it is difficult or impossible to monitor the condition of the steel after the jacket is installed.

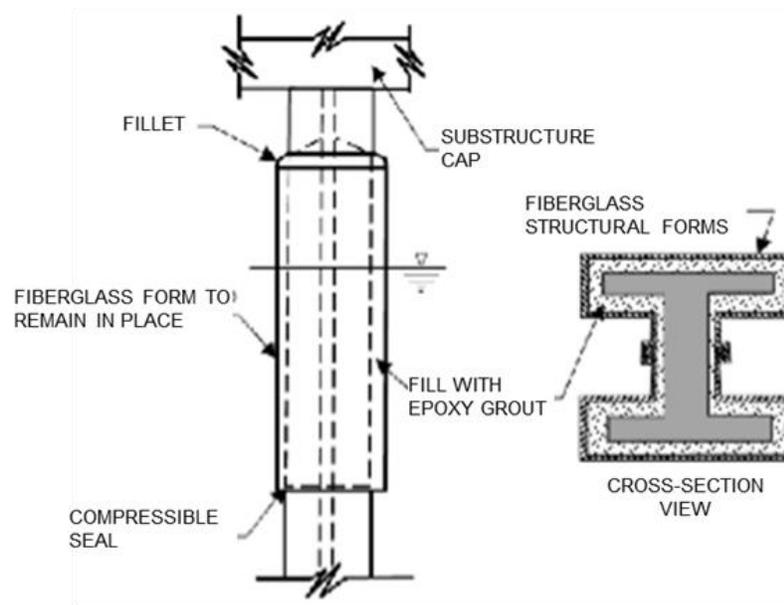
Figure 2.3 Formed fiberglass jacket (Wan, 2013)

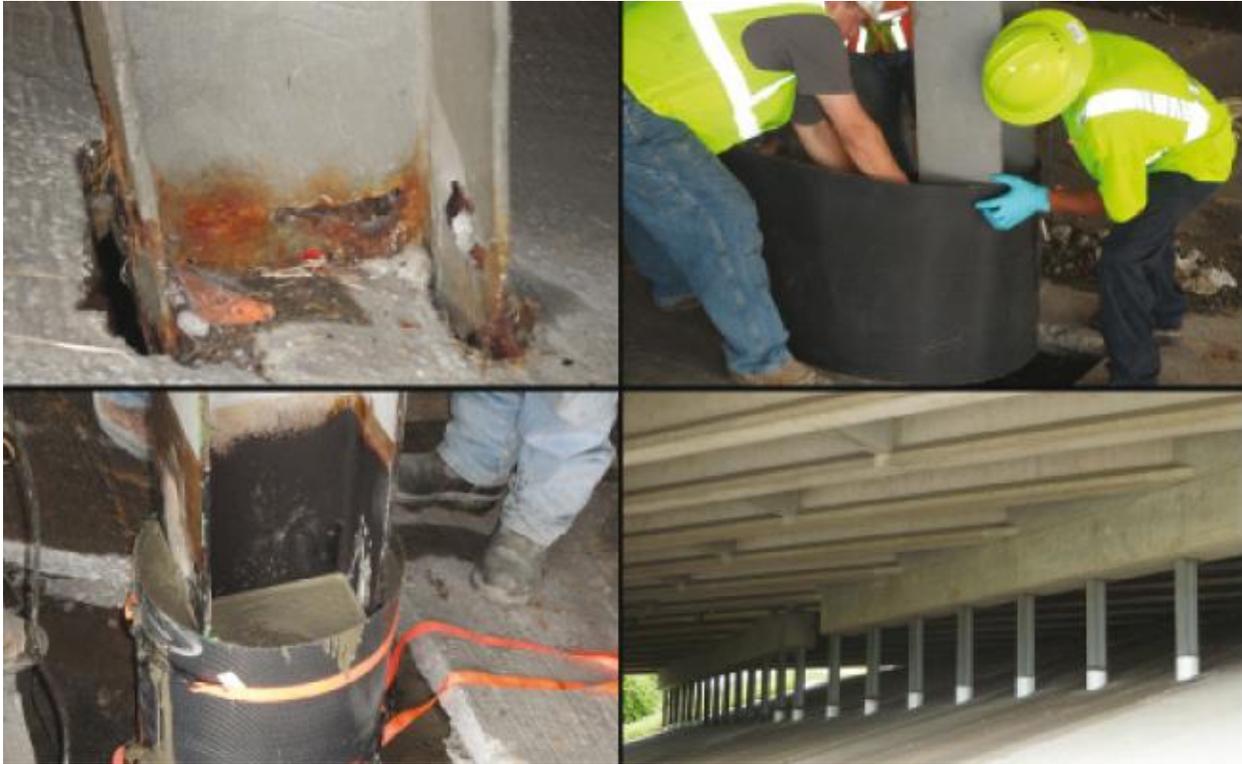
Figure 2.4 Wrapped fiberglass jacket (QuakeWrap Australia, 2016)

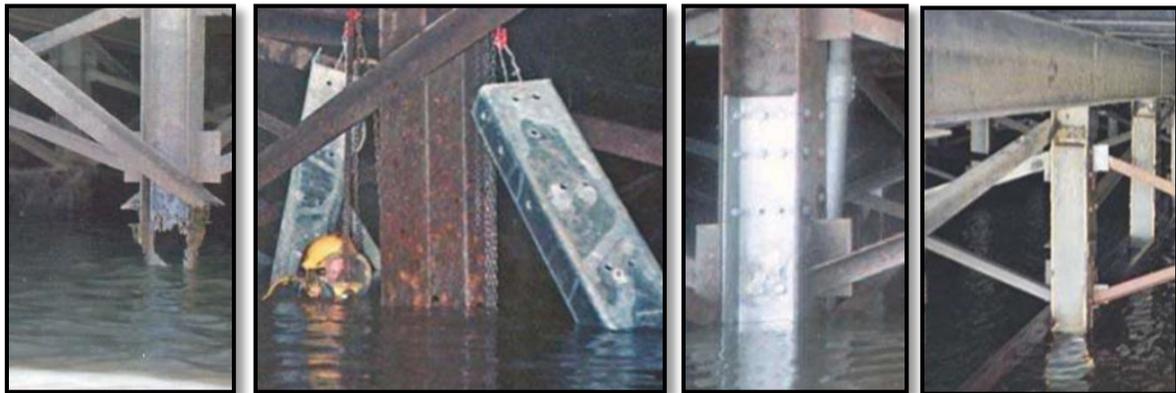
Figure 2.5 Hydro-Brace installation process

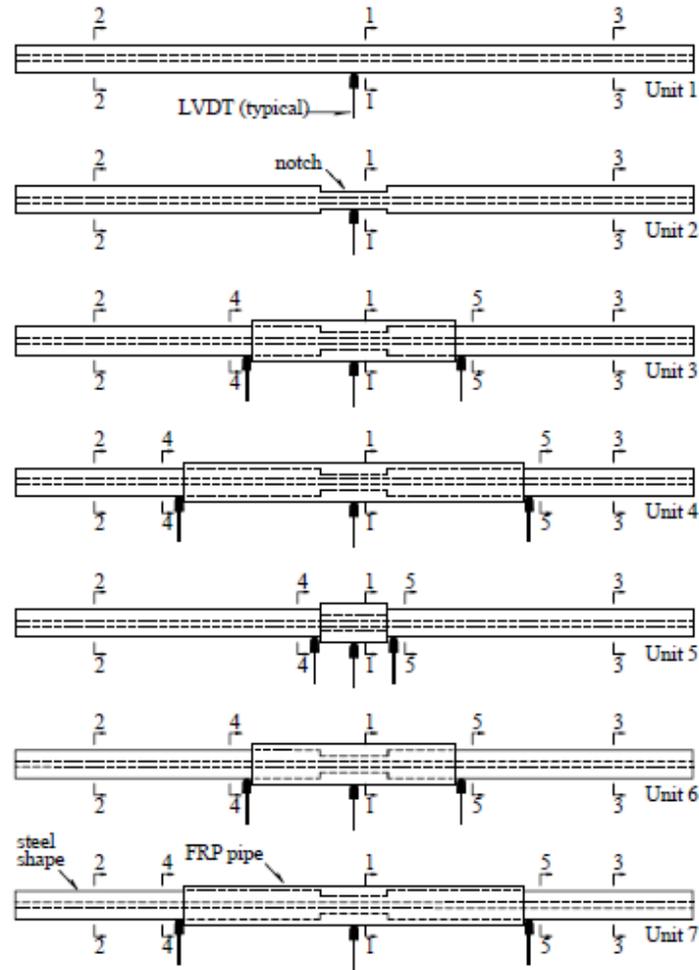
Figure 2.6 Test specimen configurations (Liu, 2003)

Liu (2003) researched the benefit of FRP (Fiber Reinforced Polymer) wraps on piles with simulated corrosion. Axial testing was performed at the University of Missouri-Rolla to determine the capacity of the piles with varying wrap lengths and concrete fills. Sketches of the test specimens are shown in figure 2.6. Axial loading tests demonstrated that increasing wrap lengths correlated to increased benefits to strength. Even when the wrap covered only the deteriorated region without lapping sound material, the capacity was almost fully restored. The type of concrete used also played a role in the pile strength. The test results indicated that retrofitted pile strength increased with wrap length and the strength increase was compounded using expansive concrete.

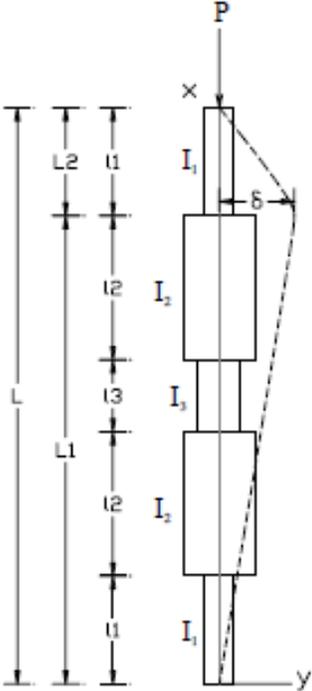
Figure 2.7 Stiffness distribution and deflection shape (Liu, 2003)

An analytical model was developed using the energy method in order to calculate the pile strength. By setting the strain energy equal to the work done, the researchers were able to develop the buckling load equation representing the column strength of a compression element, as shown in figure 2.7.

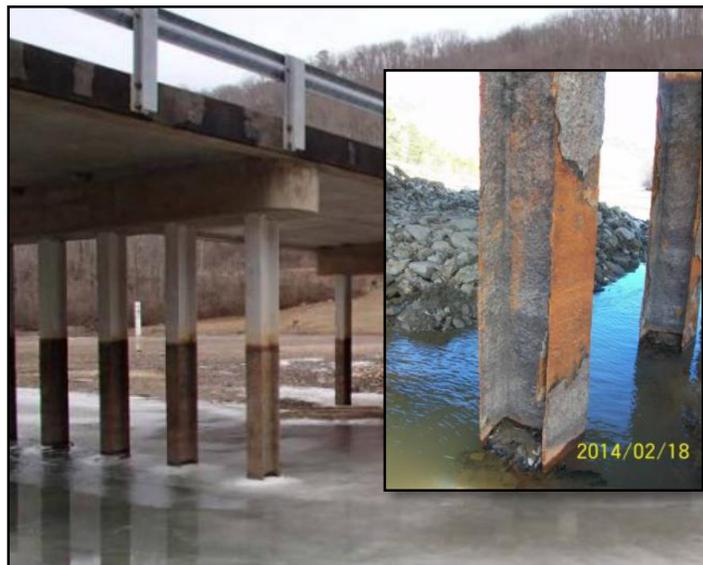
Figure 2.8 Deterioration on bridge substructure (Vijay et al. 2014)

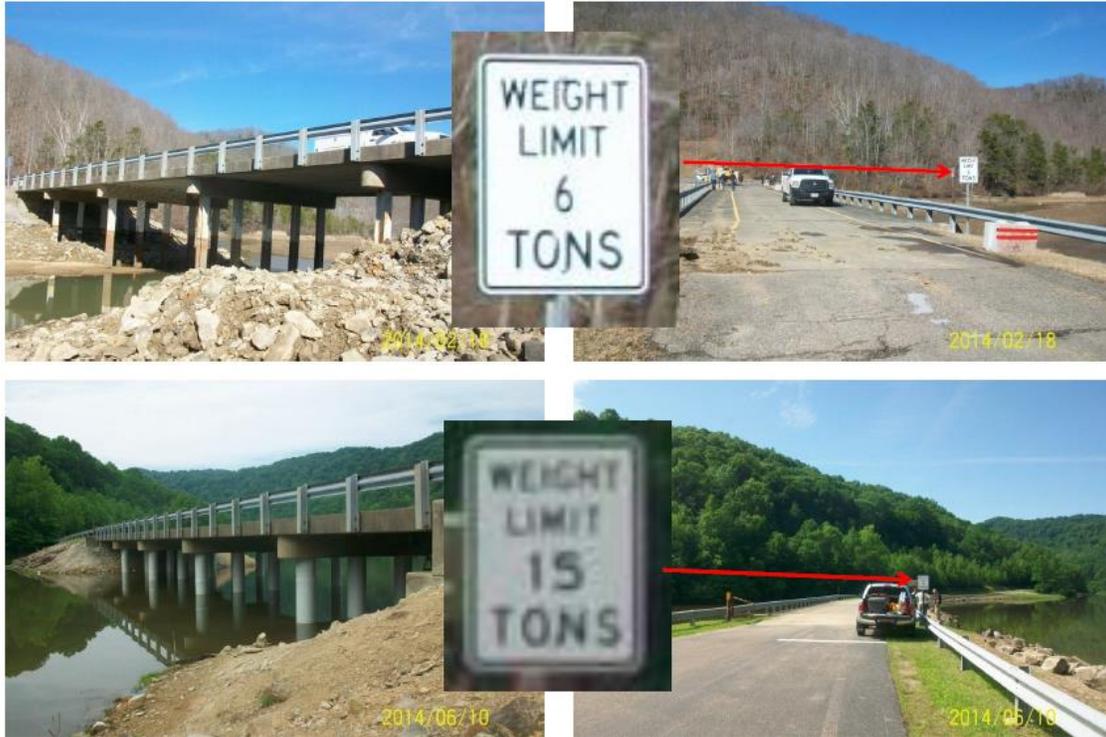
Figure 2.9 Before and after indicating load rating change (Vijay et al. 2014)

In an effort to reduce the cost of repairs, the United States Army Corps of Engineers requested research on the use of FRP material for various hydraulic structures (Vijay, Clarkson, GangaRao, Soti, & Lampo, 2014). One of these applications was a bridge with a steel substructure. The structure included a pile bent with all piles located in a waterway. The piles experienced significant section loss up to 6 feet high (see fig. 2.8). The piles were wrapped with a full height FRP shell and filled first with epoxy grout for a depth of 9 inches, then with self-consolidating concrete for the remainder of the wrap height. The FRP shell was also wrapped with two layers of GFRP (glass FRP) prior to filling. The research project is ongoing, but thus far the repairs have shown a cost savings of 35% and a favorably short construction time. Prior to repairs the bridge had been reduced to a single lane, 6 ton limit, but after repairs the bridge was opened to two lanes and a 15 ton limit (see fig 2.9).

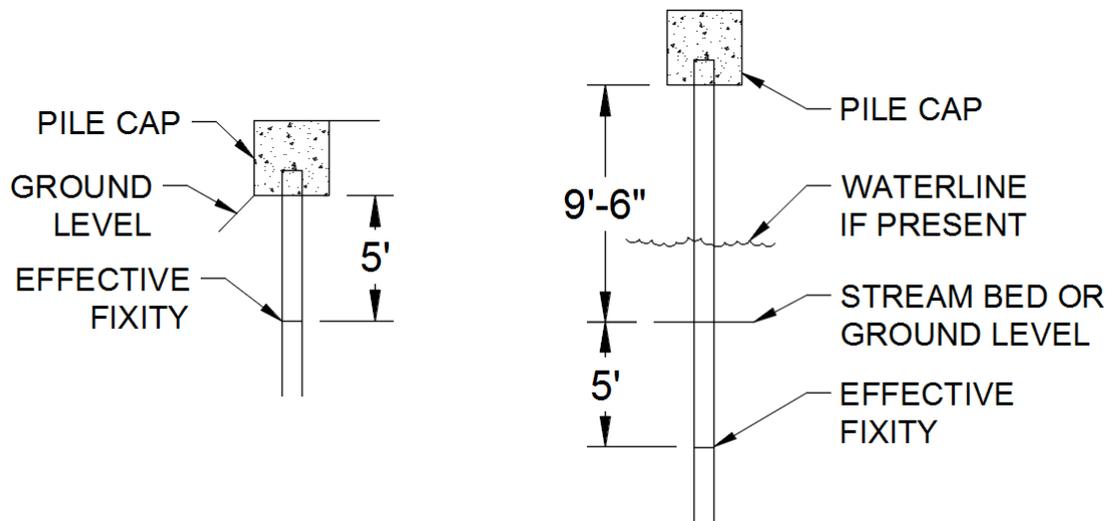
Figure 3.2 Non-deteriorated test cases

Non-deteriorated tests established a baseline for the ultimate load that an undamaged specimen could resist and provided a reference for a comparison of capacity, failure mechanisms, and instrumentation readings after deteriorated and retrofitted cases. No special modification were required for non-deteriorated cases other than those previously indicated. Schematic representations for the two cases are presented in figure 3.2

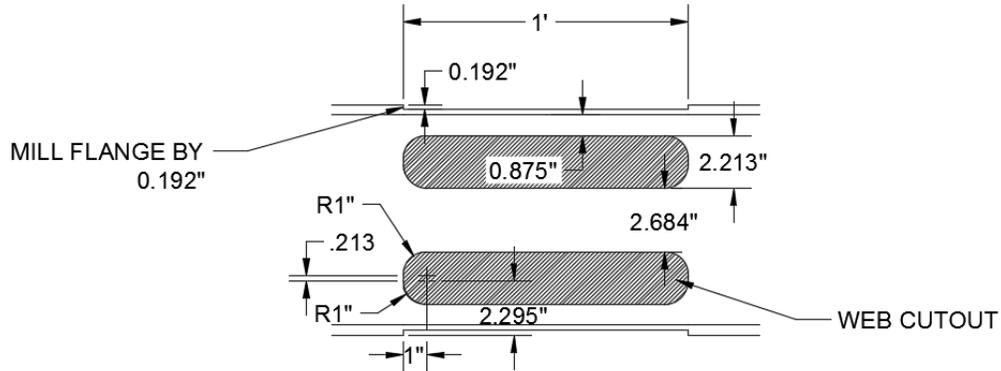
Figure 3.3 Deteriorated section milling detail

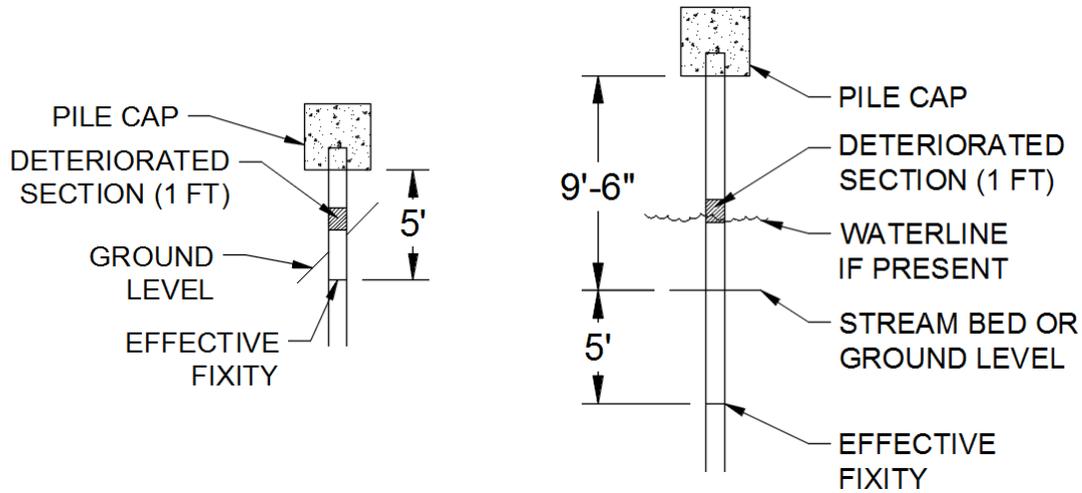
Figure 3.4 Deteriorated test cases

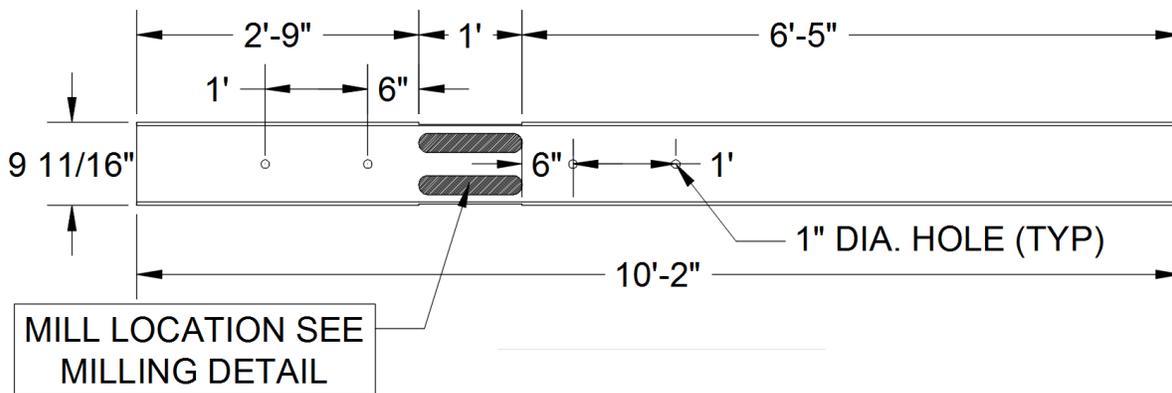
Figure 3.5 Elevation view of retrofitted test case milling

Retrofitted specimens were milled and prepared with plate steel similarly to the deteriorated specimens prior to placing reinforced concrete consistent with NDOR's standard detail. Four 1 inch diameter holes (two on either side of the deteriorated section) were also cut through the web for doweled rebar, as shown in figure 3.5. The dowel holes were spaced at 12 inches on center, with the farthest dowels installed 18 inches from the boundary of the deteriorated section. Embedded instrumentation was installed with protective covering for both the strain gages and lead wires prior to placing concrete around the deteriorated steel section. Rebar was placed within the form to provide a cage, as illustrated in repair plans supplied by NDOR. Lastly, the concrete was placed and vibrated to consolidation, creating a test specimen that represented the two scenarios shown in figure 3.6 Instrumentation outside the concrete was similar to the previously described non-deteriorated and deteriorated cases, and installation was deferred until after the concrete had been placed while waiting for the concrete to cure.

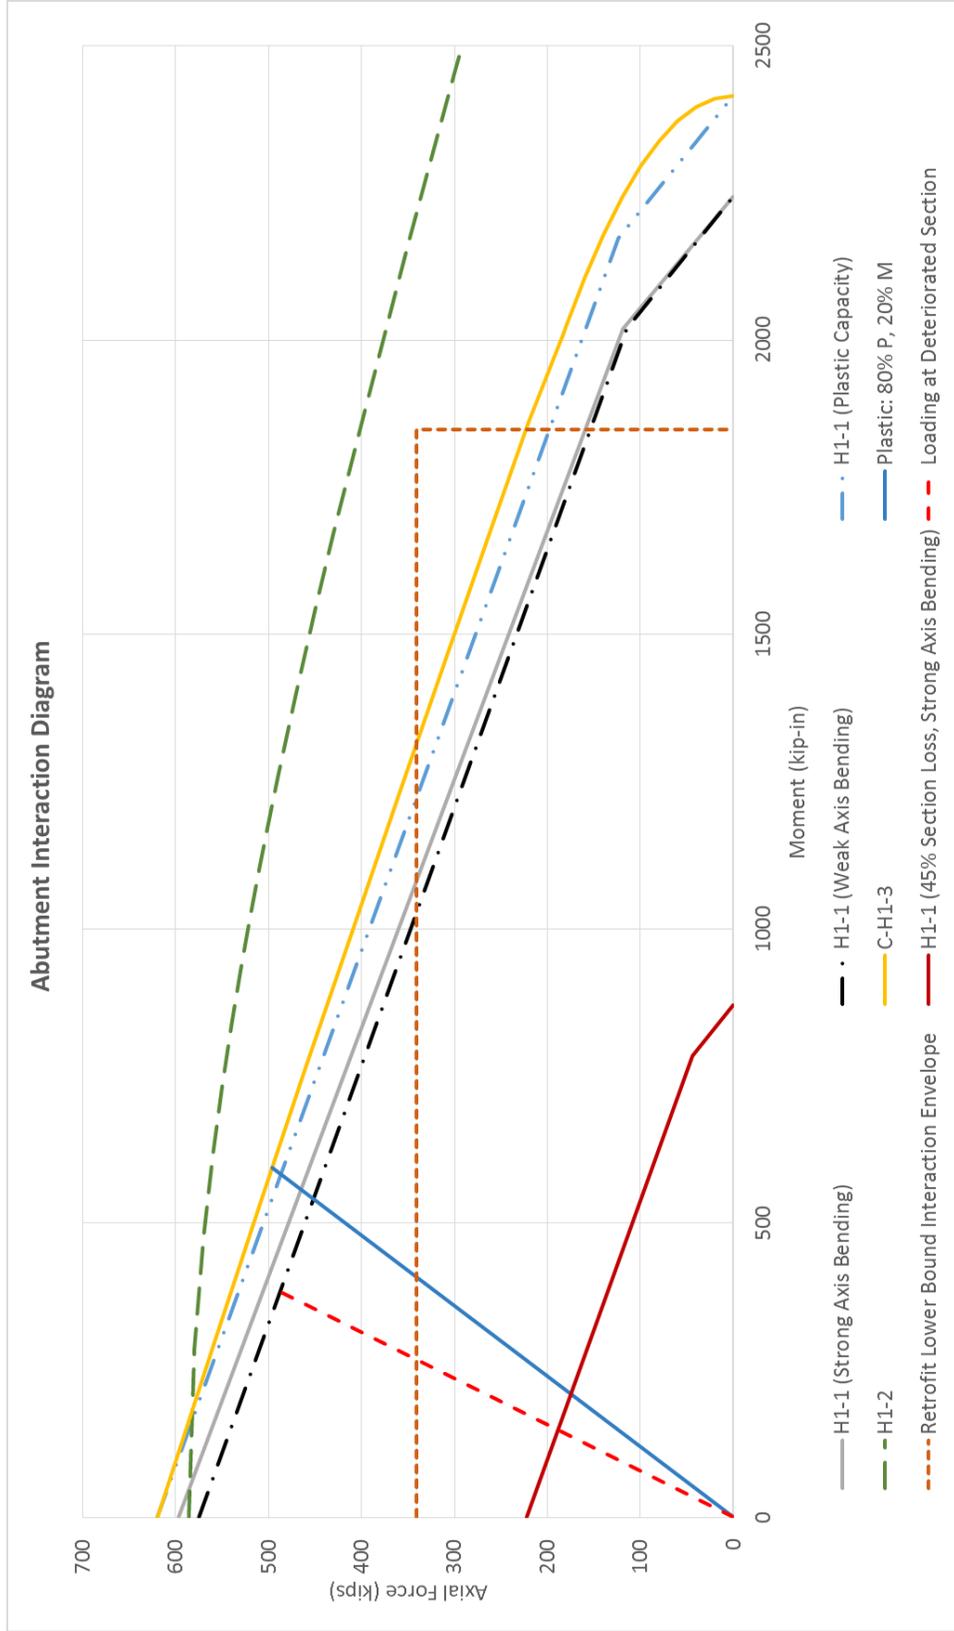
Figure 3.7 Abutment interaction diagram

Figure 3.7 and figure 3.8 show the interaction diagrams for both pile types. The limits of the pile capacities were calculated based on equation H1-1 for strong and weak axis column buckling, as well as equation H1-2. For the deteriorated pile, equation H1-1 was utilized to predict the capacity against strong axis column buckling. The line labeled “Plastic: 80% P, 20% M” represents the loading ratio at the critical section (the depth of fixity) for the non-deteriorated pile. The line labeled “Loading at Deteriorated Section” accounts for the reduced moment arm to the deteriorated section relative to the depth of fixity, and the corresponding reduction in moment relative to axial load. The non-deteriorated loading ratio is based on the calculations preceding figure 3.9. The rectangular retrofit envelope is described in a subsequent section.

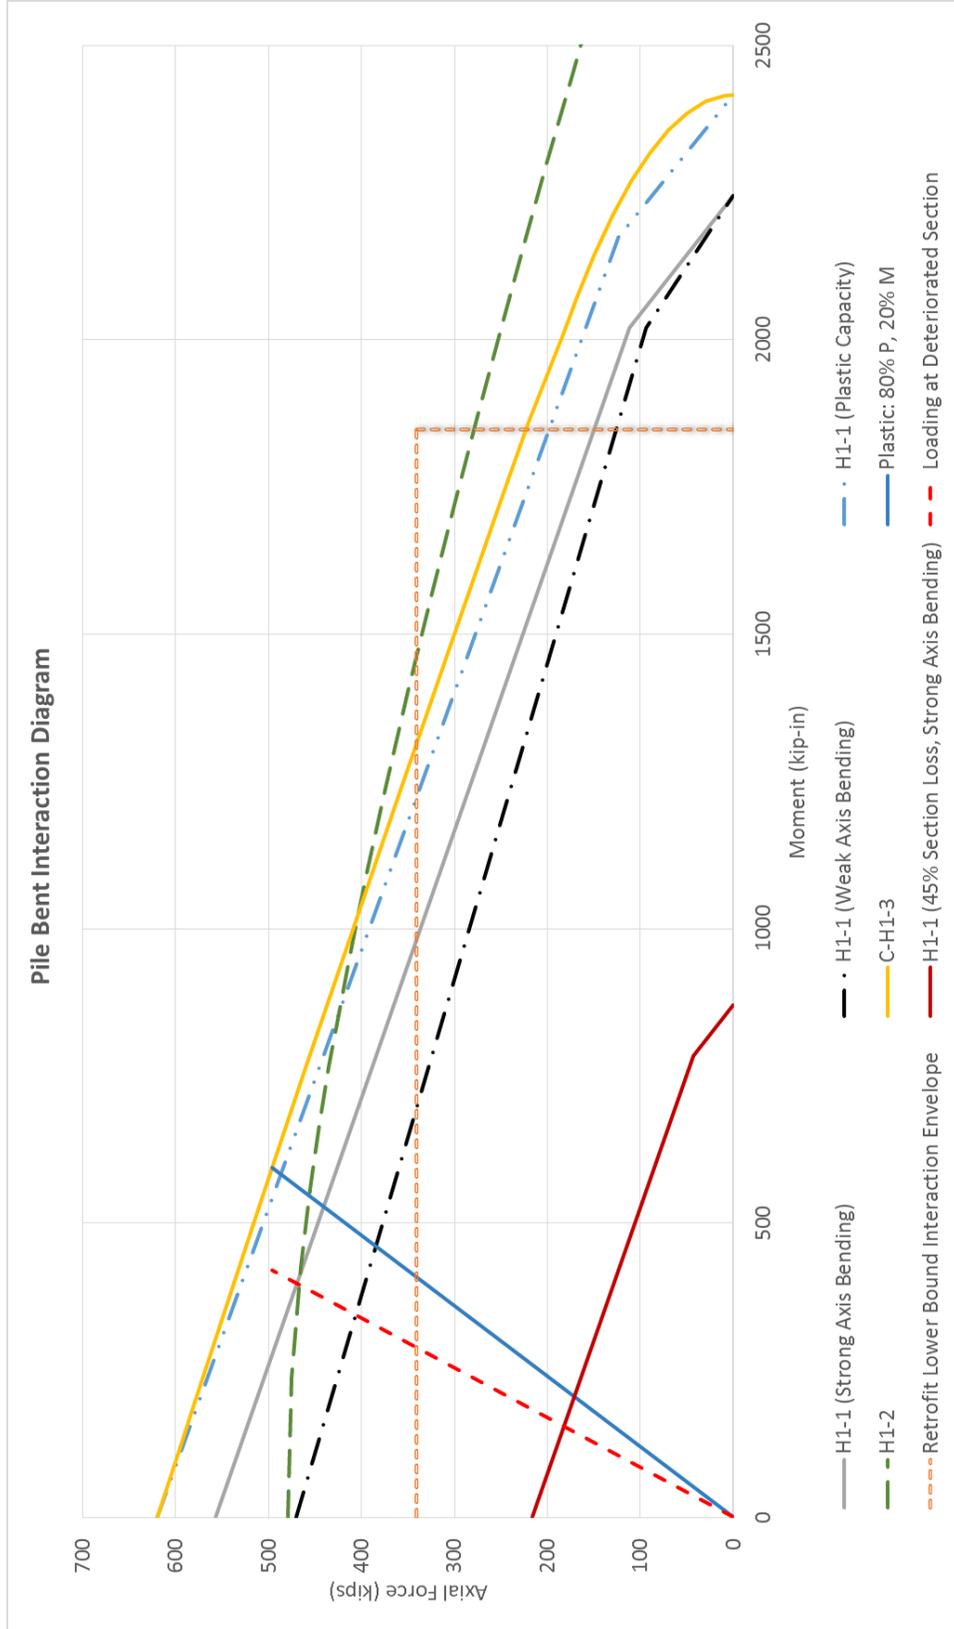
Figure 3.8 Pile bent interaction diagram

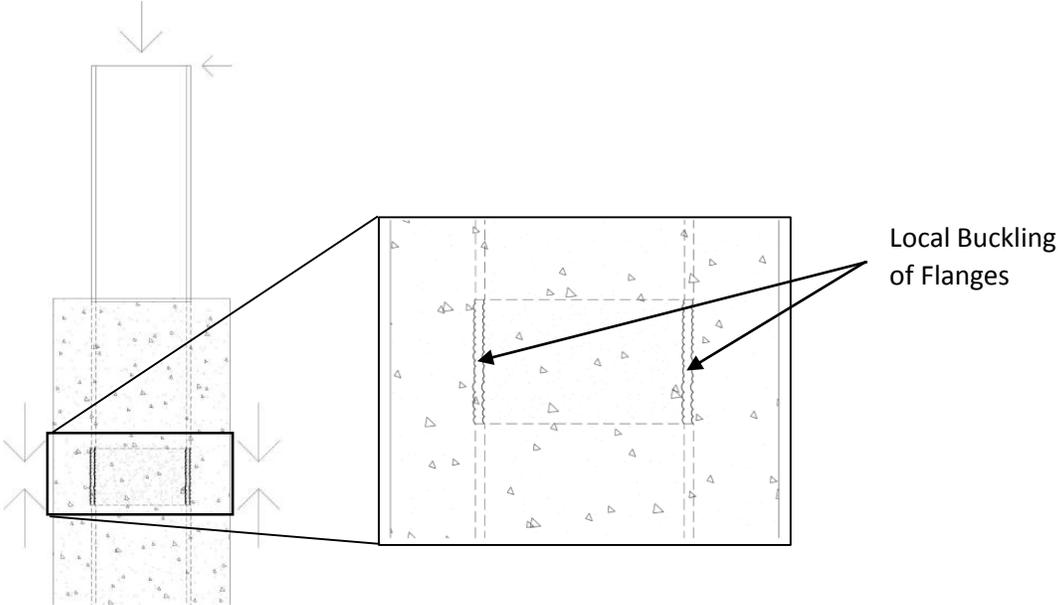
Figure 3.10 Failure case 1

mechanism implicitly presumes low bond between the steel and concrete. Figure 3.10 illustrates failure case 1. The second considered failure case arises from local buckling due to the shear-induced moment at the deteriorated section, as shown in figure 3.11. This mechanism corresponds to poor moment transfer between the steel and concrete. The final failure case considered, shown in figure 3.12, occurs when the jacket acts compositely with the pile preventing local buckling of the steel within the jacket and carrying the excess flexure demand, leading to local buckling and plastification of the non-deteriorated, noncomposite section outside of the jacket.

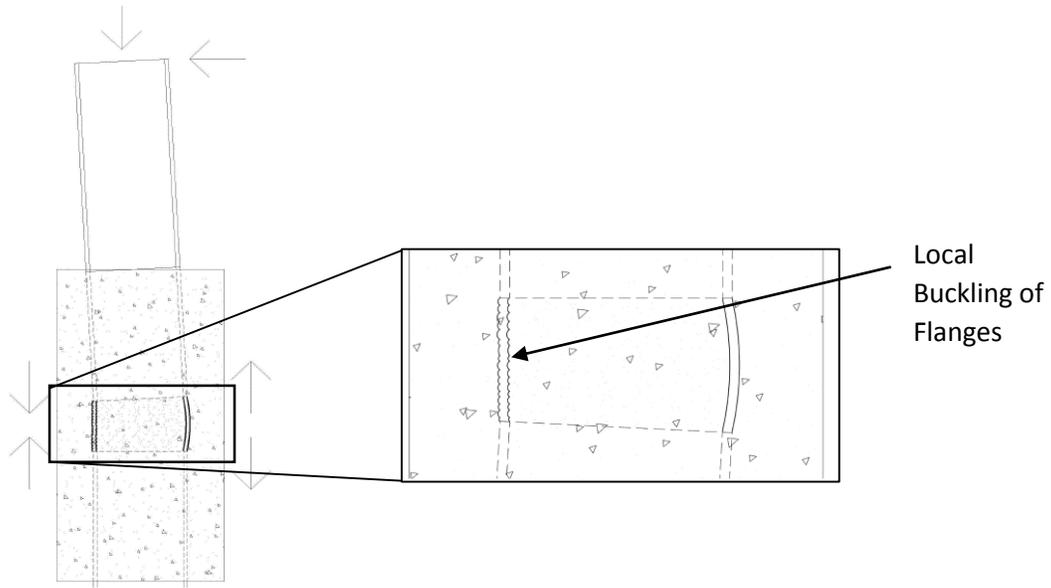
Figure 3.11 Failure case 2

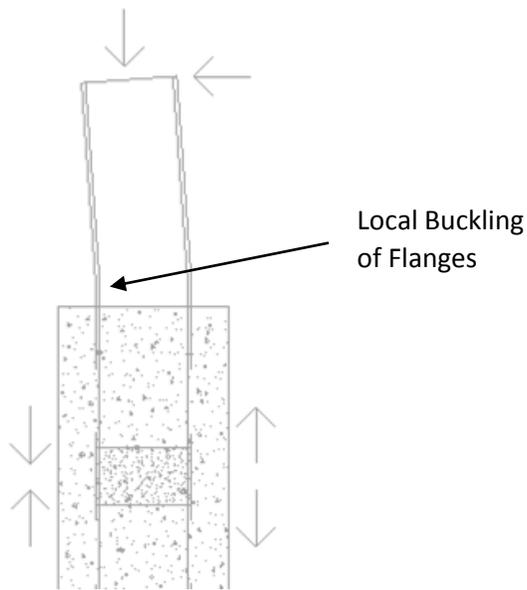
Figure 3.12 Failure case 3

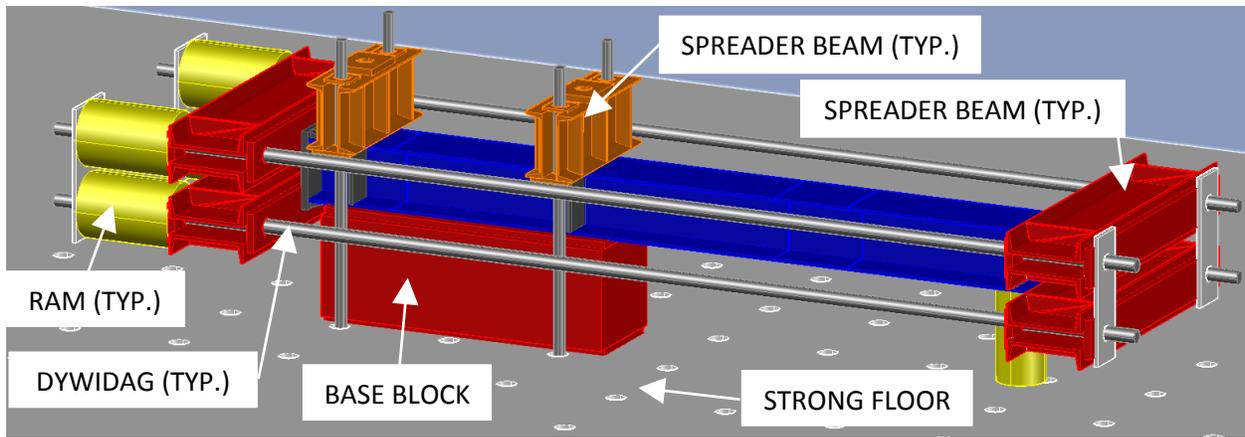
Figure 3.13 AutoCAD drawing of test setup

The pile was placed horizontally with the flange face parallel to the floor as shown in figure 3.13. The specimen was placed on spacers, which rested on a steel-encased concrete block (referred to as the base block) that supported the pile's base, and tensioned to the strong floor with built-up spreader beams and Dywidag rods. A self-reacting frame was utilized to apply the axial load, and a single ram applied the shear load by reacting against the strong floor. The self-reacting frame consisted of four RCH-1506 hollow core rams, each acting on a 1¾ inch, cold-rolled, Dywidag all thread bar. The bar and ram reacted against custom built spreader beams, which consisted of two channels spaced and connected by 1-inch thick steel plates. The shear load was opposed by the two smaller spreader beams that were used to tension down the pile to form a couple and induce moment in the specimen.

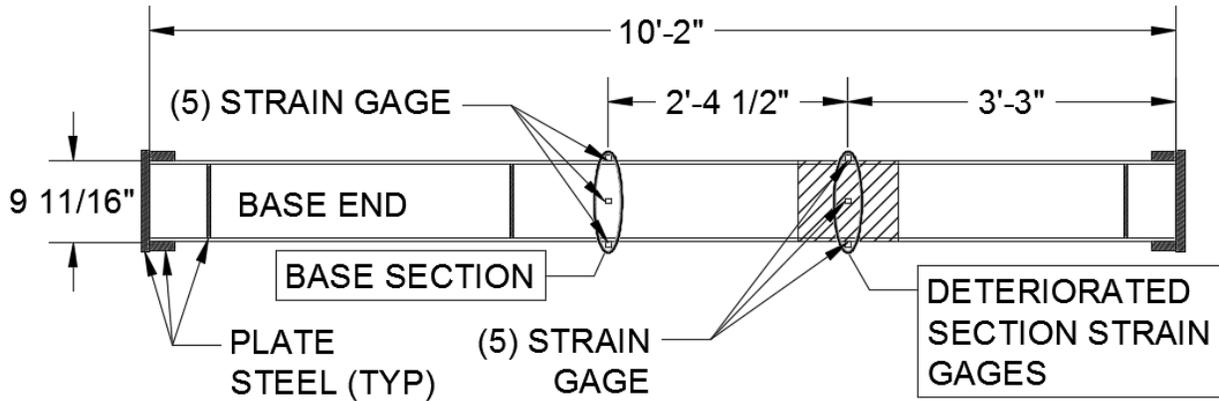
Figure 3.14 Elevation view of strain gage locations

For all of the tests strain gages were located at the base and deteriorated sections, as shown in figure 3.14. Both locations were instrumented with five gages, as illustrated in figure 3.15: one centered on the web and one centered in each half of the exterior flange face for both flanges.

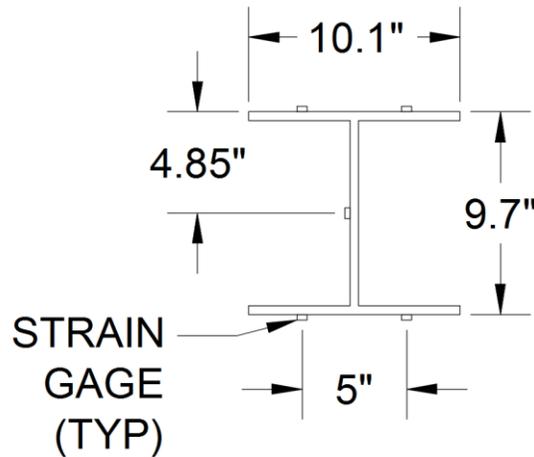
Figure 3.15 Cross section view of strain gage locations

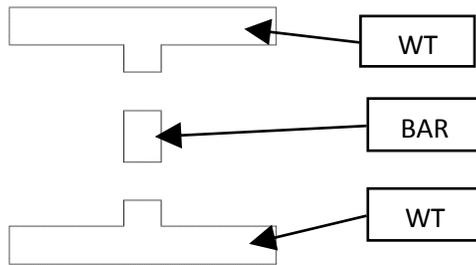
Figure 4.4 Deteriorated section elements for analysis

Calculations for the deteriorated section were similar to the fiber analysis, although more coarse. The deteriorated section effectively consisted of three elements, as shown in figure 4.4. Each flange was effectively a WT, and the web was a rectangular bar. Strains were averaged at each flange, and considered representative for the WT element as a whole. Strains were converted to stresses, stresses to forces, and forces to resultant axial load and moment, as described previously for the fiber analysis. Moment calculations only required a single scalar value for y_i to represent the distance from the mid-depth of the section to the centroid of each WT element as shown in figure 4.5.

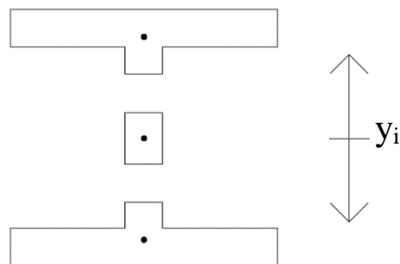
Figure 4.5 Moment arm distances for deteriorated section elements

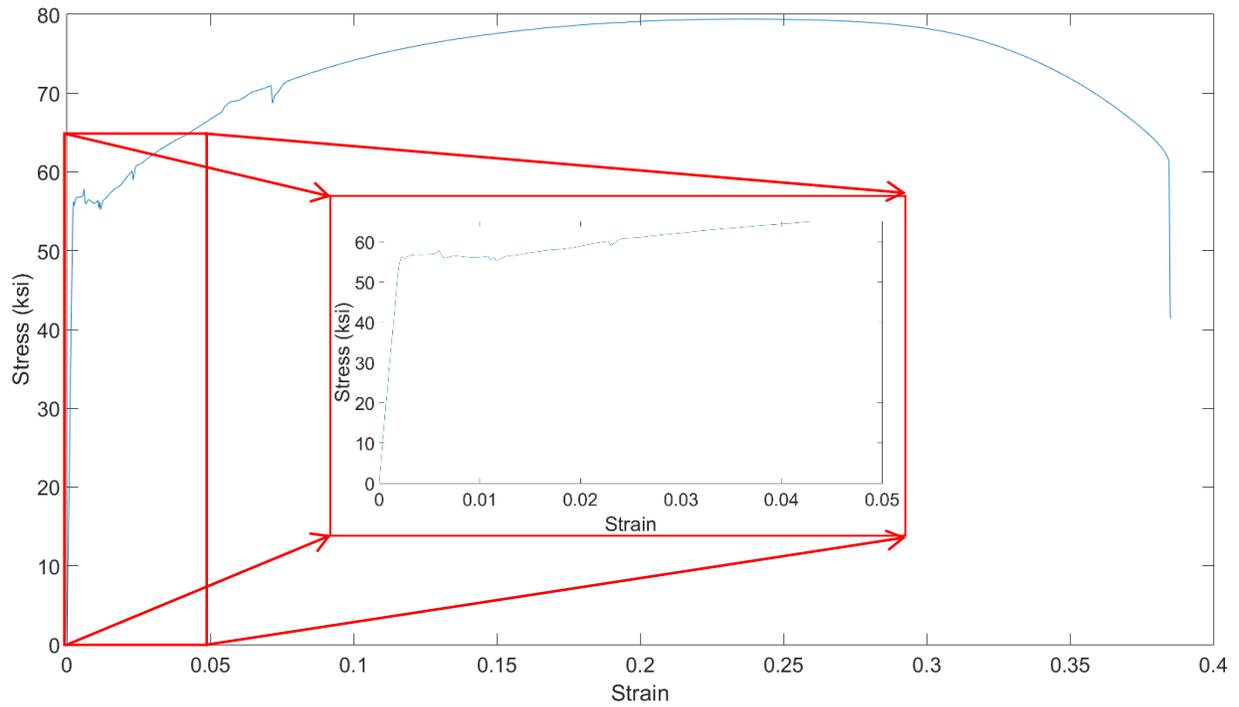
Figure 5.1 56 ksi stress vs. strain

Steel Yield Strength
Remaining Abutment Case and Pile Bent Case Piles	56 ksi
Abutment Case, Non-deteriorated Pile	55 ksi

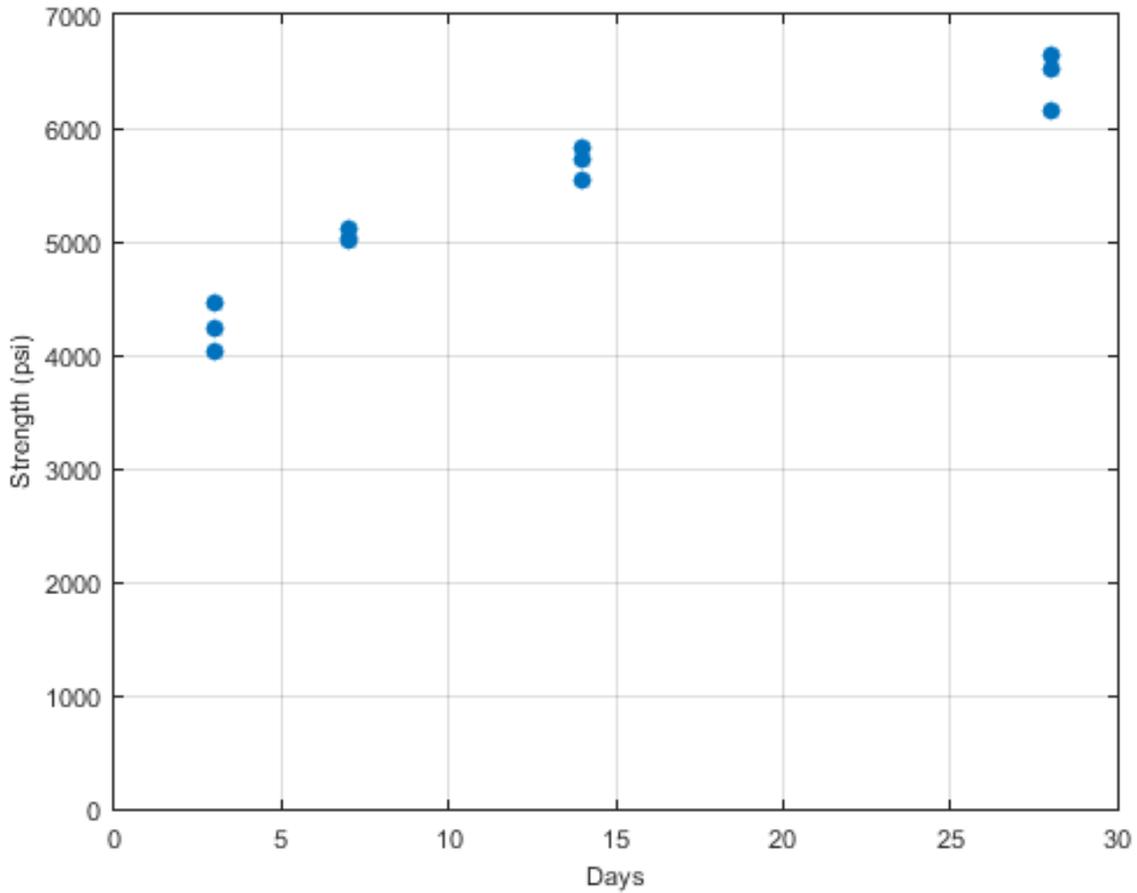
Figure 5.3 Concrete strength vs. days

Sample A	Sample B	Sample C	Average
3 Day Break	4,244	4,456	4,038	4,246
7 Day Break	5,116	5,014	5,036	5,055
14 Day Break	5,551	5,720	5,821	5,697
28 Day Break	6,157	6,648	6,530	6,445

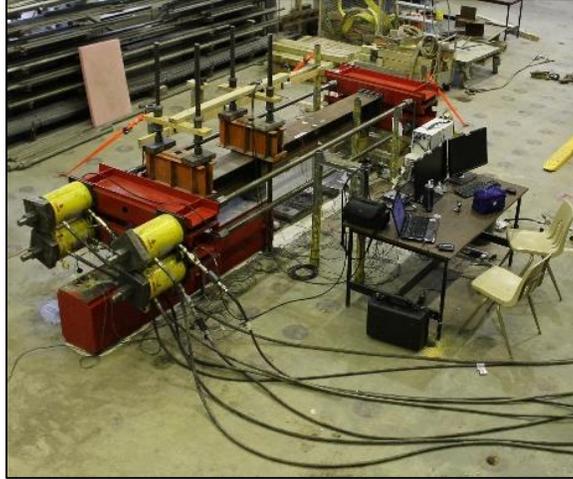
Figure 5.4 Non-deteriorated abutment test

The non-deteriorated abutment test setup is shown in figure 5.4. Based on the calculations using AISC (2010) methodology, the pile was expected to experience compression flange local buckling in pure flexure and flange local buckling in pure compression. Since both the compression and flexure limits had similar failure cases, local buckling failure of the top flange near the base end of the pile was anticipated and was observed, as shown in figure 5.5. The pile performed as expected and provided a sound baseline against which to compare the remaining abutment tests.

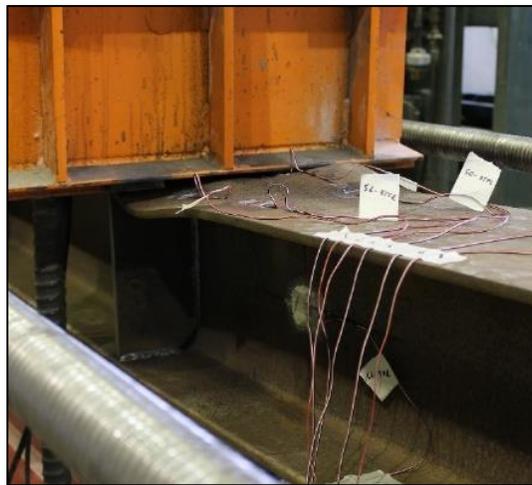
Figure 5.5 Buckling of base section top flange

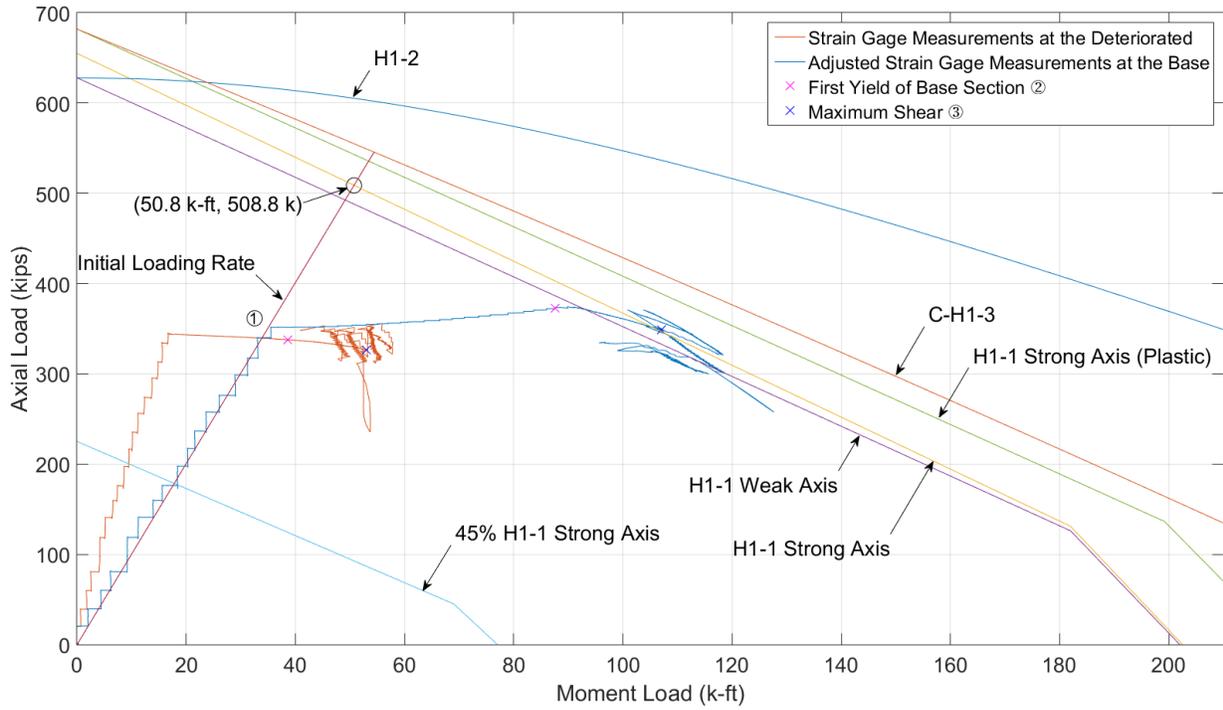
Figure 5.6 Non-deteriorated abutment case axial vs. moment

Yielding and local buckling progressed slowly and gradually after the steel reached its combined P-M loading limit. The stockiness of the pile's cross section, coupled with its relatively short overall length, provided a great deal of stiffness and allowed the section to carry loads near the material's plastic limit, as illustrated in figure 5.6.

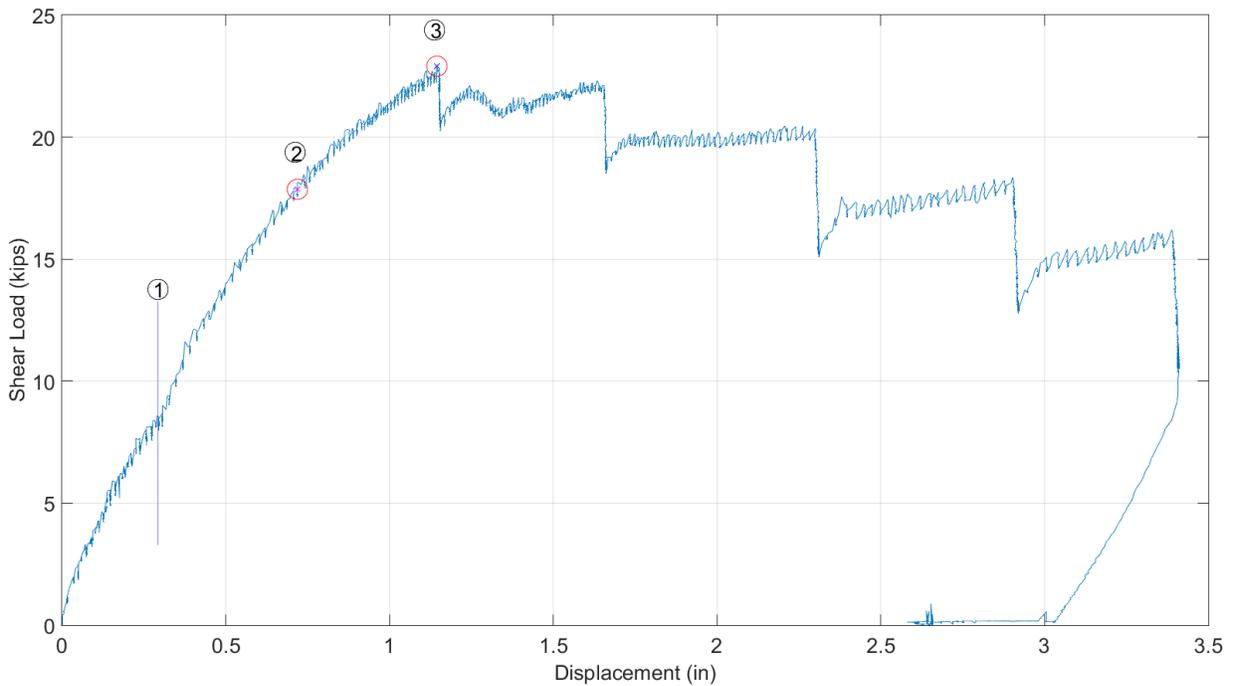
Figure 5.7 Non-deteriorated abutment shear vs. displacement

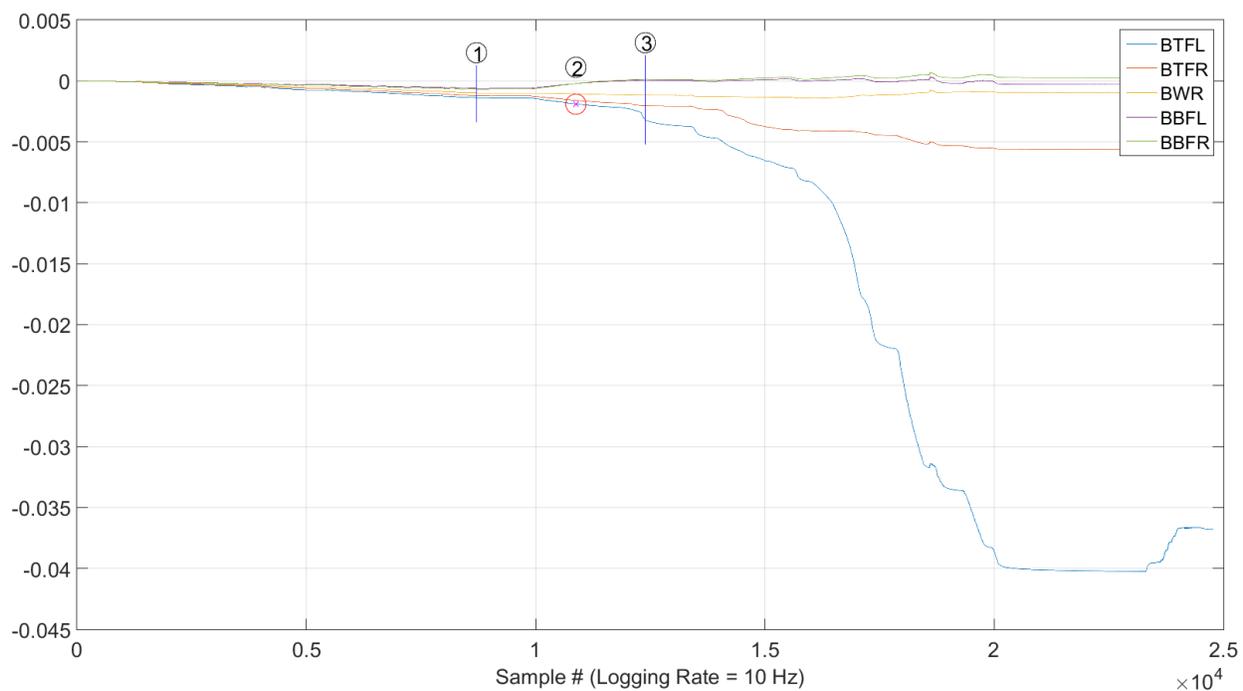
Figure 5.8 Non-deteriorated abutment base section strain vs. sample

Strain response is shown in figure 5.8 and figure 5.9 for the base and deteriorated sections, respectively. Local buckling caused strains measured at BTFL to increase drastically, representative of both the compression developed at the top of the section due to flexure compounded by local buckling deformations. At the elastic deteriorated cross-section, all strains trend negatively (compression) up to the encircled 1 where 80/20 loading ended. The load was held constant for a short time, followed by application of additional shear causing broader divergence of relative tension (tending toward positive) and compression (tending toward negative) in flexure.

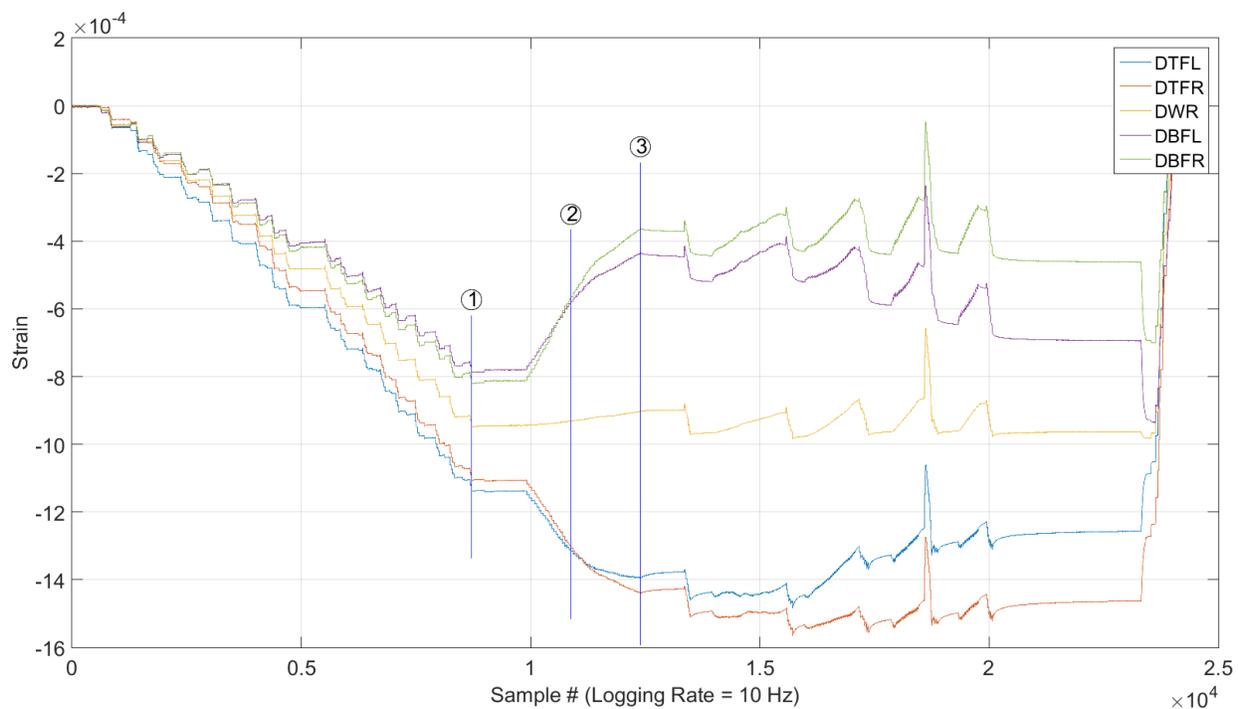
Figure 5.9 Non-deteriorated abutment deteriorated section strain vs. sample
