Report SPR-P1(15) M027

Final Report
26-1121-4025-001

Performance Assessment of Deteriorated and Retrofitted Steel HP Piles

June 2016

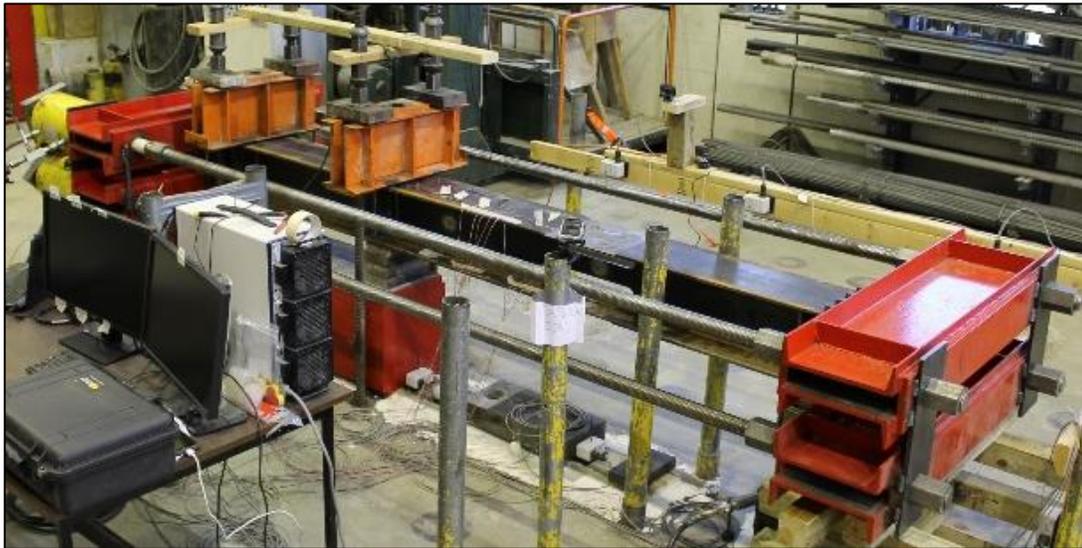
Figure 5.10 Deteriorated abutment test

The deteriorated abutment case test setup is shown in figure 5.10. Failure occurred by initial local buckling of the milled flange region. The deteriorated region initially resisted applied loading as a frame, but the top flange portion of the deteriorated section could not fully participate in resisting additional applied loads after local buckling occurred. Subsequently, the web region of the deteriorated section provided primary resistance to shear racking deformations. The web region developed plastic hinges at each end of the deteriorated region, as illustrated in figure 5.11 and figure 5.12, and instability of the specimen against combined loads. Local buckling effects and load redistribution effects are evident in figure 5.13. Strain measurements at the top flange and web deviate from the trend of the group near the 10,000 sample mark.

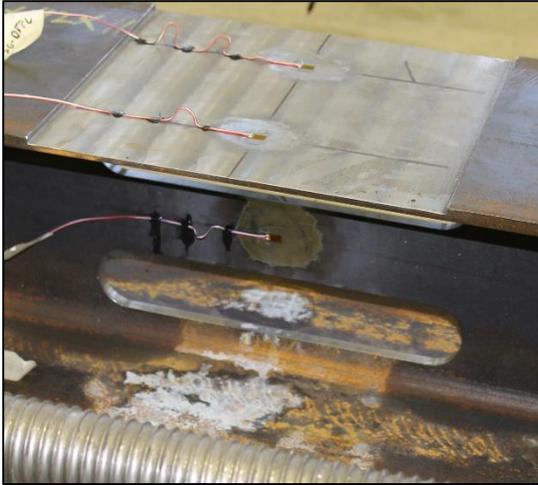
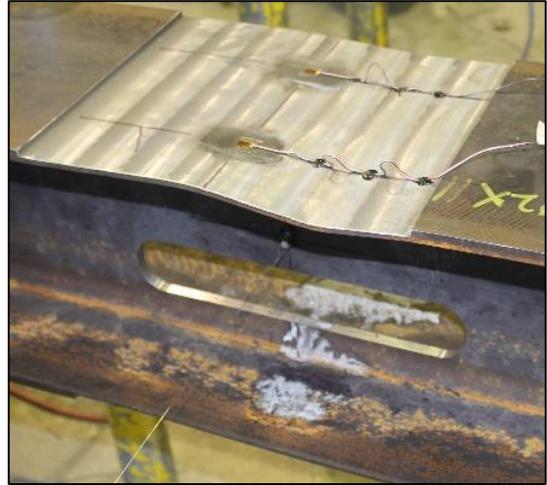
Figure 5.11 Deteriorated abutment test: deteriorated section before and after

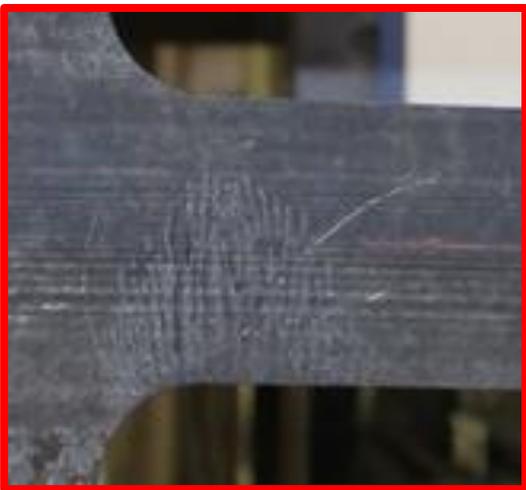
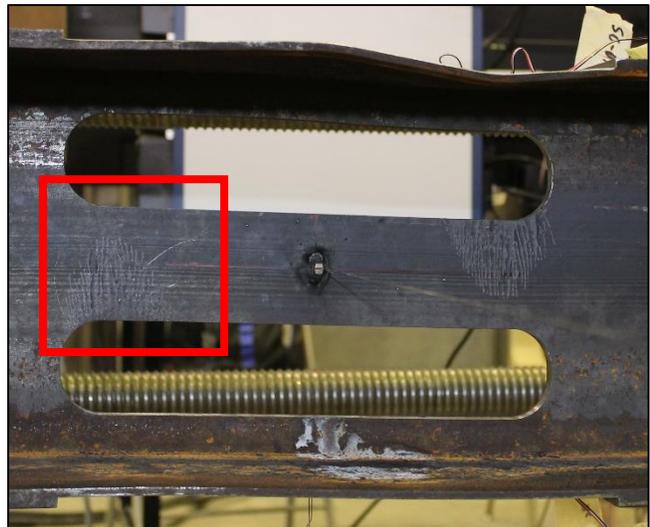
Figure 5.12 Deteriorated abutment shear failure at the deteriorated section

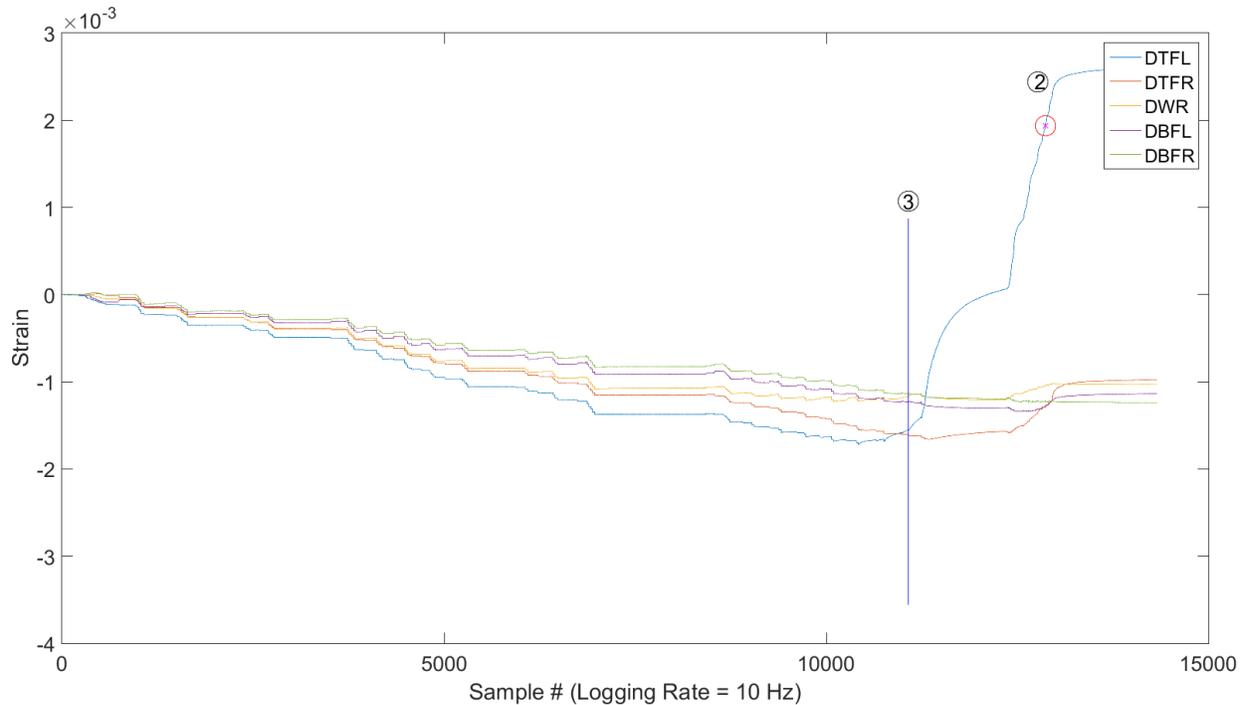
Figure 5.13 Deteriorated abutment deteriorated section strain vs. sample

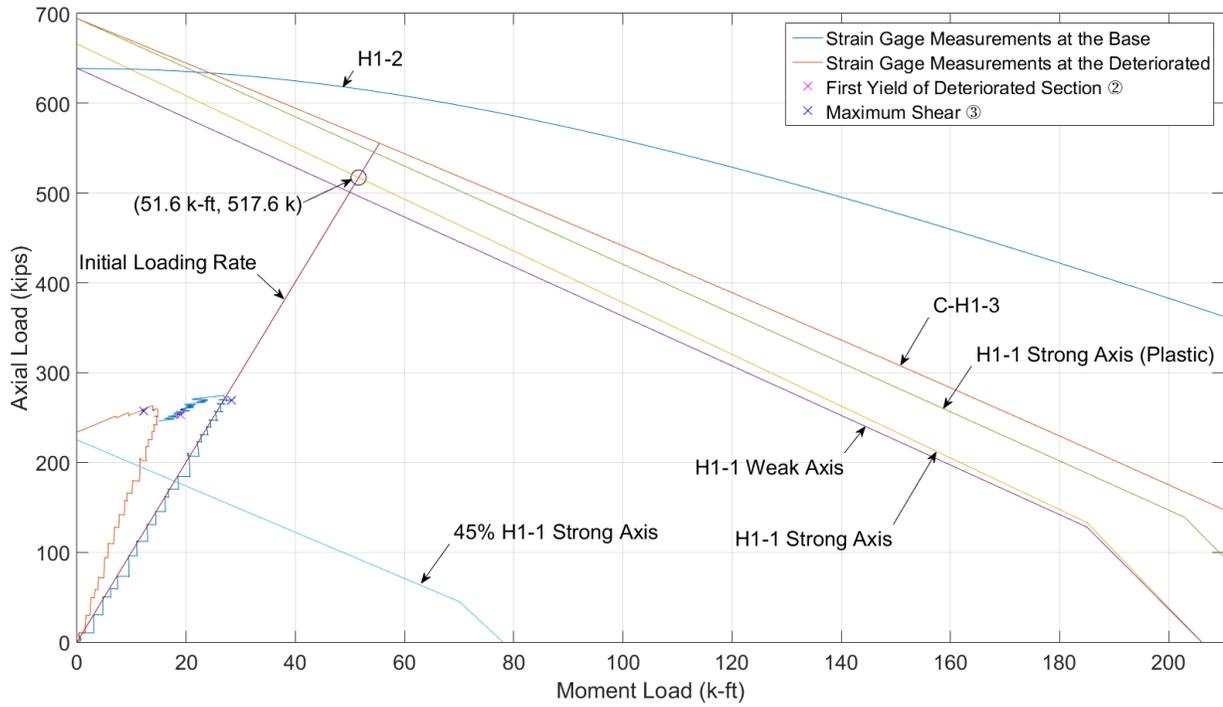
Figure 5.14 Deteriorated abutment axial vs. moment

Preliminary analyses estimating the capacity of the specimen neglected capacity beyond local buckling of the deteriorated flange, but the experiment displayed significant capacity in excess of that anticipated prior to instability. The anticipated pile capacity is plotted in figure 5.14 and shows that the pile axial capacity exceeded 250 kips in compression, more than 25% higher than the anticipated 200 kip limit for the deteriorated section. Figure 5.15 and figure 5.16 provide additional data for the shear load and the base section strains, respectively, for comparison with other abutment scenario cases. Strains at the base section remained well within the elastic range.

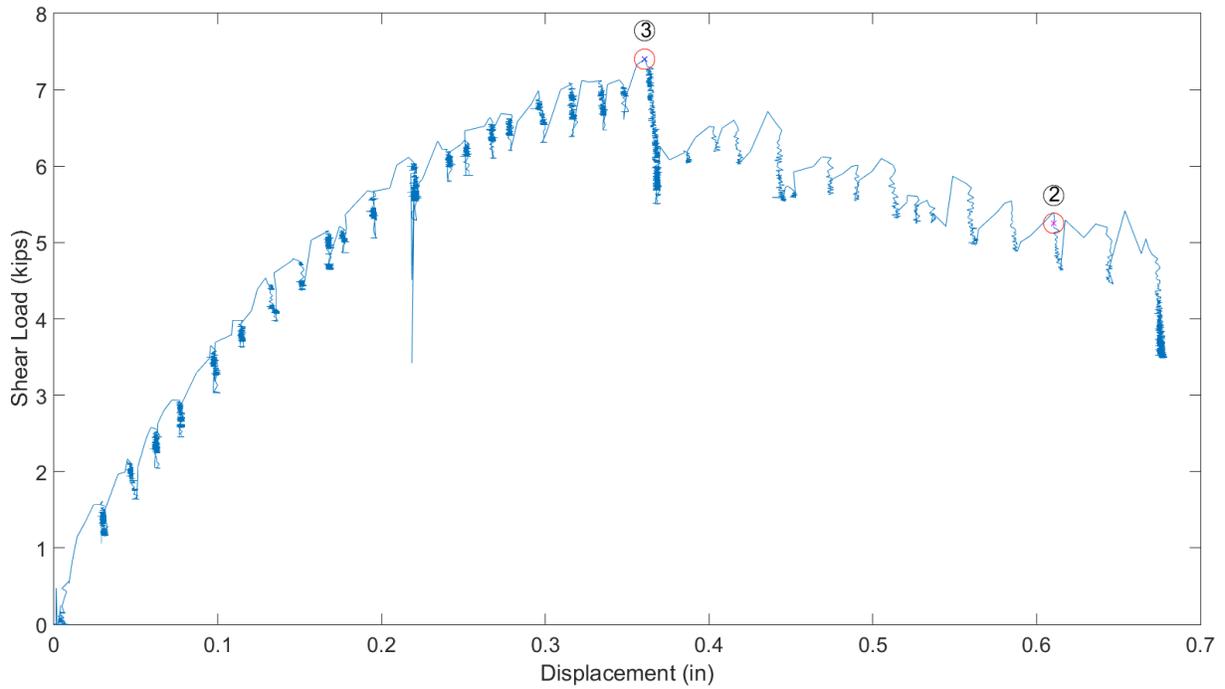
Figure 5.15 Deteriorated abutment shear vs. displacement

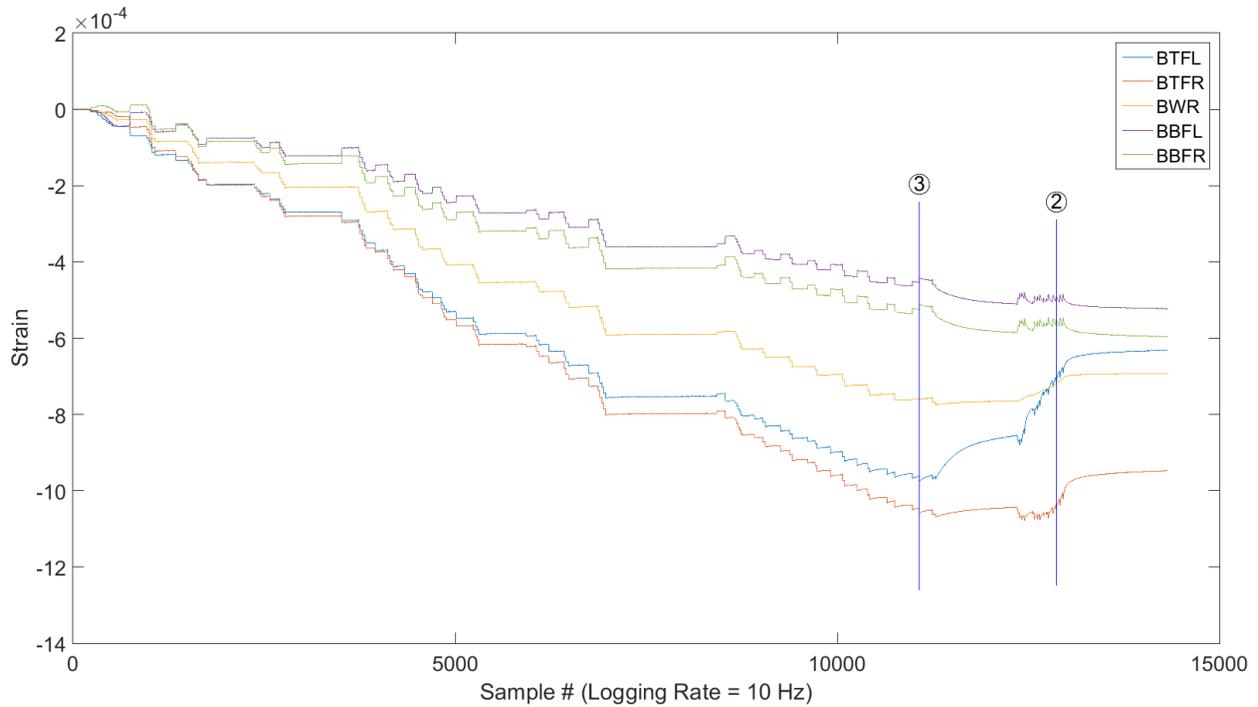
Figure 5.16 Deteriorated abutment base section strain vs. sample

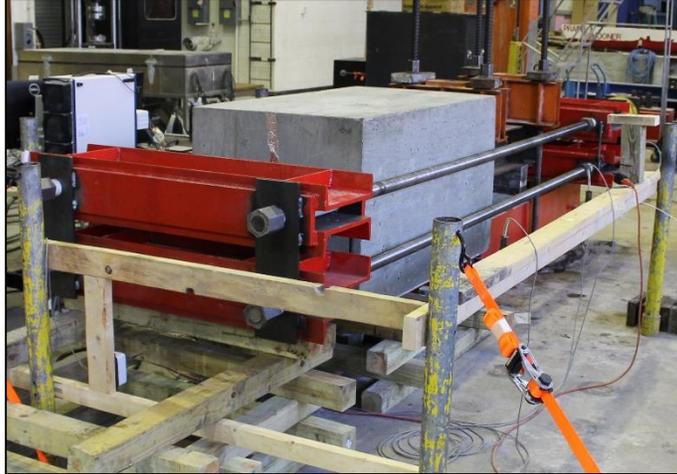
Figure 5.17 Retrofitted abutment test

The retrofitted abutment test setup, shown in figure 5.17 performed as intended by stabilizing the deteriorated section and restoring the pile to its original non-deteriorated strength. The pile was able to withstand the same loading as the non-deteriorated pile and even carried a slightly higher shear load. An increase in stiffness was an additional benefit and the buckling failure seen in the deteriorated test was eliminated.

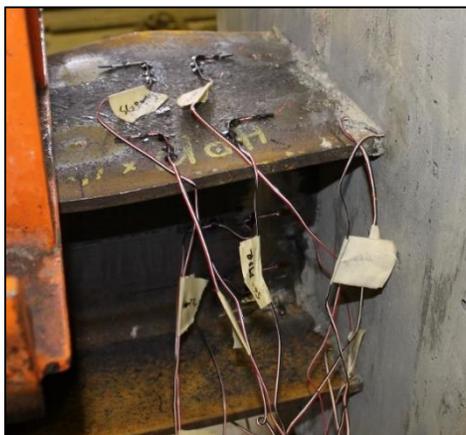
Figure 5.18 Retrofitted abutment base section failure

The pile failed in a similar manner to the non-deteriorated pile, with a local buckling failure at the base outside of the retrofitted section. The pile experienced local buckling at the top flange, as illustrated in figure 5.18. The retrofit provided bracing for the cross-section of the pile and held the all plate elements of the cross-section rigidly in place, causing the buckling zone to be shorter than in the non-deteriorated test.

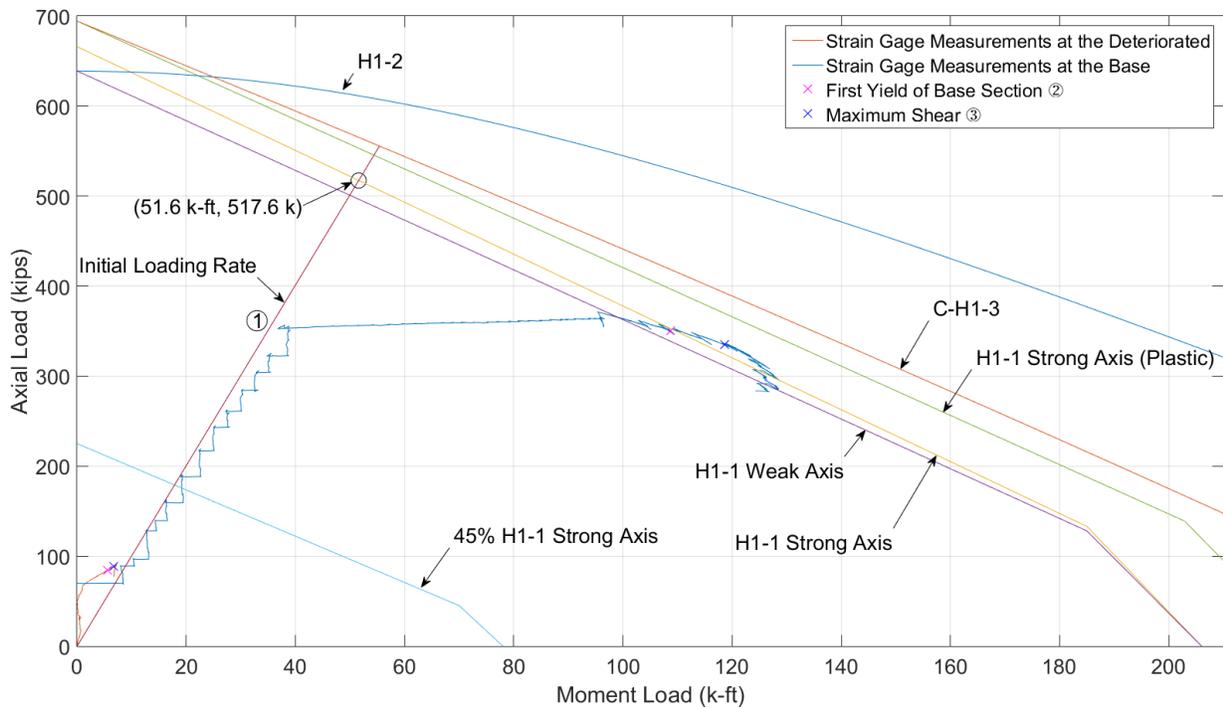
Figure 5.19 Retrofitted abutment axial vs. moment

Figure 5.19 shows that the deteriorated steel section supported less than 100 kips of axial load and only 10 k-ft of moment. The recorded strains at the deteriorated steel section are plotted in figure 5.20, showing that yield strains (approximately 19×10^{-4}) were not reached at any location. This data indicates that the concrete bond was substantial and the retrofit drew a considerable amount of load, despite the lack of mechanical connectors. The bond strength anticipated for this retrofit was 71 kips. From the strain gage data within the concrete jacket, the maximum axial load carried by the pile was 93 kips of the total 333 kips applied to the specimen at that time. The remaining 240 kips were carried by the jacket through the concrete/steel bond. This indicates a minimum bond of 203 psi, which is 3.38 times greater than the AISC (2010) recommended value.

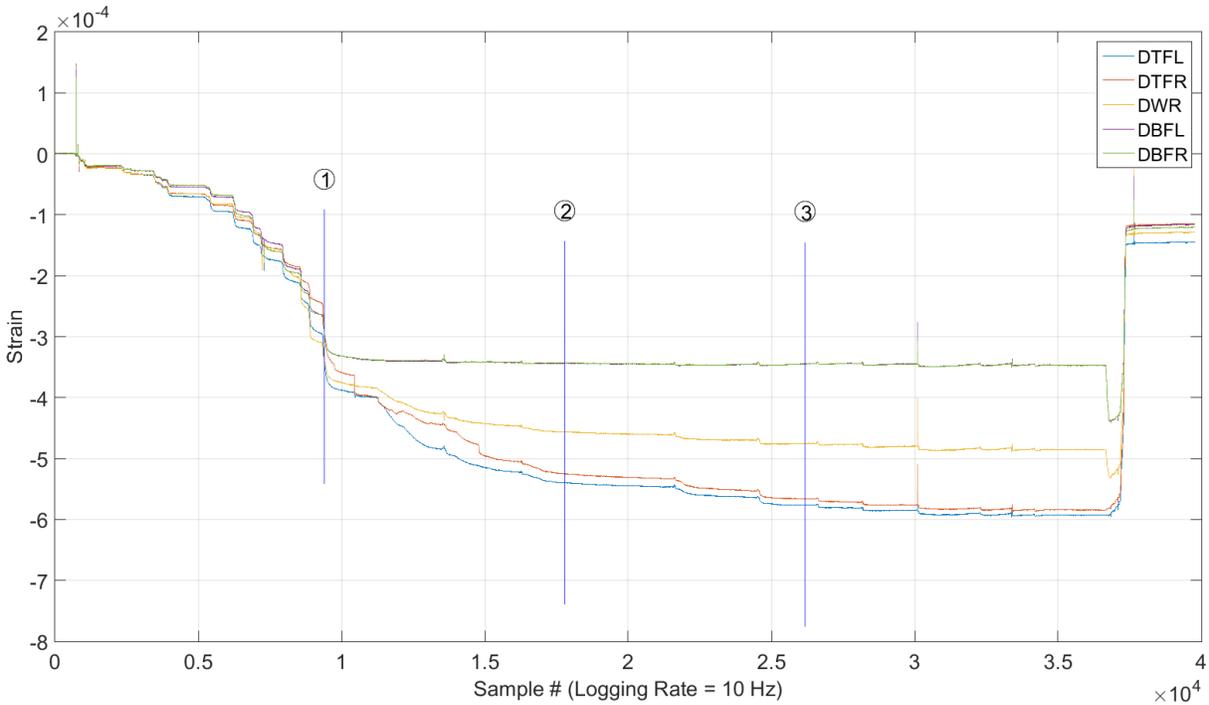
Figure 5.20 Retrofitted abutment deteriorated section strain vs sample

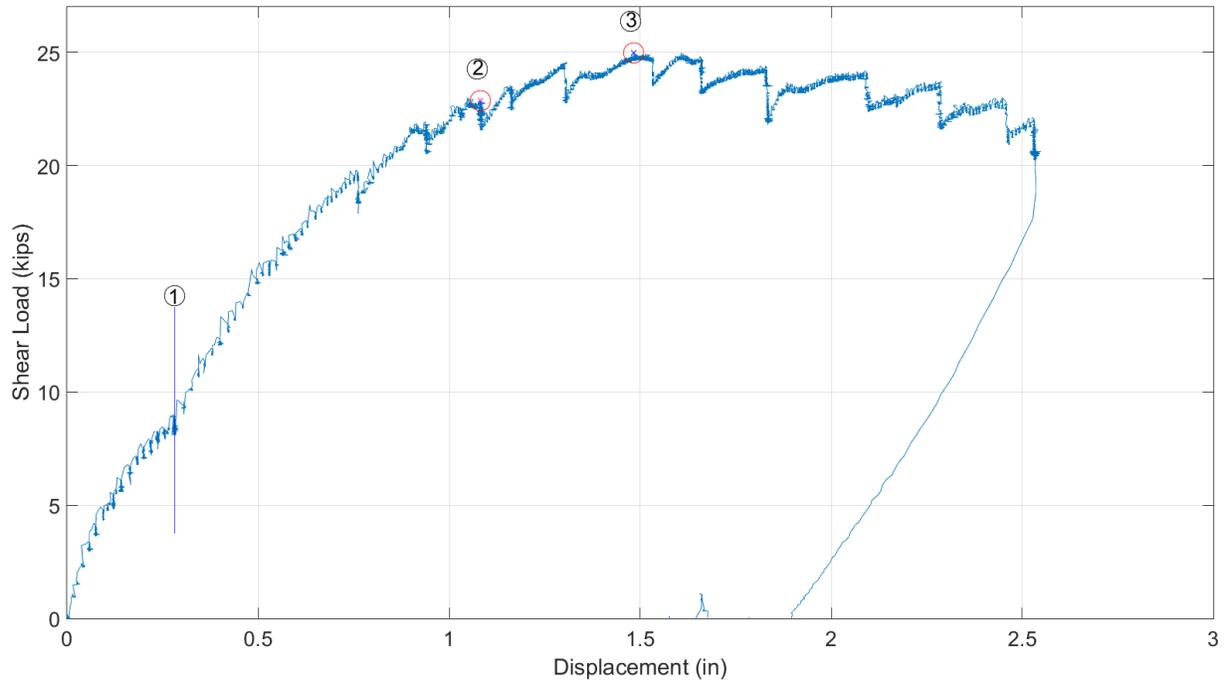
Figure 5.21 Retrofitted abutment shear vs. displacement

The pile experienced less displacement in comparison to the non-deteriorated case, as shown in figure 5.21. The added stiffness allowed the pile to carry greater load prior at instability in comparison to the non-deteriorated case because stiffening afforded by the retrofit reduced the influence of second order effects. The retrofitted specimen required an increase of 2 kips in shear to reach instability, an increase of 9% over the non-deteriorated case. Similar to the non-deteriorated test, instability resulted from yielding and local buckling at the top flange of the base section. Figure 5.22 shows the recorded strains at the base, confirming that strains exceeded the yield limit at the top flange.

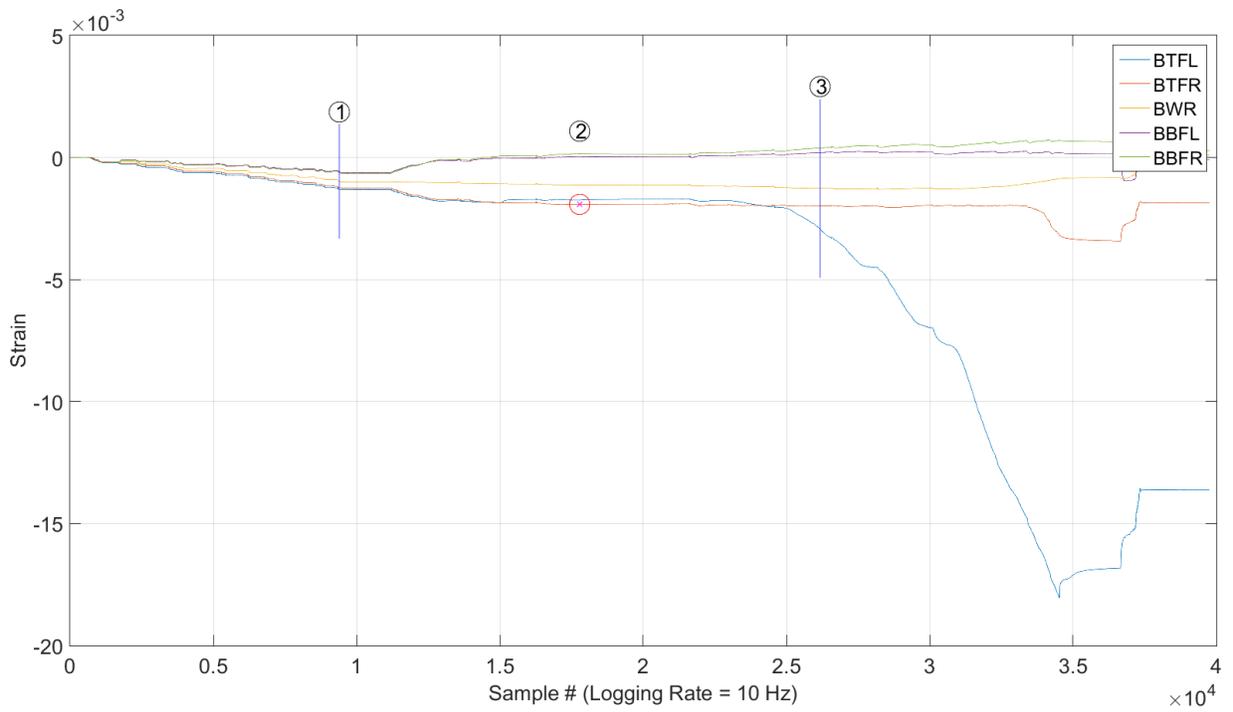
Figure 5.22 Retrofitted abutment base section strain vs. sample

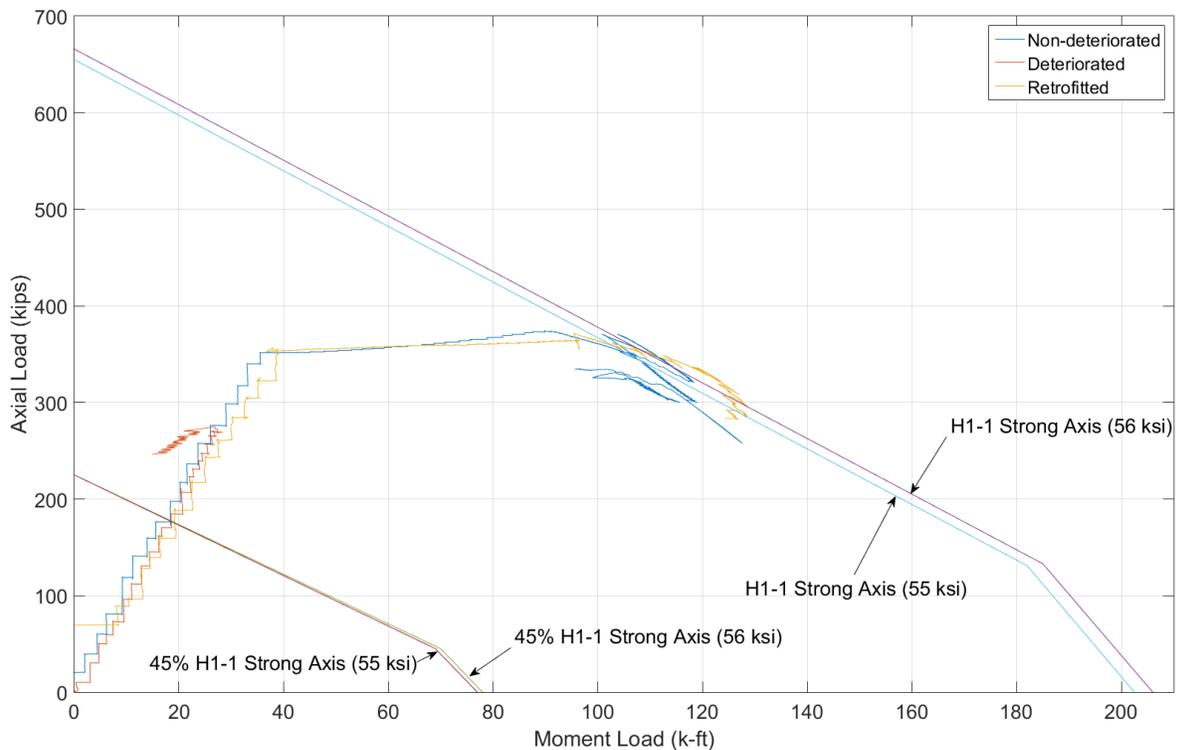
Figure 5.23 Abutment case base section axial vs. moment

Combined loading results are provided for the base and deteriorated sections in figure 5.23 and figure 5.24, respectively. Each plot shows an overlay of abutment case results for non-deteriorated, deteriorated, and retrofitted specimens. The base section governed the non-deteriorated and retrofitted cases, with practically identical P-M interaction responses in figure 5.23 confirming the effectiveness of the retrofit. Demands developed at the base of the deteriorated specimen were limited by the performance of the milled location. The demands developed at the deteriorated steel section for the retrofitted specimen were far less than either of the other two specimens, although the base demands were identical to the non-deteriorated. The retrofit achieved far greater composite action with the steel than expected, reducing the demand imposed on the deteriorated steel section.

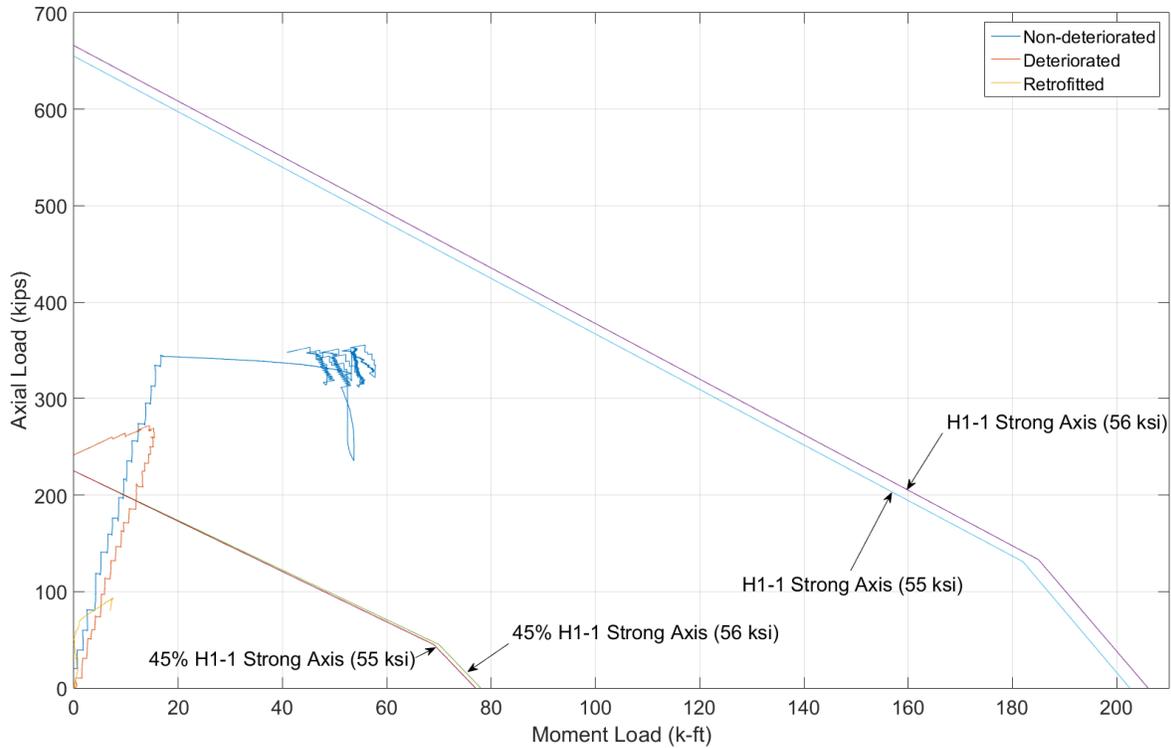
Figure 5.24 Abutment case deteriorated section axial vs. moment

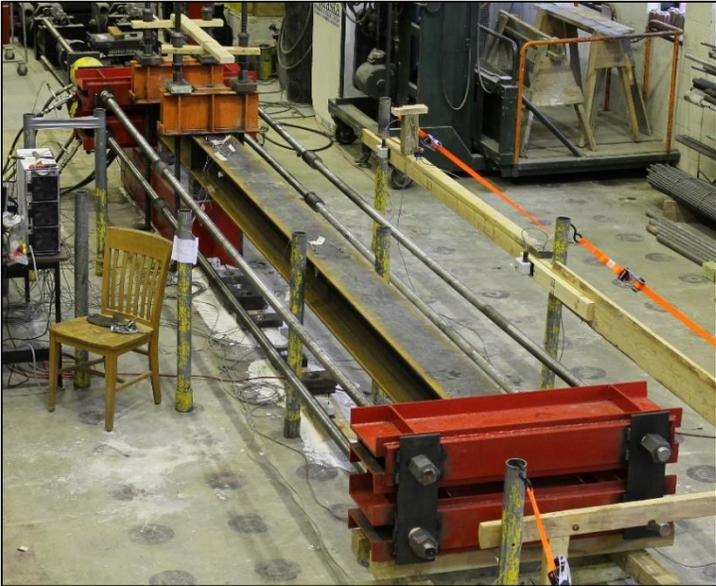
Figure 5.25 Non-deteriorated pile bent test

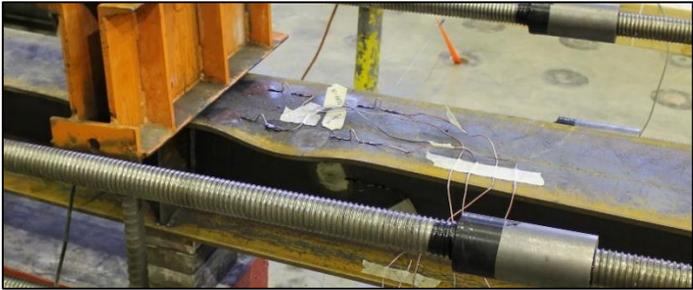
Figure 5.26 Non-deteriorated pile bent local buckling of base section

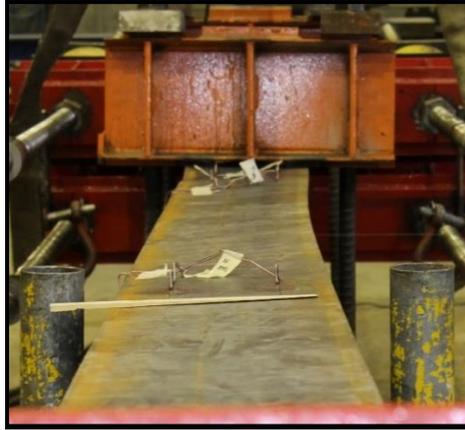
Figure 5.27 Non-deteriorated pile bent LTB failure

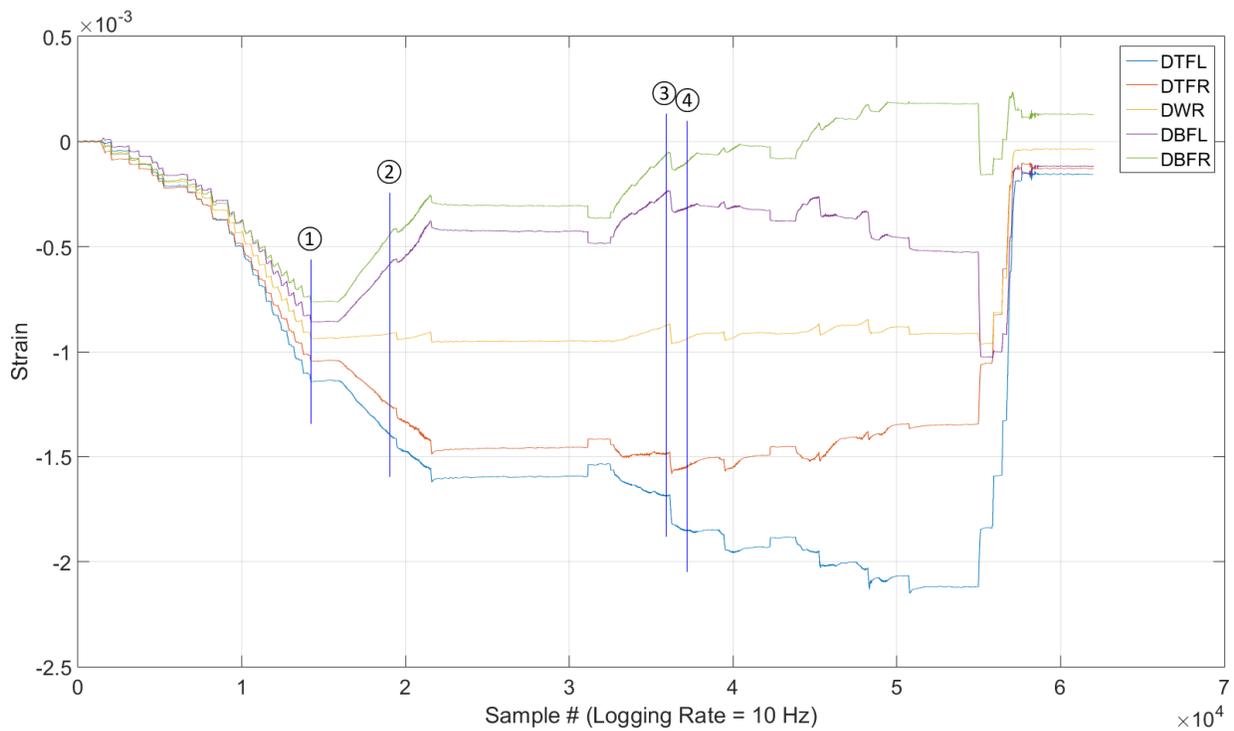
Figure 5.28 Non-deteriorated pile bent deteriorated section strain vs. sample

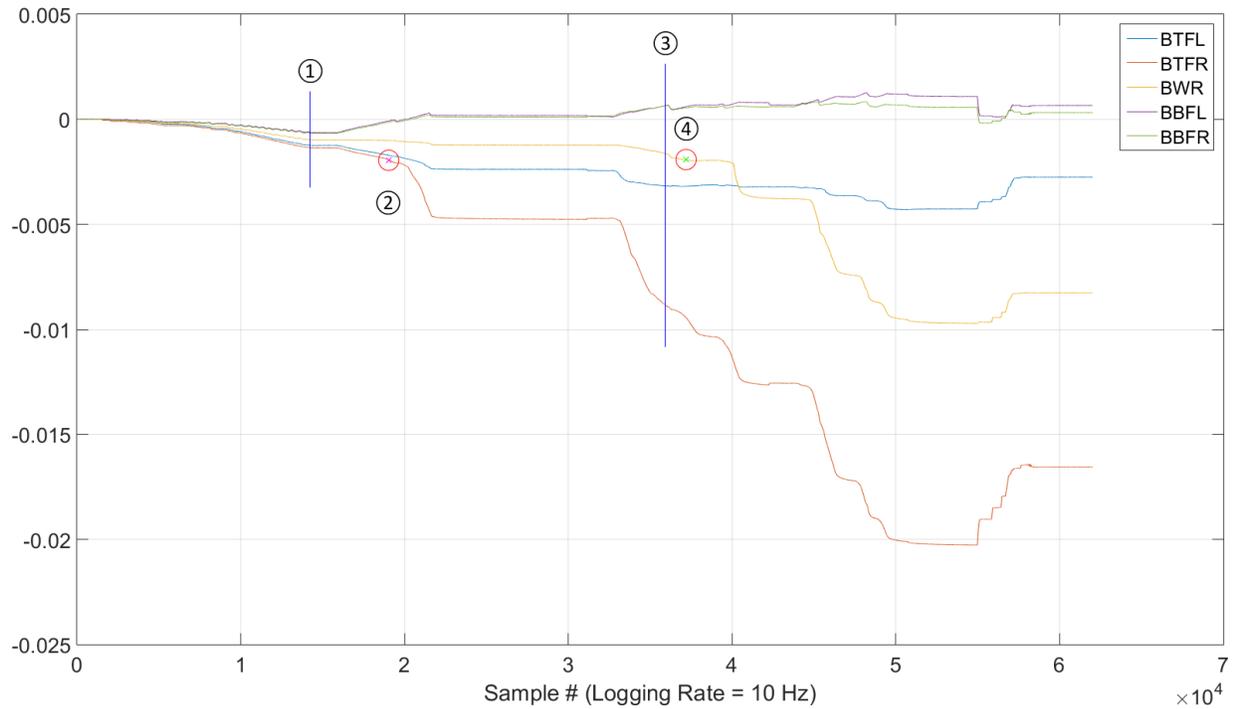
Figure 5.29 Non-deteriorated pile bent base section strain vs. sample

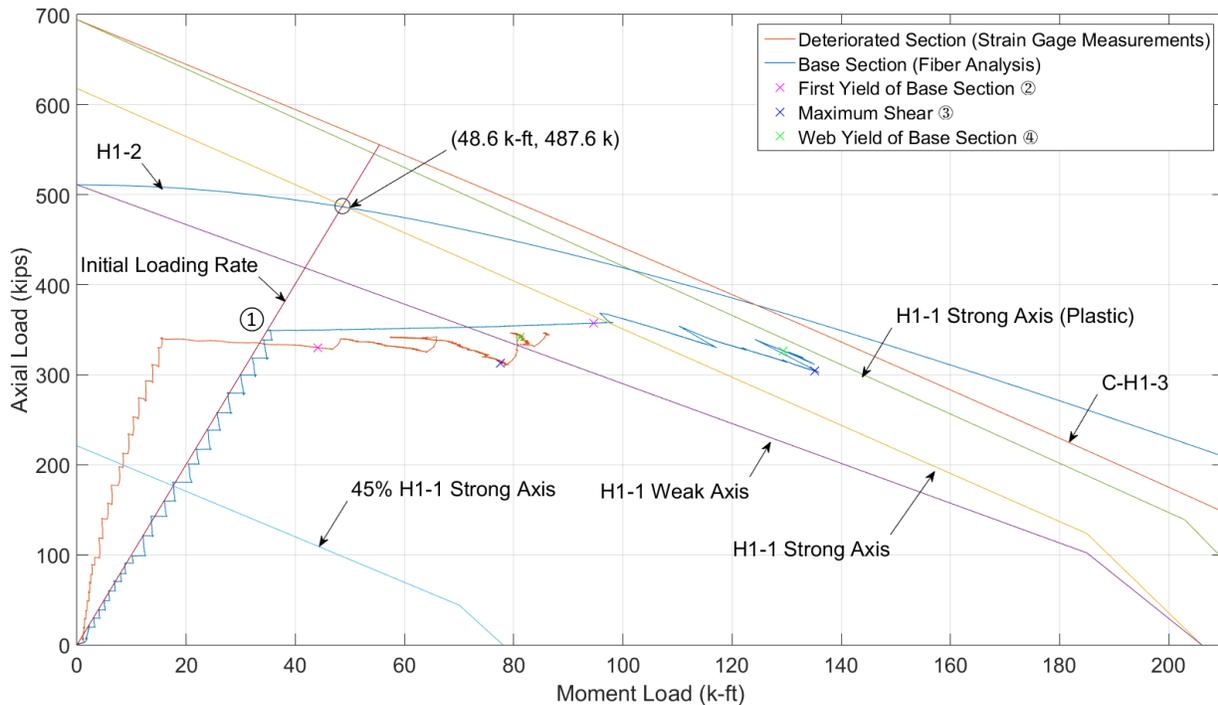
Figure 5.30 Non-deteriorated pile bent axial vs. moment

deteriorated abutment case, the pile exceeded the H1-1 Strong Axis envelope and failed prior to the H1-1 Strong Axis (Plastic) envelope, as shown in figure 5.30. These results are consistent with expected performance based on preliminary calculations. The H1-1 Strong Axis envelope is anchored by maximum axial and moment capacities limited by flange local buckling, and first yield was in fact observed when the P-M interaction reached this envelope. This envelope is accepted as a reasonable design basis, but the true ultimate strength is not achieved until greater plastification of the cross-section is achieved, as demonstrated by yield strains penetrating at least to mid-depth of the web.

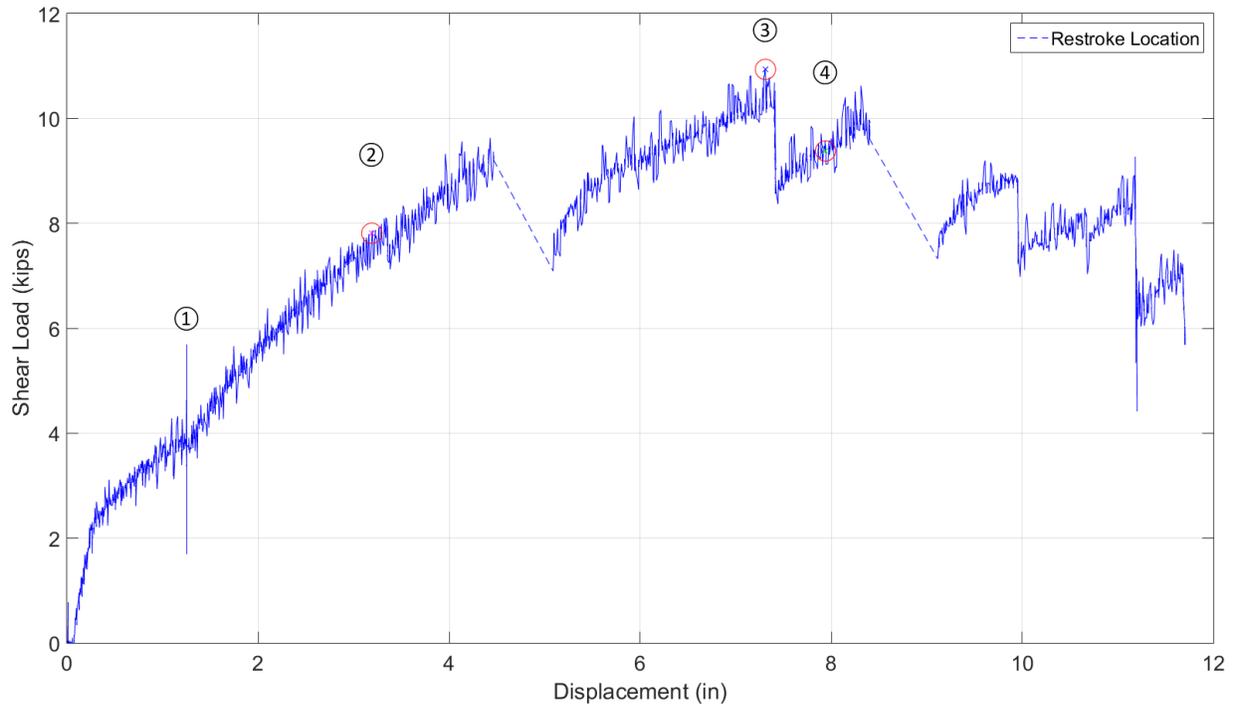
Figure 5.31 Non-deteriorated pile bent shear vs. displacement

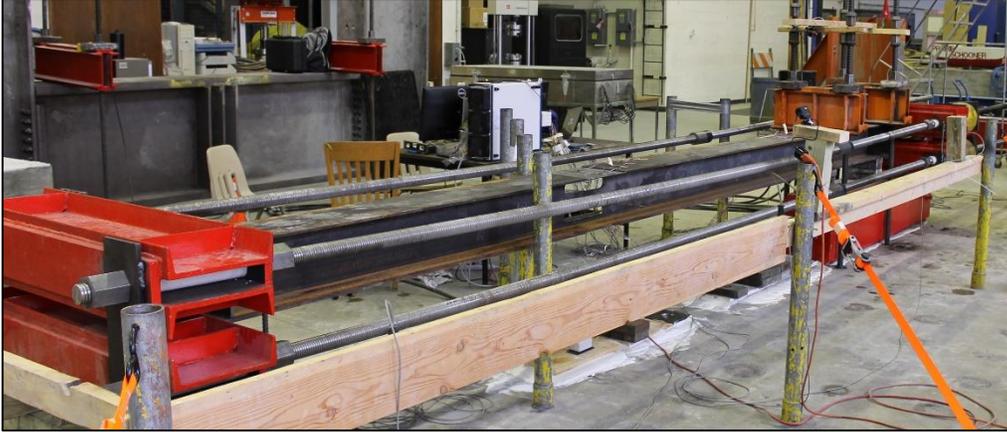
Figure 5.32 Deteriorated pile bent test

The deteriorated pile bent test setup is shown in figure 5.32. This specimen demonstrated an abrupt global bifurcation mechanism. Local buckling in the web of the deteriorated section preceded a global buckling of the cross section at the deteriorated location, as shown in figure 5.33. The pile experienced weak axis buckling at the upper flange WT element and the web bar element, and shearing with plastic weak axis flexure at the ends of the bottom flange WT.

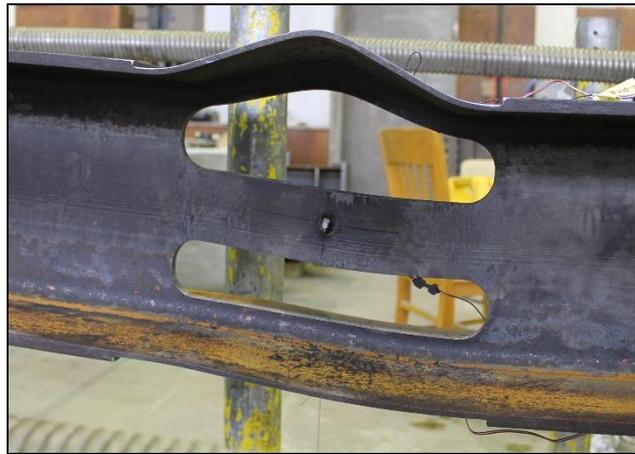
Figure 5.33 Deteriorated pile bent deteriorated section global section failure

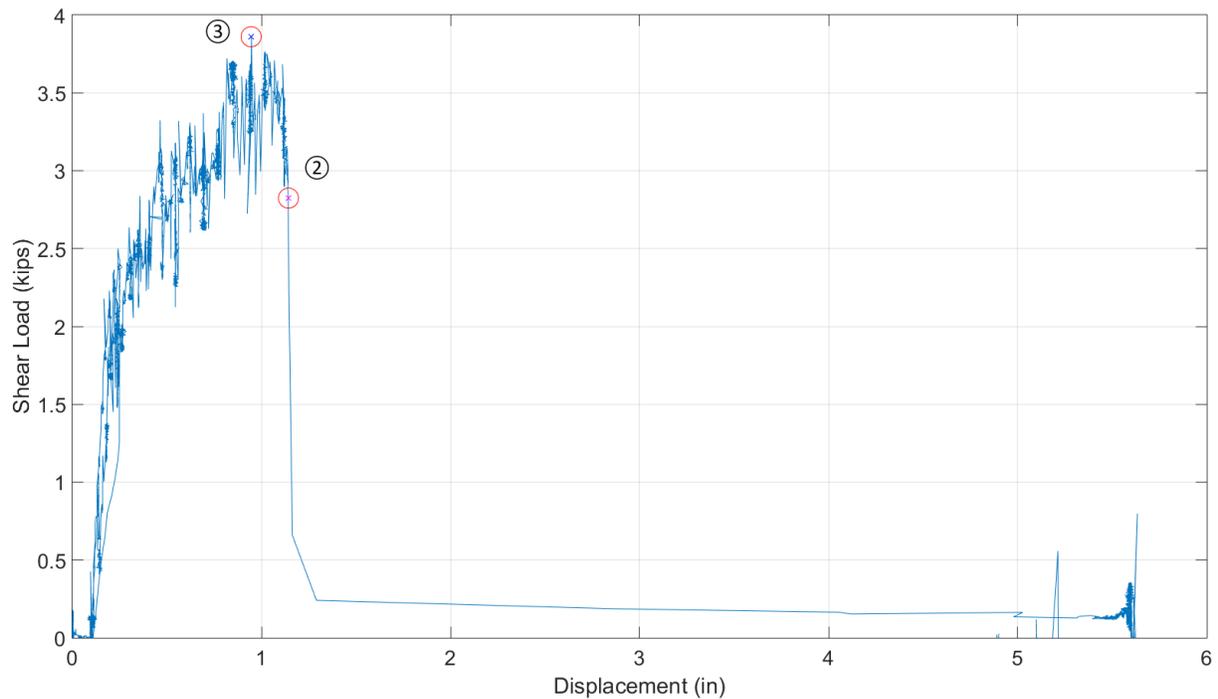
Figure 5.34 Deteriorated pile bent shear vs. displacement

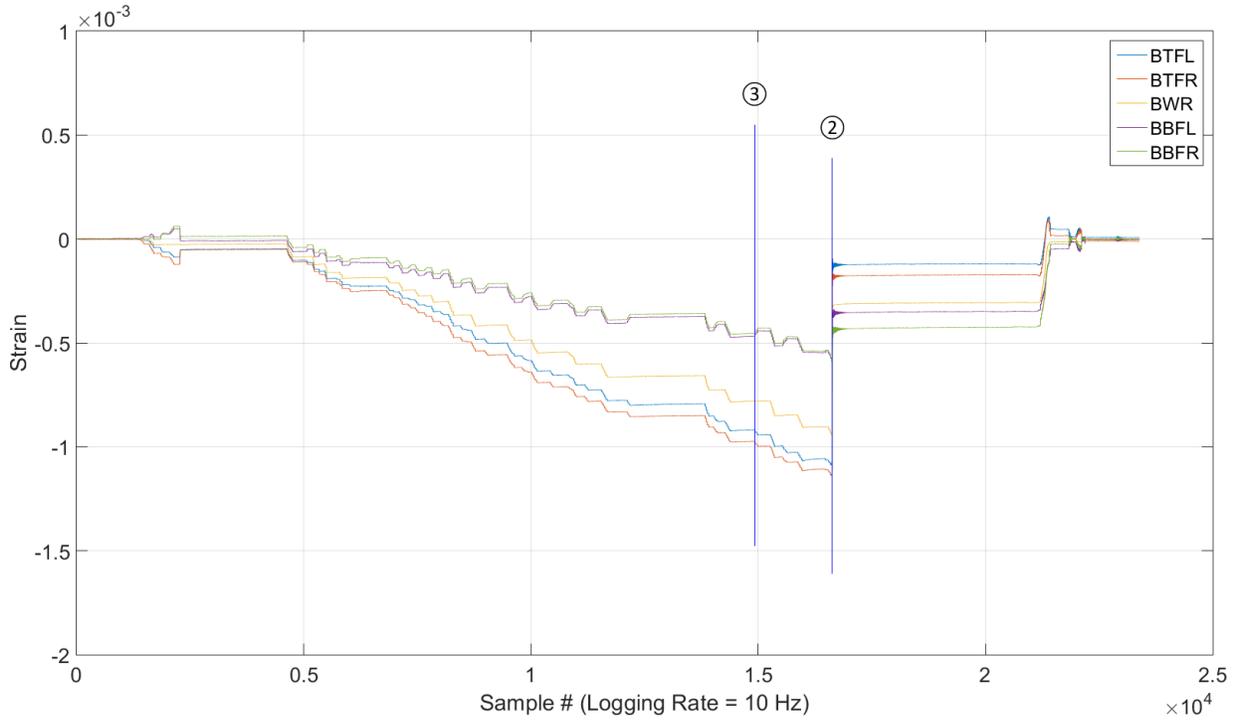
Figure 5.35 Deteriorated pile bent base section strain vs. sample

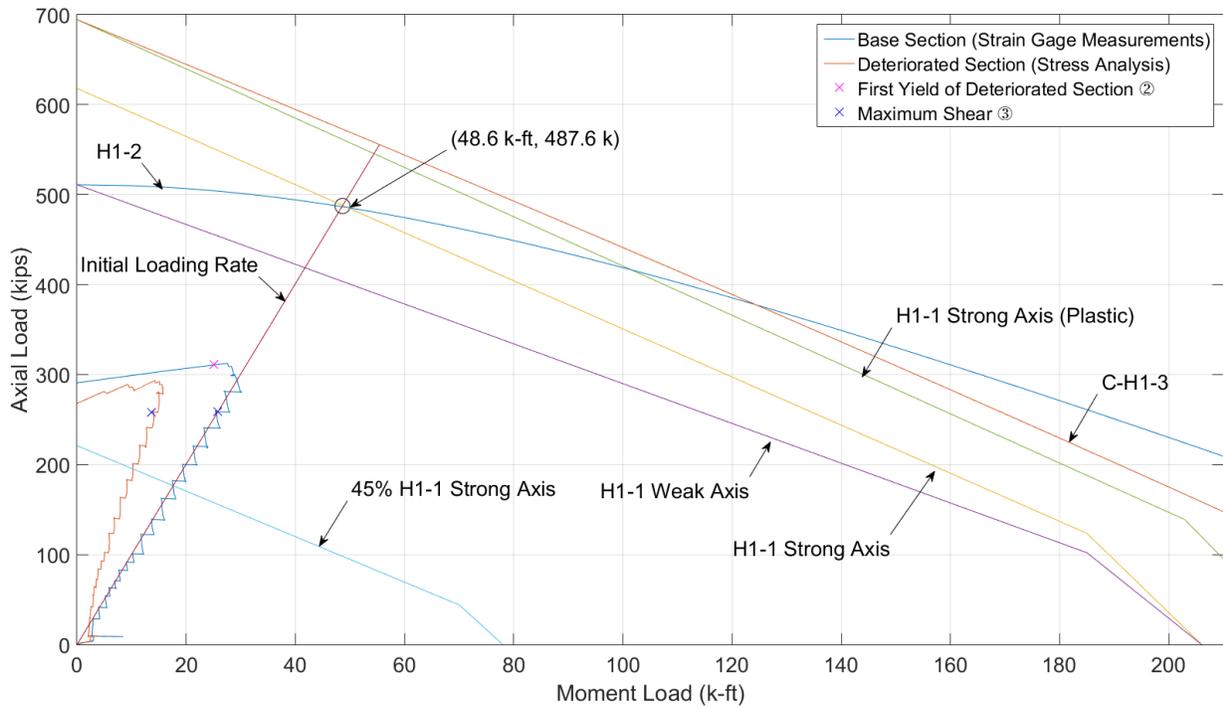
Figure 5.36 Deteriorated pile bent axial vs. moment

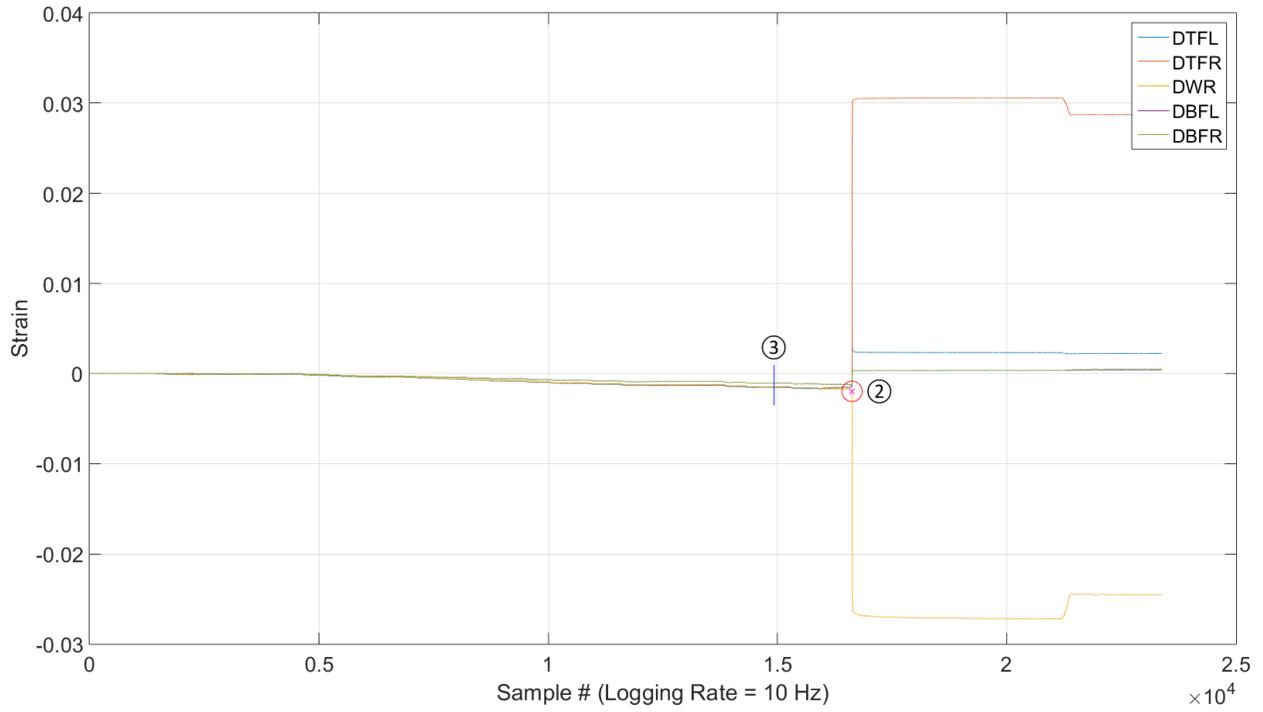
Figure 5.37 Deteriorated pile bent deteriorated section strain vs. sample

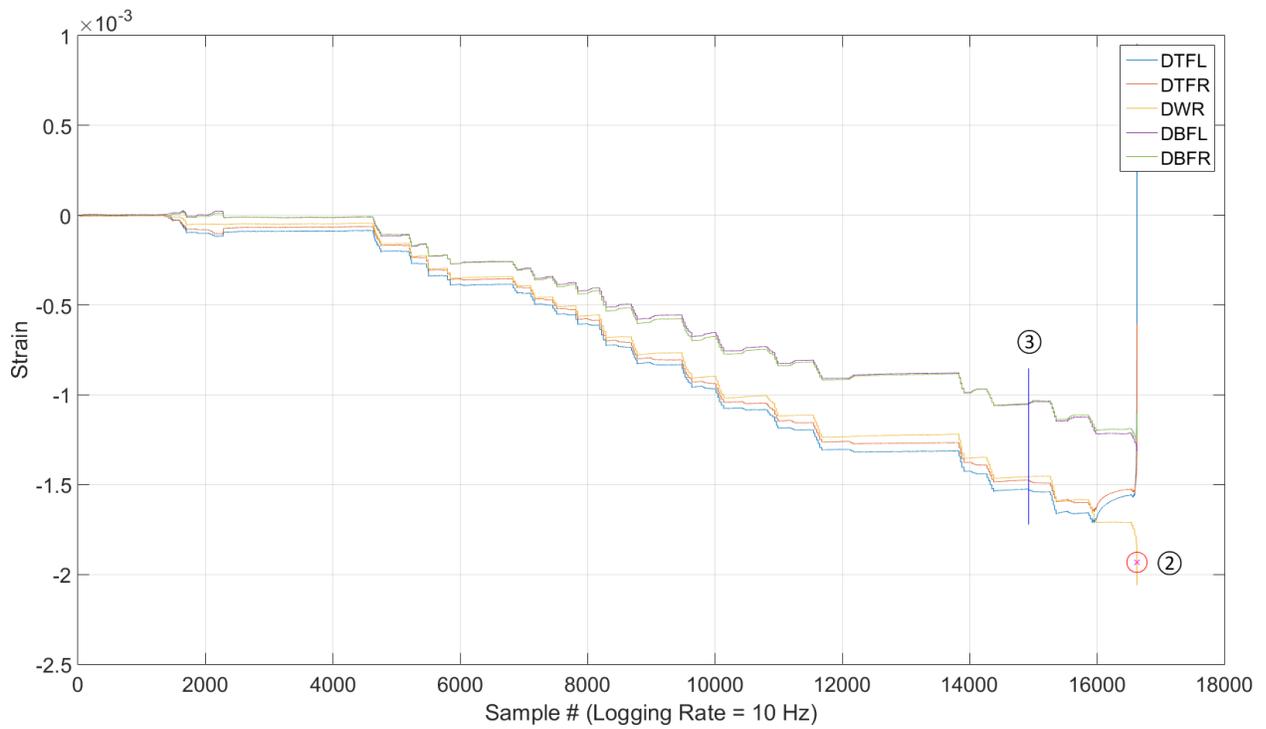
Figure 5.38 Deteriorated pile bent deteriorated section strain vs. sample zoomed in

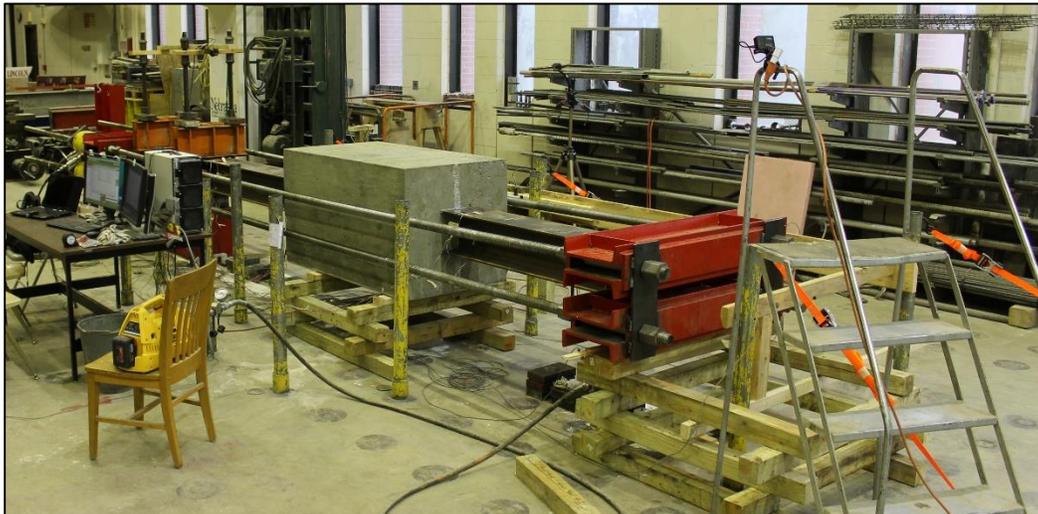
Figure 5.39 Retrofitted pile bent test
