Report SPR-P1(15) M027

Final Report
26-1121-4025-001

Performance Assessment of Deteriorated and Retrofitted Steel HP Piles

June 2016

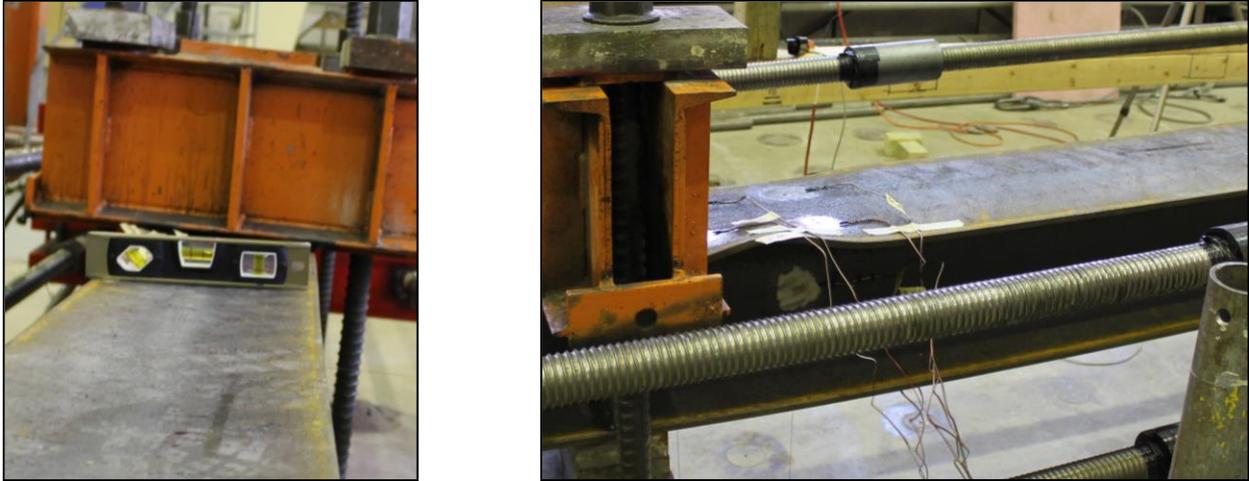
Figure 5.40 Retrofitted pile bent failure

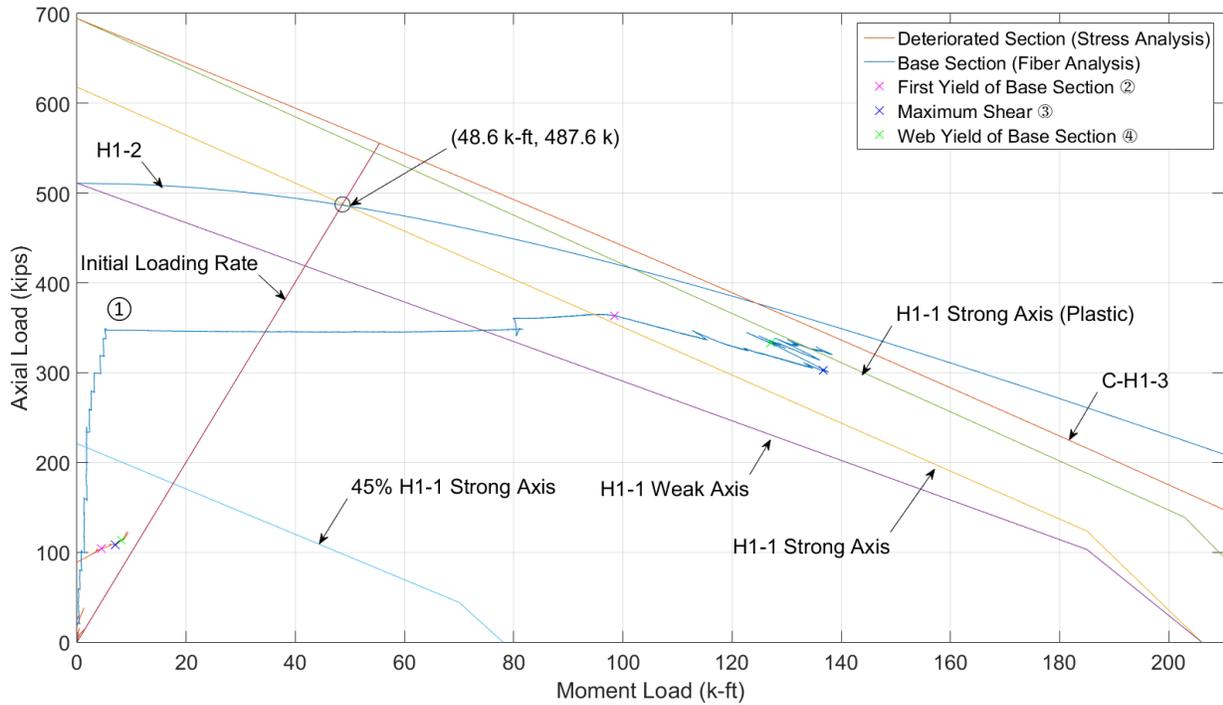
Figure 5.41 Retrofitted pile bent axial vs. moment

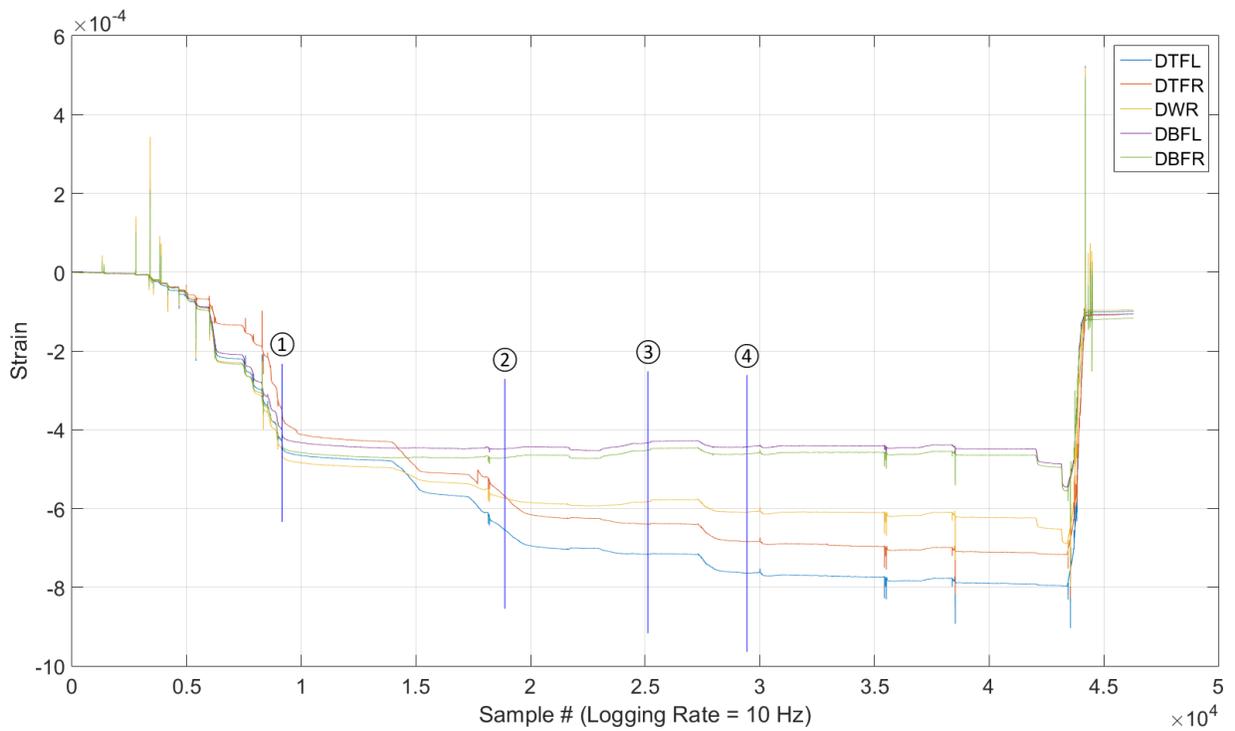
Figure 5.42 Retrofitted pile bent deteriorated section strain vs. sample

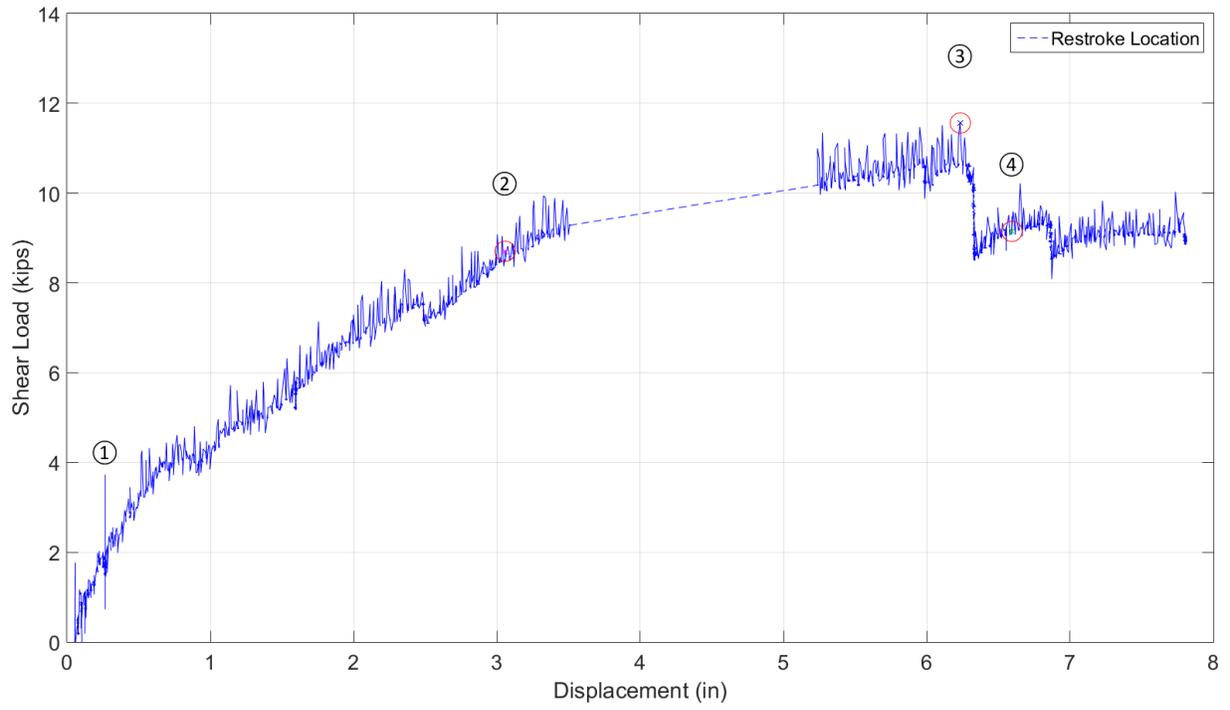
Figure 5.43 Retrofitted pile bent shear vs. displacement

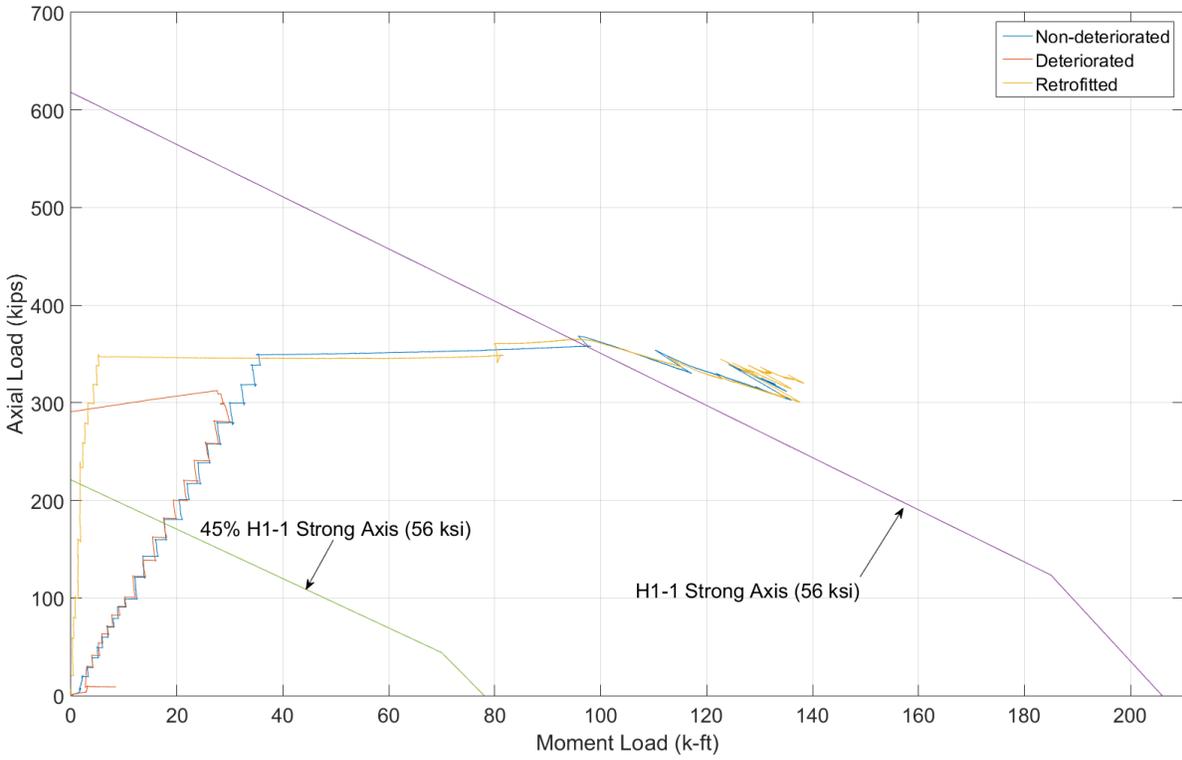
Figure 5.45 Pile bent case base section axial vs. moment

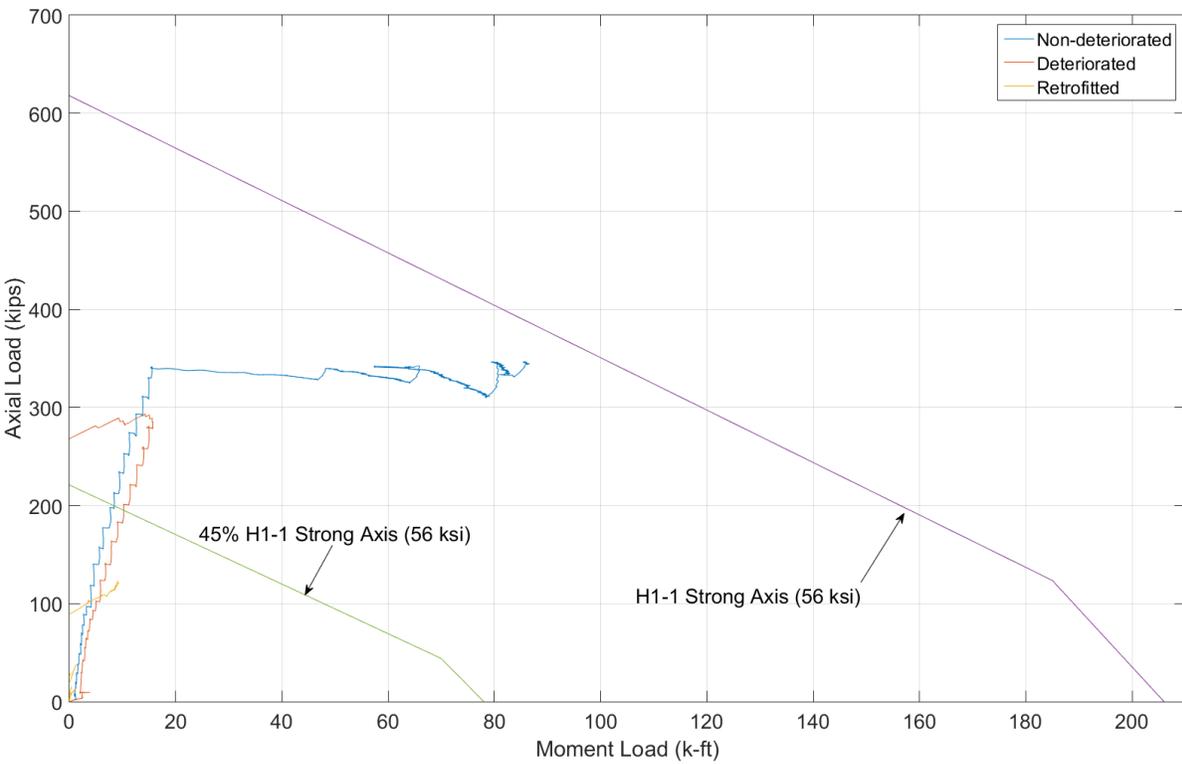
Figure 5.46 Pile bent case deteriorated section axial vs. moment

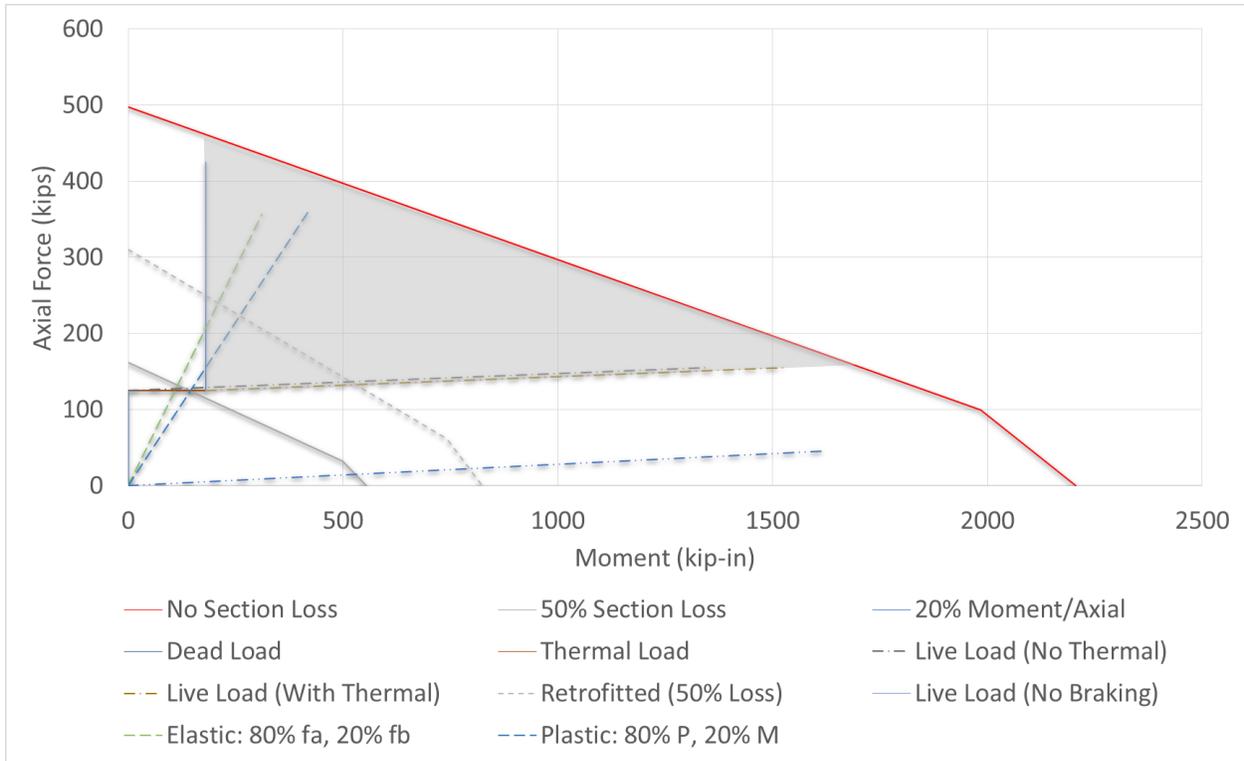
Figure A.1 Potential loading scenarios and ultimate combined load targets
