Report FY21(012)

Field Demonstration of GPR and UAV Technologies for Evaluation of Two US 75/77 Bridges

Department of Civil Engineering, University of Nebraska-Lincoln

July 2021

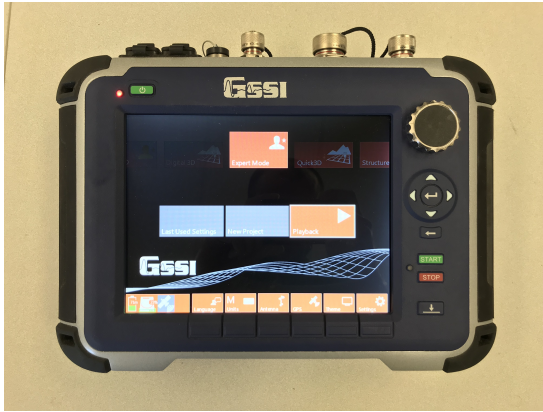
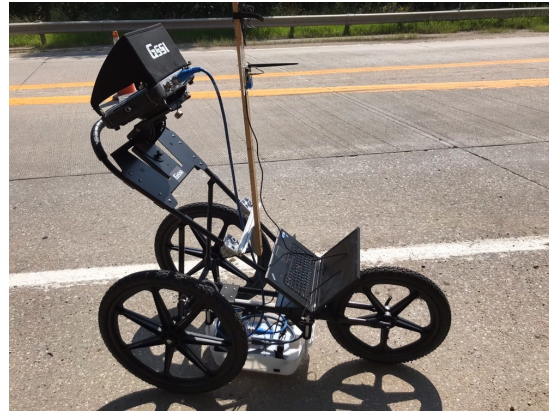
Fig. 2.1. GSSI-4000 GPR system.

A survey cart, shown in the **Figure 2.1**, was used in ground-coupled GPR survey. Since ground-coupled GPR survey can only be conducted at a walking speed, traffic control is needed. The center frequency of the antenna determines the maximum penetration depth of EM wave and the vertical resolution of the B-scan image. Increasing the frequency will improve the image resolution at the cost of decreasing the penetration depth. In most bridge deck surveys, ground-coupled antennas with a center frequency of 1.5 GHz provides sufficient penetration depth and adequate resolution. The time range determines the total time that GPR records for the reflections from the subsurface. The proper time range can be determined by the expected penetration depth and velocity information.

(a) GSSI SIR-4000 computer

(b) GPR system on a survey cart

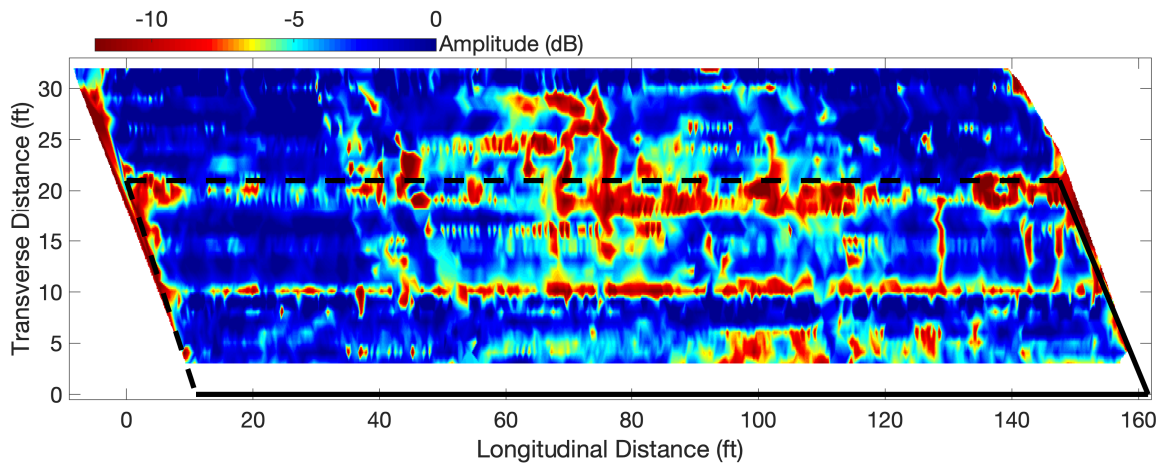
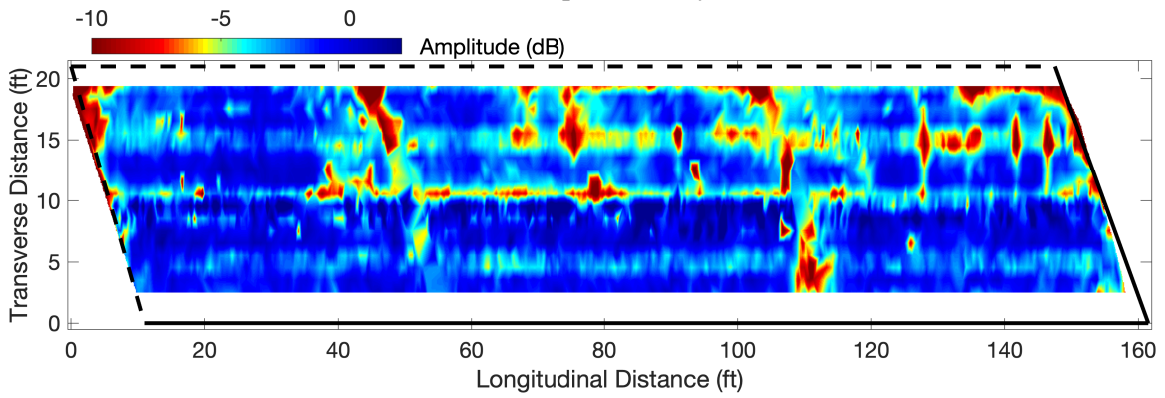
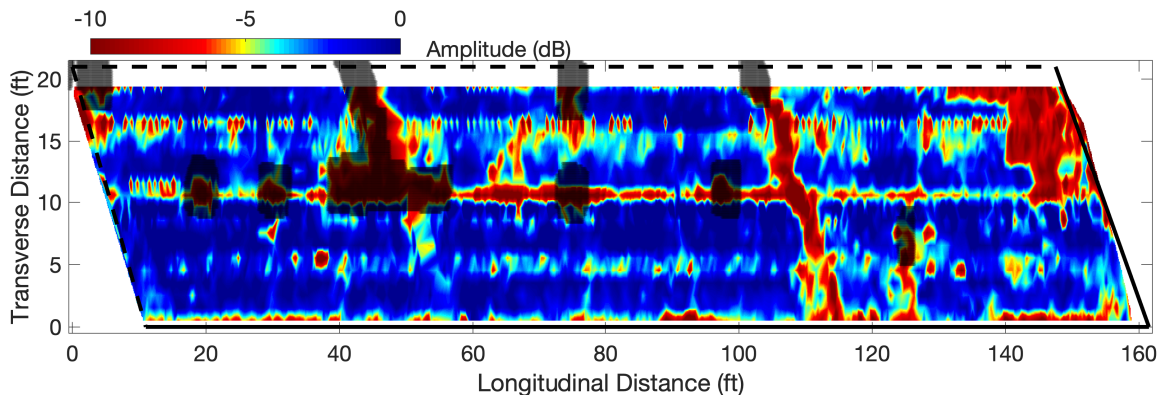
Fig. 3.3. GPR amplitude maps from bridge S075 17596 in three construction stages

Figure 3.3a shows the GPR amplitude map based on data collected on bridge S07517596 deck with existing asphalt overlay. The black lines show the boundaries of western lane and shoulder. In this map, low amplitude areas are shown with red color to indicate deck deterioration. Low amplitude is also observed along a horizontal line at 10 ft in transverse

(a) On asphalt overlay

(b) On concrete before repair

(c) On repaired concrete

Figure 3.3b shows the GPR amplitude map using data collected on the western lane and shoulder of the bare concrete deck after the asphalt overlay was removed. Similar to the map with the asphalt overlay, low amplitudes occurs along the shoulder joint at 10 ft in transverse direction. Deterioration is also observed along two more horizontal lines at 5 ft and 15 ft in transverse direction, which are also observed on the map of asphalt overlaid deck but with less clarity. Although the map on bare concrete gives less severe deterioration than the map on asphalt overlay, both maps highlight the same deterioration regions.

Figure 3.3c shows the GPR amplitude map of the bridge deck after repairing delaminated regions detected by chain drag test. Figures 3.3b and 3.3c are very similar, except for the repaired regions marked by the transparent dark color. Since the new concrete patches were still wet during the GPR testing, they are shown as red color due to high attenuation of GPR signals in wet concrete. These patches should not be misinterpreted as defects.

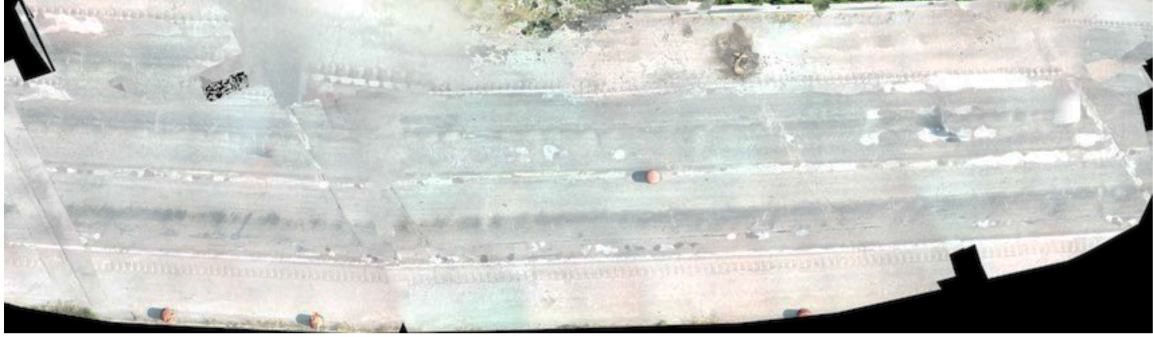
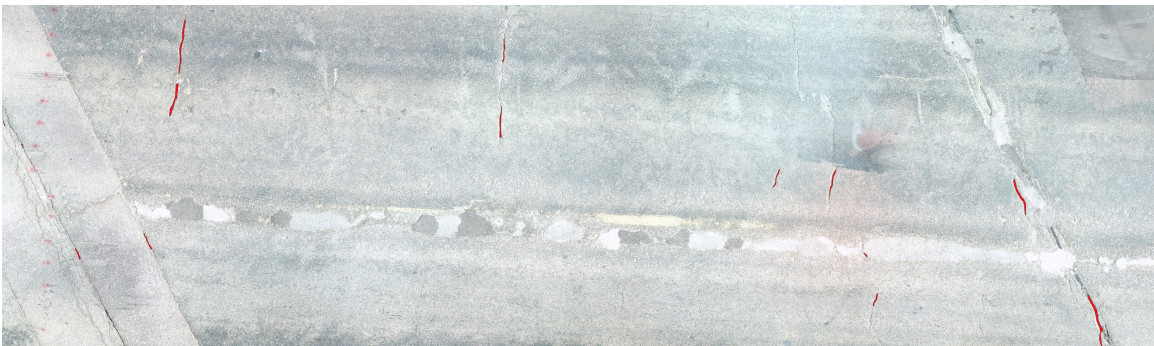
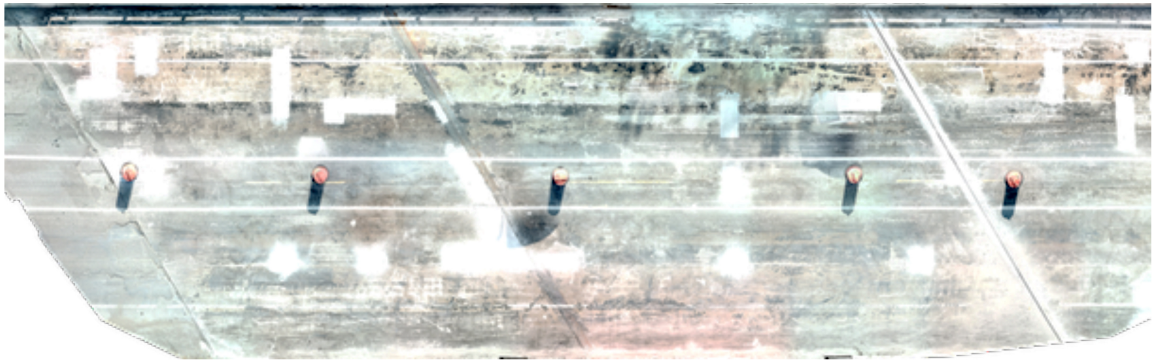
Fig. 3.5. Stitched UAV images of bridge S075 17596 before and after repair

only on one side of the bridge and the flight had to be paused and resumed multiple times while semi-trailers were passing by. As a result, the stitched image map is warped and missing some important information within the area of interest (Figure 3.5a). In this study, delamination, patched area, and cracks were the type of defects that was inspected with our data analytics tools.

The images collected from the UAV for this bridge had some limitations as discussed above. Traffic control was conducted only on one side of the bridge and data collection was interrupted multiple times. In addition, the image capture from the UAV had to be conducted from a height 16 ft above the bridge deck. This can be improved by having manual control of the UAV for future data collection to improve the resolution of the images being collected. The predictions made from the deep learning model did not show much crack information. In the zoomed image of the top left corner between the expansion joints, some of the transverse cracks were detected from the prediction as shown in Figure 3.5b. These are also the locations in proximity where delamination was identified by NDOT chain drag operation after asphalt removal and later repaired with concrete patches (patches identified in Figure 3.5c).

In the second data collection conducted on the repaired bridge on September 18, most of the images (230 images; 99%) had an overlapping feature which allowed a better stitching result as shown in Figure 3.5c. The stitching results are improved than the image collected on 8/24. Since the images were still collected from 16 ft above the bridge deck, there were not many cracks detected on the bare deck. Yet, the photos do allow to compute the area of patches.

(a) Stitched UAV image collected on asphalt overlaid concrete deck

(b) Closeup view of the left top corner with cracks detected on Bridge S075 17596 (asphalt overlaid concrete deck)

(c) Stitched UAV image of bridge S075 17596 collected on repaired concrete deck

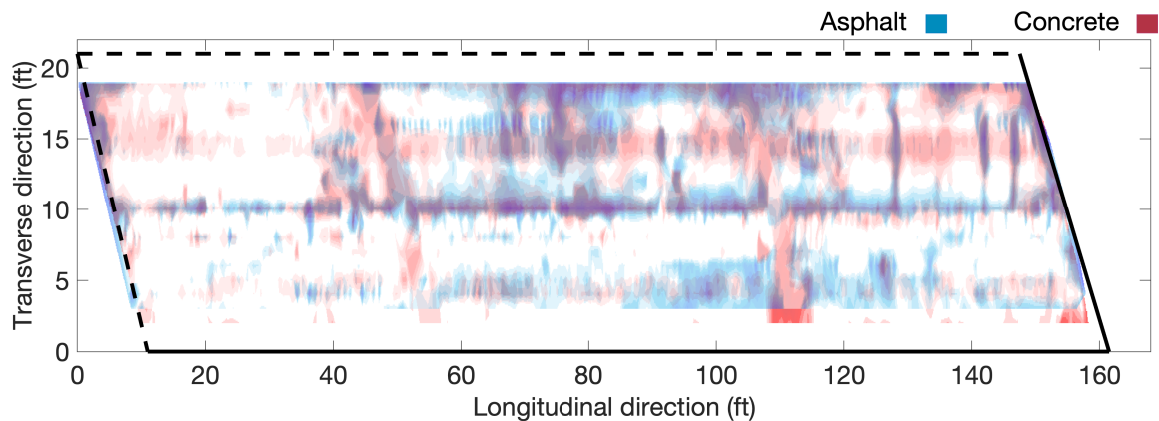
Fig. 3.6. Comparison of GPR maps collected on Bridge S075 17596 on asphalt overlay and on concrete deck

GPR data collected on the same bridge on asphalt overlay and bare concrete will allow us to analyze the correlation between two sets of data, and evaluate the effect of asphalt overlay on GPR. GPR amplitude maps on asphalt overlay (Figure 3.3a) and on bare concrete (Figure 3.3b) are in general agreement. For qualitative comparison of these two GPR results, we overlapped the deteriorated areas detected by two GPR scans and showed the overlapped comparison in Figure 3.6.

In Figure 3.6, the red color represents deterioration detected by GPR scans on bare concrete, and the blue color indicates deterioration detected by GPR scans on asphalt overlay. Purple color indicates deterioration detected by both GPR scans. In general, both maps agree with each other in deterioration regions, especially along the cold joint at 10 ft (transverse direction) and a horizontal line at 5ft. Both maps also detect deterioration at the end joints and in the driving lane between 70 ft and 120 ft. However, the GPR data collected on concrete (red) detected more deteriorated areas in the driving lane along a horizontal line at 15 ft in the transverse direction. These areas might have less severe deterioration (light blue color in Figure 3.3b) which was not clearly shown in GPR data collected on asphalt overlay.

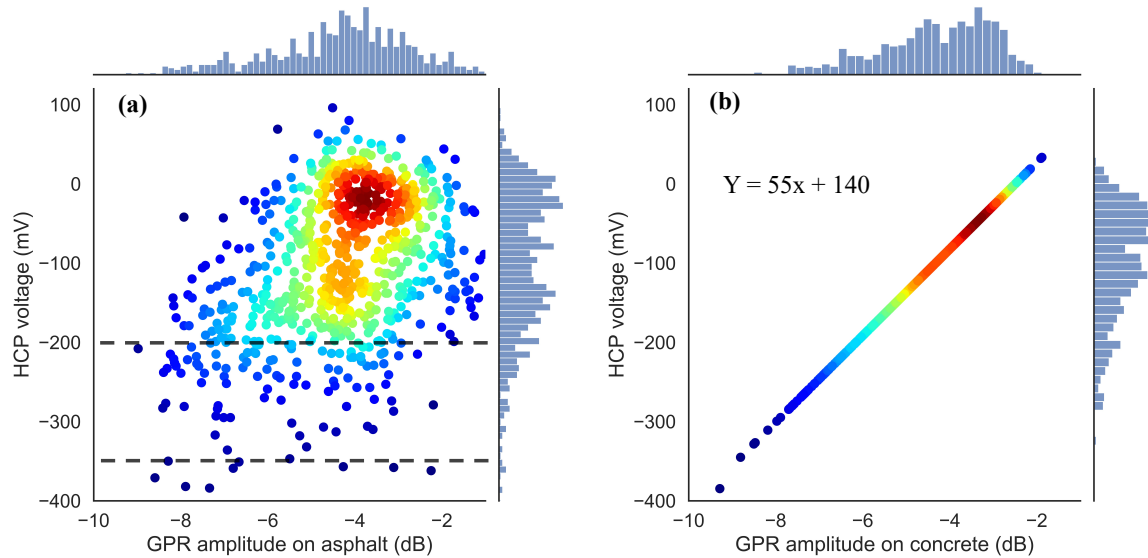
Fig. 3.9. Autoencoder (a) input and (b) output for GPR and HCP data collected on asphalt and bare concrete

The third autoencoder is designed to determine the relationship between GPR rebar amplitudes collected on asphalt overlay and HCP voltages collected on the bare concrete. Figure 3.9a gives the scatter plot. Unlike in Figure 3.8a, data points in this plot show large scattering. The correlation between GPR on asphalt and HCP is weak and any conclusion from this relationship may not be reliable. Therefore, instead of using the relationship in Figures 3.9b, GPR threshold amplitudes were determined indirectly based on relationship

between GPR and HCP data collected on concrete, and between GPR amplitudes collected on asphalt and on concrete. According to formulas presented in Figures 3.7 b and 3.8, thresholds of -8.1 dB and -5.75 dB was obtained for GPR amplitudes on asphalt with respect to -350 mV and -200 mV in HCP data.

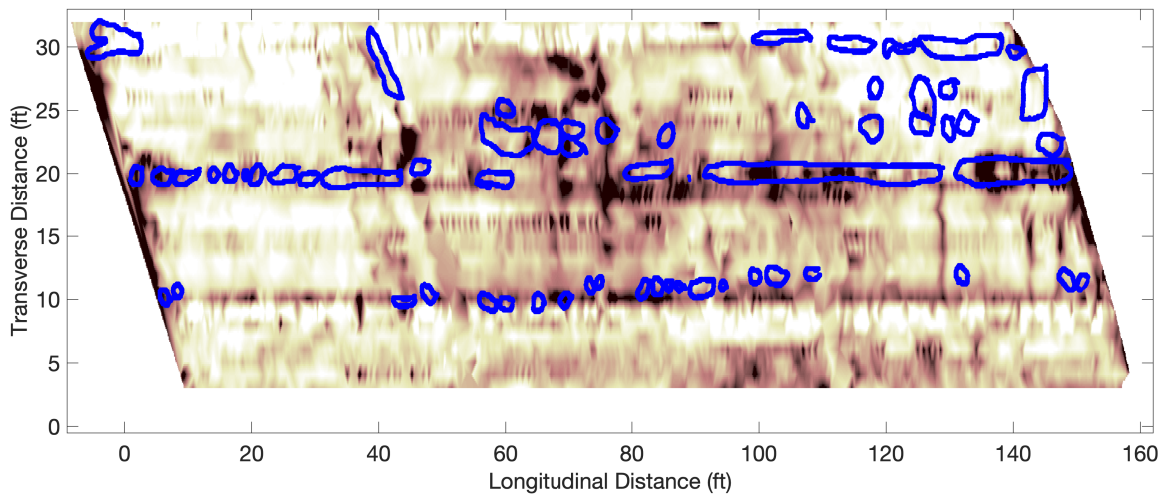
Fig. 3.10. Asphalt surface defects overlapped on GPR amplitude map collected on asphalt overlay

Figure 3.10 shows the location of surface defects on asphalt surface that are extracted from the UAV stitched image in Figure 3.5a and then overlapped on the GPR amplitude map collected on the asphalt overlay. Most defects on asphalt overlay correspond to low amplitude on the GPR map, and especially good agreement is obtained along the shoulder joint and the lane divider. Some surface defects near the top right corner are not shown in GPR map on asphalt overlay. Combining information from both GPR and UAV images will provide more accurate evaluation of bridge deck.

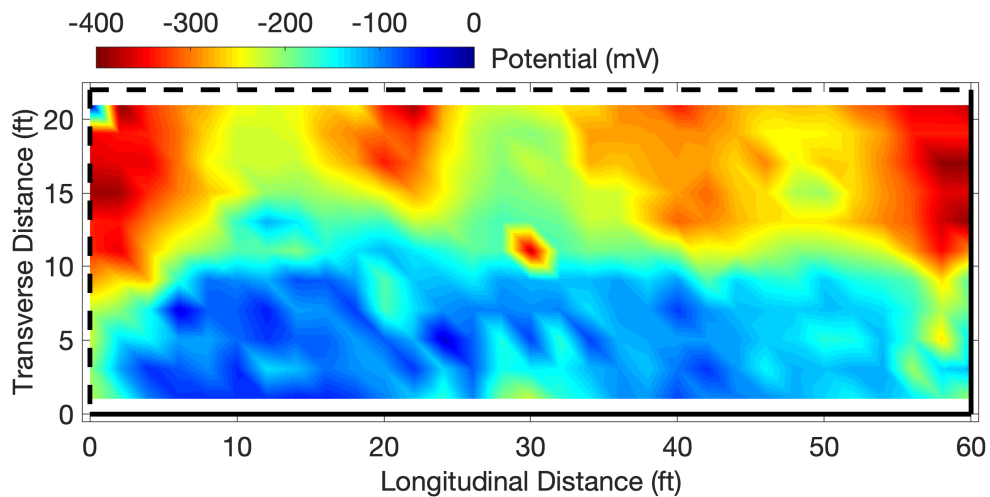
Fig. 3.14. Half cell potential map of the bridge S075 17062

HCP data was collected on a 2 by 2 ft grid on the bridge deck. To make the electrical circuit, a hole was drilled through the concrete to the bottom rebar level. Figure 3.14 shows the potential map of the bridge deck collected on the western lane and the shoulder as indicated by the blue dashed lines in Figure 3.12. In contrast to shoulder, the driving lane may have high probability of corrosion activity according to the HCP data.

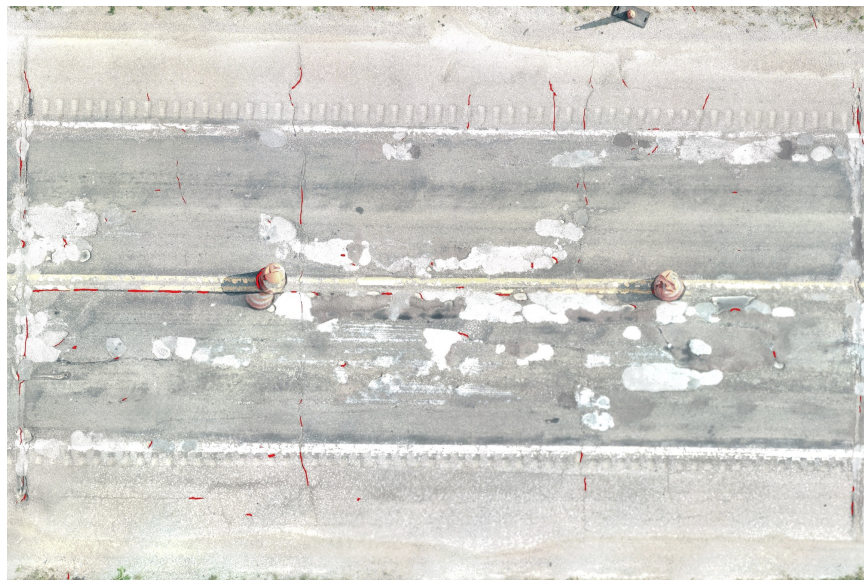
Fig. 3.15. Stitched image of asphalt overlaid concrete deck for bridge S075 17062

A total number of 200 images were collected on August 24 from the Bridge S075 17062 for a 13-minute data collection time and 126 images were collected on September 18 from the identical bridge for a 16-minute data collection time after the deck was repaired. Approximately 6,100 square feet of area was covered from each data collection. In the first data collection conducted on the asphalt overlay bridge on August 24, 98% of the images had sufficient features to allow stitching for the calibrated images. The results are demonstrated on a stitched image map shown in Figure 3.15. Figure 3.15 also shows the crack detection conducted by the deep learning model. It is clearly shown that several transverse cracks are identified within the traffic lane and shoulder of the bridge. The cracks are formed between and in proximity to where the expansion joints are located in this bridge.

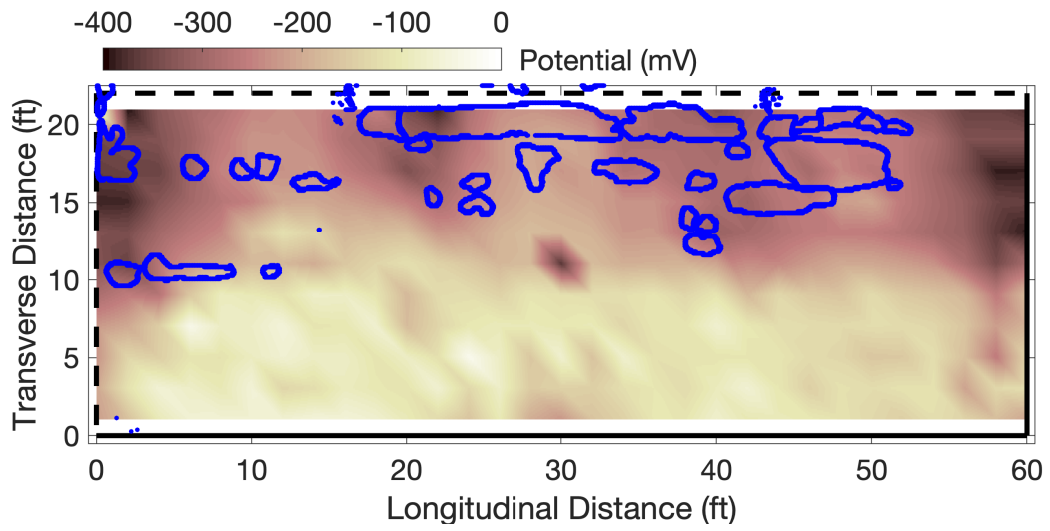
Fig. 3.17. Surface defect locations overlapped on HCP map

Figure 3.17 shows location of defects on asphalt overlay overlapped on the HCP map of the bridge deck. Most spalls and old asphalt patches are on the driving lane where the HCP data had more negative voltages. This comparison means surface defects on asphalt overlay may indicate concrete deck deterioration to some degrees, but the surface defect area is much less than the actual deterioration area detected by the HCP measurements.
