BRIDGE ASPHALT OVERLAY WITH WATERPROOFING MEMBRANE EFFECTIVENESS STUDY US-75/77 NEAR HOMER, NEBRASKA

VCS Project Number – F20041NE
October 15, 2020

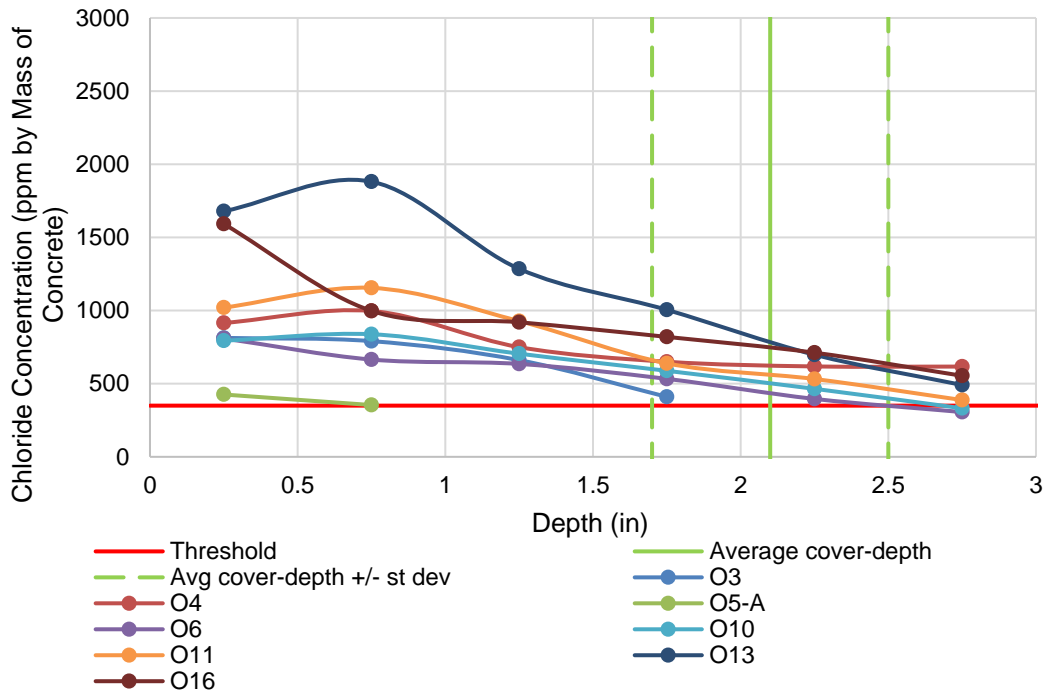
Figure 4: Chloride Concentration Profiles for the Original Section of the Bridge S075 17062 Deck

Figure 4 through Figure 7 present the chloride concentration profiles for all the collected samples. The average reinforcement cover-depth and the average plus or minus one standard deviation are indicated in the plot by vertical green lines, and the chloride threshold value of 350 ppm is plotted as a horizontal red line. For Bridge S075 17062, the cover-depth over the piers is shown on the plots since it was not possible to core to the reinforcement depth in the spans.

When concrete is exposed to an environment containing chloride ions, either from deicing salt application or marine exposure, chlorides will diffuse into the concrete from the surface. This results in the highest chloride concentration at the surface and a decreasing chloride concentration with increasing depth as observed in the original sections of the two decks (Figure 4 and Figure 6).

For Bridge S075 17062, almost all the samples from the original deck (7 out of 8 or 88%) had chloride concentrations above the corrosion initiation threshold in the depth range 1.7 to 2.5 in, which is the average cover-depth plus/minus one standard deviation for the reinforcement over the piers. This indicates that the reinforcement over the piers is at a high risk for chloride-induced corrosion. However, since the majority of the reinforcement in this bridge had significantly higher cover-depths (7.1 in) and the chloride concentrations at that depth are expected to be well below the threshold, a majority of the reinforcement away from the piers is not expected to be at risk for chloride-induced corrosion. Additionally, though chloride concentrations in the original concrete were above thresholds that are typically considered likely to initiate corrosion, the corrosion potential shown in Figure 2 and Table 3 indicate, that only 2.4% of this bridge deck has a probability of active corrosion. The total area of shallower concrete cover is 15.8% of the deck. As can be seen in Figure 2, the higher areas of corrosion potential occur near the supports (abutments and piers) where the reinforcing steel has shallower concrete cover.

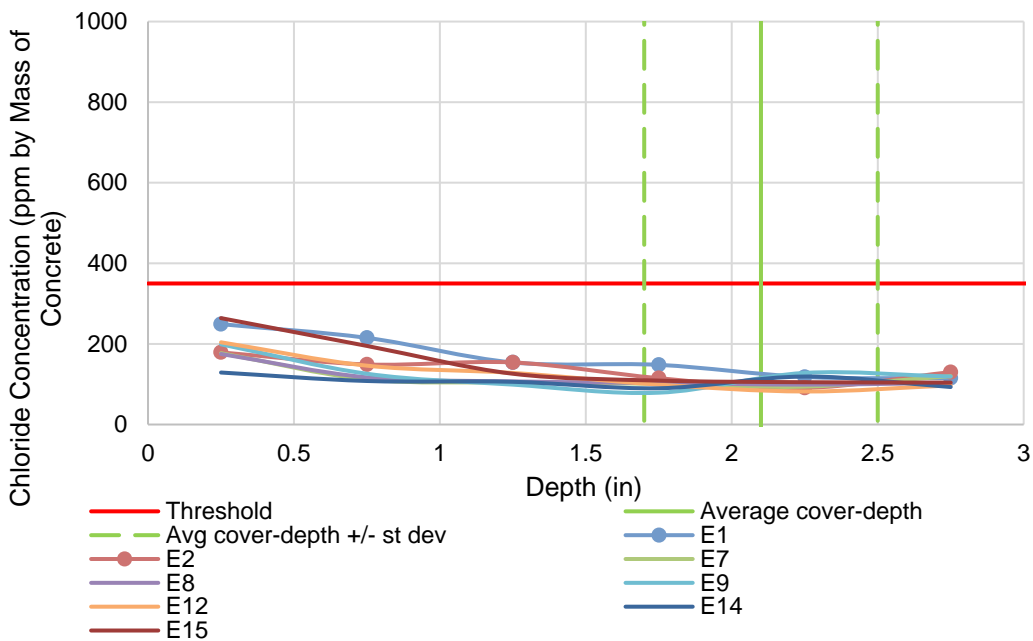
Figure 5: Chloride Concentration Profiles for the Widened Section of the Bridge S075 17062 Deck

In the widened sections, no significant change was observed in chloride concentration with increasing depth, which indicates that the chlorides present in the widened sections are background chlorides naturally present in cement and aggregates. It is clear that the waterproofing membrane was very effective in protecting the concrete from chloride ingress. Reinforcement in the widened sections is not at risk for chloride-induced corrosion.

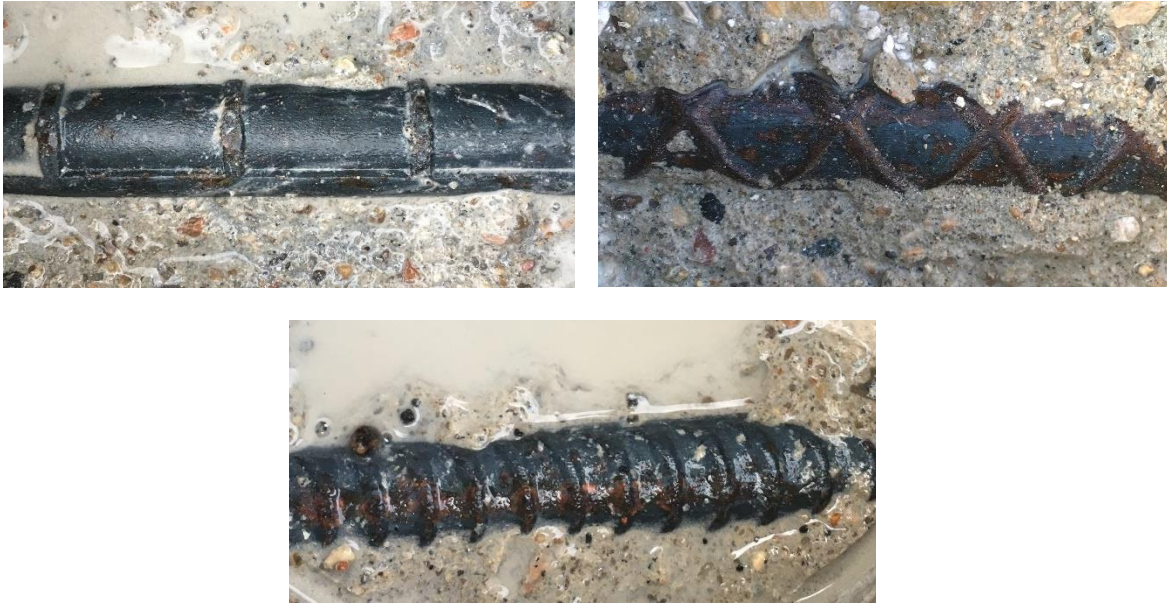
Figure 8: Typical Reinforcement Condition in Bridge S075 17596

It was not possible to core over the reinforcement in Bridge S075 17062 due to the high average cover-depth. However, in Bridge S075 17596 a number of cores were extracted over the reinforcing steel to visually inspect the condition of the reinforcement. The bars were observed to be in good condition with only minor surface rust. Typical images presented in Figure 9.

- i. Visual observation of the rebar exposed during coring indicated that the rebar is in good condition with only minor surface corrosion.
 - b. The shallow rebar that was observed over the piers in Bridges S075 17062 is at risk of chloride-induced corrosion at the present time. However, there is no risk of chloride-induced corrosion to the rebar away from the piers due to their high cover-depth.

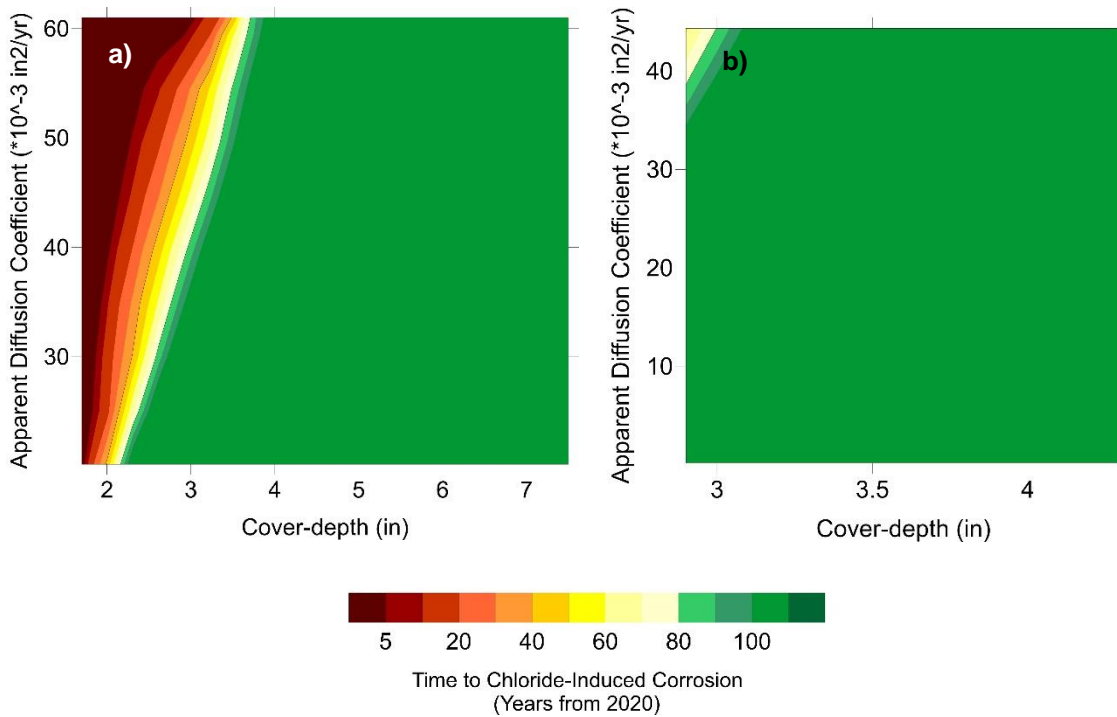
Figure 12: Projected Time to the End of the Propagation Period. Showing Bridge S075 17062 at left and Bridge S075 17596 at right

over the piers in Bridge S075 17062 is at risk for the chloride-induced corrosion at the present time or in the near future. However, for the deeper reinforcement in the spans there is no risk of corrosion for the next 100 years. For Bridge S075 17596, there is also no risk of chloride-induced corrosion in the foreseeable future as long as the deck continues to be protected from deicing salts (Figure 12b). Exposing the deck to deicing salts will increase the chloride surface concentration and change the rate of diffusion thus reducing the remaining service life of the deck.
