SAFETY PERFORMANCE EVALUATION OF THE NEBRASKA OPEN BRIDGE RAIL ON AN INVERTED TEE BRIDGE DECK

MIDWEST ROADSIDE SAFETY FACILITY

NEBRASKA DEPARTMENT OF ROADS

MwRSF Research Report No. TRP-03-133-04

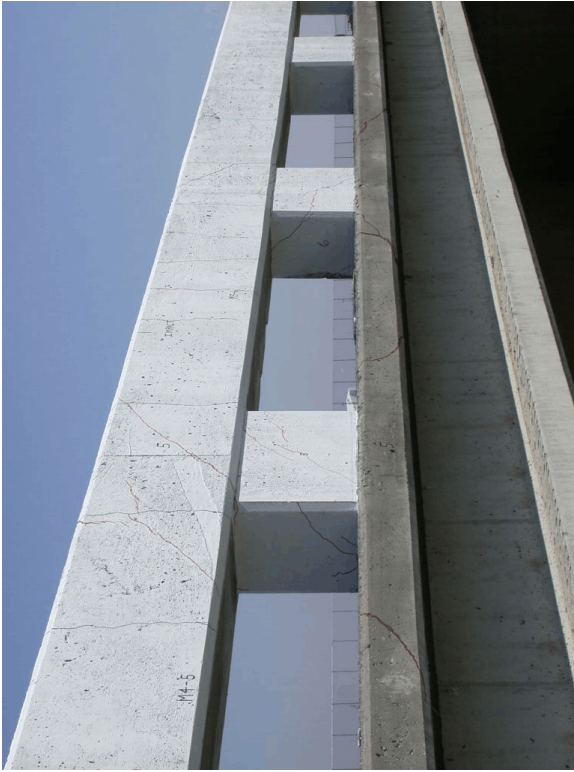
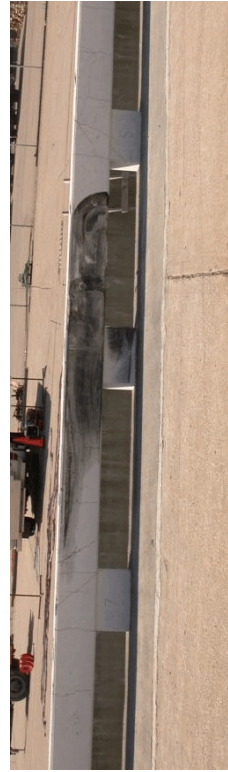
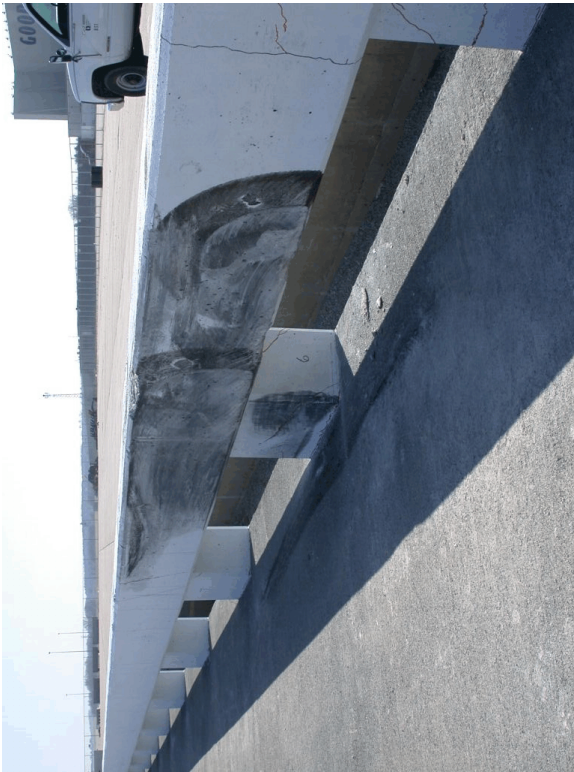
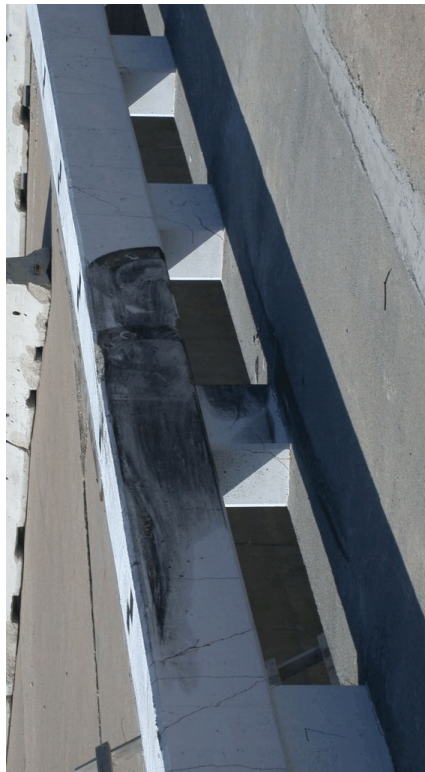
Figure 29. Open Concrete Bridge Rail System Damage, Test NIT-1

Damage to the barrier was moderate, as shown in Figures 29 through 36. Barrier damage consisted of deck, post, and rail cracking along with contact and gouge marks. The length of vehicle contact along the concrete bridge rail was approximately 4 m (13 ft).

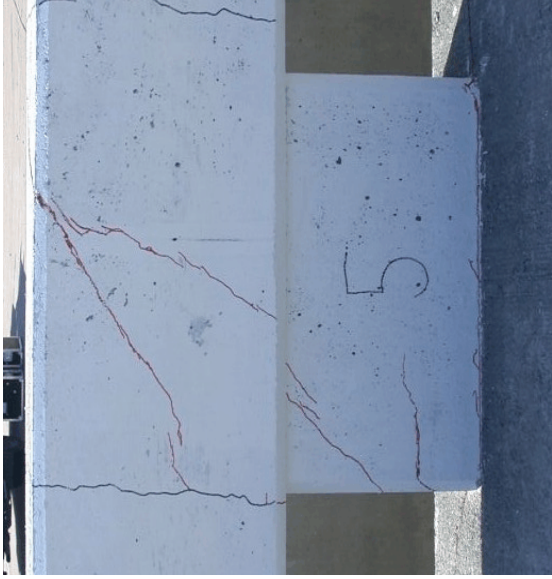
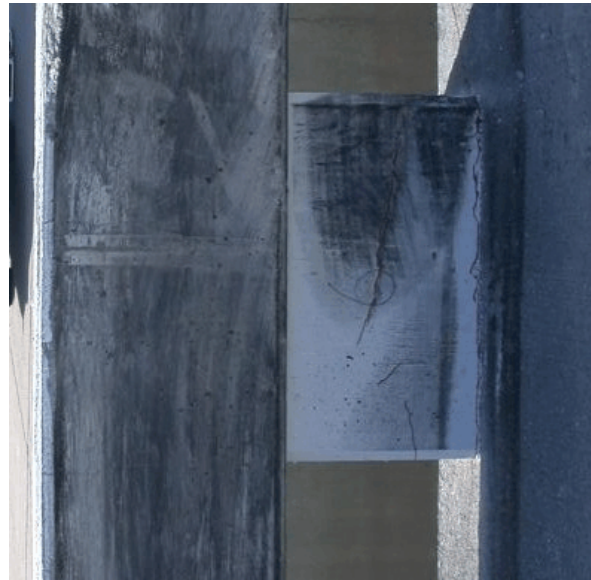
Figure 31. Open Concrete Bridge Rail Post Damage, Test NIT-1

The damage to the front of the posts and rail consisted of a very fine diagonal crack above post no. 4 and a crack at the base of post no. 4. Vertical cracks were found on the rail just

downstream of post no. 4 and on the upstream and downstream sides of post no. 5. Light cracks were found on the front, upstream, and downstream faces of post no. 5. Heavy cracks were also found on post no. 6 and on the top of the rail between post nos. 5 and 7. Hairline cracks were found on the backside faces of post nos. 5 and 6. Concrete spalling, 25-mm (1-in.) deep by 76-mm (3-in.) wide by 381-mm (15-in.) long, was found slightly upstream of post no. 6. Black contact marks were found on the rail 686-mm (27-in.) downstream from the center of post no. 5 through 178-mm (7-in.) upstream from the center of post no. 7.

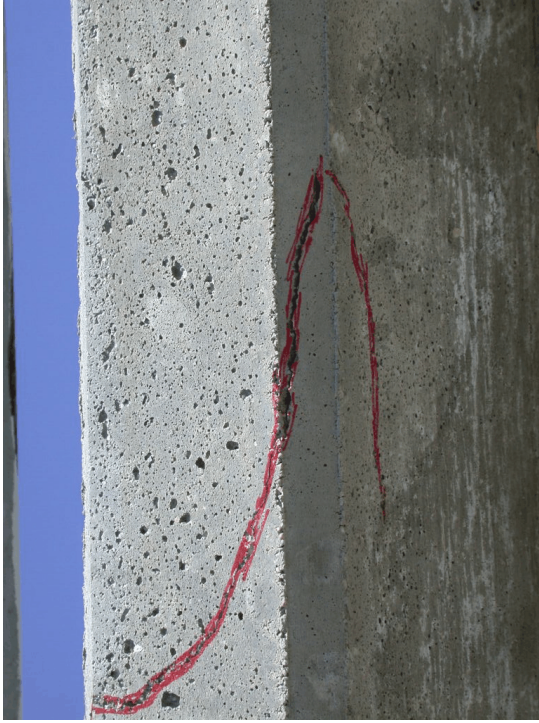
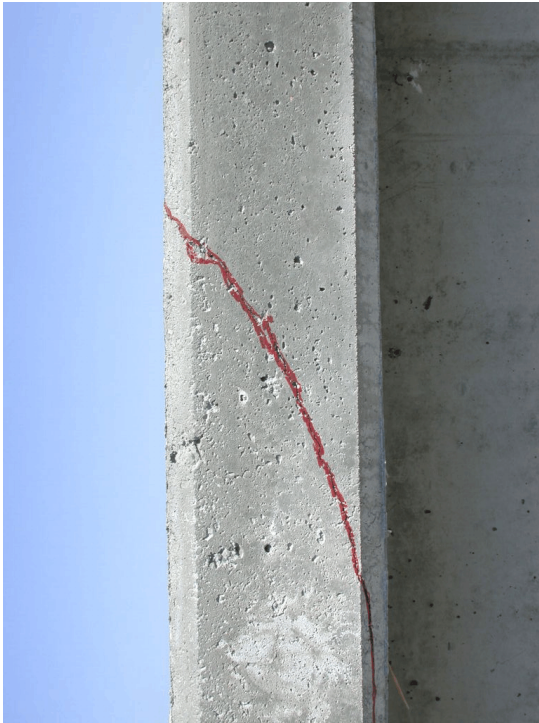
Figure 34. Bridge Deck Damage Around Post No. 5, Test NIT-1

Damage to the deck consisted of minor hairline cracks and black contact marks. One crack originated at the front-upstream corner of post no. 5 and continued diagonally back 559 mm (22 in.) then down the back of the deck for 203 mm (8 in.) for a total length of 762 mm (30 in.) upstream from the upstream face of post no. 5. Another crack originated at the downstream face of post no. 5, continued diagonally for about 254 mm (10 in.) where it reached the back edge of the deck and then continued for 152 mm (6 in.) diagonally along the back face of the deck. A third crack originated at the upstream face of post no. 6 and continued diagonally upstream for 279 mm (11 in.) then 178 mm (7 in.) diagonally along the back face of the deck. Another crack originated at the back face of post no. 6 and propagated diagonally downstream 305 mm (12 in.) and then 305 mm (12 in.) along the back face of the deck. A final crack originated at the back face of post no. 6 and continued 610 mm (24 in.) diagonally downstream and then 305 mm (12 in.) diagonally across the back face of the deck. Black tire contact marks, measuring 229-mm (9-in.) wide by 2.24-m (88-in.) long, were found on the concrete deck in front of post no. 6.

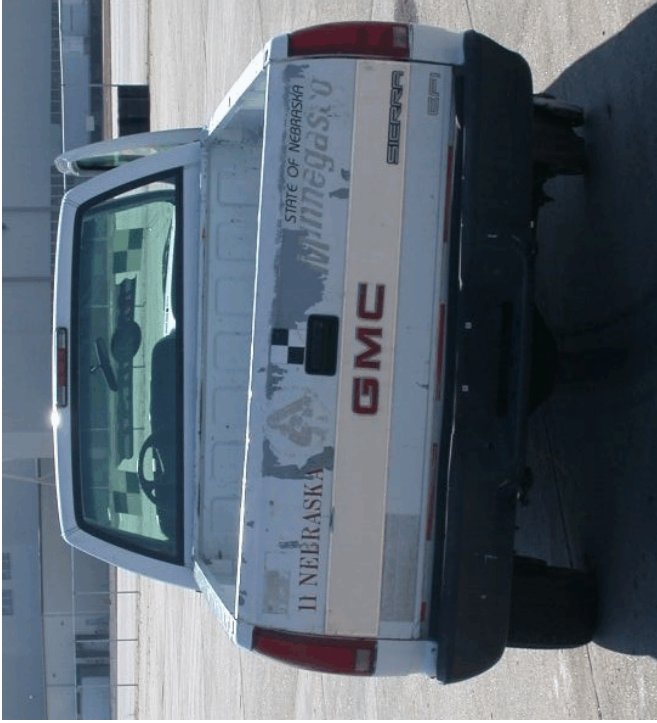
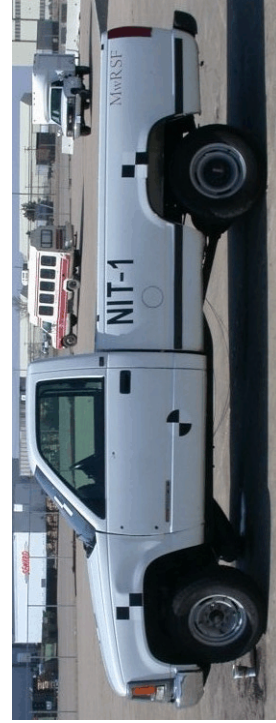
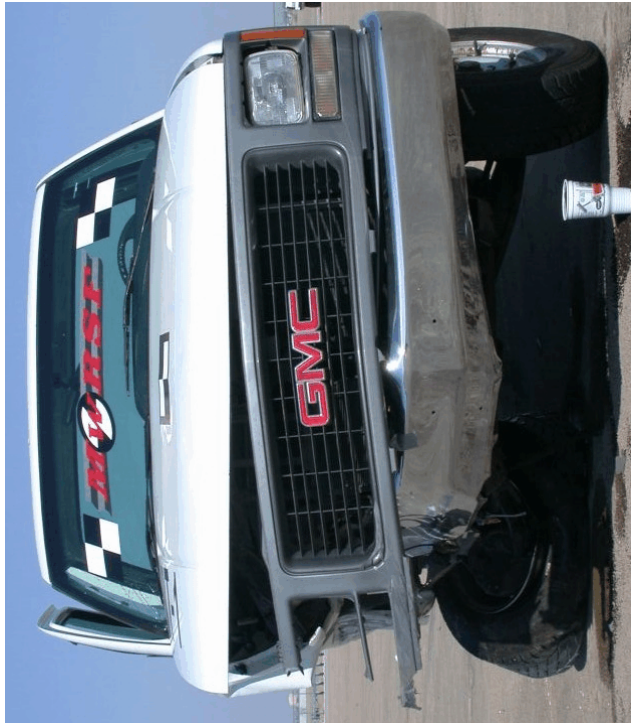
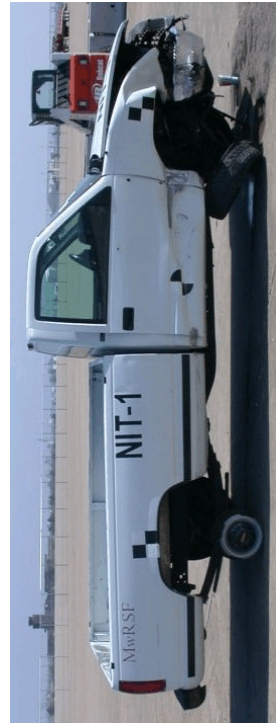
Figure 37. Vehicle Damage, Test NIT-1

Exterior vehicle damage was moderate, as shown in Figures 37 through 41. Moderate occupant compartment deformations occurred with deformations to the right-side floor pan and firewall, as shown in Figure 41. Occupant compartment deformations and the corresponding locations are provided in Appendix C.

Damage was concentrated on the right-front corner and right side of the vehicle. The right-front corner of the vehicle was crushed inward and back, including the fender, bumper, and frame rail. A buckling point was found at the center of the front bumper. A major crease was found in the frame just behind the right-front control arm. The right-front upper control arm and tie-rod disengaged completely. The right-front lower control arm joint was fractured and still attached. The right-front brake line was severed, and the exhaust manifold was cracked above the control arm assembly. Scuff marks were found on the right-rear wheel well, and the tire was ripped away from the hub rivets. The back of the right-front steel rim was damaged from the lower control arm, and the tire was separated from the rim. Deformation of the right-side door and the right side of the truck bed were also observed, and heavy contact marks were found along the entire right side of the vehicle. The top of the right-side door and the hood were jarred open. The grill was broken and deformed around the right-side headlight assembly. The right side of the radiator housing was deformed. The truck's cab shifted toward the left approximately 51 mm (2 in.) offset from the truck box. A small crease was observed on the left-front fender. The lower-right corner of the windshield encountered a minor crack and starrng. The left-rear tire remained inflated. The roof and the right-side, left-side, and rear window glass remained undamaged.

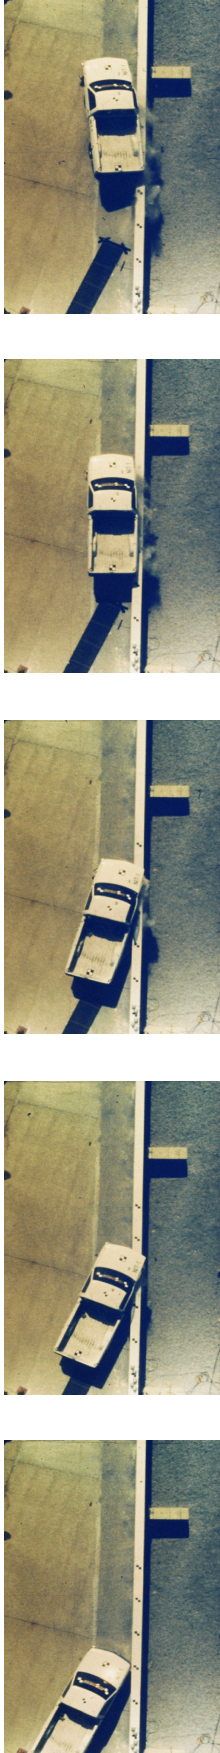
Figure B-1. Summary of Test Results and Sequential Photographs (English), Test NIT-1

● Test Number	NIT-1	● Vehicle Speed	62.0 mph
● Date	3/20/02	● Impact	49.7 mph
● Appurtenance	Nebraska's Open Concrete Bridge Rail Attached to an Inverted Tee Bridge Deck System	● Vehicle Angle	26.6 deg
● Total Length	104.8 ft	● Impact	est. 13-15 deg
● Concrete Material	Nebraska 47-BD Mix	● Exit	None
● Reinforcing Steel Material	Grade 60 Rebar - Epoxy Coated	● Vehicle Snagging	None
● Concrete Bridge Rail		● Vehicle Pocketing	None
Length	97 ft	● Vehicle Stability	Satisfactory
Width	14 in.	● Occupant Ridedown Deceleration (10 msec avg.)	6.29 G's < 20 G's
Depth	16 in.	Longitudinal	7.75 G's
Top Mounting Height	29 in.	Lateral (not required)	
● Concrete Bridge Posts		● Occupant Impact Velocity	21.65 ft/s < 39.37 ft/s
Length	24 in.	Longitudinal	25.43 ft/s
Width	11 in.	● Vehicle Damage	Moderate
Height	13 in.	TAD ⁹	I-RFQ-4
Spacing	96 in.	SAE ¹⁰	I-RFEW4
● Concrete Bridge Deck		● Vehicle Stopping Distance	158 ft downstream

Length	104.8 ft	● Barrier Damage	5 ft laterally behind
Width	72 in.	● Maximum Rail Deflections	Moderate
Thickness	6 in.	Permanent Set	NA
● Vehicle Model	1995 GMC 2500 ¾-ton pickup	Dynamic	0.9 in.
Curb	4,327 lbs	● Working Width	23.1 in.
Test Inertial	4,445 lbs		
Gross Static	4,445 lbs
