NEBRASKA

DEPARTMENT OF TRANSPORTATION

Evaluation of Tie-Bar Anchoring Methods: Non-Shrink Grout vs. Epoxy

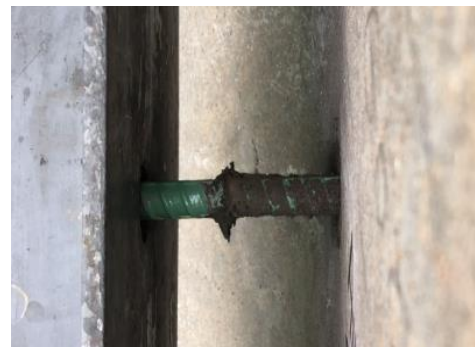
Figure 1 - A tie-bar pulled from the barrier. Grout can be seen on the bar after pulling from the barrier.

During this phase of the testing, researchers discovered that regardless of drilled-hole preparation, required strength of 12,000 lbs. was not achieved. Figure 2 shows the tie bar pulling from the barrier before achieving required strength. All the pull-out testing will be evaluated in accordance of the strength of anchors in concrete Elements ASTM E 488
