Pavement Quality Indicators Study

Five Year Report

Construction Management Department
University of Nebraska
Lincoln, NE 68588-0500

1. Report No SPR - 1 P563	2. Government Accession No.	3. Recipient's Catalog No.	
4. Title and Subtitle Pavement Quality Indicators		5. Report Date June 6, 2008

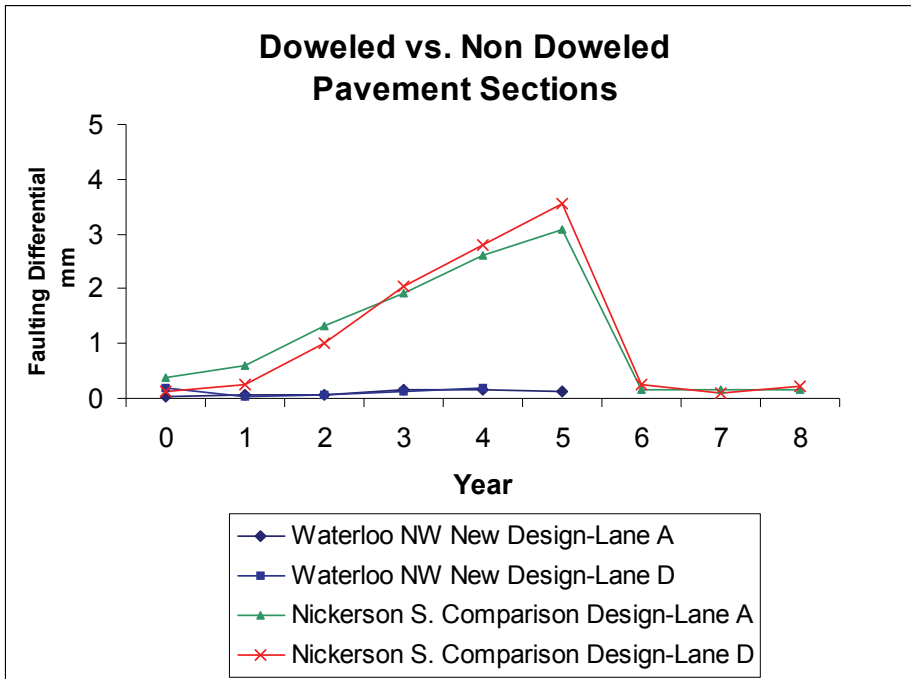
Figure 1.1: Faulting Differential, Waterloo NW and Nickerson South

This graph shows how the dowel bars used in the Waterloo NW section have limited the amount of faulting over the past five years.

The graph also shows the benefits of dowel bar retrofits. Nickerson South experienced a dowel bar retrofit in year 6 as is visible by the significant decrease in the level of faulting. Its important to notice the initial trend over the first five years (prior to the retrofit) as that trend shows a steady increase in faulting to nearly 3 mm (half the allowable maximum) by year five.

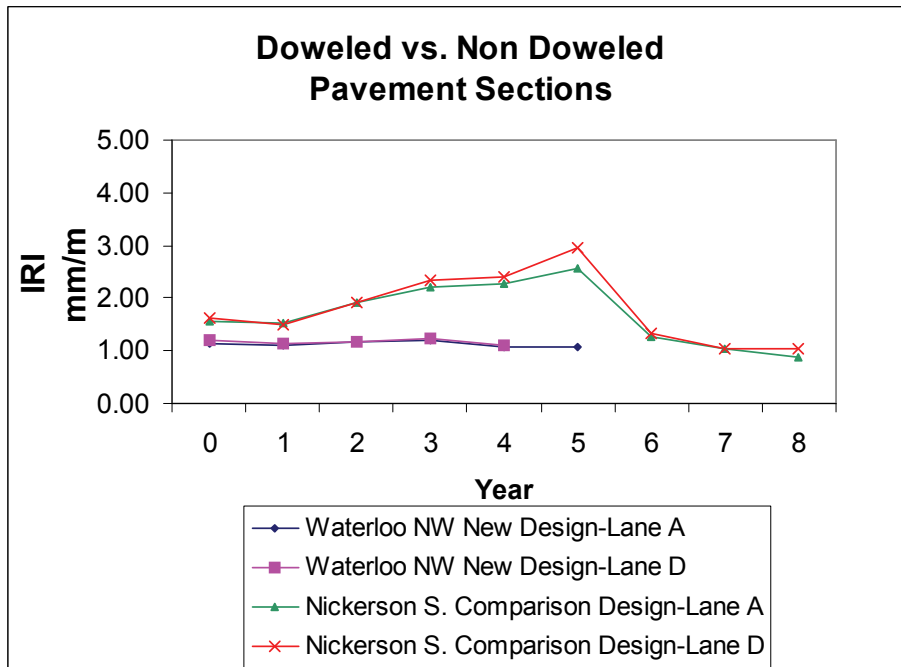
Figure 1.2: IRI, Waterloo NW and Nickerson South

Similar to the previous graph, the doweled Waterloo NW section is smoother than the traditional Nickerson South section.

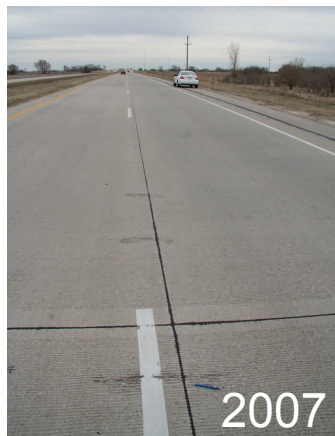
Location: MM 168.5

- Placement of tie bars too close to pavement surface across longitudinal joint caused surface cracking shown in photo at left.

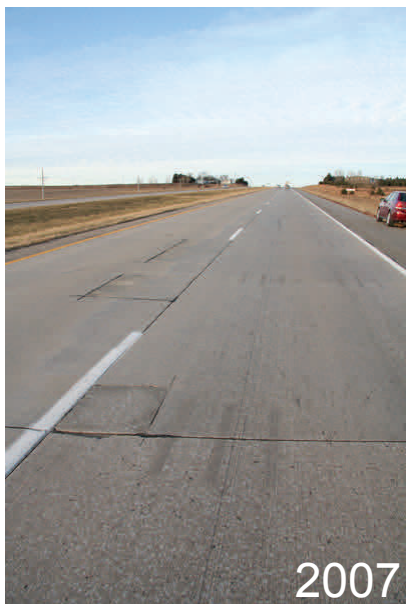
Location: MM 268

- Saw cut patches showing disintegration of concrete.
- Grout patches from dowel bar retrofit are also visible.

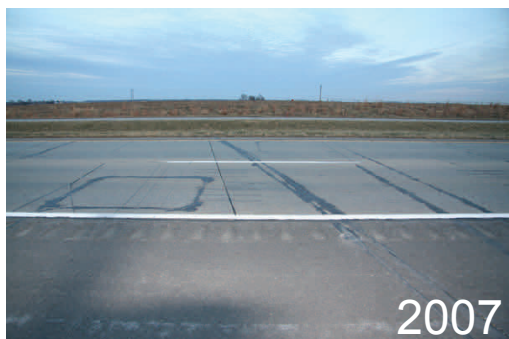
Location: MM 253

- Cracks forming where roadway was undermined during utility work.

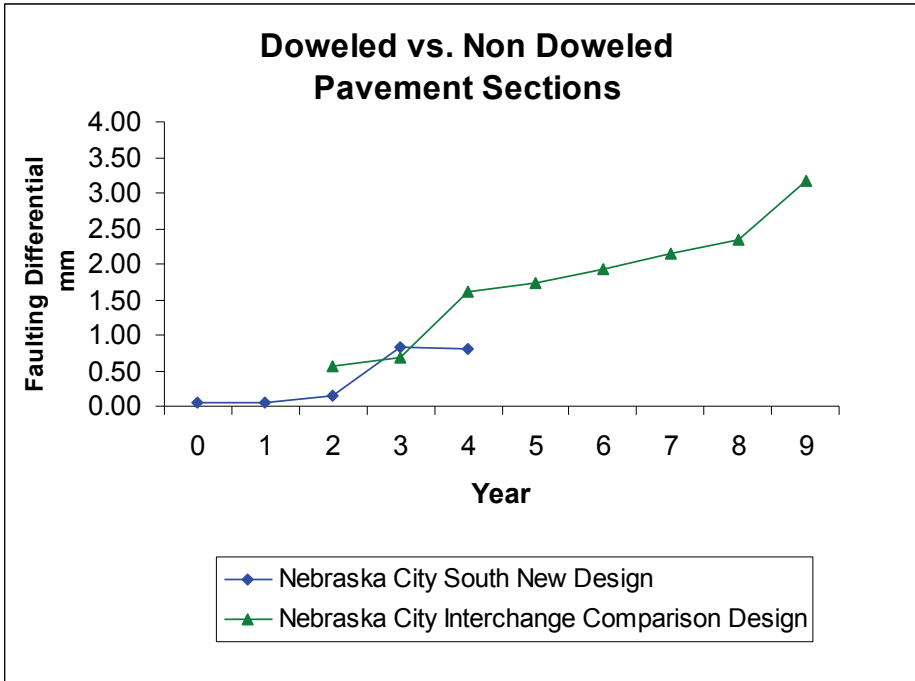
Figure 2.1: Faulting Differential, Neb. City South and Neb. City Int.

The doweled pavement (Nebraska City South) has outperformed the non-doweled section for most indicators.

At the end of year nine, the non-doweled pavement exhibits faulting of about 3 mm. The doweled pavement is experiencing less severe faulting, averaging about 1 mm after four years.

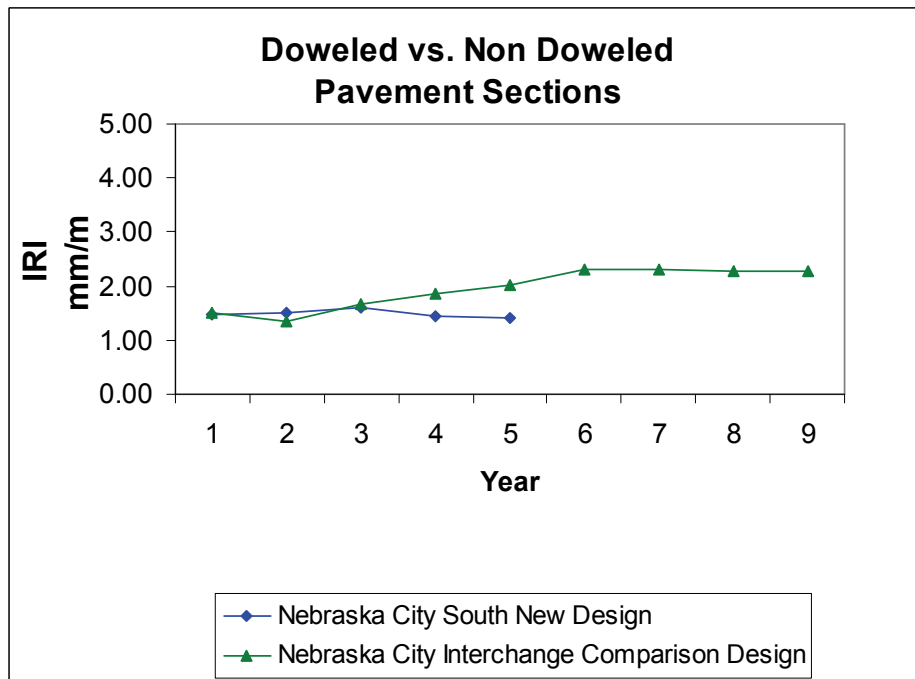
Figure 2.2: IRI, Neb. City South and Neb. City Int.

Over the past four years the doweled pavement has shown little increase in IRI while the conventional section showed a steady increase.

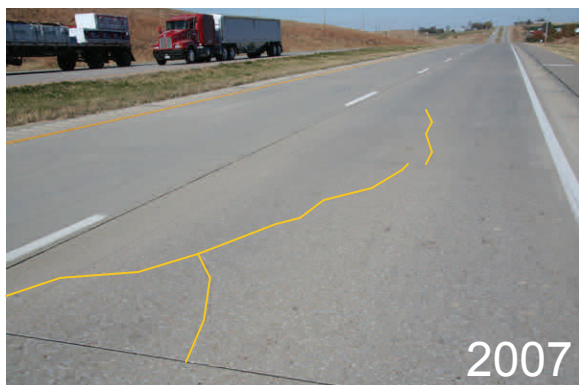
Location: MM 43.8

- High slab cracking.
- Concave road surface for three sections.
- Standing water in shoulder joints.

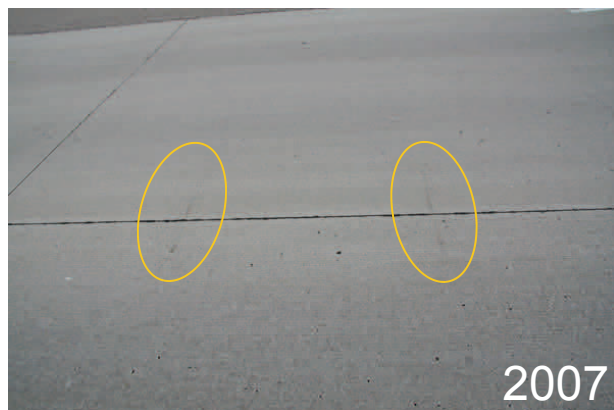
- Perpendicular edge cracking along centerline.
- 2”– 8” transverse cracks approximately every four feet along centerline.
- High placement of tie bars across longitudinal joint caused surface cracking shown at left.

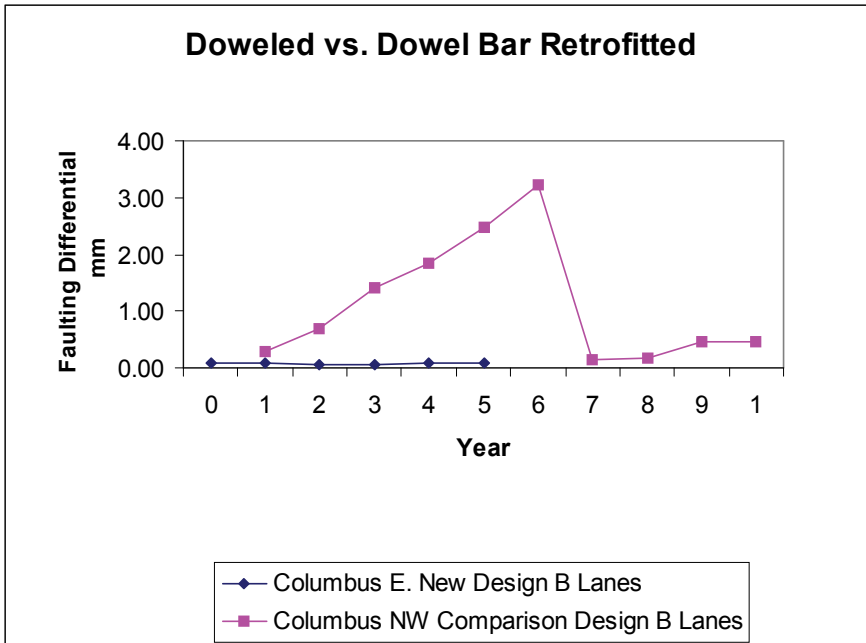
Figure 3.1: Faulting Differential, Columbus E. and Columbus NW.

Columbus NW, originally a non-doweled section, experienced a steady increase in the level of faulting to almost 3 mm after six years.

The level of faulting significantly decreased after a dowel bar retrofit was performed on the Columbus NW section in the seventh year. While Columbus NW has seen a slow increase in the level of faulting, faulting is now much less severe than prior to the dowel bar retrofit.

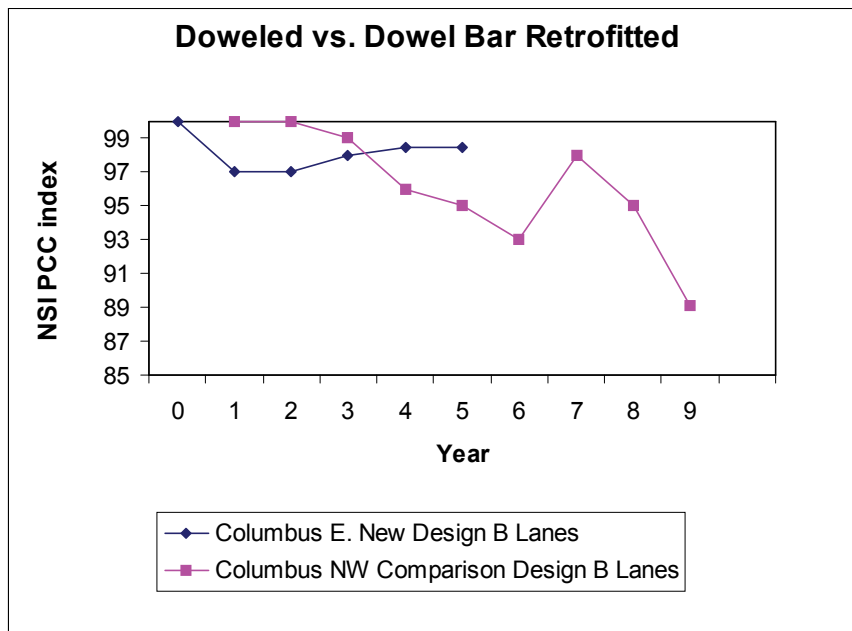
Figure 3.2: NSI PCC, Columbus E. and Columbus NW.

This graph shows how Columbus NW section reacted to a dowel bar retrofit in year seven. Since the retrofit, there has been a significant decrease in the Nebraska Serviceability Index (NSI). This decrease is caused by placing the retrofitted dowel bars too close to the shoulders, thereby causing cracking of pavement along the shoulders. This problem is visible in the pictures of the Columbus NW section.

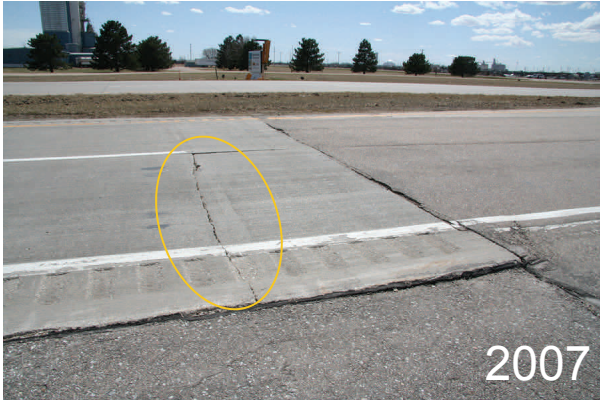
Location: MM 384.35

- Transverse cracking near the end of the study section.
- Faulting greater than 3 mm.

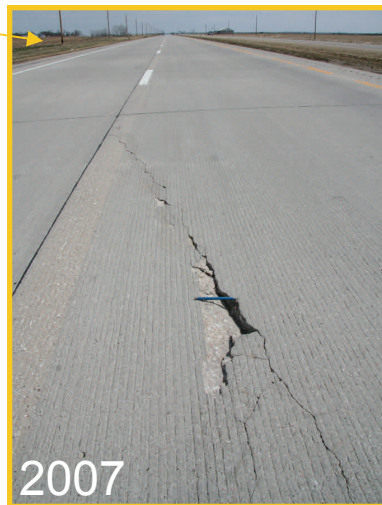
Location: MM 190.8

- Longitudinal cracking.
- Extends three panels (~50 feet) in length.
- Longitudinal cracking is not typical of this section.

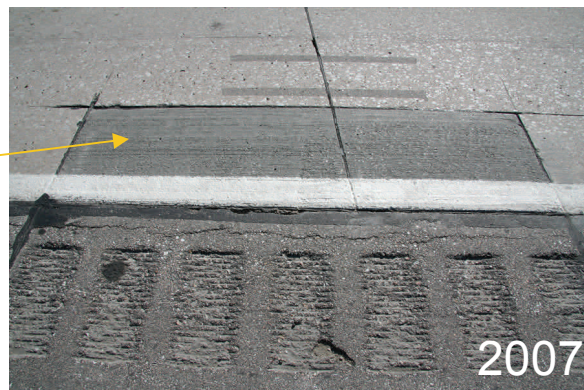
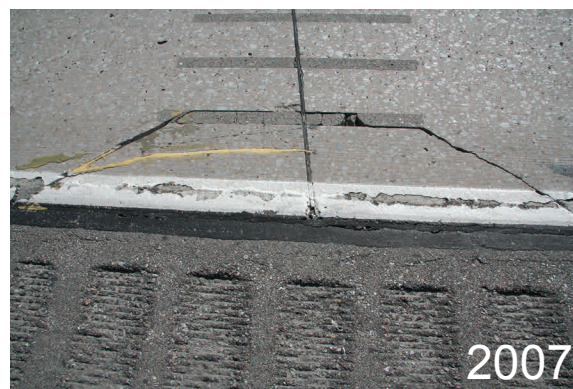
Location: MM 115.9

- Cracking along shoulder where dowel bars were retrofitted is common throughout the study section.
- Euroteck foam was used to prevent additional settling and to raise cracked panels.
- Retrofitted dowel bars placed too close to edge of pavement caused the cracking.
- Retrofitted dowel bars are now placed 6” closer to the centerline to prevent cracking of this type.

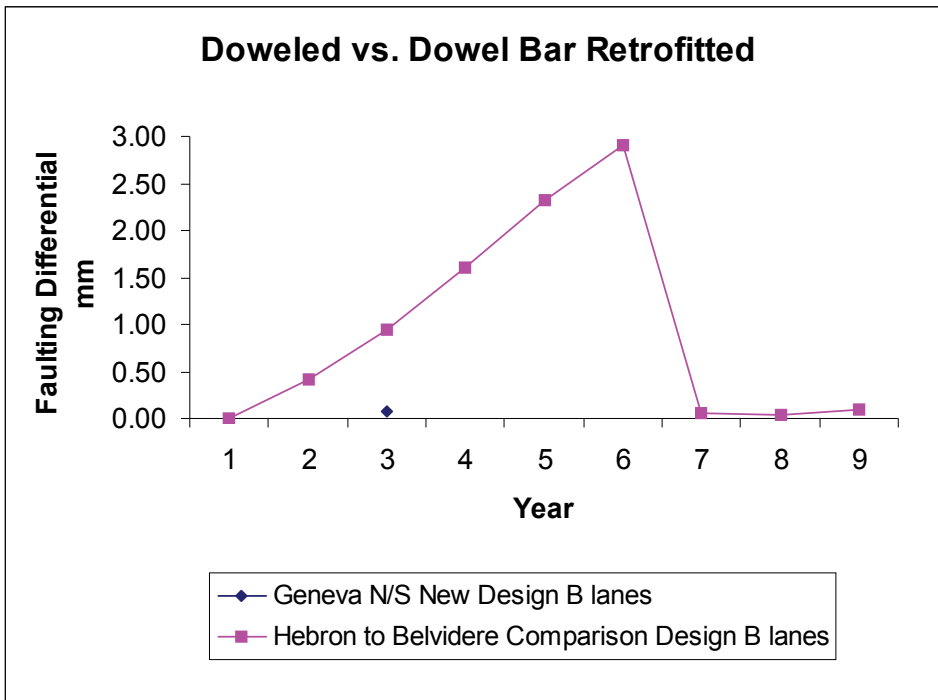
Figure 4.1: Faulting Differential, Geneva N/S and Hebron to Belvedere.

The doweled Geneva North and South section has outperformed the non-doweled conventional section with regard to most indicators.

A dowel bar retrofit in year seven of the Hebron to Belvidere section has resulted in faulting almost identical to that found when dowel bars were inserted during pavement construction.

The doweled Geneva North and South section has shown little to no faulting after four years.

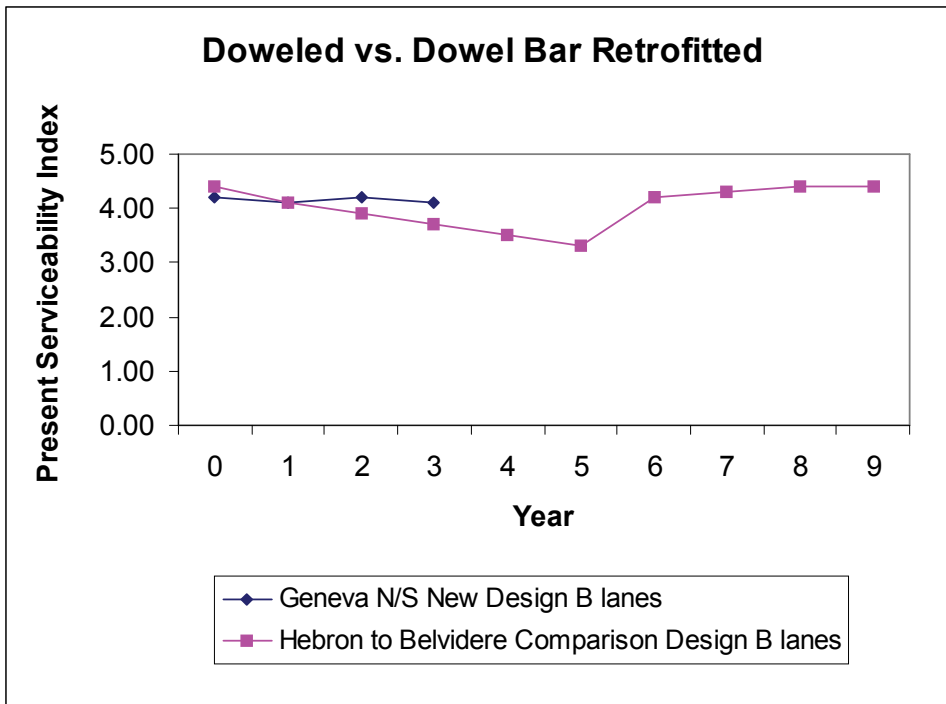
After five years, the Present Serviceability Index (PSI) dropped from a very good rating to a good rating. If that trend had continued, the PSI for Hebron to Belvidere would have decreased to a fair or poor rating within a few years.

The dowel bar retrofit in year seven increased the PSI to a level similar to that found in the innovative pavement section.

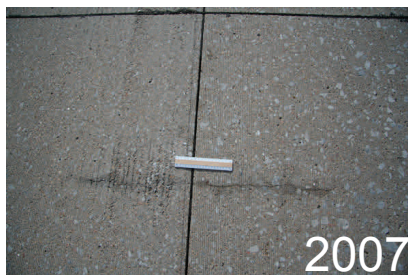
- Surface cracking extending through 11 to 12 panels along longitudinal joint.
- 2'8" cracks above tie bars across longitudinal joints.

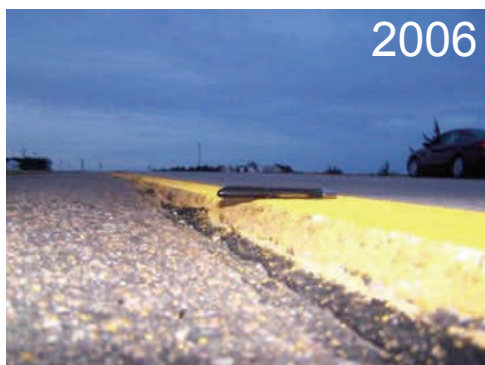
Location: MM 17

- Shoulder drop off.

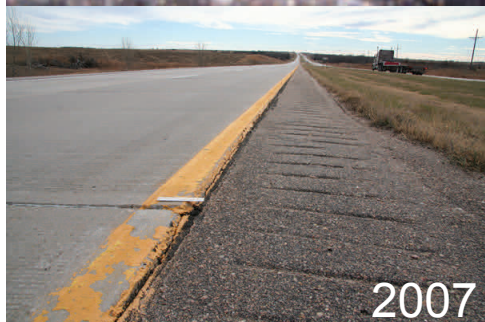
- Magnitude of drop off has not increased from previous years.

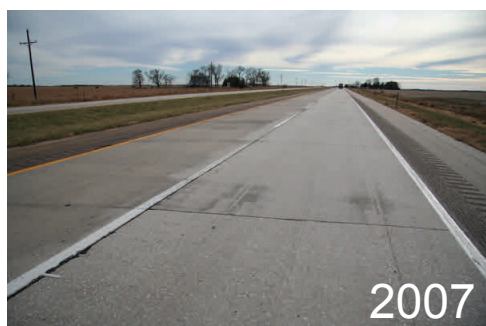
Location: MM 14.9

- Pavement disintegration.
- Prominent crown between lanes.

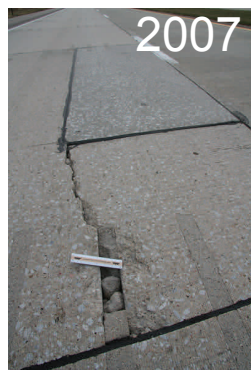
Location: MM 15

- Severe longitudinal cracking where highway was undermined for utilities work.

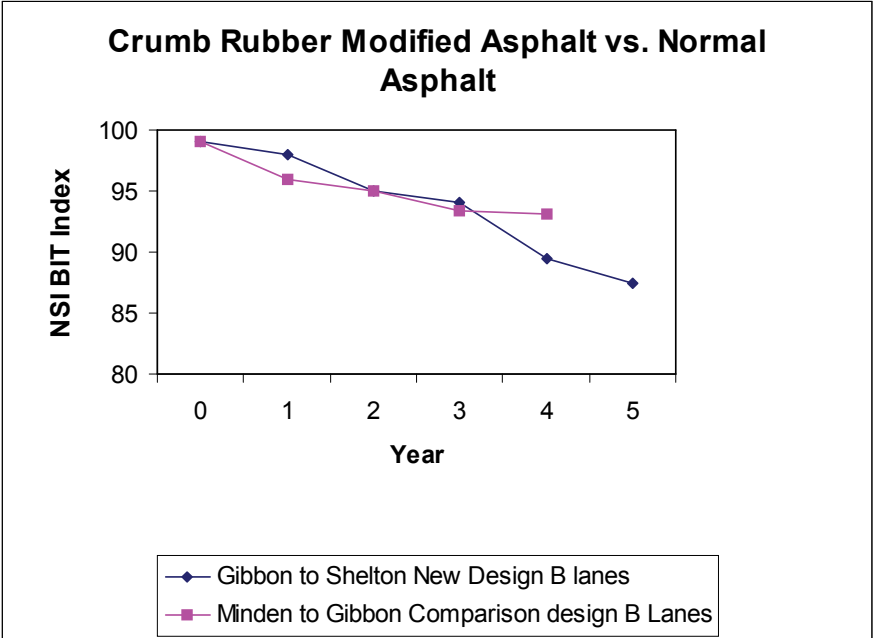
Figure 5.1: NSI Bit, Gibbon to Shelton and Minden to Gibbon.

The crumb rubber modified asphalt from Minden to Gibbon has outperformed the conventional asphalt comparison section with regard to surface condition of the pavement as measured by the NSI bituminous index (see graph at left).

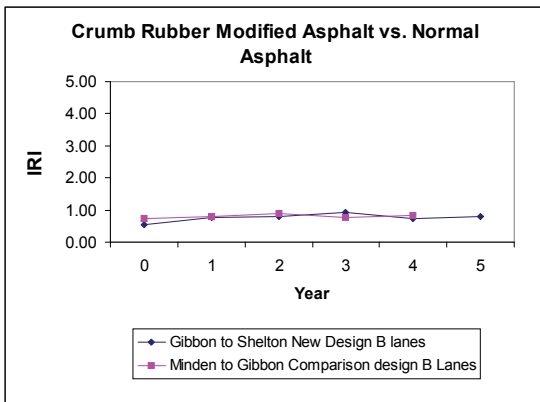
Figure 5.2: IRI, Gibbon to Shelton and Minden to Gibbon.

These two sections behaved very similarly with respect to the International Roughness Index (IRI), Present Serviceability Index (PSI) and rut depth. The crumb rubber modified asphalt appears to perform marginally better only because it appears to maintain slightly better surface integrity over identical service life.

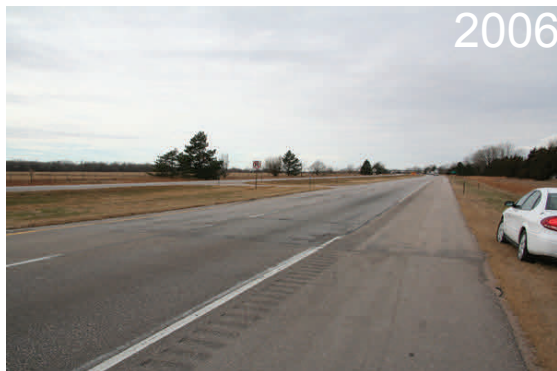
Location: MM 290.96

- Surface distress near end of study section.
- Longitudinal and transverse cracking.

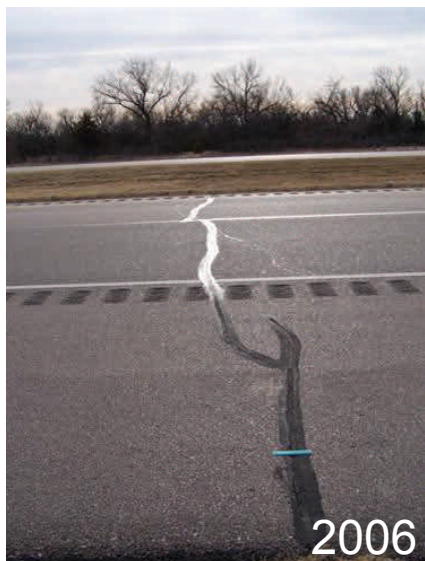
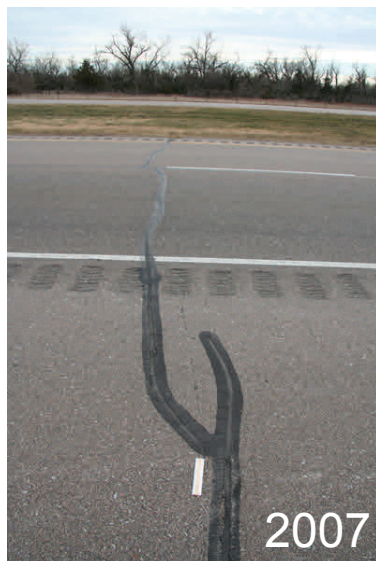
Location: MM 279.5

- High severity transverse cracking.
- Cracking beginning outside of areas where cracks have been sealed.

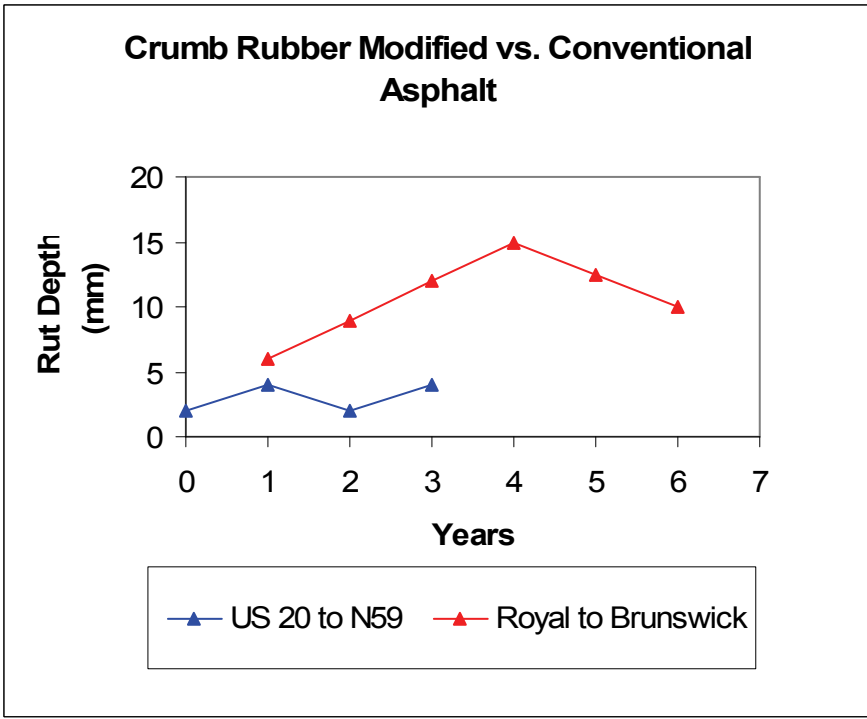
Figure 6.1: Rutting Depth, US20 to N59 and Royal to Brunswick.

The crumb rubber modified asphalt (US20 to N59) shows far less rutting than the conventional asphalt pavement section.

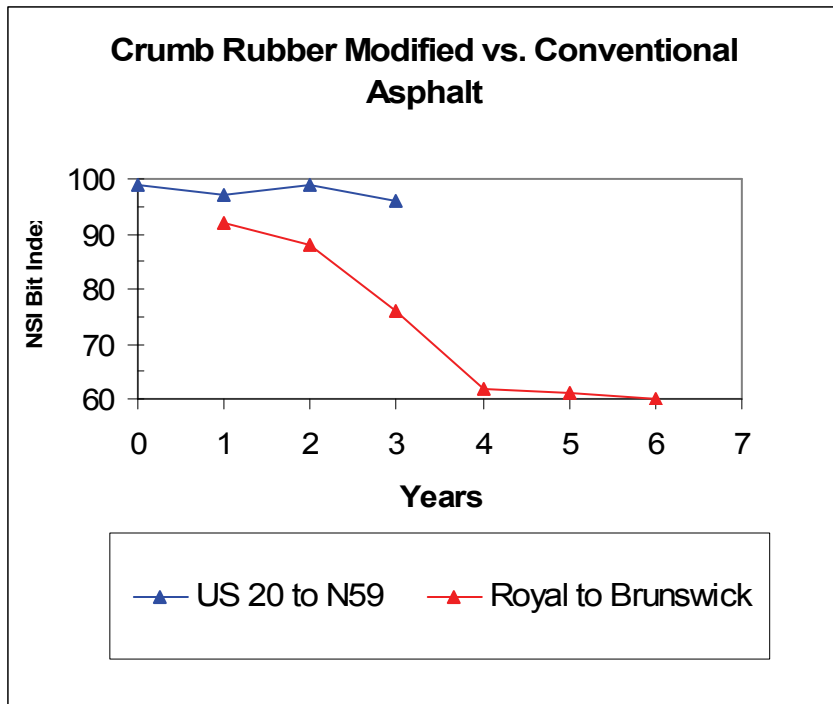
Figure 6.2: NSI Bituminous Index, US20 to N59 and Royal to Brunswick.

The crumb rubber modified asphalt (US20 to N59) has consistently outperformed conventional asphalt with regard to surface condition of the pavement as reflected by the NSI bituminous index.

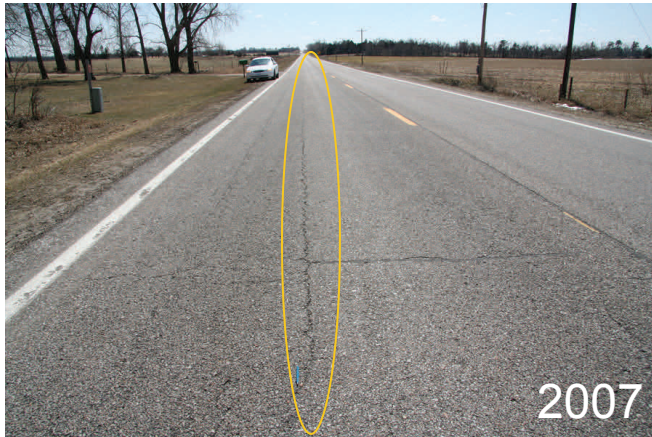
Location: MM 171.3

- Longitudinal crack ~ 100' in length.

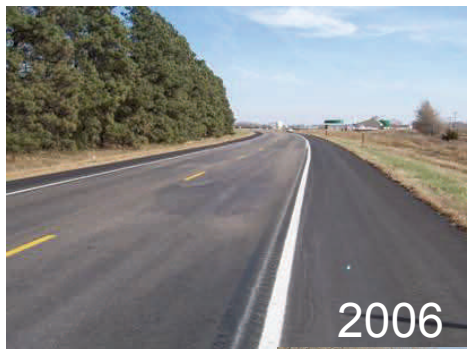
Location: MM 341.9

- Pavement rehabilitation in 2006.
- Some surface wear was already visible in 2007.

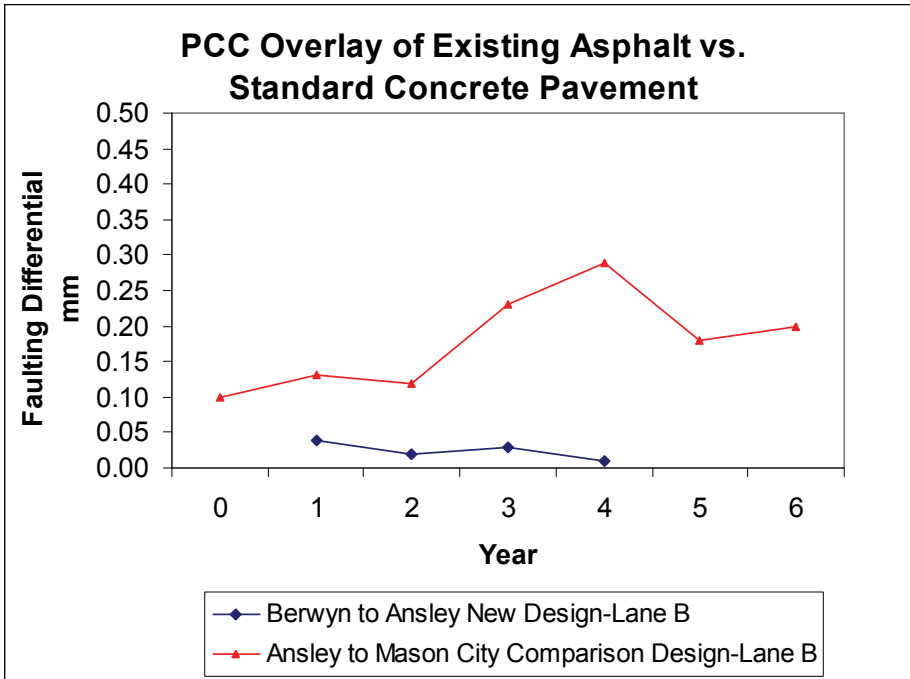
Figure 7.1: Faulting Differential, Berwyn to Ansley and Ansley to Mason City.

Dowelled pavement (Berwyn to Ansley) has outperformed the conventional PCC section for all parameters.

While the non-dowelled pavement has seen an increasing trend of faulting over the past six years, the dowelled pavement has shown little to no faulting over the four years of the study.

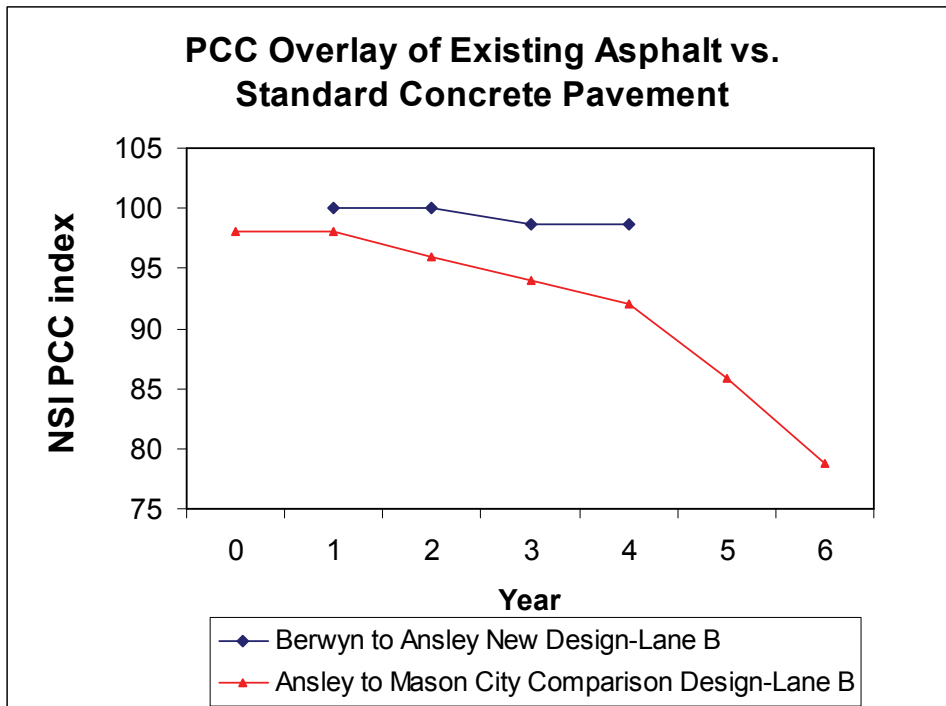
Figure 7.2: NSI PCC, Berwyn to Ansley and Ansley to Mason City.

The PCC overlay has outperformed the comparison section in relation to surface condition of the pavement.

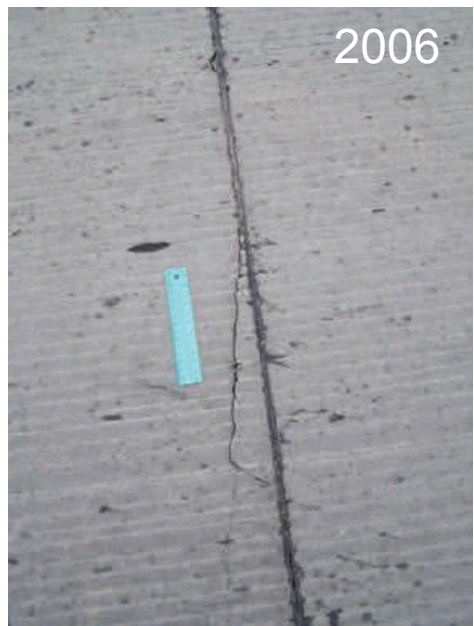
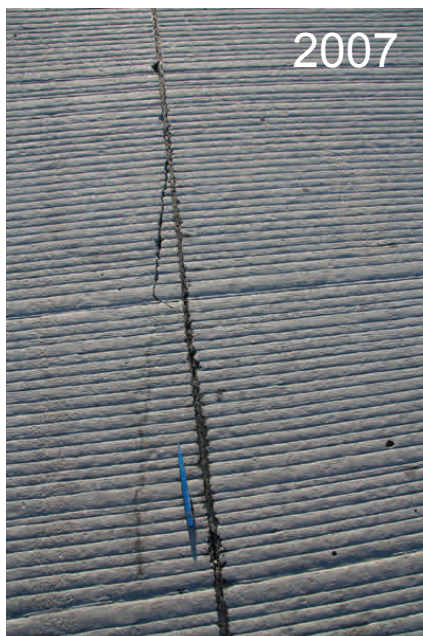
Location: MM 293.9

- 1.5' diagonal slab cracking.
- Between 2006 and 2007 hairline cracks advanced about six inches.

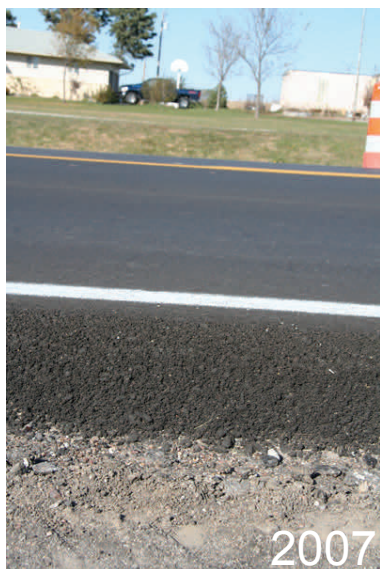
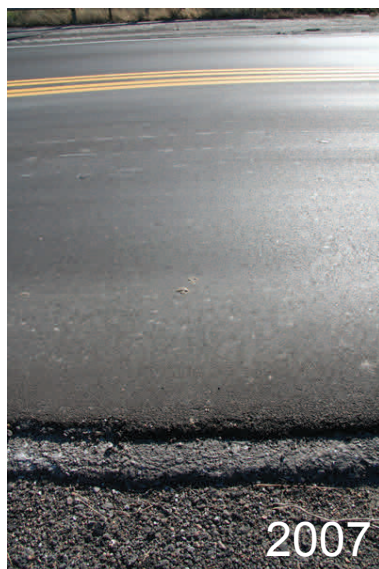
- Contractor was finishing construction during site visit in fall of 2007.
- Pictures show highway approaching a cable guard rail location.

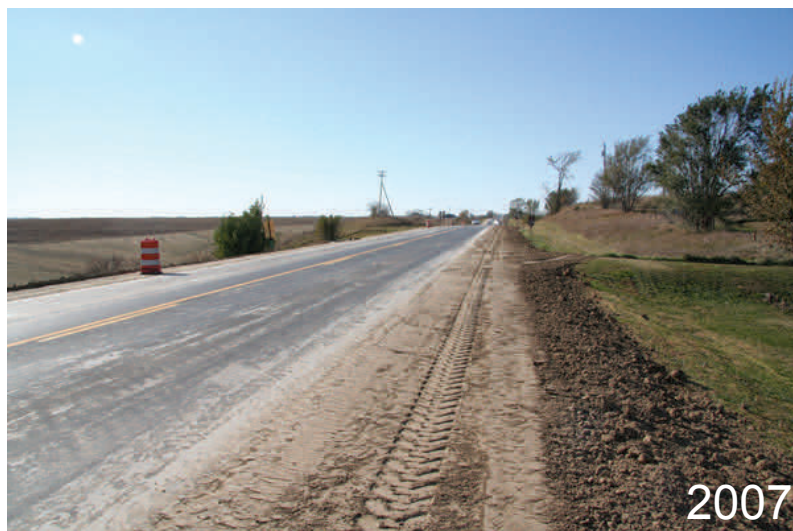
- Finish grading was being performed on the shoulders of study sections during site visit in fall of 2007.

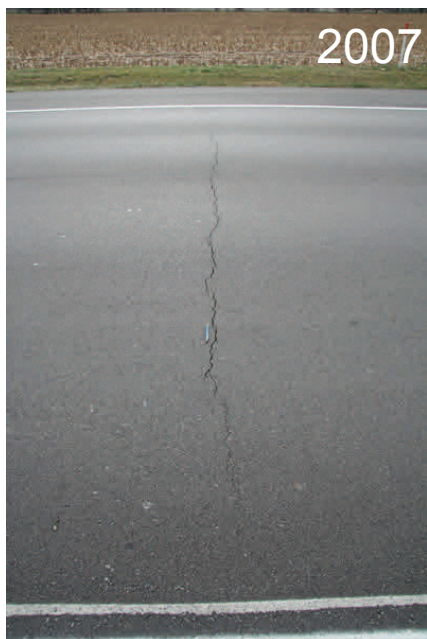
Location: MM 442 +20

- Thin transverse cracking.
- Roadway appears in excellent condition, but it is possible to see thin transverse cracks when walking the section.
- Cracking is surprising because this section is less than one year old.
