Evaluating the Impact of Deck Removal Method on the Performance of NU Girders

Nebraska Department of Roads (NDOR)

Project Number: SPR-P1 (12) M325

FINAL REPORT

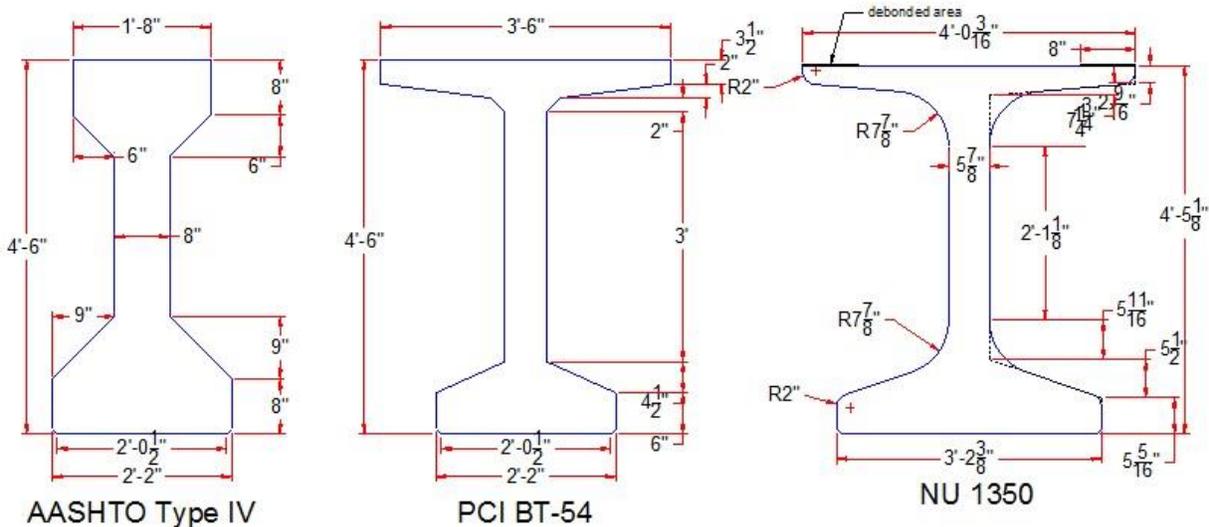
With the evolution of precast/prestressed concrete bridge I-girders comes greater structural capacity and ability to span lengths of up to 200 ft. Figure 1-1 shows the evolution of cross section of typical concrete bridge I-girders from the standard AASHTO girders to PCI Bulb Tee girders, and recently to wide and thin top flange I-girders (e.g. NU girders). Precast/prestressed concrete I-girders with wide and thin top flanges have unique characteristics compared to the other concrete girders. The wide and thin top flange provides an adequate platform for workers, shorter deck span, and reduced girder weight. While the wide and thick bottom flange accommodates a large number of prestressing to improve the section capacity, the wide and thin top flange improves girder stability during construction and reduces the tendency to side sway when long spans are used.

FIGURE 1-1: CROSS SECTIONS OF STANDARD AASHTO GIRDERS (LEFT) AND NU GIRDERS (RIGHT)

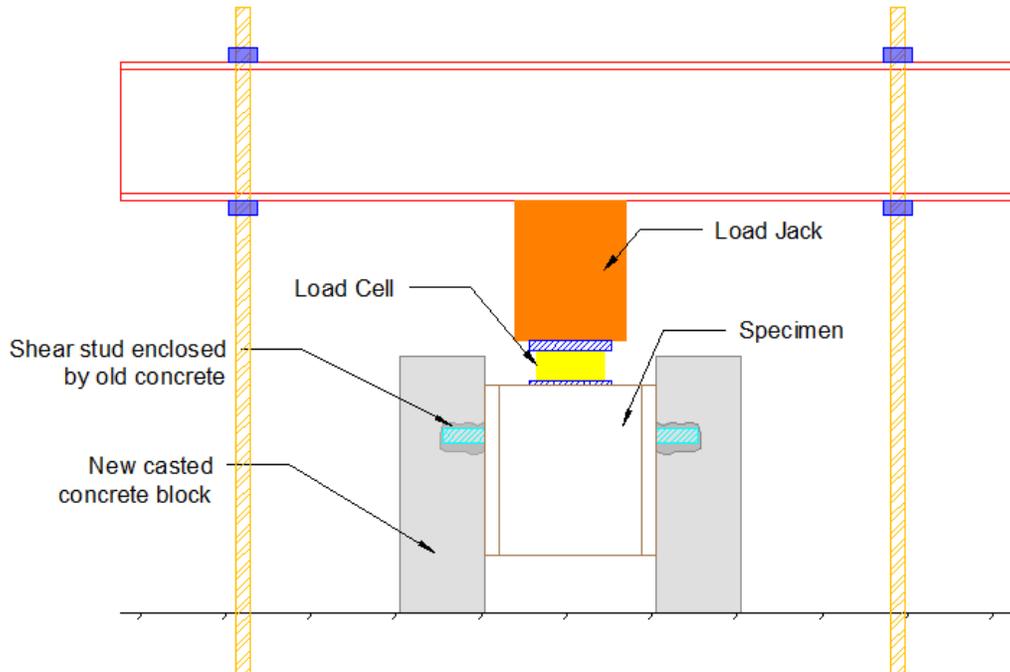
ISU Bridge Center has conducted a research on the shear capacity of three different types of shear connectors with varying levels of deck removal. Three different types of shear connectors welded to I-beams were tested for shear capacity and behavior of the connection with the testing variable being different levels of removed concrete; 50%, 75%, and 100%. The three different types of shear connectors are standard shear studs, c-channel connector, and the angle with welded bar connector. The testing consisted of 27 specimens; three specimens for every variation of concrete removal and type of shear connector. The test setup is shown in Figure 2-1.

FIGURE 2-1: ISU SHEAR CONNECTOR TEST SETUP

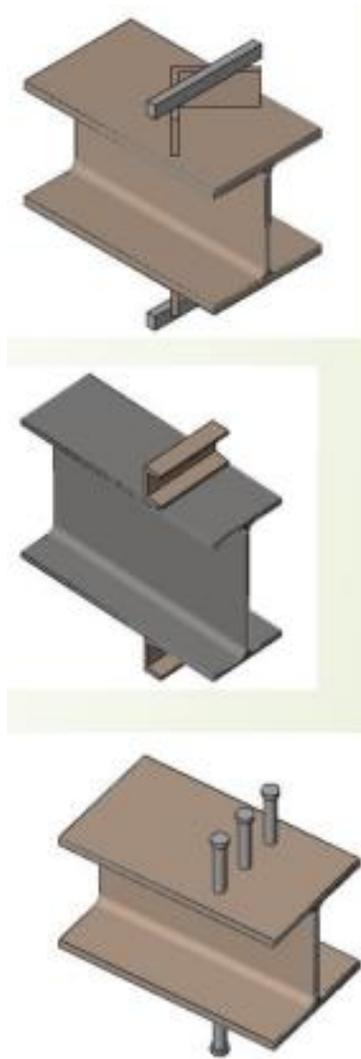
It should be noted that no specific height and width dimensions of the concrete around the connector were used to classify 50%, 75%, or 100%, but instead were classified by weight. Figure 2-2 shows the different types of shear connectors used in testing. The different type of shear connectors used are shear studs, c-channel connectors, and an angle with a welded bar connector.

FIGURE 2-2: ANGLE + BAR, C-CHANNEL, AND SHEAR STUD CONNECTORS (*COURTESY OF ISU BRIDGE CENTER*)

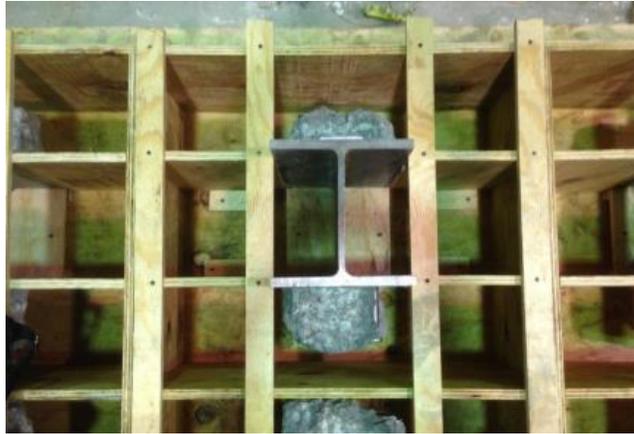
Specimen forms were made by casting the “new” deck around the shear connectors with existing concrete on shown in Figure 2-3 and Figure 2-4.

FIGURE 2-3: SPECIMEN FORMING (*COURTESY OF ISU BRIDGE CENTER*)

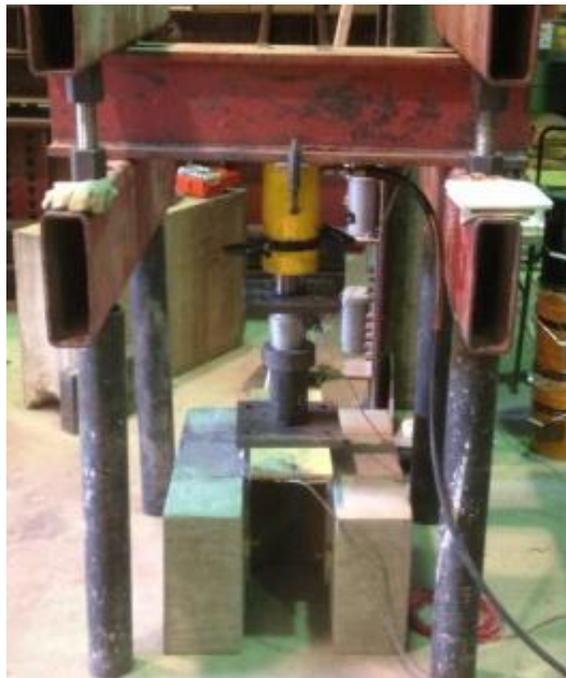
FIGURE 2-4: ISU PUSH-OFF TEST SETUP (*COURTESY OF ISU BRIDGE CENTER*)

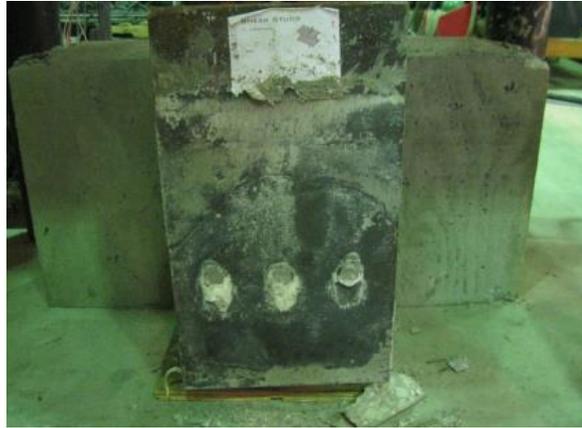
Specimen failure mode is shown in Figure 2-5. All of the shear connector types had the same resultant failure mode, which is shearing off the connector at the deck to girder interface.

FIGURE 2-5: SHEAR STUD CONNECTOR FAILURE MODE (COURTESY OF ISU BRIDGE CENTER)

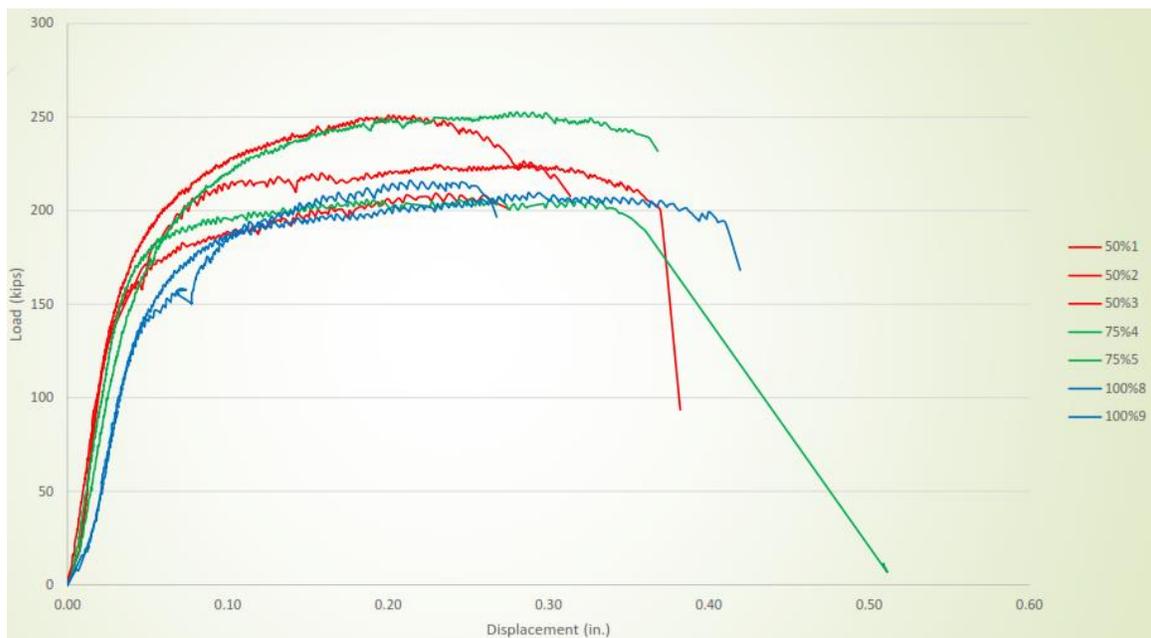
The results of testing the different connectors with varying concrete deck removal levels of 50%, 75%, and 100% are shown in Figure 2-6 through Figure 2-8. From the graphs, there is no correlation between the level of deck removal and the behavior of the connection. Therefore, it can be concluded that the amount of concrete removal around the shear connectors does not adversely affect the behavior of the connection.

FIGURE 2-6: LOAD VS AVERAGE DISPLACEMENT FOR SHEAR STUDS (COURTESY OF ISU BRIDGE CENTER)

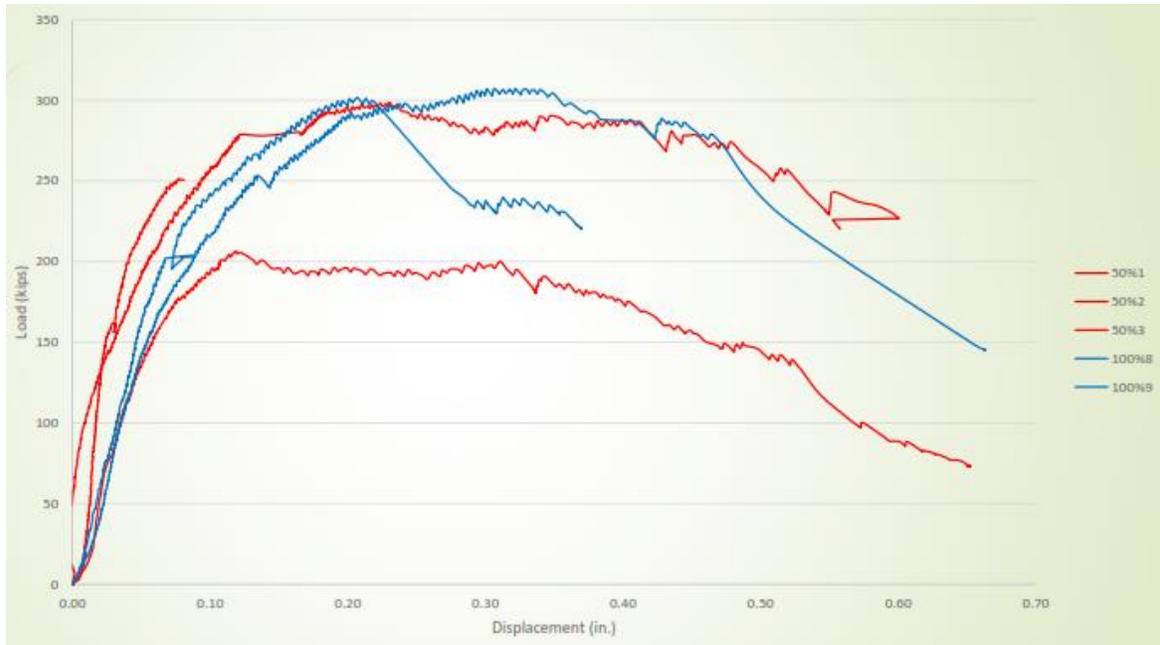
FIGURE 2-7: LOAD VS AVERAGE DISPLACEMENT FOR C-CHANNEL (COURTESY OF ISU BRIDGE CENTER)

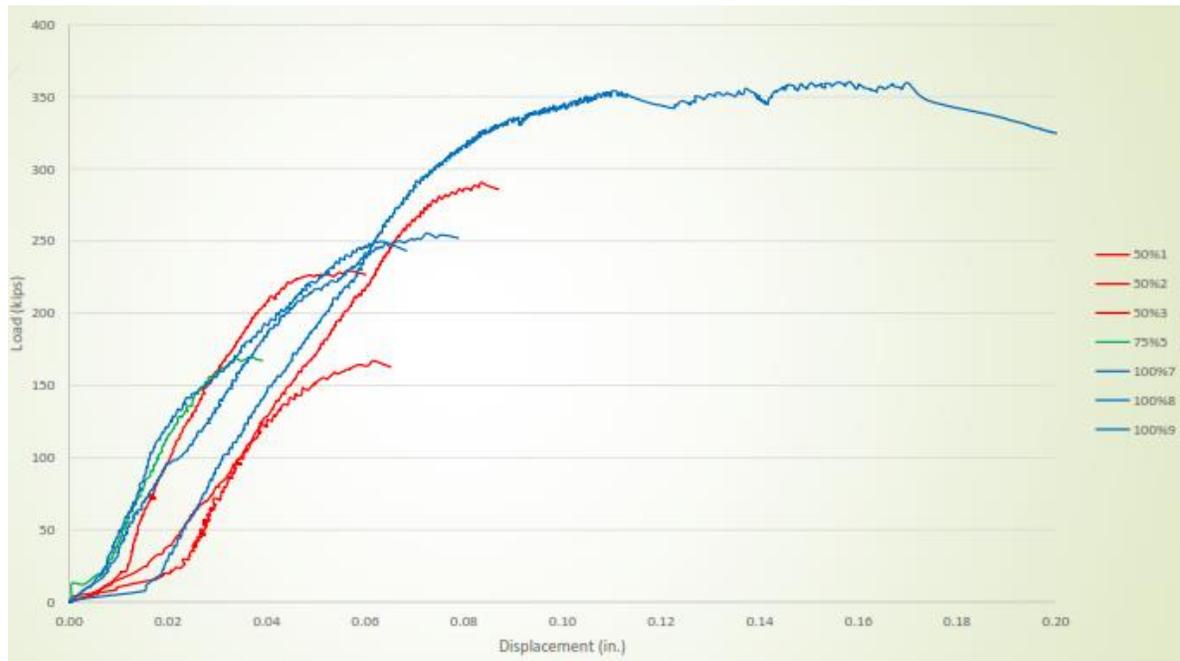
FIGURE 2-8: LOAD VS AVERAGE DISPLACEMENT FOR ANGLE + BAR (COURTESY OF ISU BRIDGE CENTER)

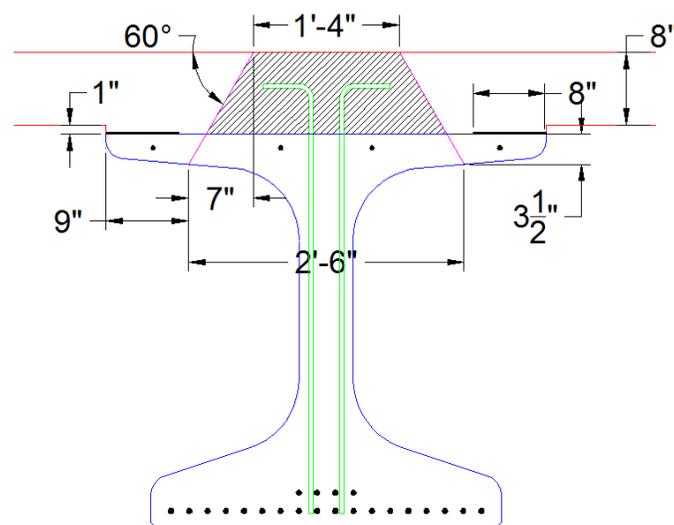
A saw-cut machine with a blade that could pivot to a certain angle is needed so it can perform sloped cut without the need for the costly and time-consuming operation of using the guided rail with wall saws. In this case, using the sloped saw to cut through the top flange can be good alternative if the structural capacity and stability of the girder when the top flange width is reduced is not a problem. Figure 2-9 shows sketch of this alternative where the shaded area is jack hammered and the new deck is then formed similar to forming decks on steel girders. The new deck can have a haunch to provide adequate cover for the exposed steel in the girder top flange. This alternative does not require the debonded zone, but the ability of cut deck panel to carry the weight of construction equipment needs to be investigated.

FIGURE 2-9: SLOPED SAW CUT ALTERNATIVE

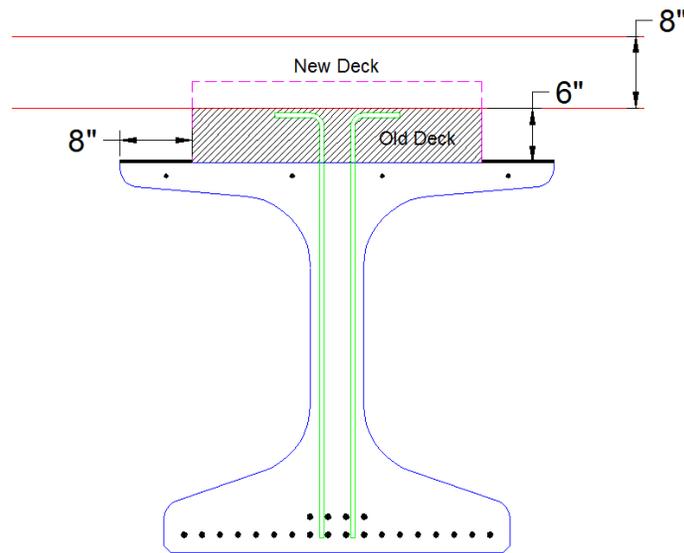
Another alternative is shown in Figure 2-10. Mill the top 2-3 in. of the deck over the girder, cut and lift deck panels between girders, keep the old deck around the shear connector, pour the new deck on top of it, and connect old and new deck to achieve composite action (using new connectors on the top or the side of the old deck). This solution will result in about 5 in. increase in deck elevation.

FIGURE 2-10: ALTERNATIVE METHOD IN POURING NEW DECK ON TOP OF OLD DECK

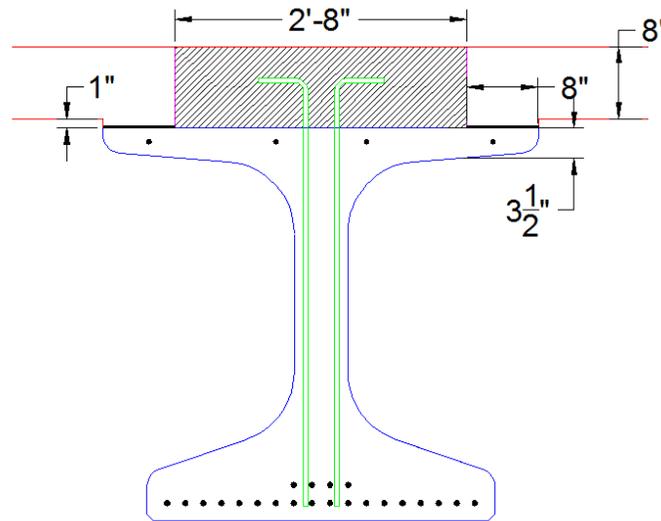
A third alternative is shown in Figure 2-11. Saw cut the deck panels vertically at the debonded zone, use mini-excavator to break the concrete above the girder, and use heavy excavator to break the deck between girders. Avoid using 15-kip and 30-kip jack hammers because using these small jack hammers is very time consuming and costly.

FIGURE 2-11: VERTICAL SAW CUT AT DEBONDED ZONE ALTERNATIVE

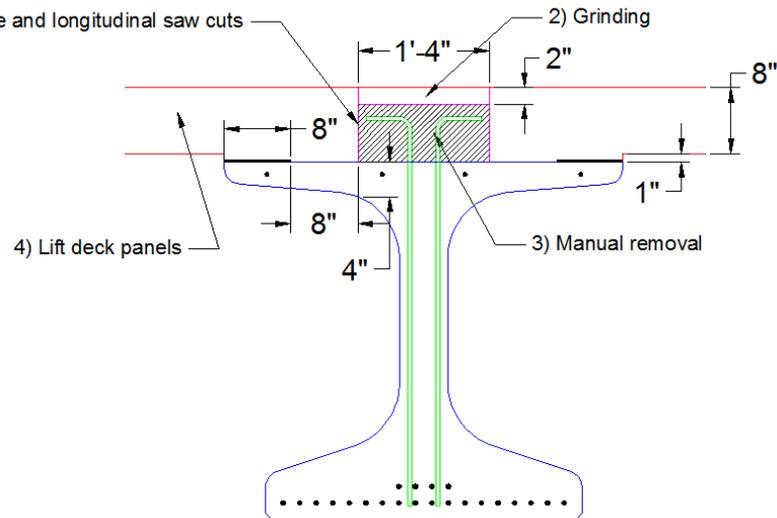
A fourth alternative is shown in Figure 2-12. Saw cut deck transversely and longitudinally around shear connectors. Grind the top 2-3 in of the deck over the shear connectors (highway grinder was suggested as a way of milling that 2-3 in.). Remove the remaining concrete around the shear connectors (using small jack hammers or manual hydro-blasting). Finally, lift (pop) the slabs/panels between the girders, which should easily break the bonded area.

FIGURE 2-12: ALTERNATIVE METHOD VERTICAL SAW CUT OUTSIDE SHEAR CONNECTORS

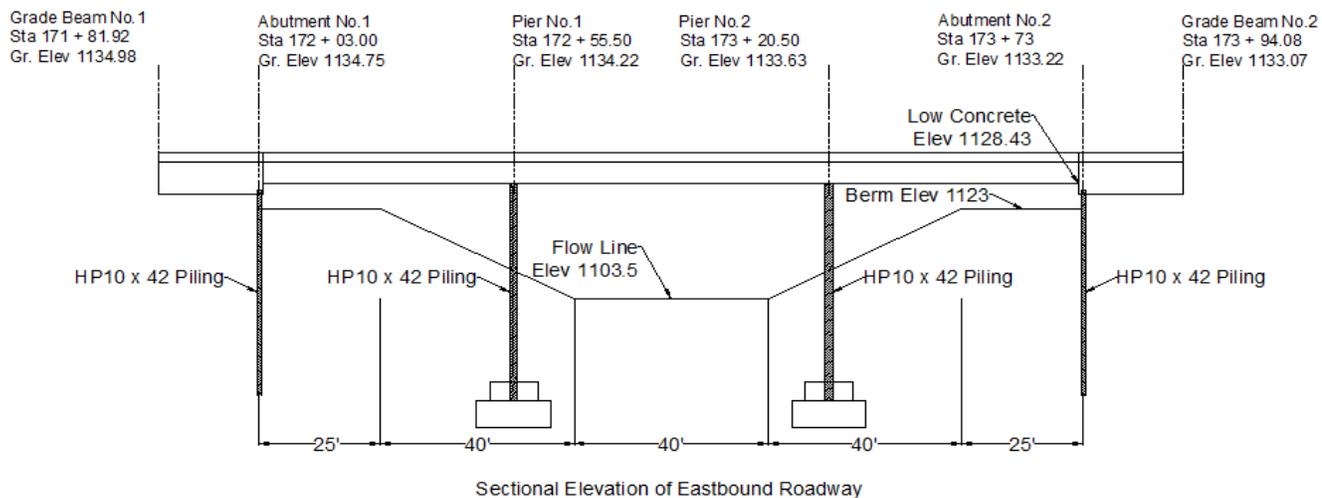
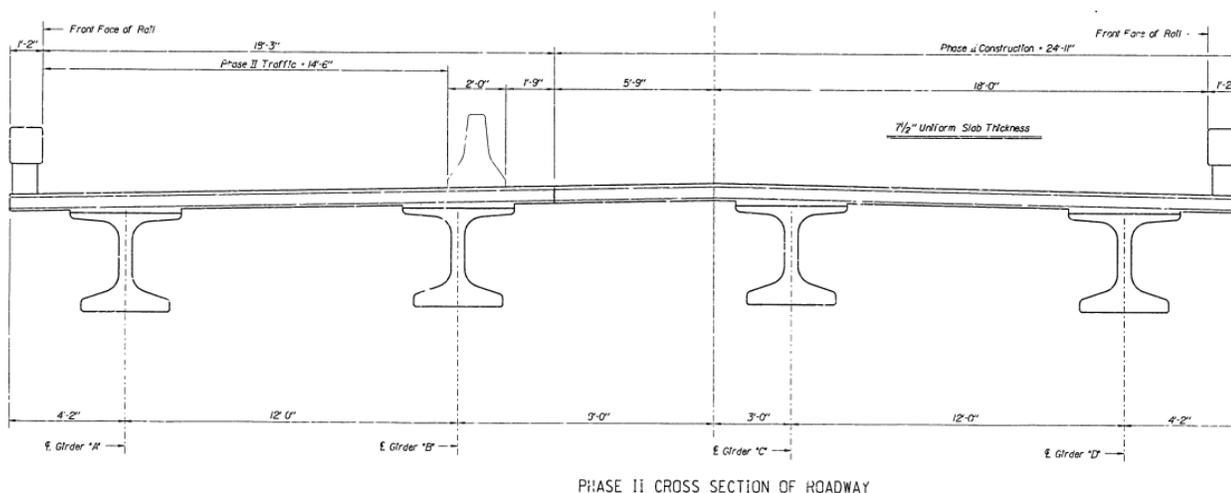
Figure 3-1 shows the sectional elevation, plan, and cross section of the Camp Creek Bridge over I-80 in Lancaster County, NE. The bridge is a 170 ft long, 42 ft wide, three span (52.5-65-52.5 ft) bridge that has four NU1100 girders per span. The bridge was built in 1996 and is being demolished after only 15 years due to its functional obsolescence. This bridge is considered one of the early bridges made of precast/prestressed NU girders. It is also the first bridge with NU girder to have its deck removed. Figure 3-2 gives a chart of deck removal methods implemented on the Camp Creek Bridge.

FIGURE 3-1: ELEVATION AND CROSS SECTION VIEWS OF THE CAMP CREEK BRIDGE

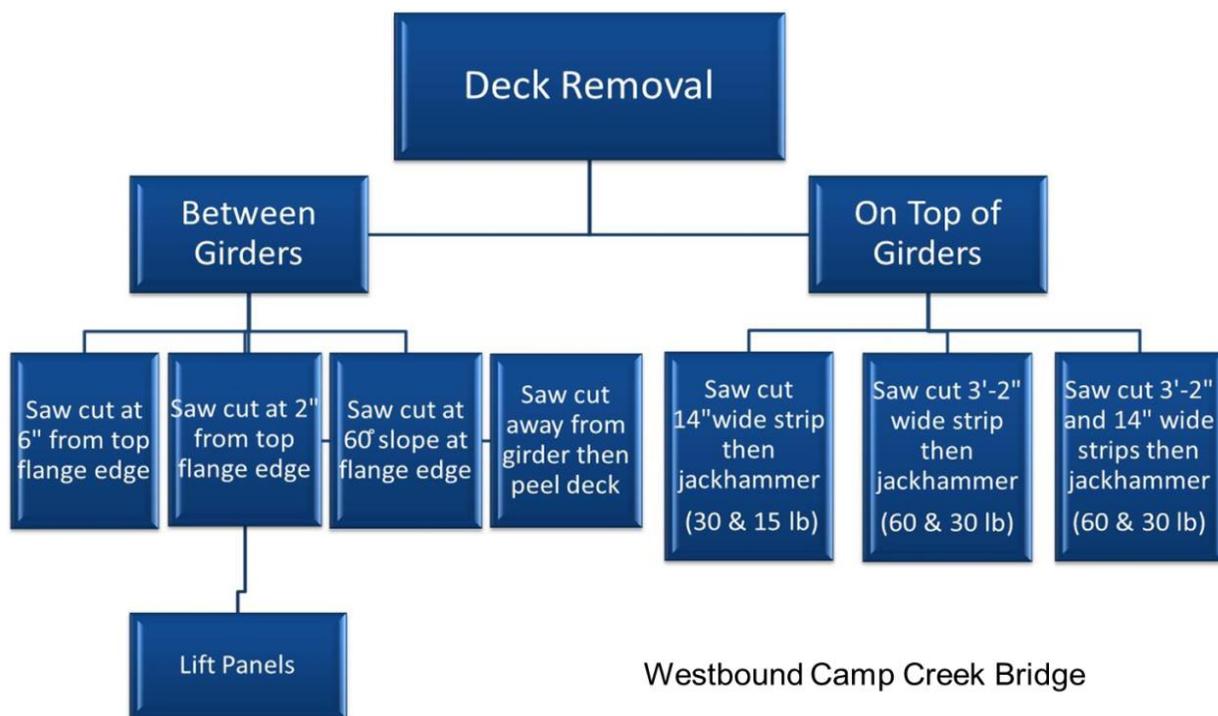
FIGURE 3-2: ORGANIZATIONAL CHART OF THE METHODS IMPLEMENTED FOR DECK REMOVAL

Referring back to the chart in Figure 3-2, three methods were used to evaluate the most efficient way for jack hammering the deck on top of the girders. The plan view of the methods implemented is shown in Figure 3-15. Three different combinations of longitudinal saw cutting and jack hammering were attempted and labeled JH1, JH2, and JH3. The rate of removal was recorded and presented for each method.

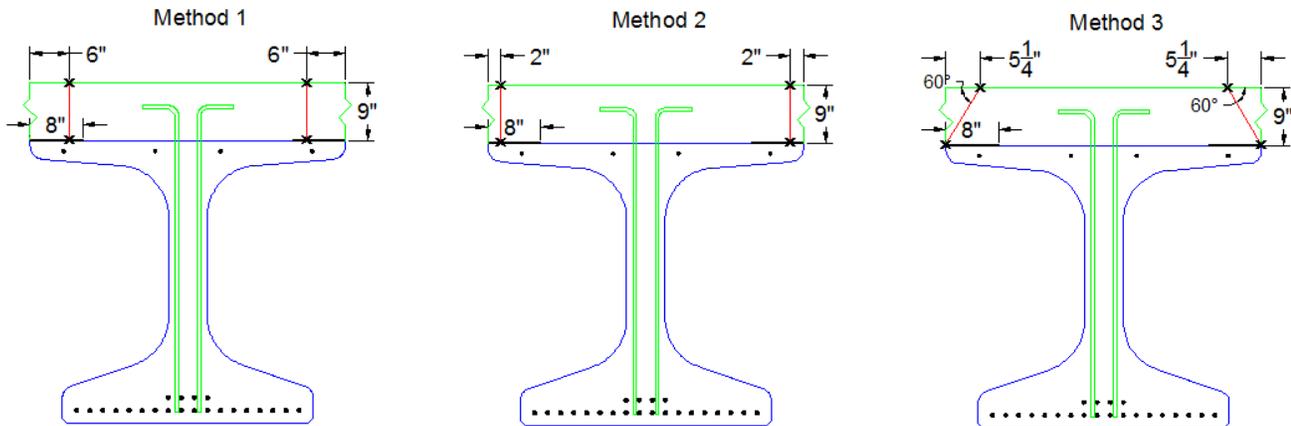
This procedure involved saw cutting the deck transversally into six 8-ft long panels while having three different longitudinal saw cuts as shown in Figure 3-3. Below lists the three different methods used for the longitudinal saw cuts:

1. Saw cutting the deck 6 in. from the edge of the top flange of the girder towards the inside of the girder, which is close to the end of the debonded zone.
2. Saw cutting the deck 2 in. from the edge of the top flange of the girder towards the inside of the girder, which is the standard practice used in conventional bridge girders.
3. Saw cutting the deck at the edge of the top flange with a 60° angle to simplify panel lifting after saw cutting.

FIGURE 3-3: IMPLEMENTED METHODS BETWEEN GIRDERS

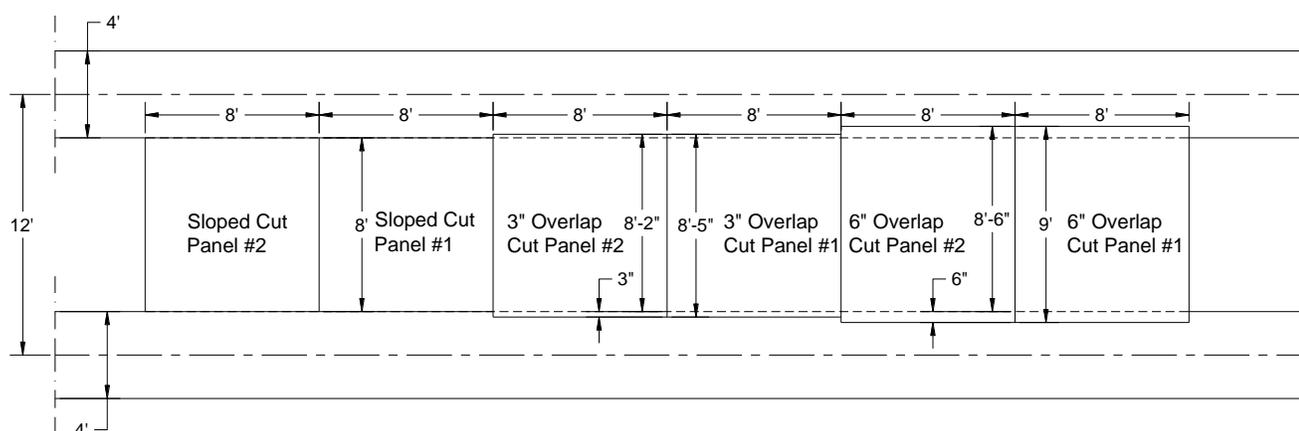
Figure 3-4 and Figure 3-5 give the panel number that corresponds to the method attempted on the panel. Two panels were saw cut and lifted for each method.

FIGURE 3-4: PLAN VIEW OF THE METHODS IMPLEMENTED FOR DECK REMOVAL IN-BETWEEN GIRDERS

Method 1 includes cutting panels #1 and #2 at 6 in. from the edge of the girders, while method 2 includes cutting panels #3 and #4 at 2 in. from the edge of the girder. All panels were transversely saw cut for their full depth (8 in.) at 8 ft spacing. The haunch was 1 in. at the ends of the girders, causing for a deck depth of 9 in. at these locations. All cuts were located at the debonded zone of the girder top flange.

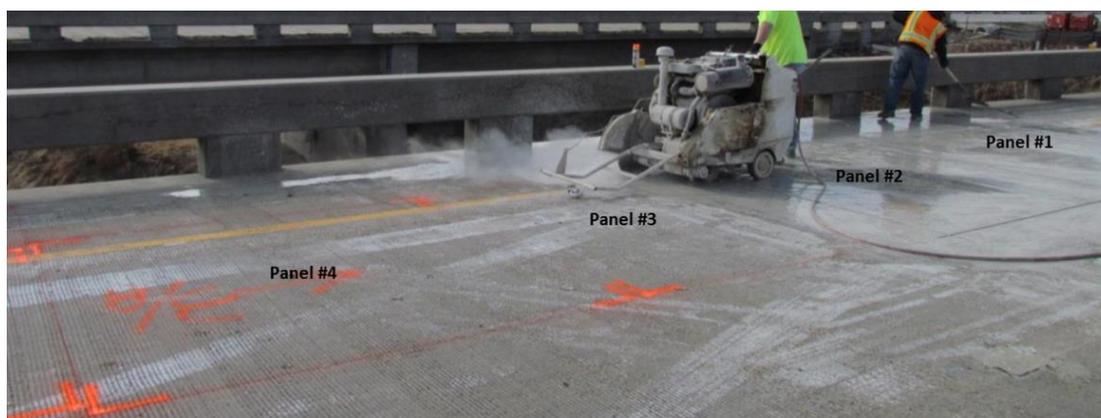
FIGURE 3-5: THE DECK WHILE SAW CUTTING, SHOWING THE PANEL NUMBERS COMPARED TO THE PLAN VIEW OF THE PROPOSED METHODS

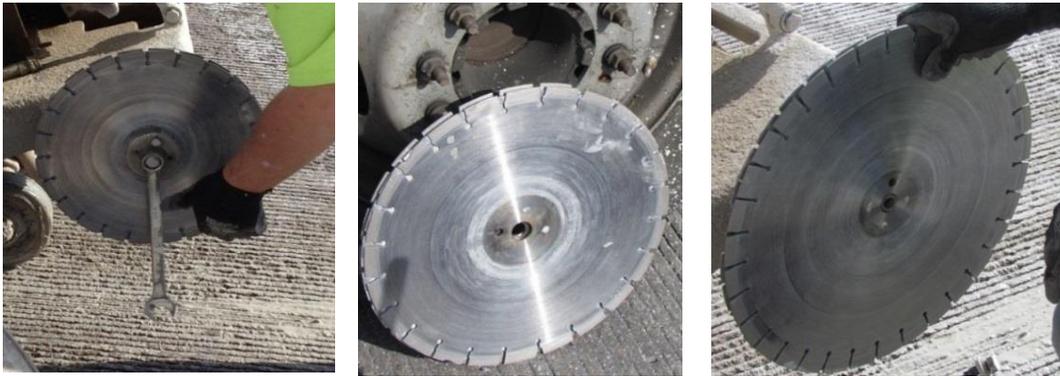
First, 14 in. diameter blades were used for two passes to create 4-4.5 in. deep cut. Second, 18 in. diameter blades were used for one pass to create 6-6.5 in. deep cut. Last, 24 in. diameter blades were used to create 7.5 – 8 in. deep cut. Figure 3-6 shows the three blade sizes used for saw cutting. Each pass took about 1 minute to cut 8 ft long. Three 1/8 in. blades were used in each cut, making for a 3/8 in. wide cut to simplify panel lifting.

FIGURE 3-6: (FROM LEFT TO RIGHT) 14 IN. DIAMETER, 18 IN. DIAMETER, AND 24 IN. DIAMETER BLADES

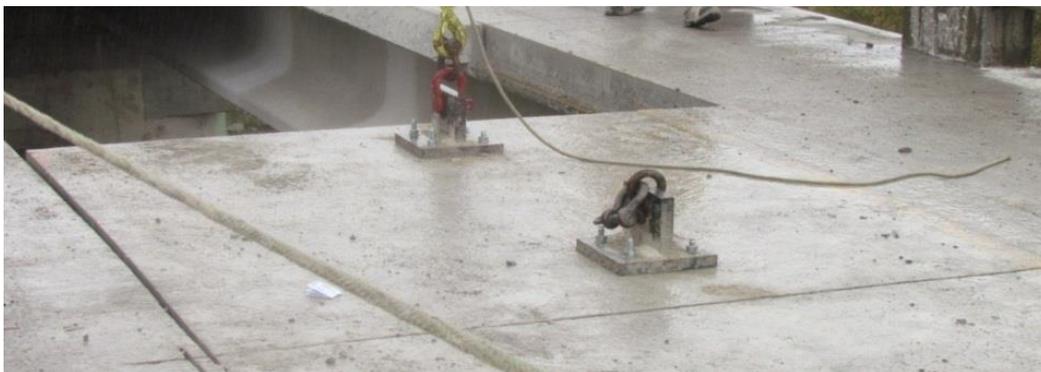
Two brackets were anchored at the centerline of the panel at 1 ft away from panel edges. Panels were lifted from one bracket first to break the bond between the panel and the deck, and then the two brackets were used to lift the panel completely (Figure 3-7). The two panels with 2 in. overlap and the first panel with 6” overlap were easily lifted.

FIGURE 3-7: LIFTING ONE SIDE OF THE PANEL TO BREAK IT LOOSE

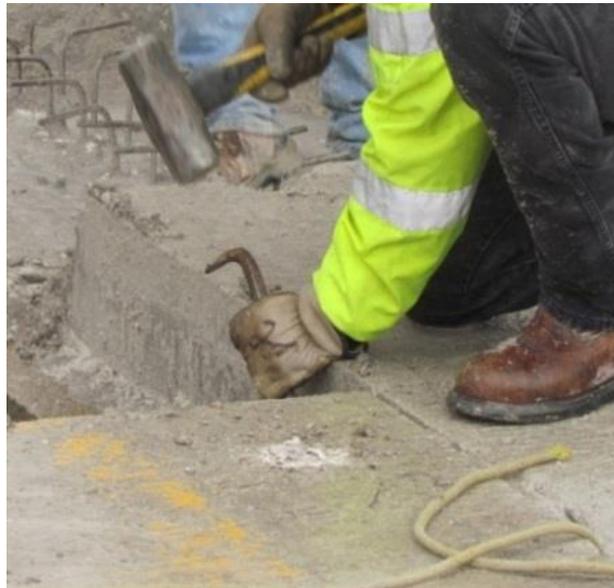
The second 6 in. overlap panel caused difficulties when the crew was performing the first lift to break the bond between the panel and the remaining part of the deck. The haunch being deeper at that part of the bridge was the reason for the difficulty. The lifted edge was hammered extensively on both sides; however, it could not separate the panel from the deck. A hammer and a chisel were used to break the haunch from the rest of the deck (Figure 3-8). Since the chisel could not go deep enough in the concrete due to the thicker haunch, a 60 lb jack hammer was used to break the deck attached to the haunch (Figure 3-9). As the crane was lifting the edge of the panel and the workers at the same time jack hammering on the panel, the bolts holding the bracket to the concrete slipped out of the panel and the location of the bracket had to be changed. The panel required a lot of wiggling until it was completely lifted. Despite the rough actions the deck has seen, the flange did not show any signs of cracks or damage.

FIGURE 3-8: BREAKING PANEL FROM DECK USING A HAMMER AND A CHISEL

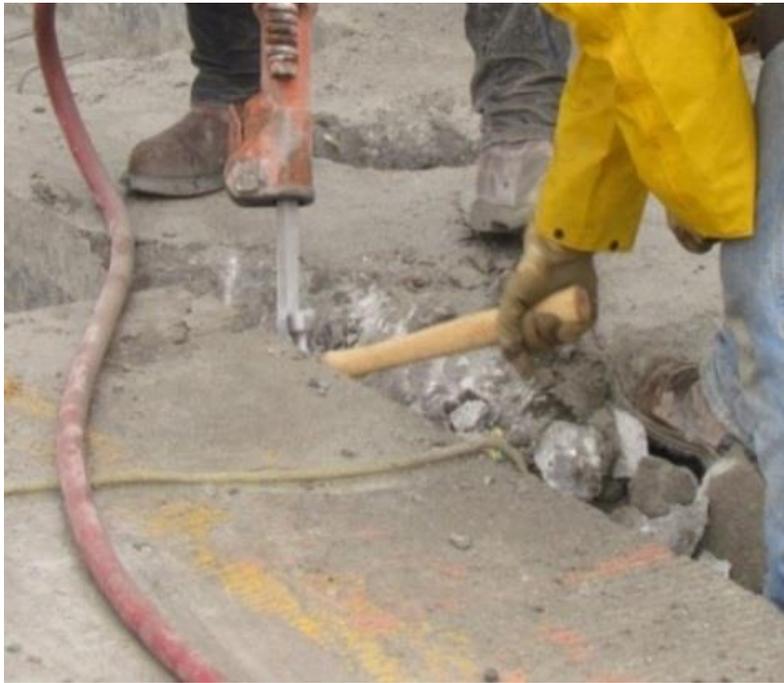
FIGURE 3-9: JACK HAMMERING THE DECK ATTACHED TO THE PANEL HAUNCH

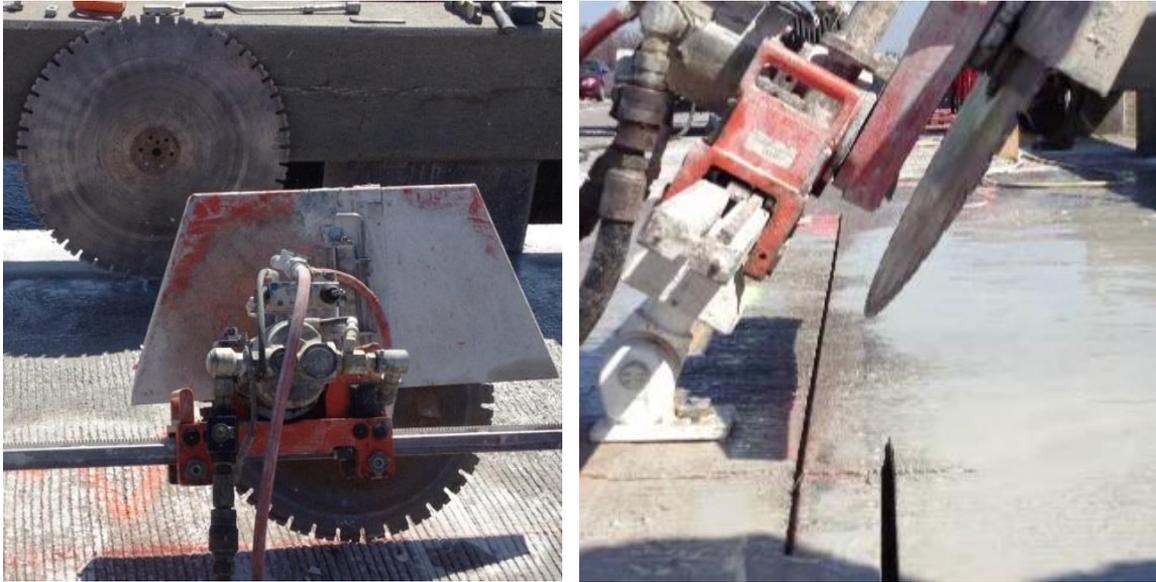
Panels #5 and #6 were longitudinally saw cut at a 60° slope at the edge of the top flange. For sloped cuts, a single 24 in. diameter blade was used to create 6 in. deep cut in two passes, then a single 30 in. diameter blade was used to complete the full cut in one pass. This procedure took about 20 minutes for 8 ft long cut (Figure 3-10). Another option was attempted to save the time of changing the blades, which was to use a 30 in. diameter blade to make the full depth cut in three passes. Even though the cutting process is easier, the process of installing the frame for the blade and anchoring it to the deck was time consuming; especially with the frame extending a maximum of 10 ft only, so for any extra length, the frame would need to be removed and re-anchored in the new location.

FIGURE 3-10: THE TWO 24 IN. AND 30 IN. DIAMETER BLADES USED IN THE SLOPED CUTS
(LEFT) AND A SIDE VIEW OF THE SLOPED BLADE MOUNTING (RIGHT)

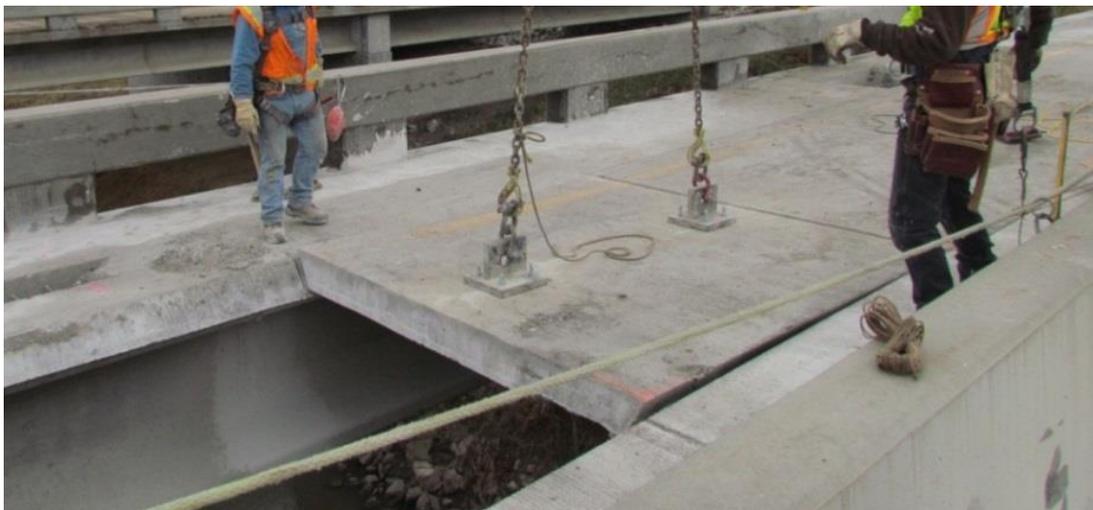
The two sloped saw cut panels were lifted first, showing no problems at all (Figure 3-11). Lifting those two panels was determined to be the easiest and fastest way due to the sloped cuts, however the saw cutting required more time. The panels were lifted without causing any damage to the girder.

FIGURE 3-11: LIFTING THE SLOPED CUT PANEL

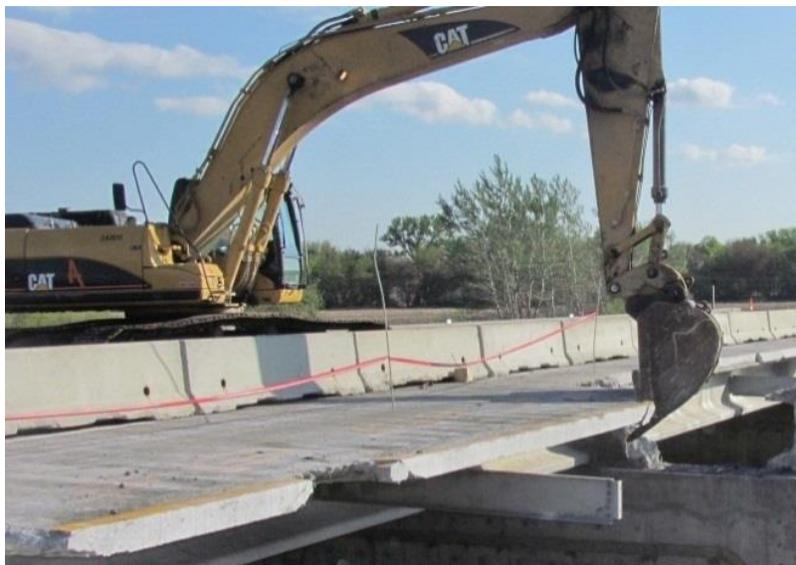
The overhang deck in Figure 3-12 was peeled from the supporting girder making use of the 8-in wide debonded strip at the edges of the top flange. A CAT 330DL excavator with a 40 kip capacity was used to lift the edge of the overhang deck. Despite the powerful shaking of the deck, the girder and the deck stayed connected. It was then suggested to push down on the edge of the deck so as to cause tension at the top of the deck and crack it. The deck cracked when it was pushed down, however the crack did not go deeper than the location of the top reinforcement mat. Unlike the rest of the overhang, the west edge of the overhang was saw cut longitudinally; as a result, the deck was broken off the flange at the saw cut line when it was pulled up. The side of the deck was broken; however, the steel reinforcement did not break (Figure 3-13).

FIGURE 3-12: THE CAT 330DL EXCAVATOR PEELING THE OVERHANG DECK

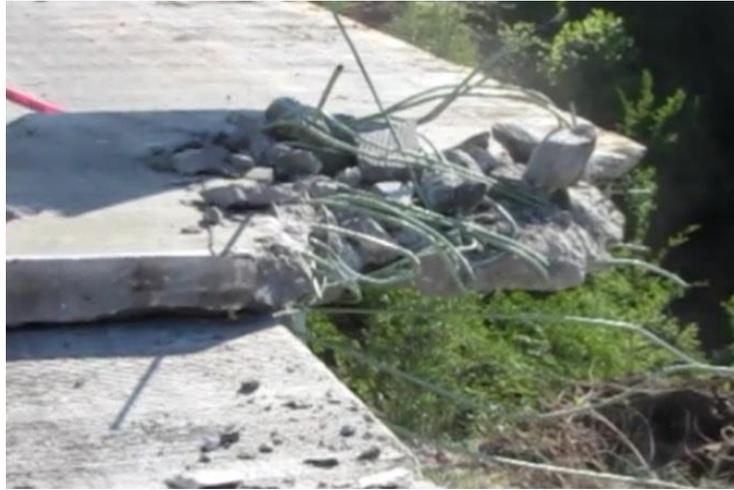
FIGURE 3-13: PART OF THE DECK THAT WAS PEELED OFF

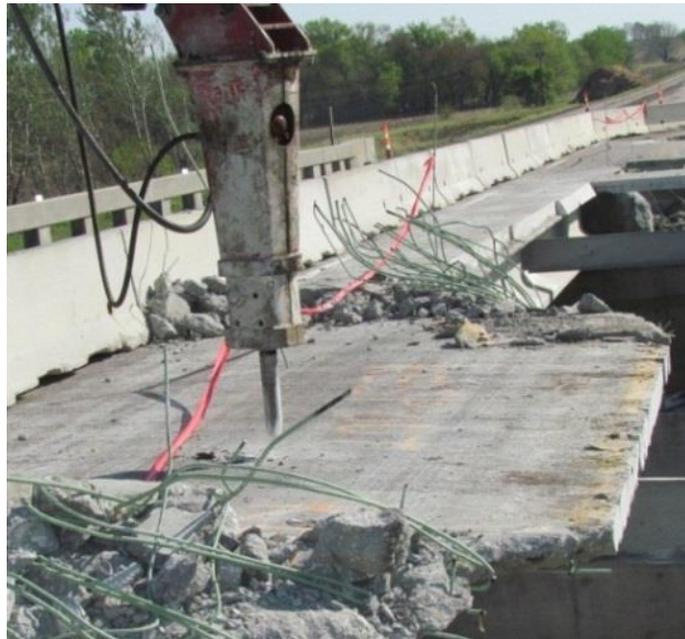
The deck was then jack hammered transversely to form 6 ft long panels to make it easier to get the deck peeled (Figure 3-14). However, the edge of the flange broke when the deck was jack hammered on top of. When the panel was then lifted by the excavator, the edge of the flange broke more and the process was stopped. Deck peeling proved to be a vigorous, inefficient, and damaging method.

FIGURE 3-14: JACK HAMMERING THE DECK USING BACKHOE

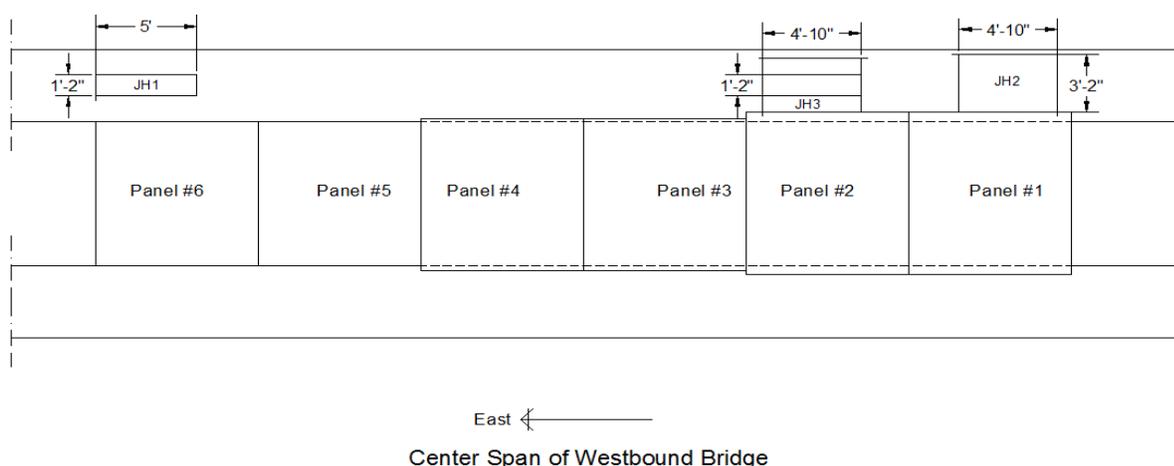
FIGURE 3-15: PLAN VIEW OF ALL THE JACK HAMMERING METHODS USED

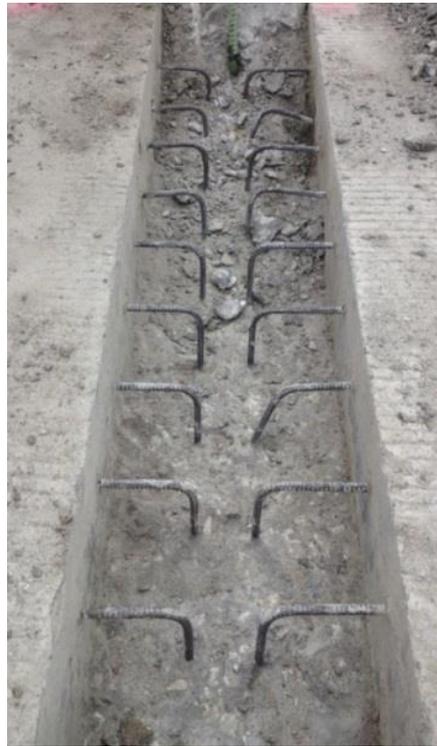
The first method was to saw cut the deck around the shear reinforcement forming a 14 in. wide by a 5 ft long rectangle for the full depth of the deck (Figure 3-16). To jack hammer this strip, first, a 30 lb jack hammer was used down to the top reinforcing mat, then, a 15 lb jack hammer was used down to the top of the girder. This process took two hours for a two-man crew to finish it. The rate of deck removal for this method is 0.343 mhr/ft².

FIGURE 3-16: 14" WIDE X 5" LONG FULL DEPTH JACK HAMMERED STRIP

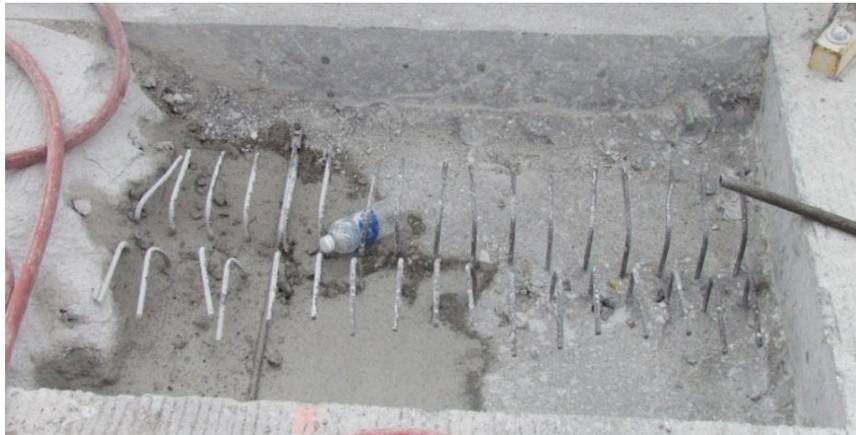
In the second method, a 4 ft - 10 in. long by 3 ft - 2 in. wide rectangle was saw cut then jack hammered (Figure 3-17). Jack hammering was performed using 60 lb and 30 lb jack hammers, which is heavier than the specified 30 lb and 15 lb jack hammers for deck removal on top of the girders. The 60 lb jack hammer was used down to the bottom reinforcing steel mat, then the 30 lb one was used down to the top flange of the girder. It took 4 hours for the two man crew to finish the jack hammering process. The girder was slightly damaged when the 30 lb jack hammer slipped off and hit the top of the girder. The rate of deck removal for this method is 0.2613 mhr/ft².

FIGURE 3-17: THE 4'10" X 3'2" JACK HAMMERED STRIP

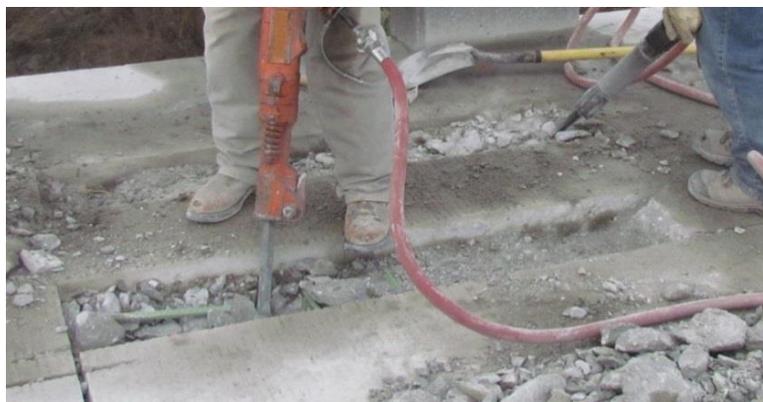
FIGURE 3-18: THE 4'10" X 3'1/2" JACK HAMMERED STRIP

The third method was to cut 4 ft - 10 in. long and 3 ft - ½ in. wide rectangle and remove concrete using 30 lb and 60 lb jack hammers. This method had additional saw cuts. Saw cuts were made directly outside the shear connectors and away from the shear connectors (Figure 3-18). This method was significantly more efficient as the broken deck came out in bigger chunks, hence, took less time and effort. The two man crew needed 1 hour and 38 minutes to finish. The girder had only one location where the jack hammer hit the top surface and caused a 5-½ in. x 2-½ in. piece that was about ½ in. deep to be chipped off the girder. The rate of deck removal for this method is 0.111 mhr/ft².

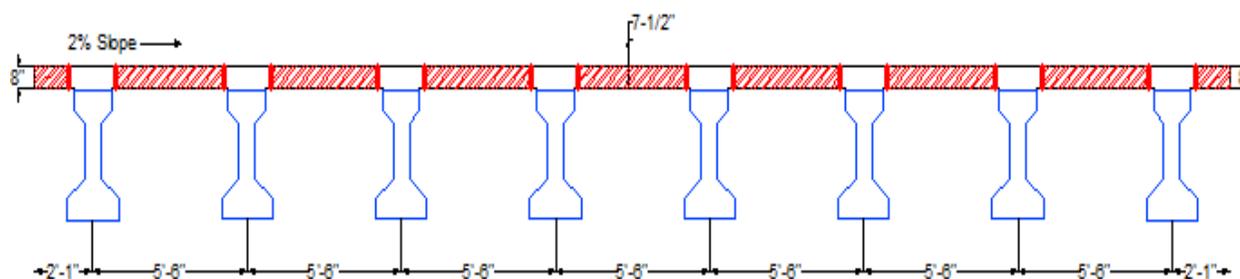
FIGURE 3-19: I-80 CHAPPELL BRIDGE CROSS SECTIONAL VIEW AND DIMENSIONS

Constructed in 1969, the Chappell Bridge interchange re-decking operations started after 44 years of being in service. The four-span bridge consists of precast/prestressed concrete AASHTO girders with a cast-in-place deck. Saw cutting and jack hammering methods were used to remove the deck. First, longitudinal saw cuts were made 2 in. from the top flanges of the girders on each side. The longitudinal cuts were to the full depth of 7-½ in. Next, transverse saw cuts were made at 7 ft. increments. The saw cut locations can be seen as the red lines in Figure 3-19 and Figure 3-20. Center to center span from girder lines is 5 ft. 6 in. Chappell Bridge spans 48', 88'-6", 88'-6", and 48' from abutment 1 to pier 1, pier 1 to pier 2, pier 2 to pier 3, and pier 3 to abutment 2, respectively.

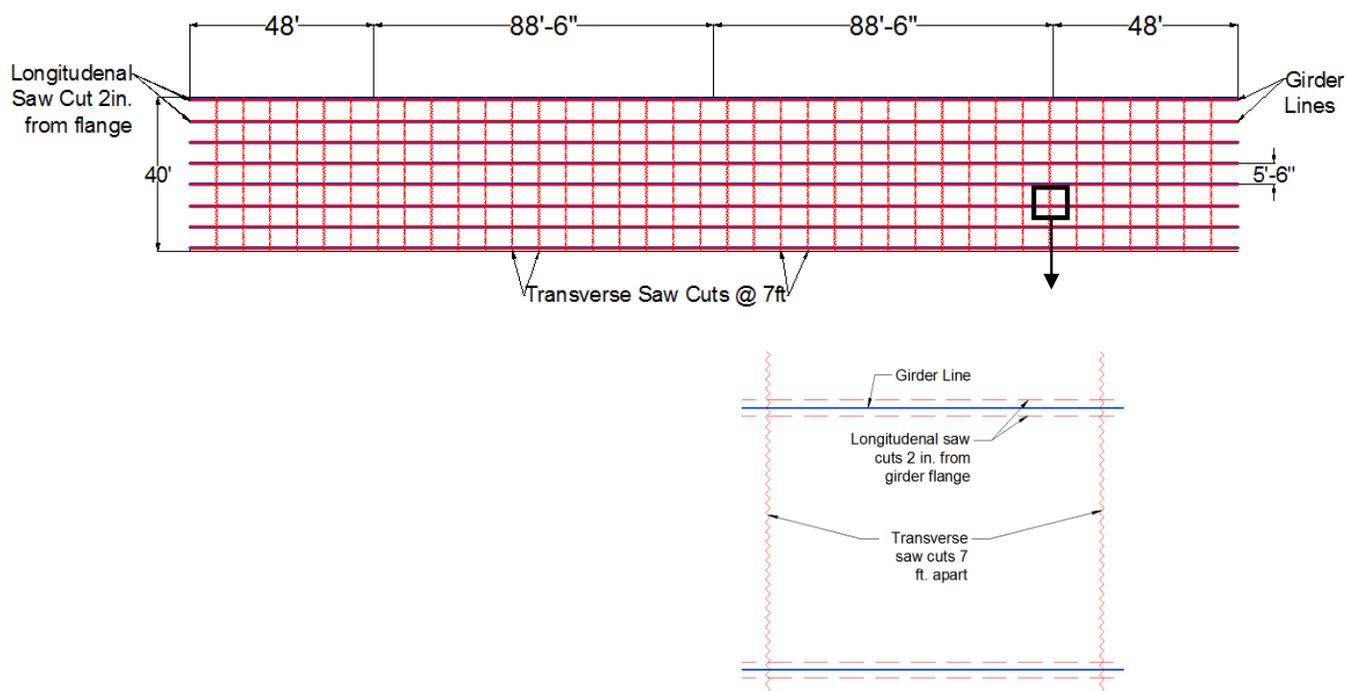
FIGURE 3-20: FOUR SPAN CHAPPELL BRIDGE PLAN VIEW WITH LOCATION OF SAW CUTS

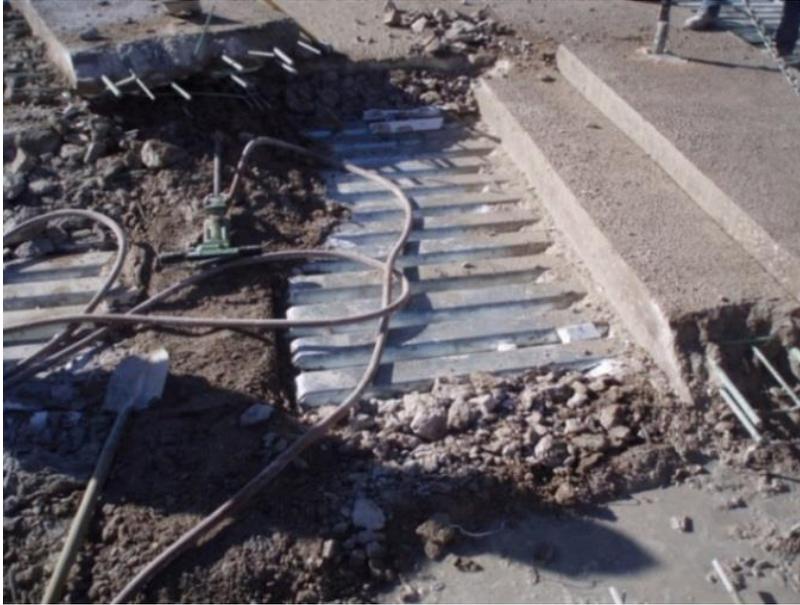
FIGURE 3-21: DECK PANEL LIFTED FROM STAY-IN-PLACE FORMS BETWEEN GIRDERS

Transverse saw cuts through the epoxy coated rebar were made starting above the middle bridge pier, the deck panels between the girders were lifted off the stay-in-place forms. The deck panels easily lifted away from the stay-in-place forms (Figure 3-21). For the deck on top of the girder, a large jack hammer mounted on an excavator was used to get the majority of concrete broken up and then finished with smaller jack hammers to minimize damaging the girders and shear connectors (Figure 3-22).
