Evaluating the Impact of Deck Removal Method on the Performance of NU Girders

Nebraska Department of Roads (NDOR)

Project Number: SPR-P1 (12) M325

FINAL REPORT

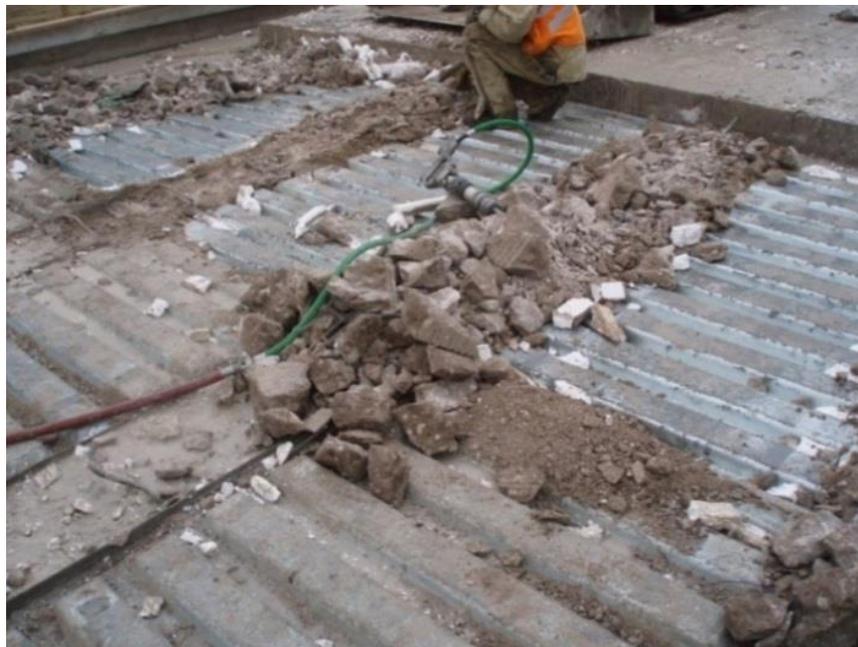
FIGURE 3-22: JACK HAMMERING ABOVE THE GIRDERS

Transverse saw cuts through the epoxy coated rebar were made starting above the middle bridge pier, the deck panels between the girders were lifted off the stay-in-place forms. The deck panels easily lifted away from the stay-in-place forms (Figure 3-21). For the deck on top of the girder, a large jack hammer mounted on an excavator was used to get the majority of concrete broken up and then finished with smaller jack hammers to minimize damaging the girders and shear connectors (Figure 3-22).

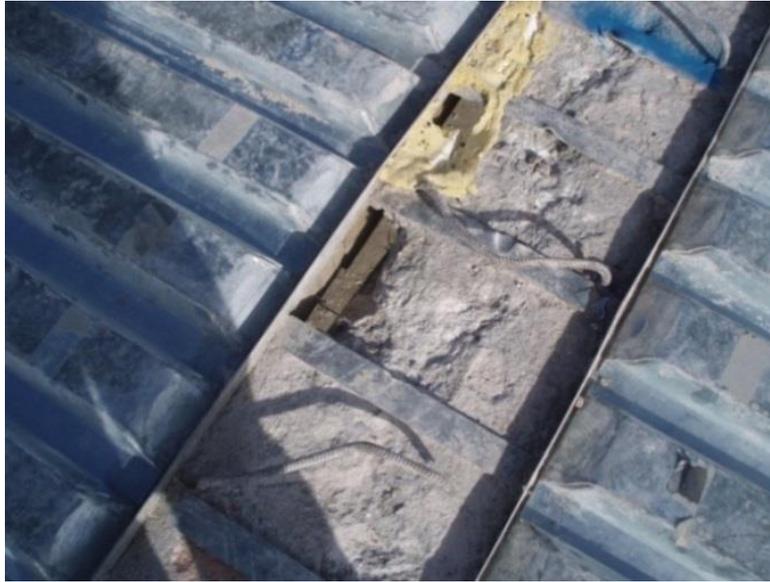
FIGURE 3-23: DAMAGED SHEAR CONNECTORS AND TOP FLANGE OF THE GIRDER

Damage occurred with the use of the large jack hammer mounted to the excavator. Figure 3-23 shows the minor damage that occurred to the top flange of the girders, as well as a half dozen shear connectors. The broken straps between the stay-in-place forms will be replaced before casting the new deck. This operation totaled 1300 man hours with 12 crewmen working 9

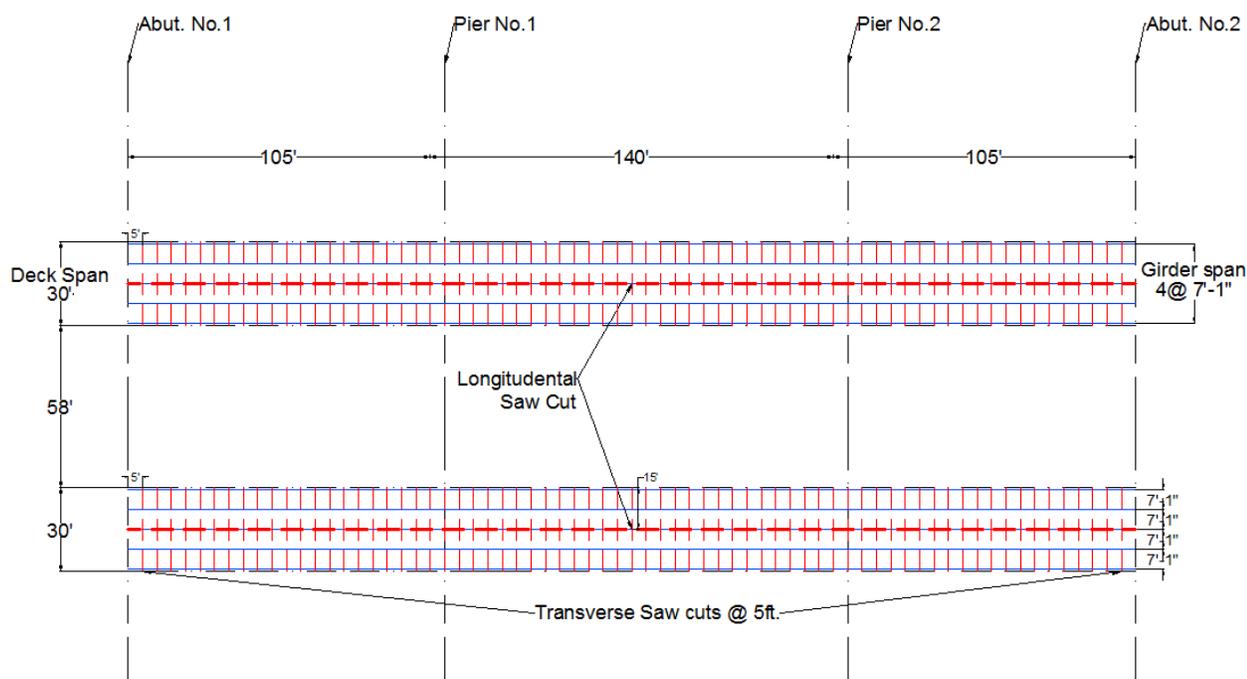
FIGURE 3-24: PLAN VIEW WITH DIMENSIONS OF SALT CREEK BRIDGE

The location of transverse and longitudinal saw cuts made can be shown as the red dashed lines in Figure 3-24 and Figure 3-25. The 5 ft by 15 ft concrete slabs were lifted with the slab crab, seen in Figure 3-26. Small concrete chunks fell to the ground from jack hammering the guard rail (Figure 3-27).

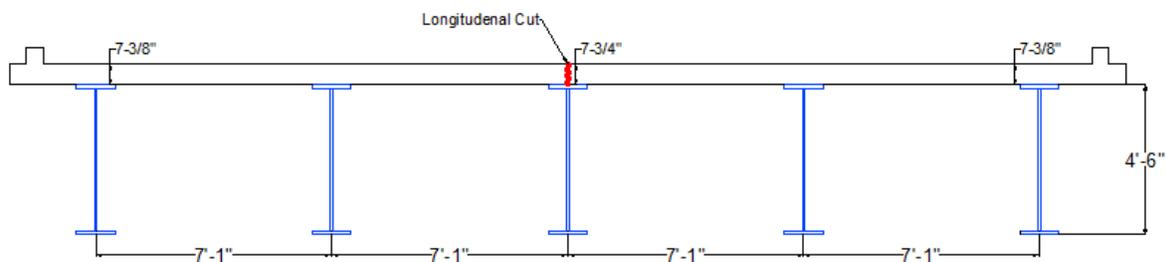
FIGURE 3-25: CROSS SECTIONAL VIEW WITH GIRDER SPAN AND THICKNESS OF DECK

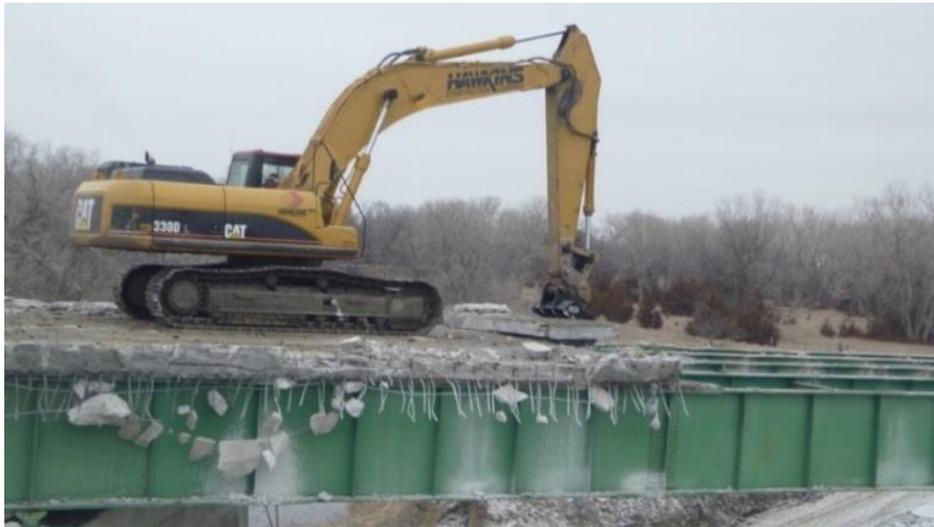
FIGURE 3-26: SLAB CRAB LIFTING DECK SLAB FROM WEST TO EAST

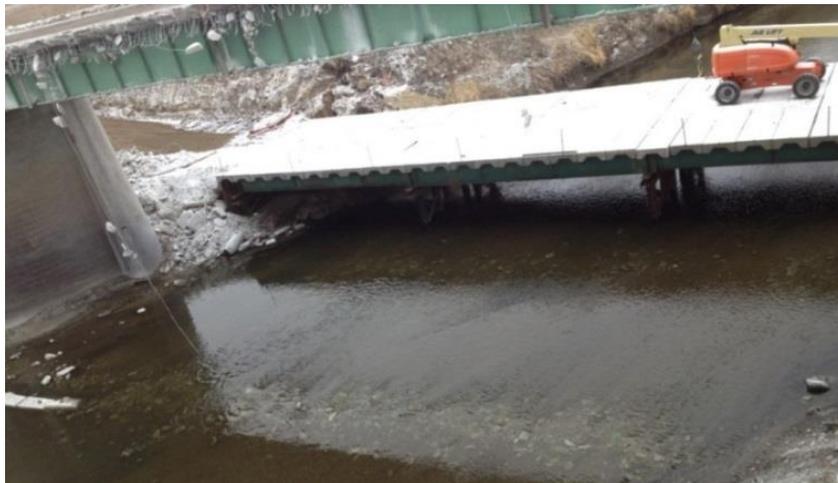
FIGURE 3-27: CONCRETE PIECES FELL TO THE WATERWAY UNDERNEATH

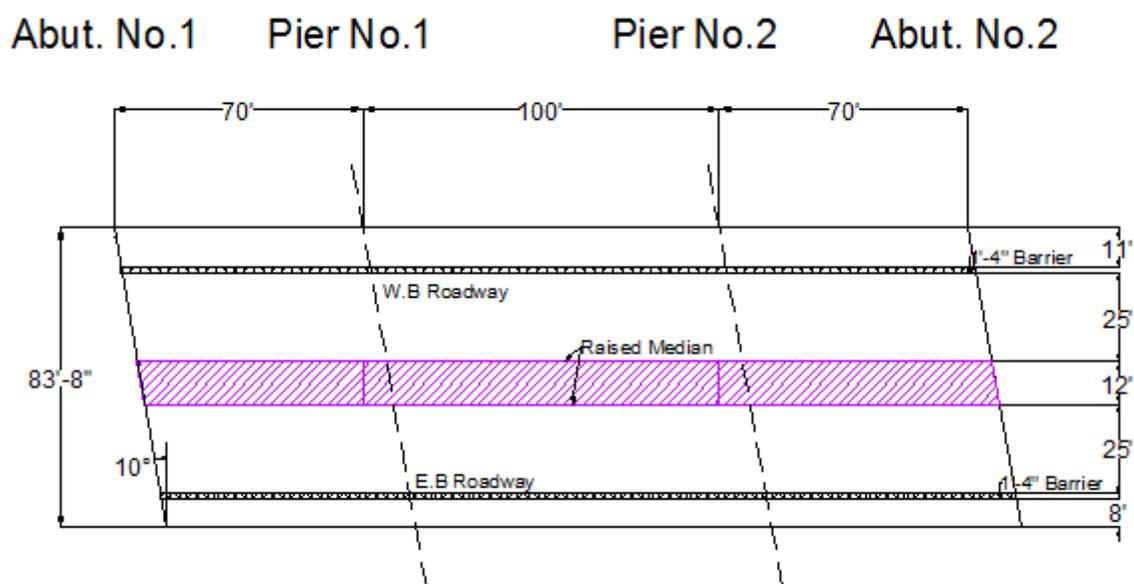
FIGURE 3-28: PLAN VIEW AND DIMENSIONS OF PACIFIC ST. BRIDGE

The purpose of this investigation was to observe sequencing of tasks in an area with high traffic volume and environmental restrictions. Also, deck removal methods were evaluated when steel I-girders with short steel stud shear connectors are used. The Pacific St. Bridge at 106th Street is located over the Big Papillion Creek. The operations were not only restricted environmentally, but also conducted on one side of the bridge, while the other side was open to two-way heavy traffic. Figure 3-28 shows the plan view of Pacific St. Bridge.

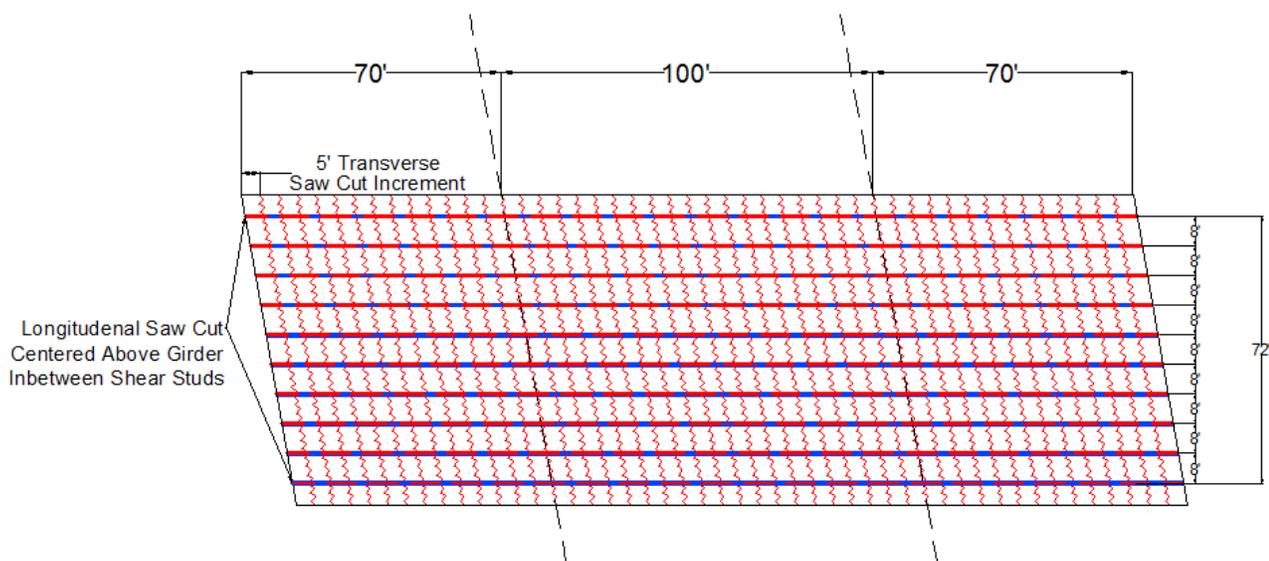
FIGURE 3-29: GIRDER LAYOUT AND SAW CUT LOCATION OF PACIFIC ST. BRIDGE

After longitudinal saw cutting, the overhang on each side of the barriers or guard rail were jackhammered and broken off. This was the biggest contributor of concrete chunks that fell to the ground below. Next, transverse saw cuts were done along the full width at an increment of 5 ft, shown in Figure 3-29.

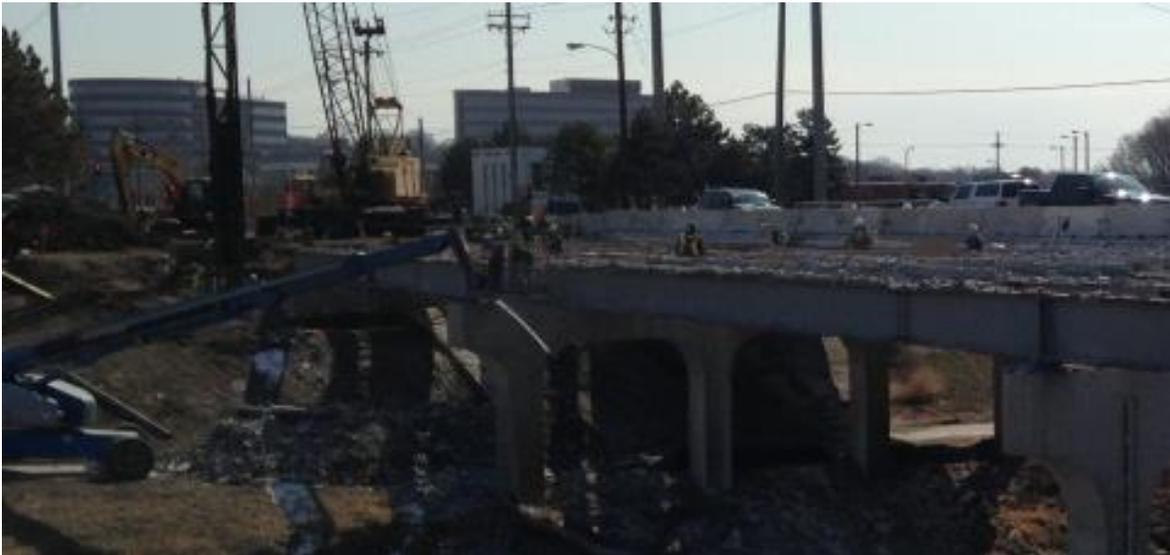
FIGURE 3-30: WORKERS USING HAND CHIPPERS TO REMOVE CONCRETE AROUND SHEAR STUDS

Next, the deck panels were lifted using a large crane. The crane's capabilities allowed lifting panels at mid-span of the bridge. The deck panels popped off from the shear connectors that were still embedded in the deck. For efficiency, a jack hammer attached to a backhoe was used to jackhammer most of the concrete above the girder. However, the remaining concrete that stayed around the shear connectors needed to be removed and cleaned up using hand chippers. The girders were then able to be removed for further sandblasting and repainting. The total deck removal process took two weeks to complete.

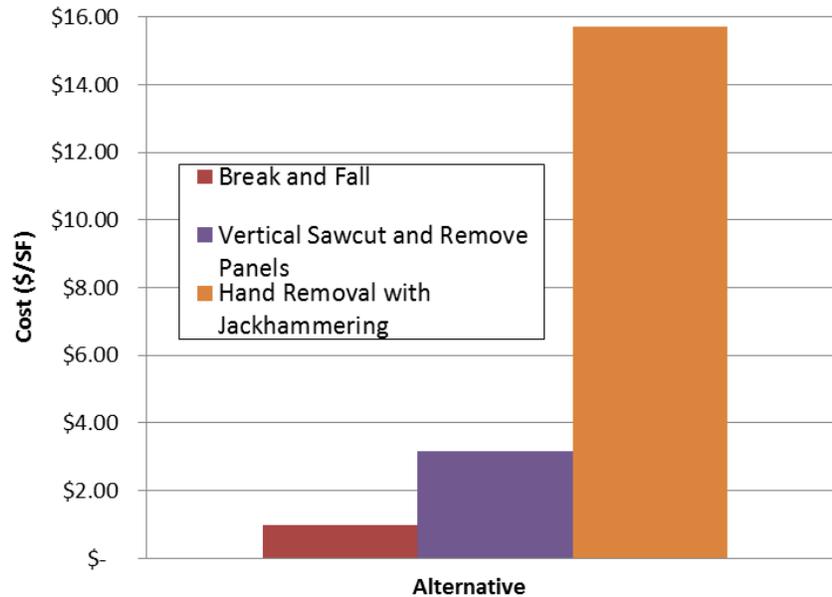
FIGURE 4-1: ILLUSTRATION OF COST VS. TYPE OF METHOD USED IN DECK REMOVAL

number of man-hours involved. Figure 4-1 shows the cost of each method in dollars per square foot of deck. These estimates were provided by averaging the cost incurred in several projects by the same contractor.

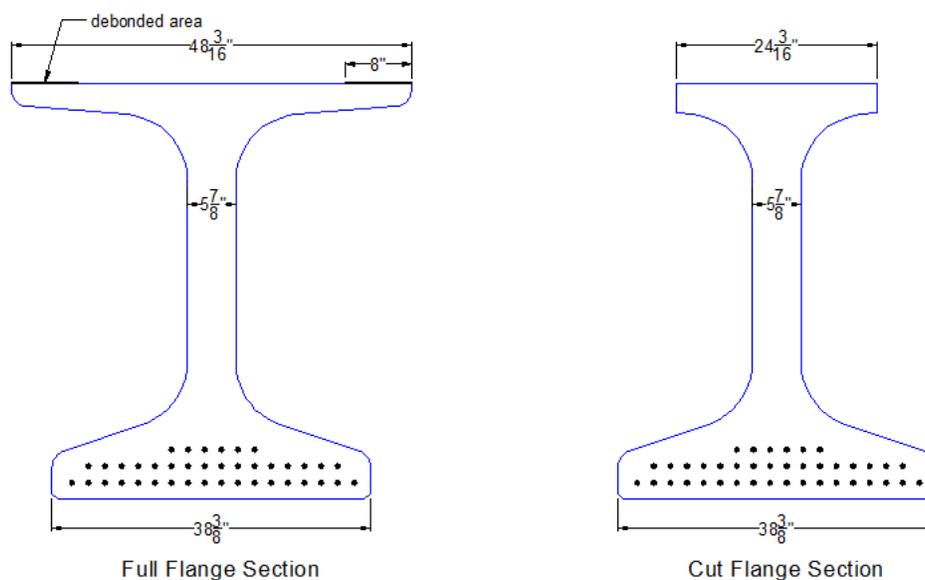
FIGURE 5-1: NON-COMPOSITE CROSS-SECTION OF A FULL FLANGE AND CUT FLANGE SECTION

Saw cutting the top flange reduces the area, inertia, and section modulus of I-girders. The geometric properties of NU girders with a full flange and cut flange are shown in Table 5-1. Geometric properties are calculated assuming reduction of top flange by 50%, or a longitudinal cut at 1 ft from flange edge on either side as shown in Figure 5-1.

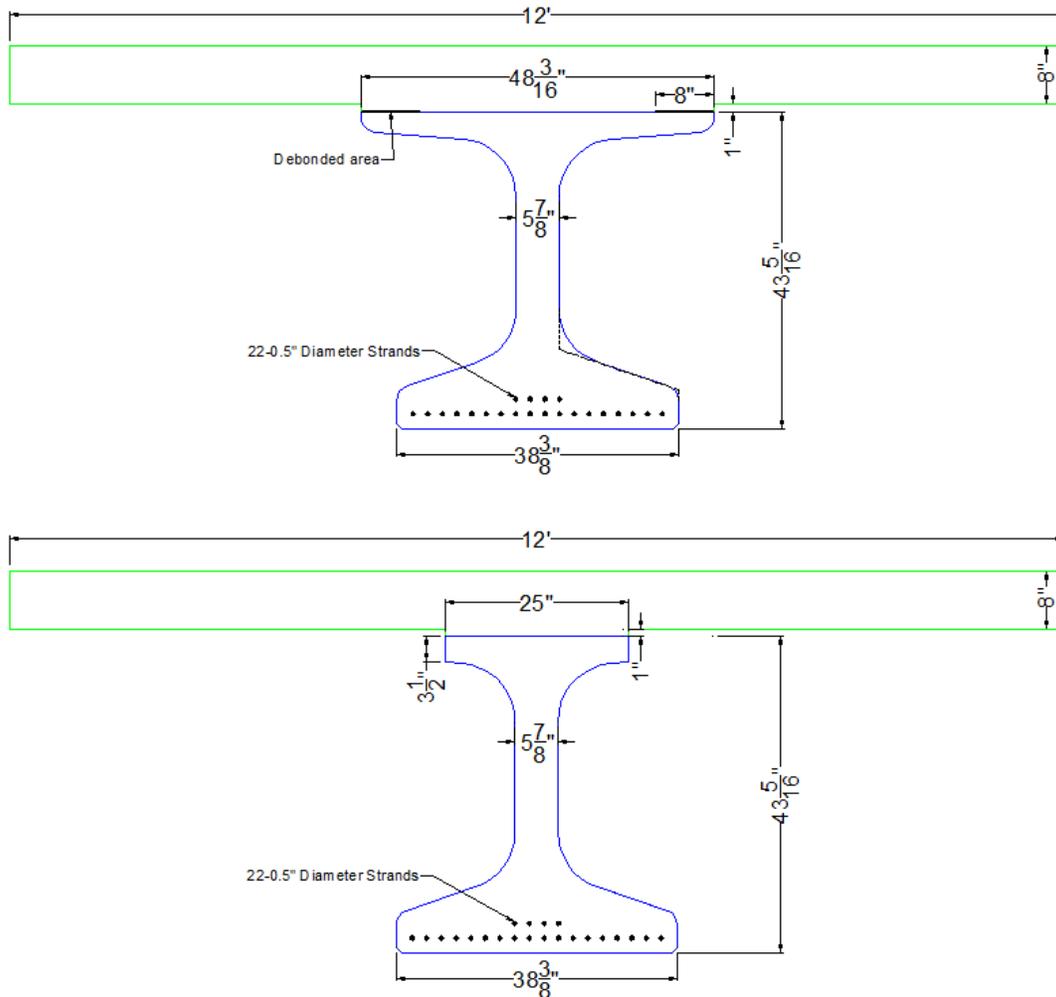
FIGURE 5-2: NU1100 GIRDER COMPOSITE CROSS-SECTIONAL DIMENSIONS

Girder cross-sectional dimensions for composite sections are shown in Figure 5-2. The bridge has girder spacing of 12 ft. Camp Creek bridge parameters are shown in Table 5-3.

Cross-sectional geometric properties of non-composite and composite sections are presented in Table 5-4. Composite cross-sections to be analyzed are shown in Figure 5-2.

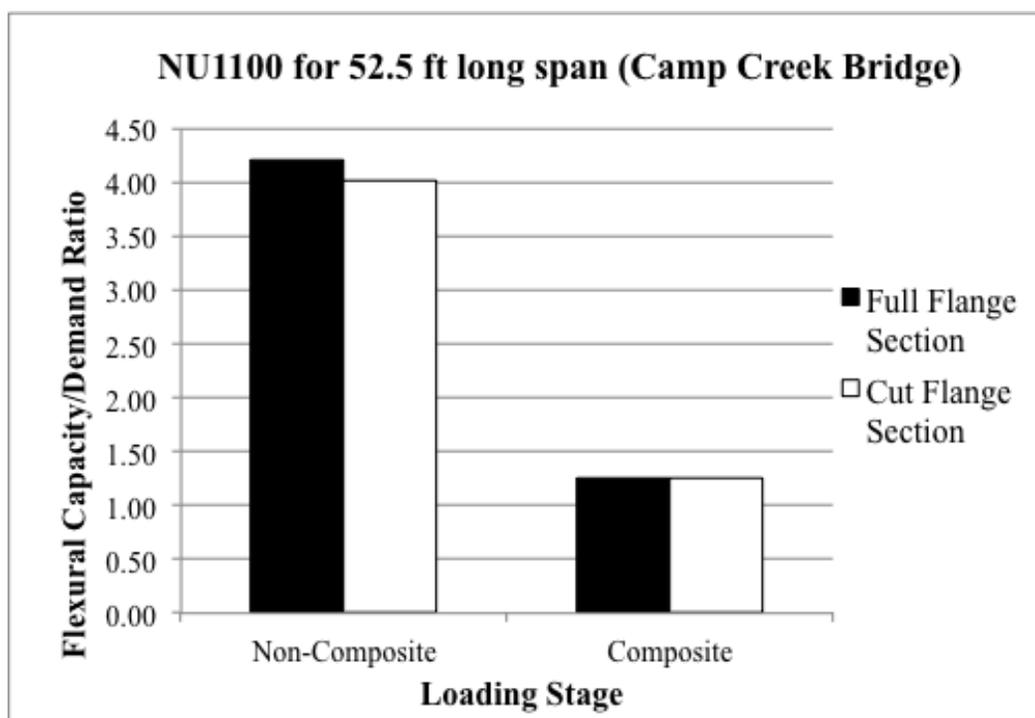
FIGURE 5-3: CAPACITY/DEMAND RATIO FOR NU1100 AT ALL LOADING STAGES

Figure 5-3 shows a graph of the capacity/demand ratio at each critical stage for the full flange section and cut flange section. The ratio in all loading stages is greater than 1.0, which is considered adequate.

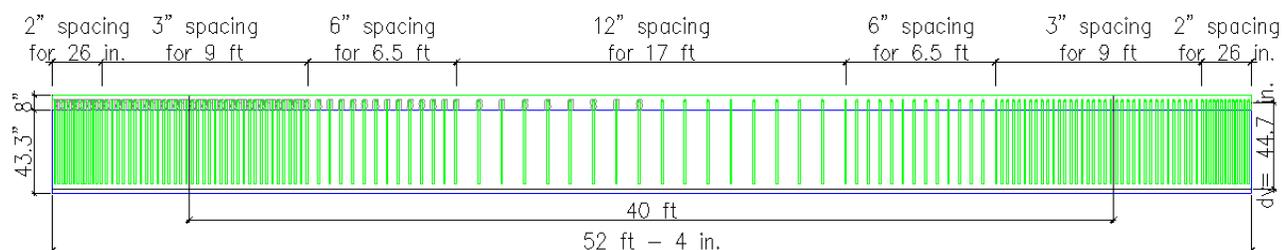
FIGURE 5-4: NU1100 STIRRUP CONFIGURATION

The stirrup configuration of the Camp Creek girders is shown in Figure 5-4. The maximum interface reinforcement spacing is 2-#3 stirrups every 12 in. at mid-span and minimum spacing of 2 in. at the ends of the girder. Stirrup reinforcement area for 2#3 bars is 0.22 in².

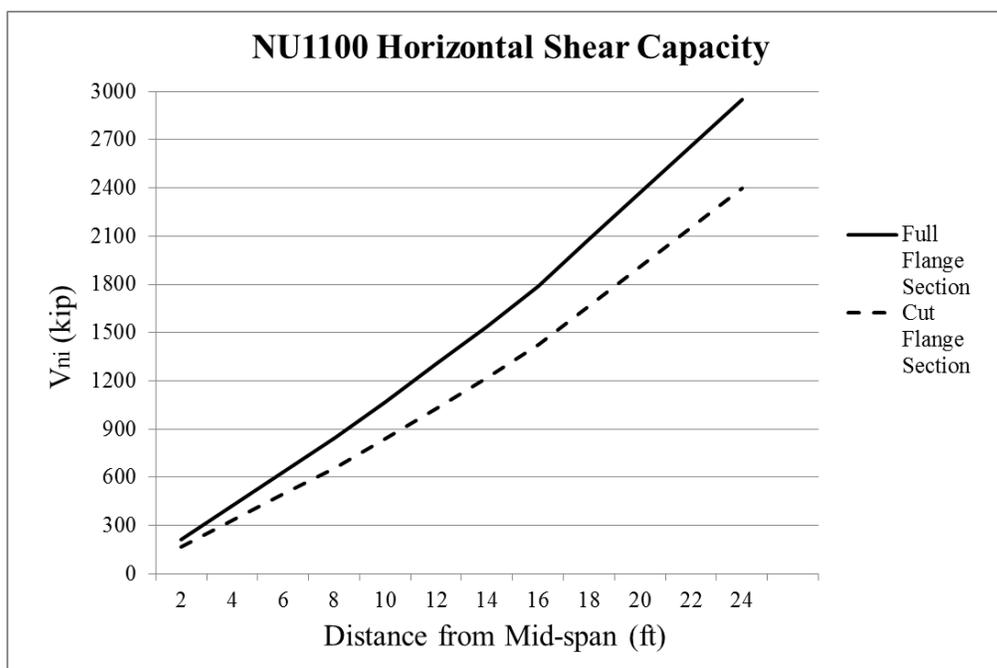
FIGURE 5-5: EFFECT OF CUTTING TOP FLANGE ON HORIZONTAL SHEAR CAPACITY FOR NU1100

Nominal horizontal shear capacity values are calculated for distances from the mid-span in increments of 2 ft. Stirrup reinforcement area for 2#3 bars is 0.22 in². The results are obtained and graphed in Figure 5-5. From the results, it is apparent that when cutting through the top flange, some horizontal shear capacity is lost due to a reduction in top flange width. The average percent loss in horizontal shear capacity over 24 ft from mid-span is 20.75%.

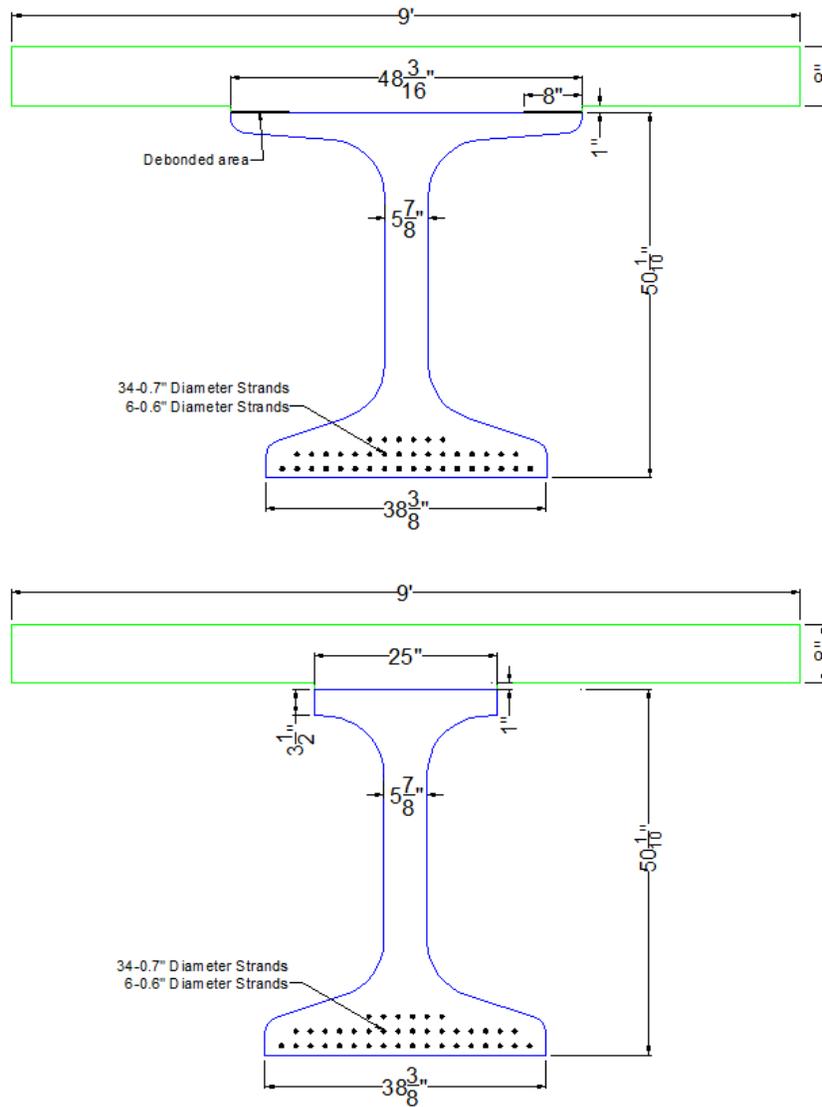
FIGURE 5-6: NU1350 GIRDER COMPOSITE CROSS-SECTIONAL DIMENSIONS

The second example is of bridge utilizing NU1350 girders. The span chosen for analysis is 140 ft long. The span-to-depth ratio is 33.53. With more than double the span-to-depth ratio from the previous example, this is a much less conservative case. The same analytical procedure is taken in analyzing the effect of cutting the top flange on flexural capacity, horizontal shear capacity, and mid-span deflection. The composite cross-sections of the NU1350 full flange and cut flange section is shown below in Figure 5-6. The bridge parameters are shown below in Table 5-9.

Cross-sectional geometric properties for the case of a NU1350 girder with a full flange and cut flange section are shown in Table 5-10. In this example, the larger girder has slightly less of a reduction in properties than in the previous example. Composite cross-sections to be analyzed are shown in Figure 5-6.

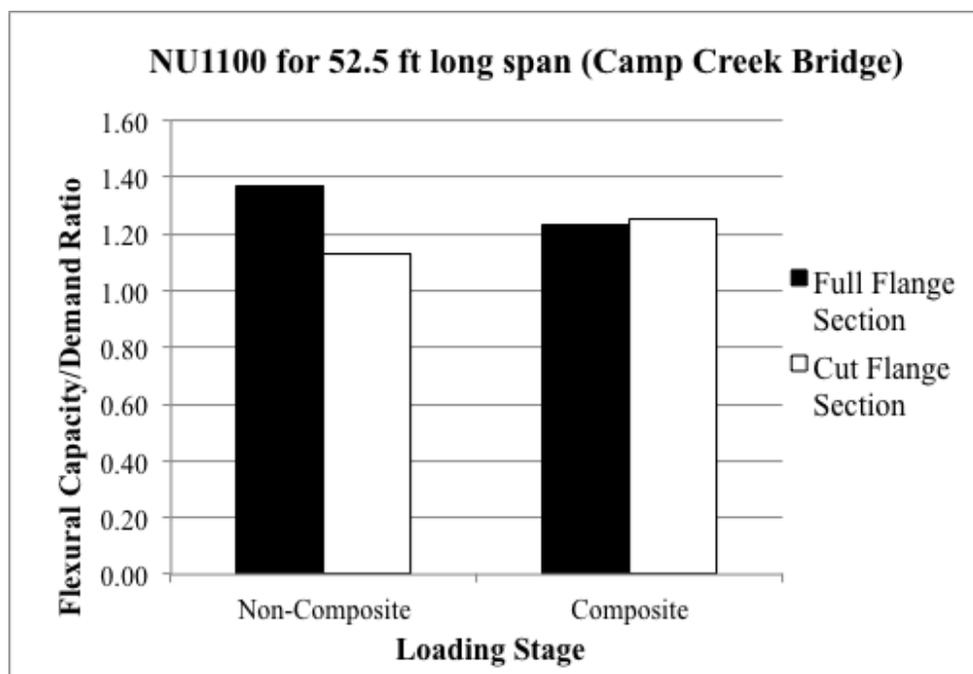
FIGURE 5-7: CAPACITY/DEMAND RATIO FOR NU1350 (OXFORD BRIDGE)

The effect of cutting the top flange reduced the girder flexural capacity by 20.81% during construction. After the deck and girder become a composite section, there is no difference in capacity with a full flange or cut flange section. The critical stage in using this method is during re-decking processes with the weight of fresh concrete during construction. Table 5-6 graphs the capacity/demand ratio for the girder in this example, showing the ratio above 1.0 as adequately designed.

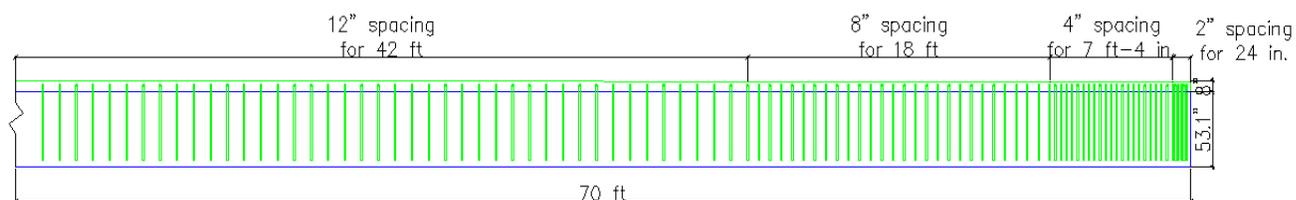
FIGURE 5-8: NU1350 STIRRUP DISTRIBUTION TO MIDSPAN OF GIRDER

The stirrup configuration of the Oxford South Bridge girders is shown in Figure 5-8. The maximum interface reinforcement spacing is 2-#3 stirrups every 12 in. at midspan and minimum spacing of 2 in. at the ends of the girder. Stirrup reinforcement area for 2#3 bars is 0.22 in².

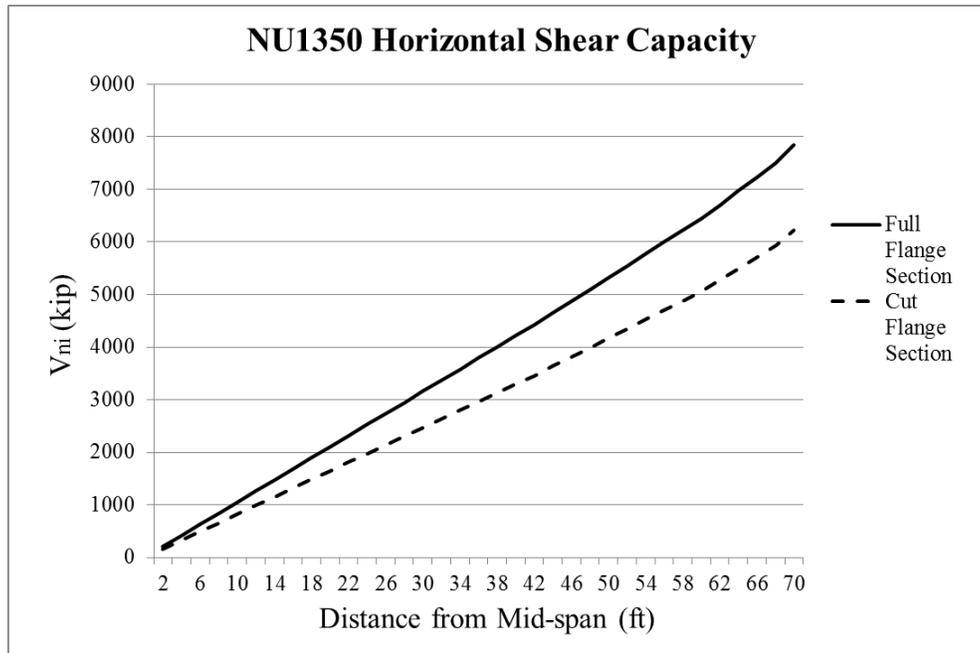
FIGURE 5-9: EFFECT OF CUTTING TOP FLANGE ON HORIZONTAL SHEAR CAPACITY FOR NU1350

Nominal horizontal shear capacity values are calculated for distances from the mid-span in increments of 2 ft. The results are obtained and graphed in Figure 5-9. From the results, the average percent loss in horizontal shear capacity over 24 ft from mid-span is 21.87%.

1. For a low span-to-depth ratio scenario, a reduction in top flange width is not detrimental to girder capacity under service loads. However, there is a significant enough difference in capacity in a large span-to-depth ratio scenario to be inadequate.
2. There is a significant reduction in horizontal shear capacity due to flange width reduction of 50%, by about 20-22%.

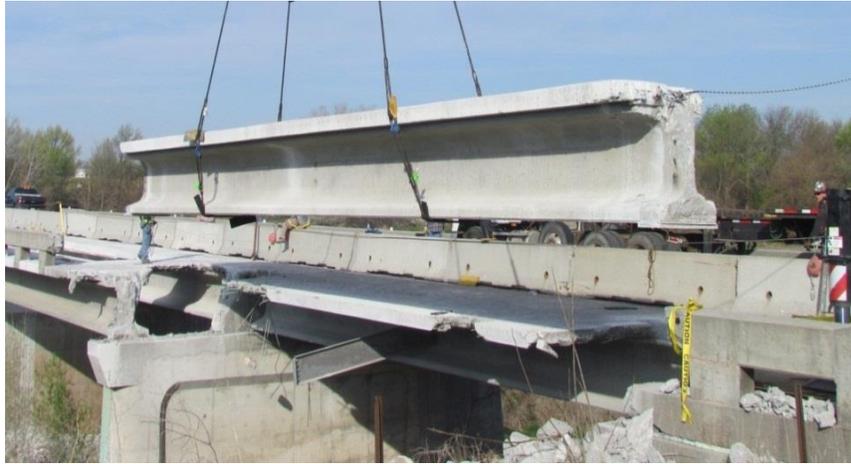
FIGURE 6-1: CAMP CREEK GIRDERS LIFTED USING STRAPS

Two 52 ft long girders were removed from the Camp Creek Bridge in the spring of 2012 and stored at Concrete Industries (CI) in Lincoln, NE to be used for this experimental investigations. The bridge deck was saw cut 8 in. from the edge of the top flange and the intermediate and end diaphragms were broken. Cross-sectional view of the bridge and bridge layout can be seen in the deck removal field investigation discussed in Section 3.1. Figure 6-1 shows one of the two NU1100 bridge girders used in the experimental investigation being lifted. Figure 6-2 shows the locations of the concrete cores drilled from the girder ends to evaluate the effectiveness of the debonding agents used between the girder top flange and the deck to facilitate deck removal without damaging the thin top flange.

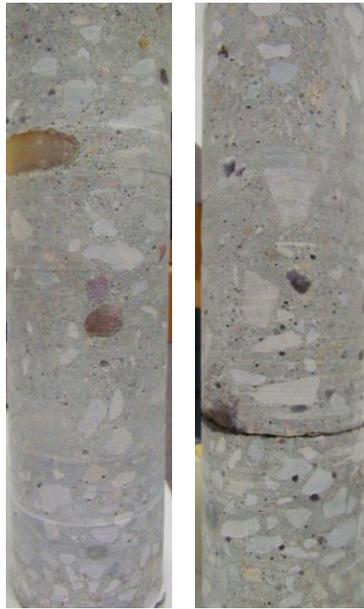
FIGURE 6-3: CORES TAKEN FROM BONDED ZONE (LEFT) AND FROM DEBONDED ZONE (RIGHT)

For each girder, four cores were drilled; two on each side of the two girders. On each side of the girders, one core was drilled in the bonded area, and one in the debonded area between the deck and the girder, shown in Figure 6-3. The cores taken in the bonded area remained in one piece, the cores taken in the debonded area split at the deck to girder interface. The orange-colored surface shown in Figure 6-4 is due to the use of debonding agent. Concrete cores were also used to estimate compressive strength of the two girders.

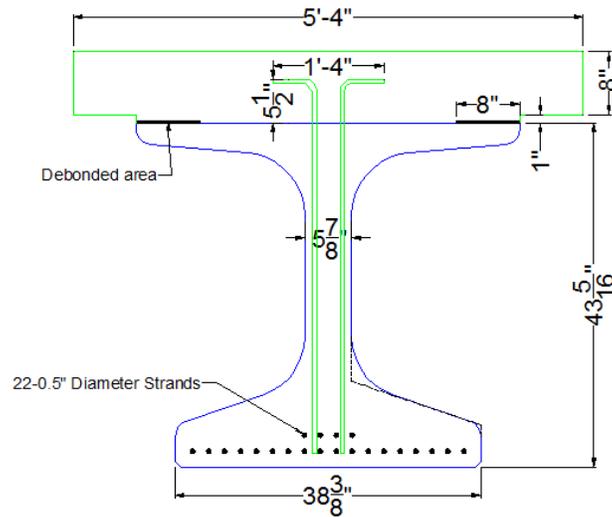
FIGURE 6-5: COMPOSITE DIMENSIONS OF GIRDERS TAKEN FROM CAMP CREEK BRIDGE

capacities will be determined via testing. The dimensions of the girders with old deck are given in Figure 6-5. The deck is 5 ft- 4in. wide and 8 in. thick with an additional 1 in. haunch. The debonded zone is 8 in. wide strip from the edges of the 4 ft wide top flange.

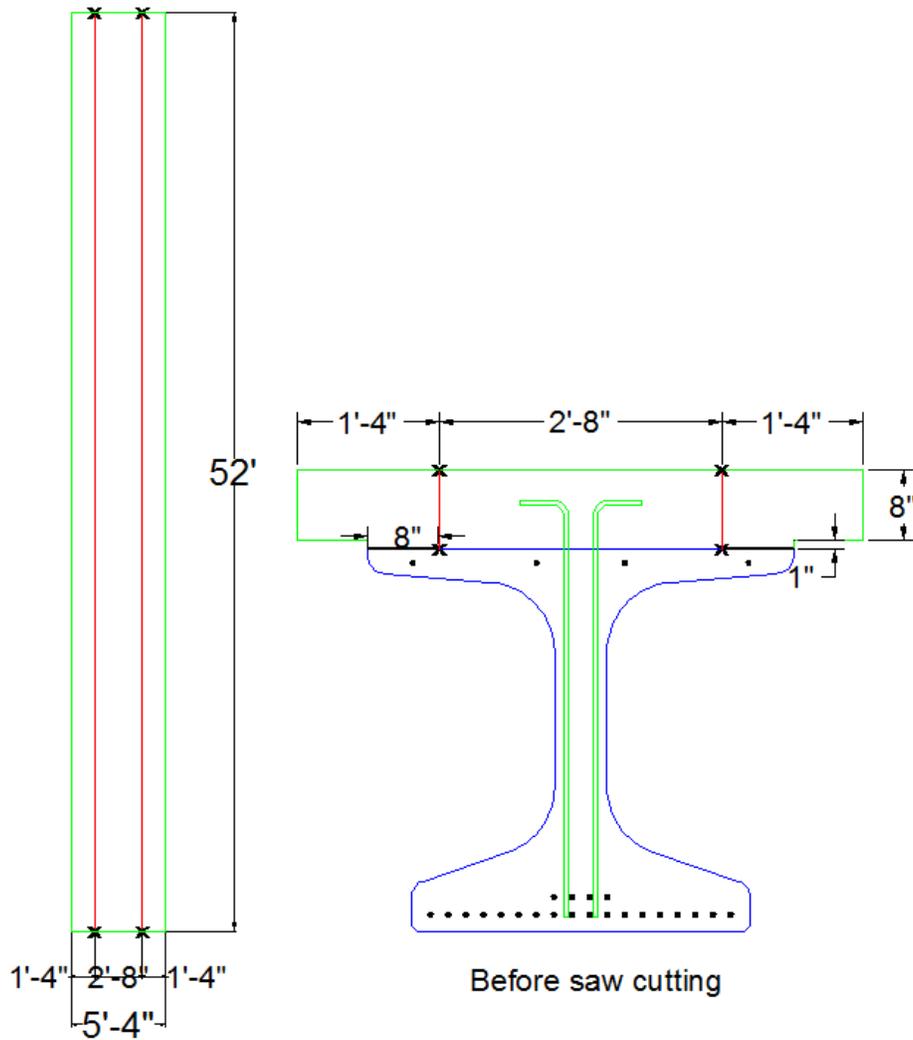
FIGURE 6-6: LOCATION OF LONGITUDENAL SAW CUTS ON GIRDER #1

For the full flange girder, saw cuts were made at the end of the debonded zone for the full depth of the deck to make the removal of the overhung portions of the deck easy to remove without damaging the girder top flange. Saw cutting closer to the shear connectors will minimize the amount of jack hammering needed, however removing the bonded deck would have been very difficult without damaging the top flange. Therefore, longitudinal saw cuts were made 1 ft – 4 in. from the center of the girder on either side. Figure 6-6 shows the location of each saw cut. The cuts were made to the full depth of about 9 in.

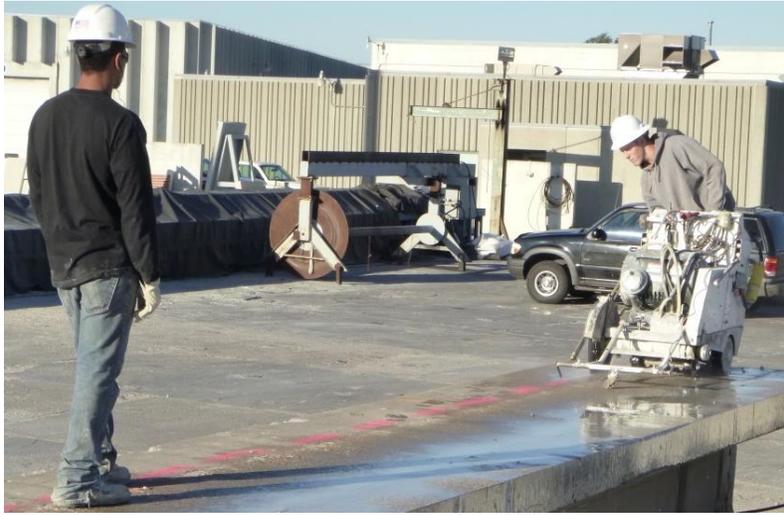
FIGURE 6-7: WORKERS MAKING THREE PASSES FOR EACH SAW CUT LOCATION

The 9 in. deep longitudinal saw cuts required 3 passes, cutting down about 2-3 in. per pass. Figure 6-7 shows the longitudinal saw cuts being made on the full flange girder. Figure 6-8 shows a cross-sectional view after all longitudinal saw cuts were made.

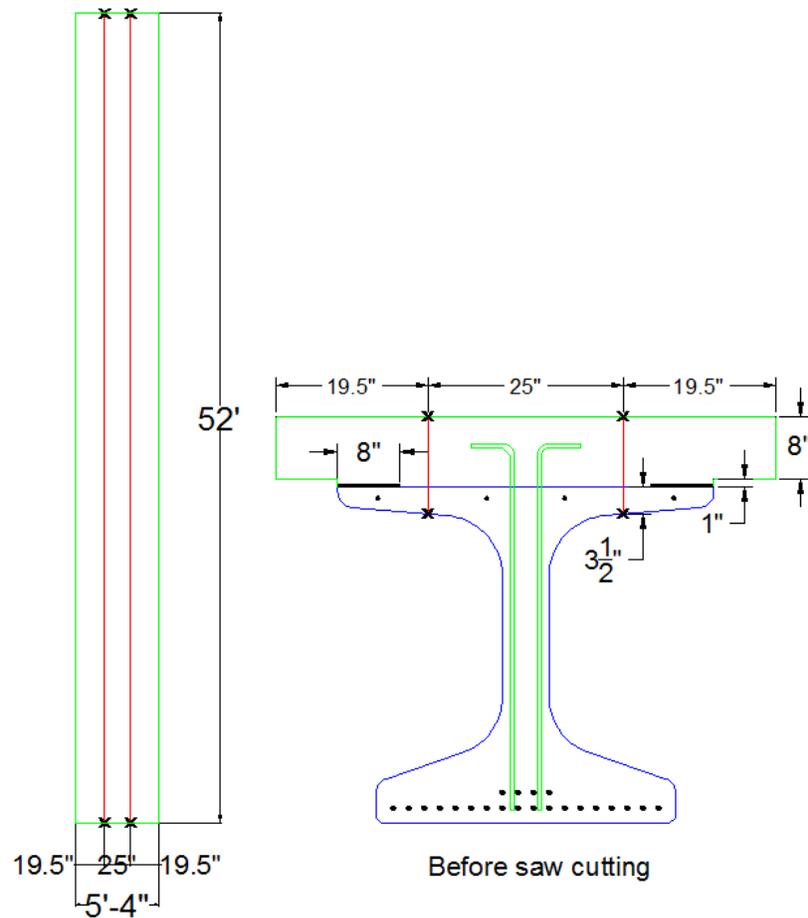
FIGURE 6-9: LOCATION OF LONGITUDENAL SAW CUTS ON GIRDER #2

For the cut flange girder, the saw cuts were made to the full depth of the deck and through the top flange. The location of saw cuts was dictated by the width of the saw cutting machine, which is 25 in. Therefore, the flange width was reduced from 48 in to 25 in. Figure 6-9 shows the location of longitudinal saw cuts on the cut flange girder, which were made 12.5 in. from the center of the girder. The cuts were made to a depth of about 1 ft.

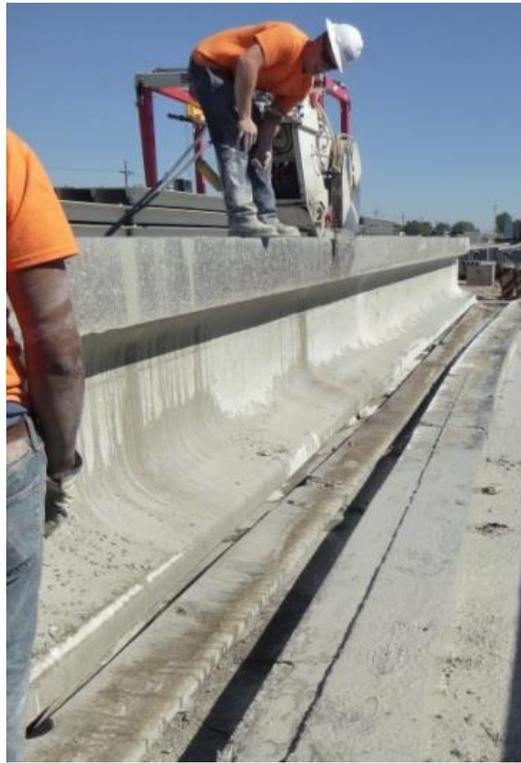
FIGURE 6-10: SEPERATION OF DECK AND FLANGE AFTER FALLING DOWN

The 12 in deep longitudinal cut required four passes, cutting down about 3 in. per pass. In the last pass, a larger blade was required. The blade was switched from an 18 in. diameter blade to a 24 in. diameter blade as shown in Figure 6-10. Saw cutting was most difficult when the blade hit a longitudinal bar, because the bar would be needed to be cut in the longitudinal direction, which slowed down the process. Figure 6-11 shows a cross-sectional view of the cut flange girder after saw cutting was completed. The total time required was five hours to finish the saw cutting on both girders. Two hours were spent on the full flange girder, and three hours on the cut flange girder.

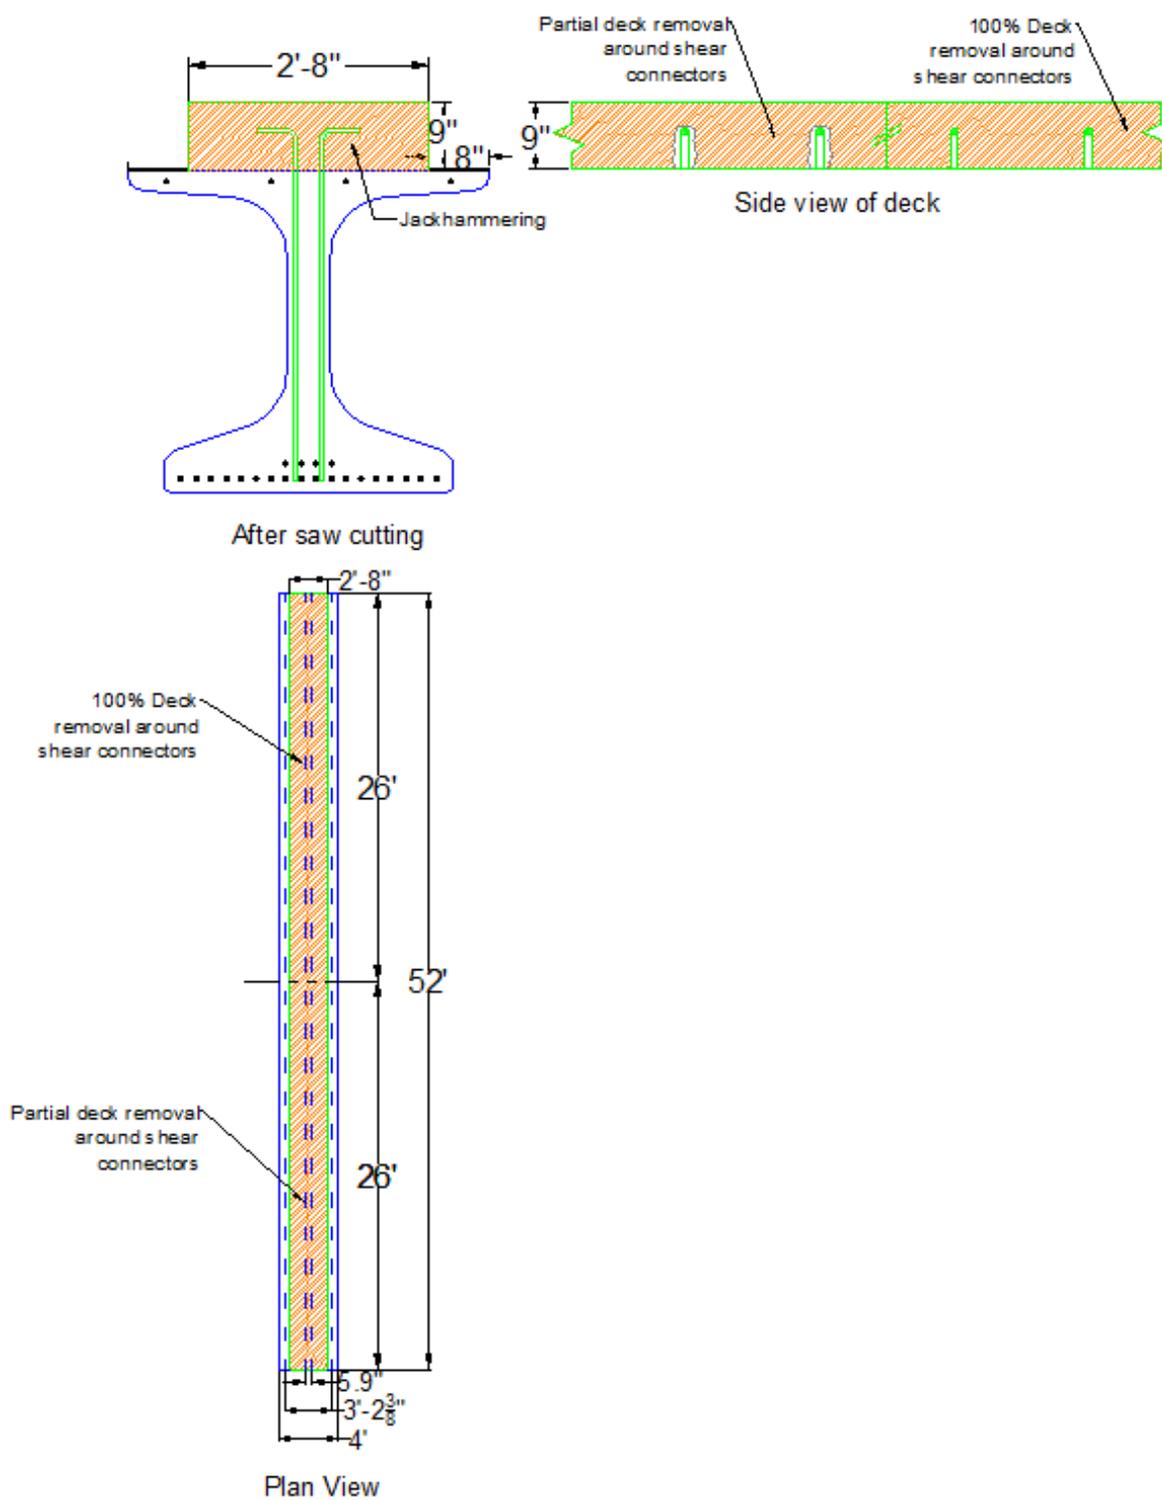
FIGURE 6-12: JACK HAMMERING PLAN FOR GIRDER #1

Figure 6-12 and Figure 6-13 shows a plan view, cross-sectional view, and side view of the jack hammering plan with the orange hatched area being the area to jack hammer. The remaining deck after saw cutting on the full flange girder is a 2 ft – 8 in. wide, 9 in. deep, and 52 ft long deck. And the remaining deck for the cut flange girder is 25 in. wide, 9 in. deep, and 52 ft long. The job took five days to complete, with the fifth day being a half day.

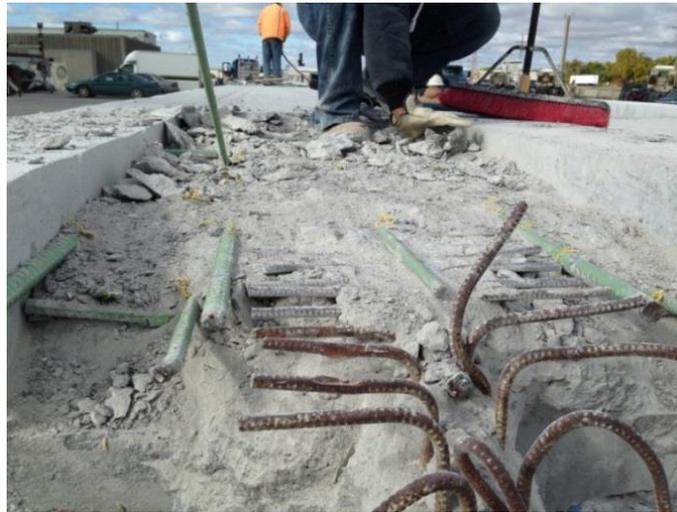
FIGURE 6-14: DIFFICULT REMOVING CONCRETE UNDER LONGITUDENAL BARS

Two sizes of jack hammers were used. The 90 lb jack hammer was used down to the depth of shear connectors. This top 4 in. of concrete took the least time per unit volume to remove. Once the shear connectors reached, the 60 lb jack hammer was used to remove the remaining concrete, which was much more difficult especially at the girder ends where the spacing between shear connectors is small as shown in Figure 6-14.

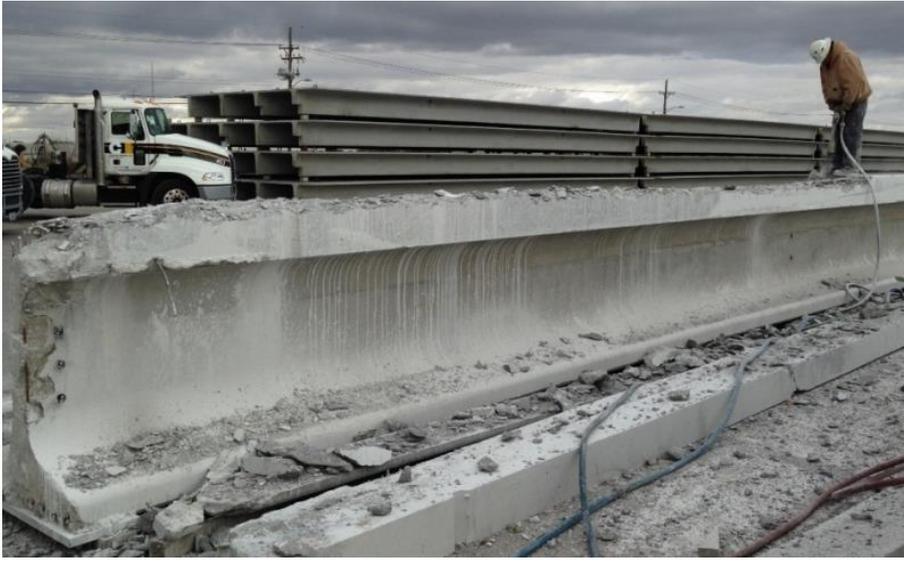
FIGURE 6-15: JACK HAMMERING DOWN TO STIRRUPS

For the full flange girder, approximately 88 ft³ total volume of concrete deck needed to be removed. For the cut flange girder, approximately 62 ft³ needed to be removed. At the end of the first day, workers removed approximately 51 ft³ of concrete. This was mostly the volume of concrete above the stirrups, shown in Figure 6-15, which is the easiest to remove.

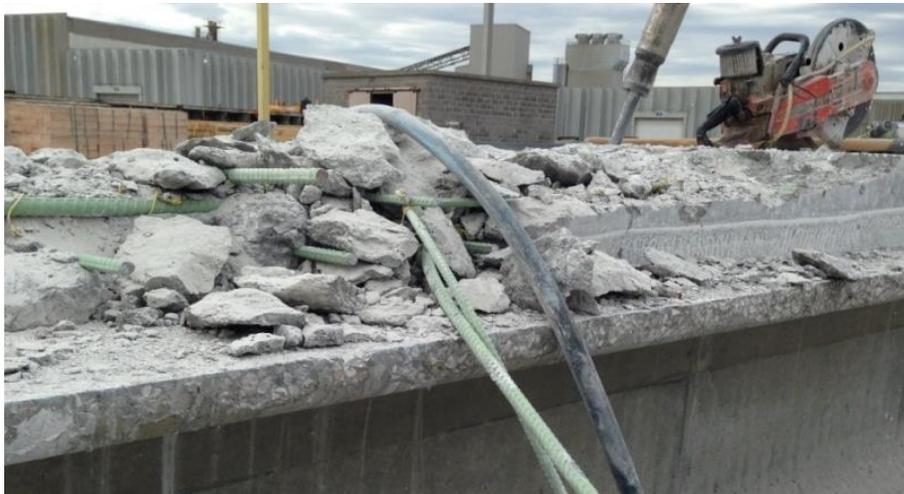
FIGURE 6-16: DAMAGED FLANGE FROM VIBRATION OF 90LB JACK HAMMER

Using the 90 lb jack hammer caused vibration that resulted in minor damages to the sides of the top flange as shown in Figure 6-16. Stirrups were also damaged from the blunt force of the 90 lb jack hammer (Figure 6-17). Few instances caused delays in jack hammering, such as the generator shutting off, and the jack hammer getting stuck.

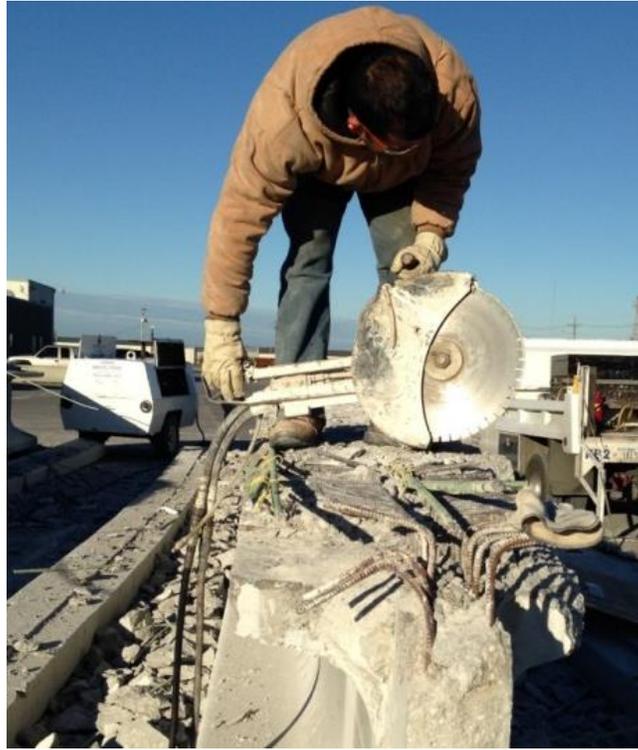
FIGURE 6-18: TRANSVERSE SAW CUTTING EVERY 5 IN.

At the end of the second day, the crew suggested to saw cut the deck transversely to speed up the deck removal with the jack hammer. A hand held saw is used. Transverse saw cuts were made every 5 in. for about a 4 in. depth, seen in Figure 6-18 and Figure 6-19. This method is much more efficient. The concrete came out easier in bigger chunks. It was especially efficient with simultaneous jack hammering and use of electric hand chipper. Jack hammers were used vertically from the top of the deck, while electric chipper was used from the side. The concrete came out in larger blocks. At the end of the second day, approximately an additional 46 ft³ of concrete had been removed. At the end of the third day, the “fully removed” half of the cut flange girder was completed, leaving only the “partially removed” half. This is approximately 26 ft³ of concrete. The full flange girder had only the concrete around the stirrups for the full length of the girder.
