Evaluating the Impact of Deck Removal Method on the Performance of NU Girders

Nebraska Department of Roads (NDOR)

Project Number: SPR-P1 (12) M325

FINAL REPORT

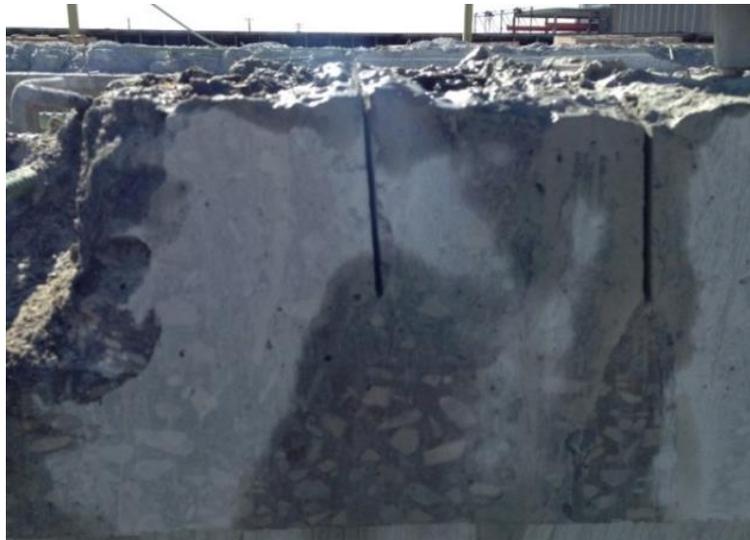
FIGURE 6-19: DEPTH OF SAW CUTS ABOUT 4 IN.; 1 IN. FROM TOP FLANGE

At the end of the second day, the crew suggested to saw cut the deck transversely to speed up the deck removal with the jack hammer. A hand held saw is used. Transverse saw cuts were made every 5 in. for about a 4 in. depth, seen in Figure 6-18 and Figure 6-19. This method is much more efficient. The concrete came out easier in bigger chunks. It was especially efficient with simultaneous jack hammering and use of electric hand chipper. Jack hammers were used vertically from the top of the deck, while electric chipper was used from the side. The concrete came out in larger blocks. At the end of the second day, approximately an additional 46 ft³ of concrete had been removed. At the end of the third day, the “fully removed” half of the cut flange girder was completed, leaving only the “partially removed” half. This is approximately 26 ft³ of concrete. The full flange girder had only the concrete around the stirrups for the full length of the girder.

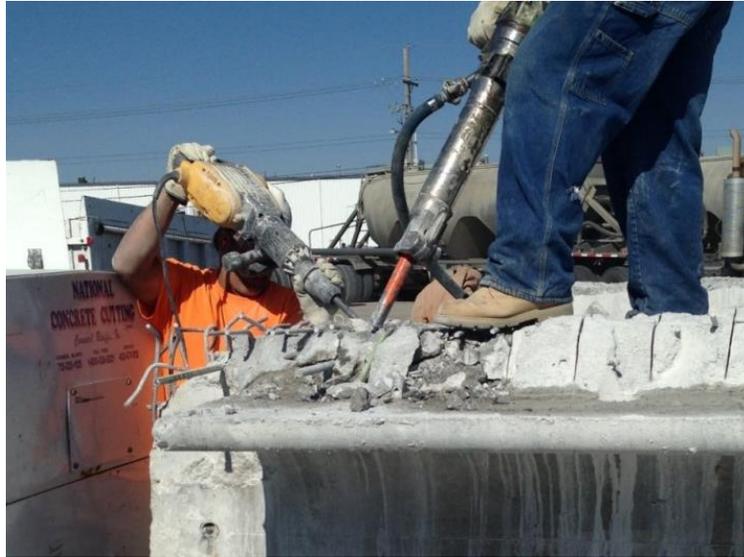
FIGURE 6-20: LEAVING SPACE UNDERNEATH STIRRUP LEGS, AND REMOVING TRANSVERSE BARS ON FULL FLANGE GIRDER

Deck removal continued with the technique of first transverse saw cutting, then jack hammering and chipping. It was specified to leave space underneath the stirrup legs, about 1-2 in. Figure 6-20 and Figure 6-21 show simultaneous jack hammering and electric chipping while

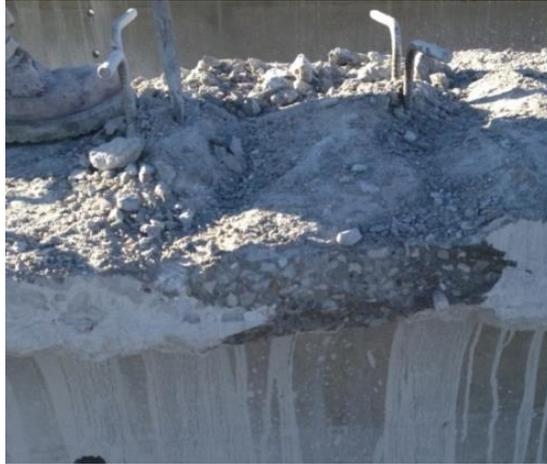
FIGURE 6-22: DAMAGED FLANGE ON GIRDER #2

On the fifth day, the jack hammering job was completed on the cut flange girder. There was damage observed on the top flange of the girder, which can be seen in Figure 6-22. Also, some damage to the stirrups, one which completely detached from the flange (Figure 6-23). The total

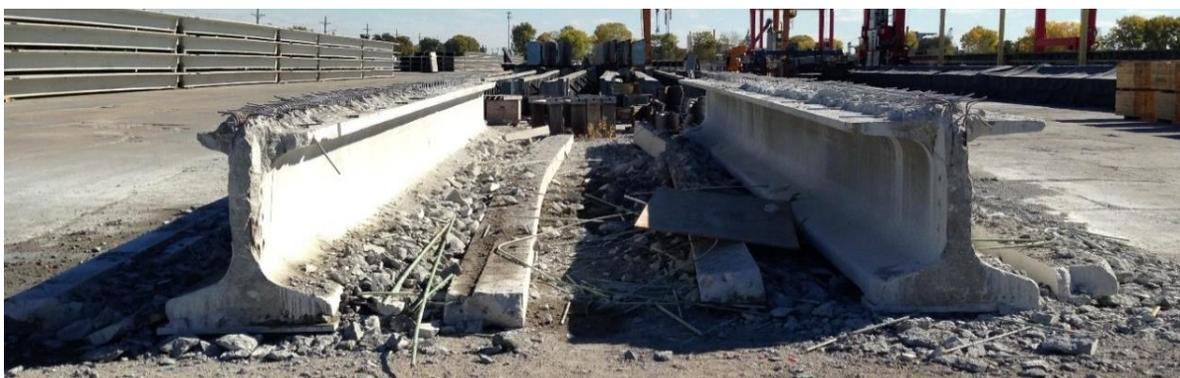
FIGURE 6-24: JOB COMPLETED ON OCT 26TH BY NOON

time to finish the last portion of the job, about 25 ft³ of concrete, took 3.5 hrs. A view of the prepared NU1100 specimen after saw cutting and jack hammering procedures is seen in Figure 6-24.

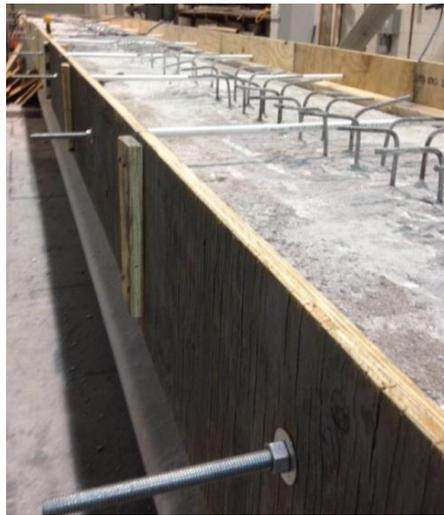
FIGURE 6-25: TIES WITH PVC PIPE SPACED 3FT APART TO HOLD FORM SIDES

For the full flange girder, a 4 ft wide and 7.5 in. thick deck was formed using plywood sheets and threaded rod ties as shown in Figure 6-25 and Figure 6-27. The new deck was reinforced transversely in two layers with #5@12 in. and longitudinally with 4#8 at the mid-thickness, which is equivalent to two layers of #4@12 in. over 8 ft wide deck.

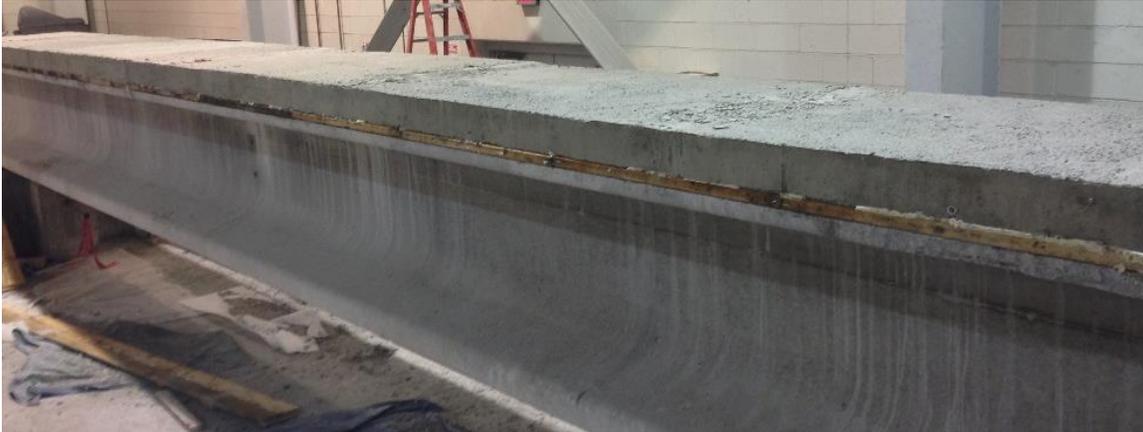
FIGURE 6-27: VIEW OF FULLY COMPOSITE DECK FOR FULL FLANGE GIRDER

The deck was poured using 8 ksi self-consolidating concrete (SCC) with 25 in. slump. This is equivalent to a 4 ksi concrete for 8 ft wide deck. Figure 6-27 shows the new deck after forms have been stripped.

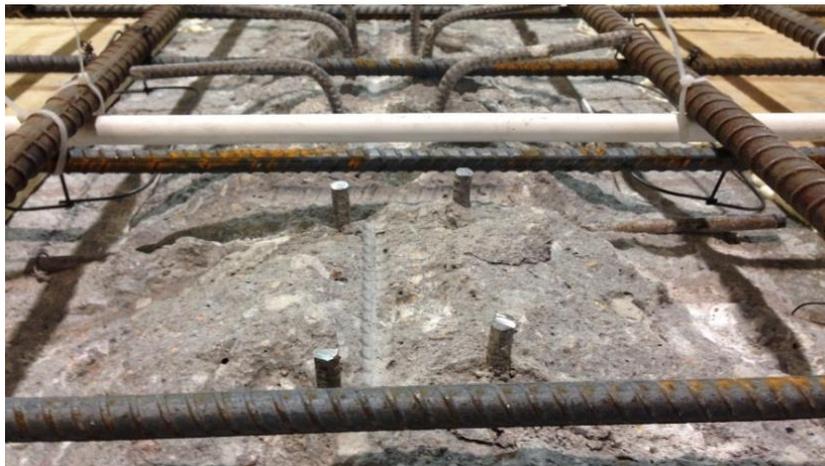
FIGURE 6-28: CUT SHEAR CONNECTORS IN PARTIALLY REMOVED SECTION

The same procedures were followed for re-decking the cut flange girder. It should be noted that two pairs of shear connectors on each half of the girder was cut off from the flange on both the fully removed and partially removed halves as shown in Figure 6-29. This was suggested to simulate the situation when some shear connectors are damaged during the jack hammering process.

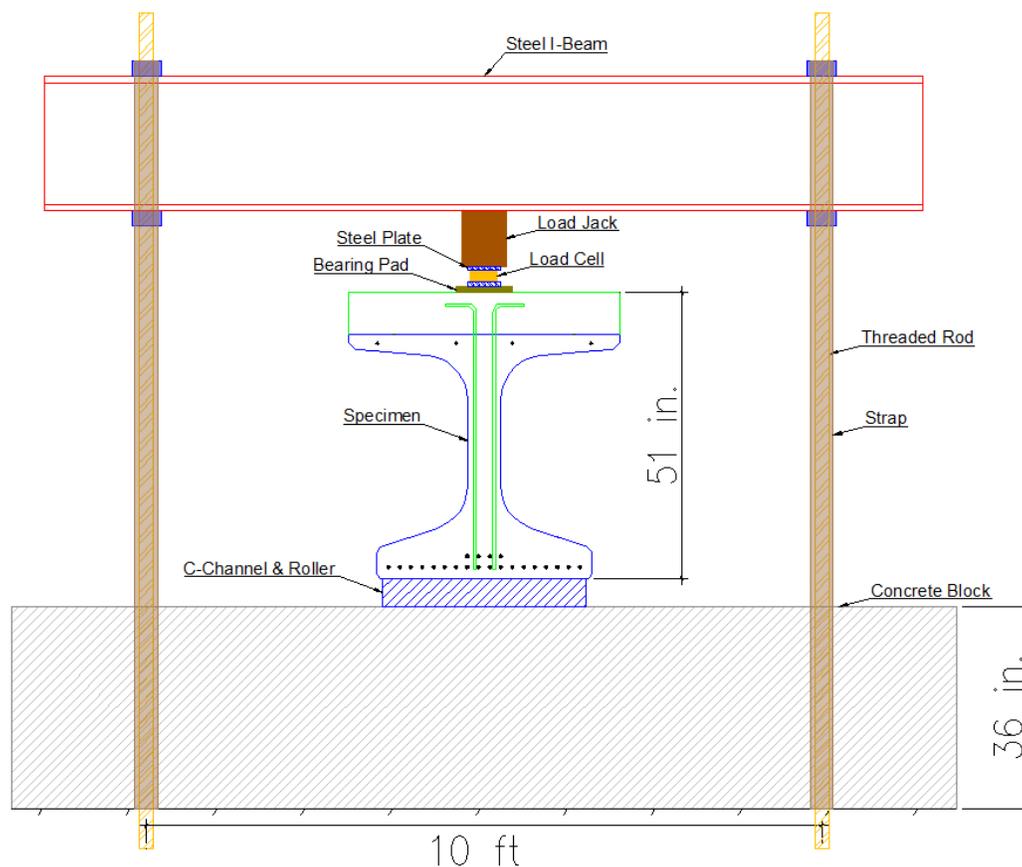
FIGURE 6-29: CROSS SECTIONAL VIEW OF TEST SETUP (FULL FLANGE GIRDER EXAMPLE)

Girders were tested in flexure after the desired concrete compressive strength was achieved. The test setup is shown in Figure 6-29. Girders were simply supported on concrete blocks and roller supports that are spaced 40 ft on center. Two threaded rods that are 10 ft apart were used to anchor the steel loading I-beam to the strong floor. A 400 kip capacity hydraulic jack and load cell were used for loading each girder at mid-span. Rotation of the loading frame was prevented by using a strap on both sides; straps were anchored into the ground 12 ft from the center of the girder on either side as shown in Figure 6-30

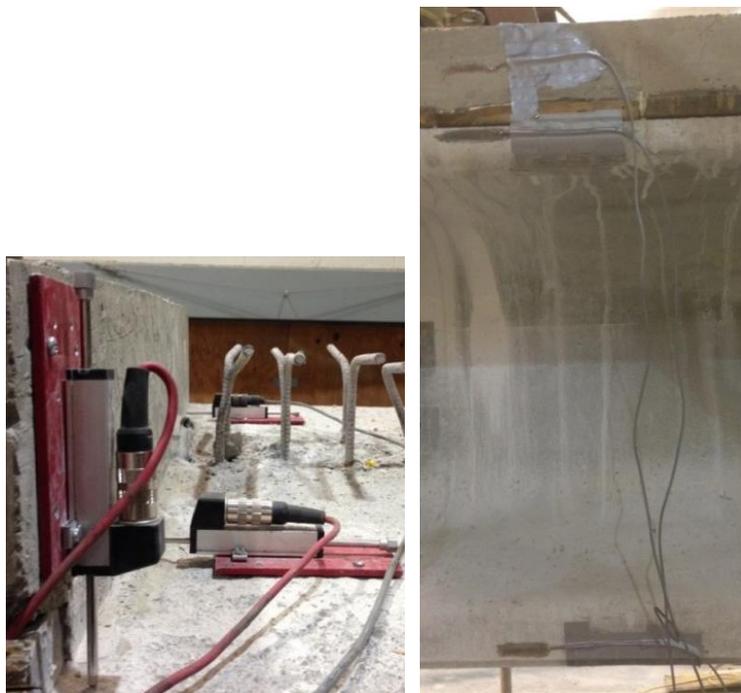
FIGURE 6-31: LVDT'S (LEFT), STRAIN GAUGES (RIGHT)

Each girder was instrumented with four horizontal and two vertical linear variable differential transformers (LVDT's) to measure displacement, one string potentiometer to measure deflection at mid-span, and three strain gauges to measure strains at the critical section. Figure 6-31 show the instrumentations used during testing. A view of the completed test setup on the full flange girder is shown in Figure 6-32.

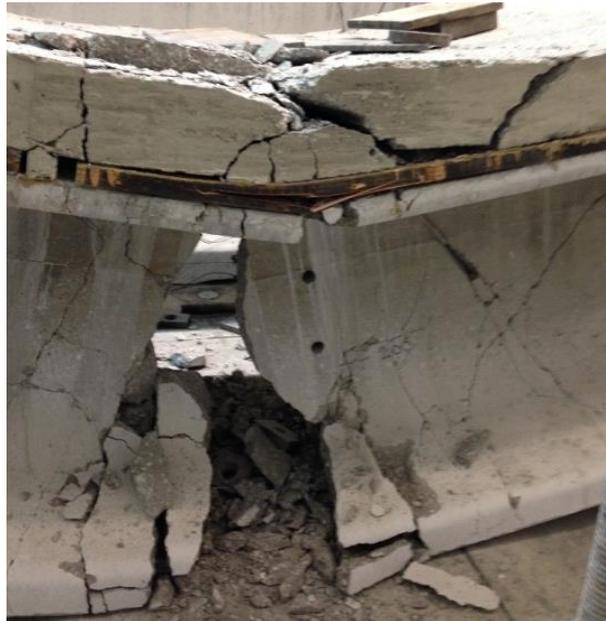
FIGURE 6-33: FAILURE MODE OF FULL FLANGE GIRDER

The full flange girder was tested on December 10th, 2013. Horizontal and vertical LVDTs will be referred to as H-NW and H-NE for the horizontal North West and North East LVDTs; and as V-N and V-S for the vertical north and south LVDTs. Strain gauges were labeled as deck, top flange, and bottom flange strain gauges. The same notations were used for the cut flange girder. The full flange girder failed in flexure at an ultimate load of 379 kips and had a cracking load of 224 kips. The vertical deflection at mid-span was 0.45 in. at the cracking load and 5.83 in. at ultimate load. Flexural failure mode is shown in Figure 6-33.

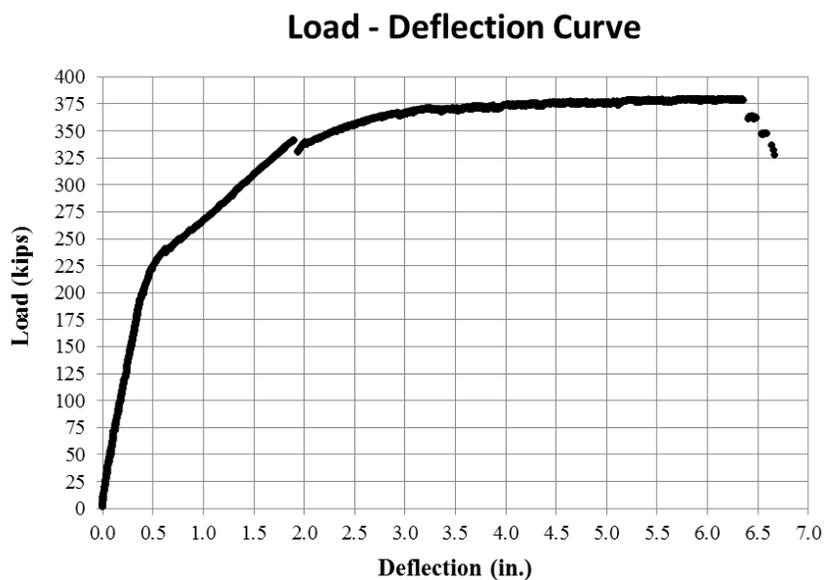
FIGURE 6-34: FULL FLANGE - LOAD VS. DEFLECTION GRAPH

The load-deflection curve of testing the full flange girder is shown in Figure 6-34. This figure indicates the elastic behavior of the composite girder up to the cracking load; and the leveling off of the curve up to the ultimate load.

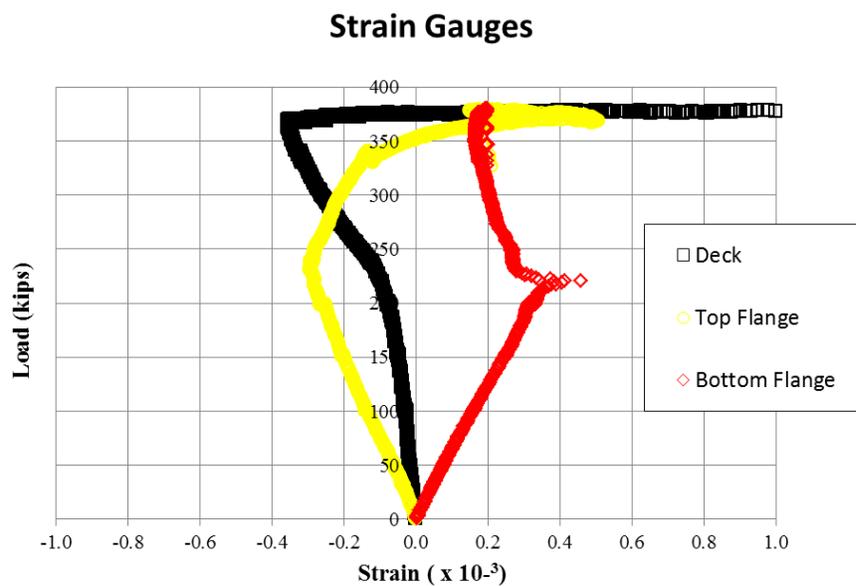
FIGURE 6-35: FULL FLANGE - LOAD VS. STRAIN GRAPH

Figure 6-35 plots strain data at the critical section. This plot indicates the increase in the compression strains at the top fibers and tension strains at the bottom fibers up to failure load, which demonstrates the composite action of the girder.

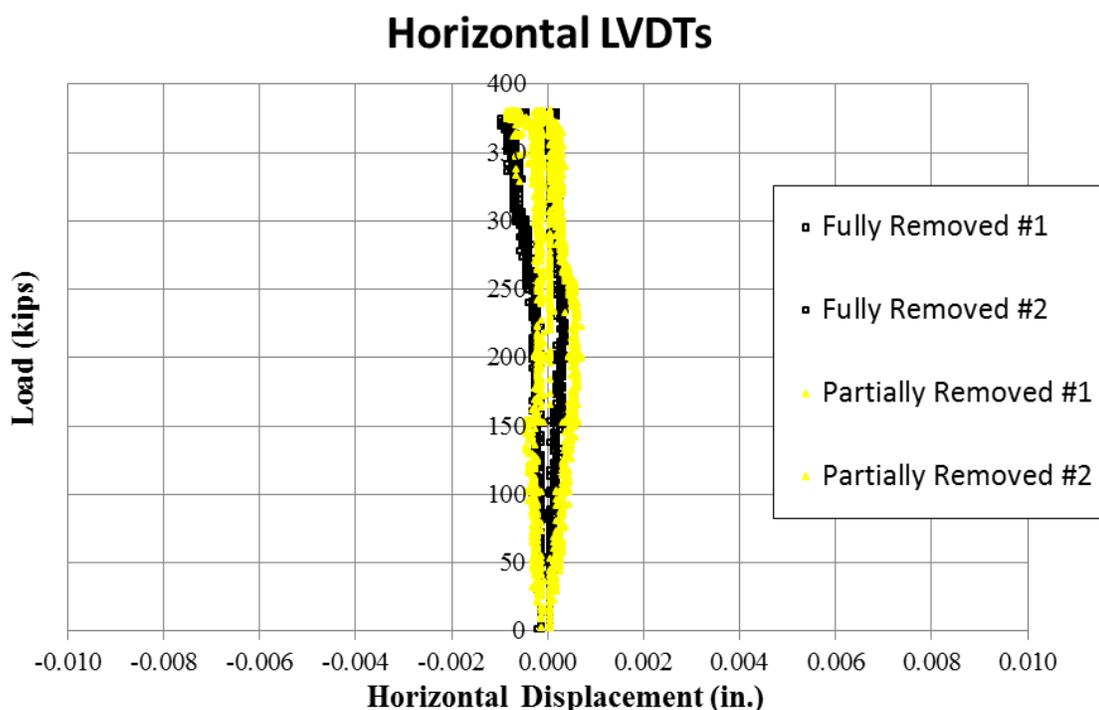
FIGURE 6-36: HORIZONTAL DISPLACEMENT FOR PARTIALLY REMOVED VS. FULLY REMOVED

The relative displacement data gathered from LVDTs is shown in Figure 6-36 and Figure 6-37. These two graphs indicate that horizontal and vertical displacements of the new deck relative to the girder are negligible as the maximum value for horizontal displacement is 0.001 in. and for vertical displacement is 0.0035 in., which are less than 0.01 in. (minimum acceptable initial slip). Furthermore, the displacements of the fully removed half of the girder and the partially removed half are identical. This indicates that the level of deck removal around the shear connectors does not affect the horizontal shear capacity of the full flange girder.

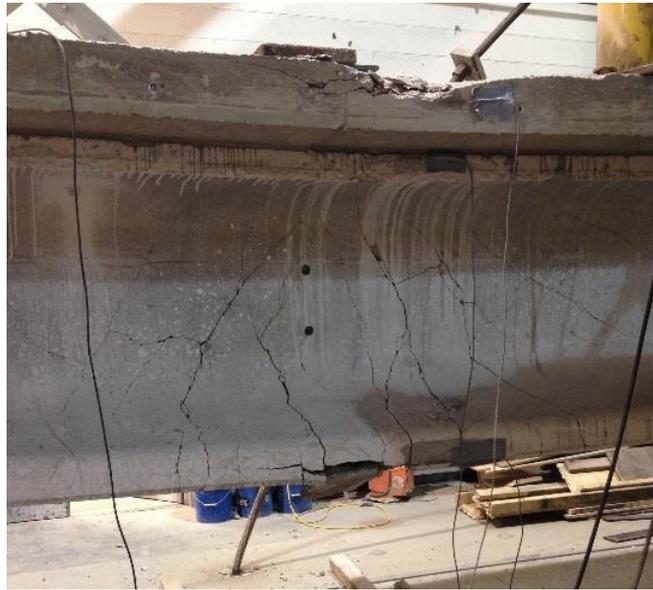
FIGURE 6-38: CUT FLANGE GIRDER FAILURE MODE

The cut flange girder was tested on January 9th, 2014. The girder failed in flexure; however the strands did not rupture as shown in Figure 6-38. The ultimate load was 378 kips and the cracking load was 230 kips. The vertical deflection at mid-span was 0.35 in. at the cracking load and 5.96 in. at ultimate load as shown in the load-displacement curve plotted in Figure 6-39. Figure 6-40 plots strain data at the critical section. This plot indicates the increase in the compression strains at the top fibers and tension strains at the bottom fibers up to failure load, which demonstrates the composite action of the girder.

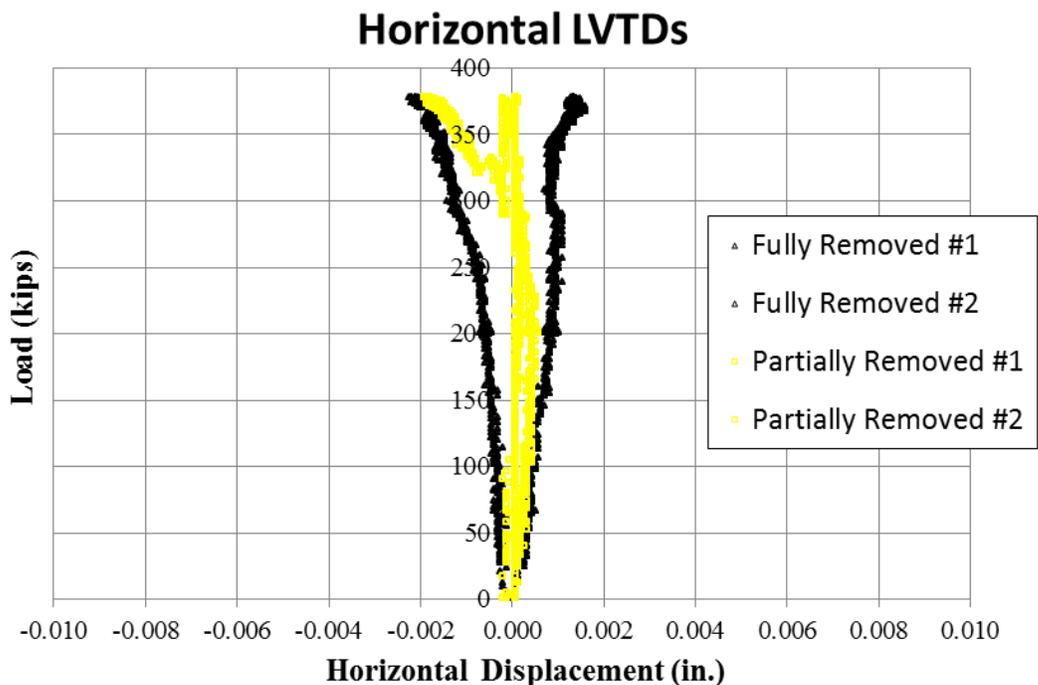
FIGURE 6-41: HORIZONTAL DISPLACEMENT FOR PARTIALLY REMOVED VS. FULLY REMOVED

Figure 6-41 and Figure 6-42 show the horizontal and vertical displacements of the new deck relative to the girder. The amount of displacements was negligible as the maximum value is 0.002 in., which is lower than the minimum acceptable value for initial slip (0.01 in.). Furthermore, the displacements of the fully removed half of the girder and the partially removed half are identical. This indicates that the level of deck removal around the shear connectors does not affect the horizontal shear capacity of the cut flange girder.

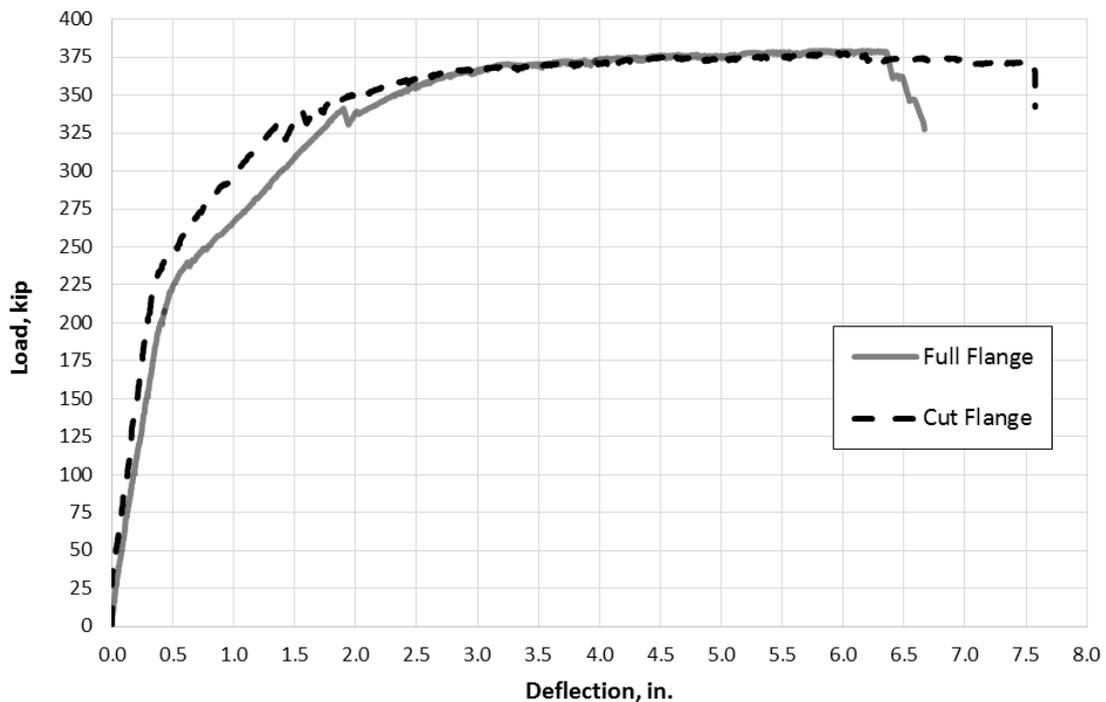
FIGURE 6-43: LOAD VS. DEFLECTION CURVE OF INVESTIGATED NU1100 GIRDERS

Comparing the test results of the full flange girder and cut flange girder indicates that the top flange width has no effect on the flexural capacity, which confirms the results of the analytical investigation presented in chapter 4. Figure 6-43 shows the load-deflection curves of the two girders, while Figure 6.45 and Figure 6.46 plot the measured cracking load, ultimate load, and deflection versus predicted ones. This plot indicates that measured values are very close to the predicted values, calculated assuming fully composite section. This means that tested girders whether full flange, cut flange, with partial deck removal, or with full deck removal behaved as fully composite with the new deck.

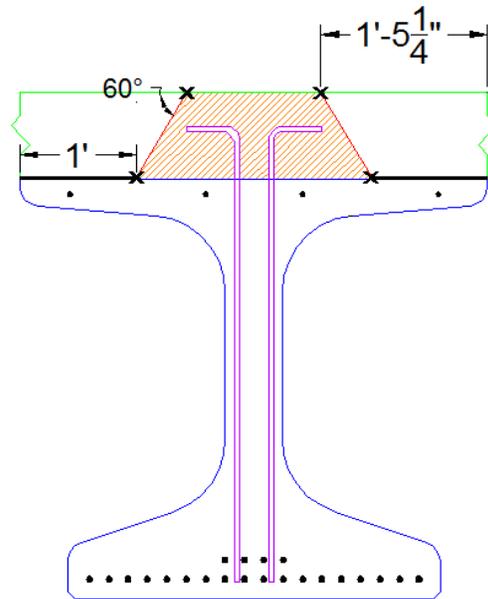
FIGURE 8-1: RECOMMENDED PRACTICE FOR DEBONDING AND SAW CUTTING

1. Extend the width of the debonded strip for wide and thin top flange girders, such as NU girders, to be at least 12 in. instead of 8 in. as shown in Figure 8-1. This will minimize the amount of deck that needs to be jackhammered, which is a tedious and costly process, and ensure easy lifting of deck panels.
2. Saw cut deck panels at angles to simplify the deck removal process rather than using vertical saw cuts as shown in Figure 8-1. However, pivoted saw cut machines are needed to improve the efficiency of this option compared to using the frame mounted saws that slow down the process.

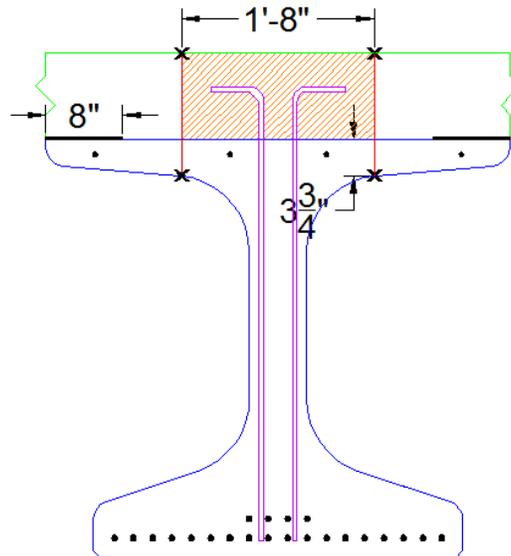
FIGURE 8-2: RECOMMENDED PRACTICE FOR EXISTING BRIDGES

3. For existing bridges with low span-to-depth ratio and narrow debonded zone, saw cut the deck outside the shear connectors and through the wide and thin girder top

flange as shown in Figure 8-2. The remaining concrete around the shear connectors could be manually removed with 60 lb jack hammers up to the level of the shear connectors, and 30 lb jack hammer below the shear connectors.
