Research Project Number SPR-FY21(010)

CRASHWORTHY PERFORATED SQUARE STEEL TUBE (PSST) MAILBOX SUPPORT – PHASE I

MIDWEST ROADSIDE SAFETY FACILITY

MwRSF Research Report No. TRP-03-473-23

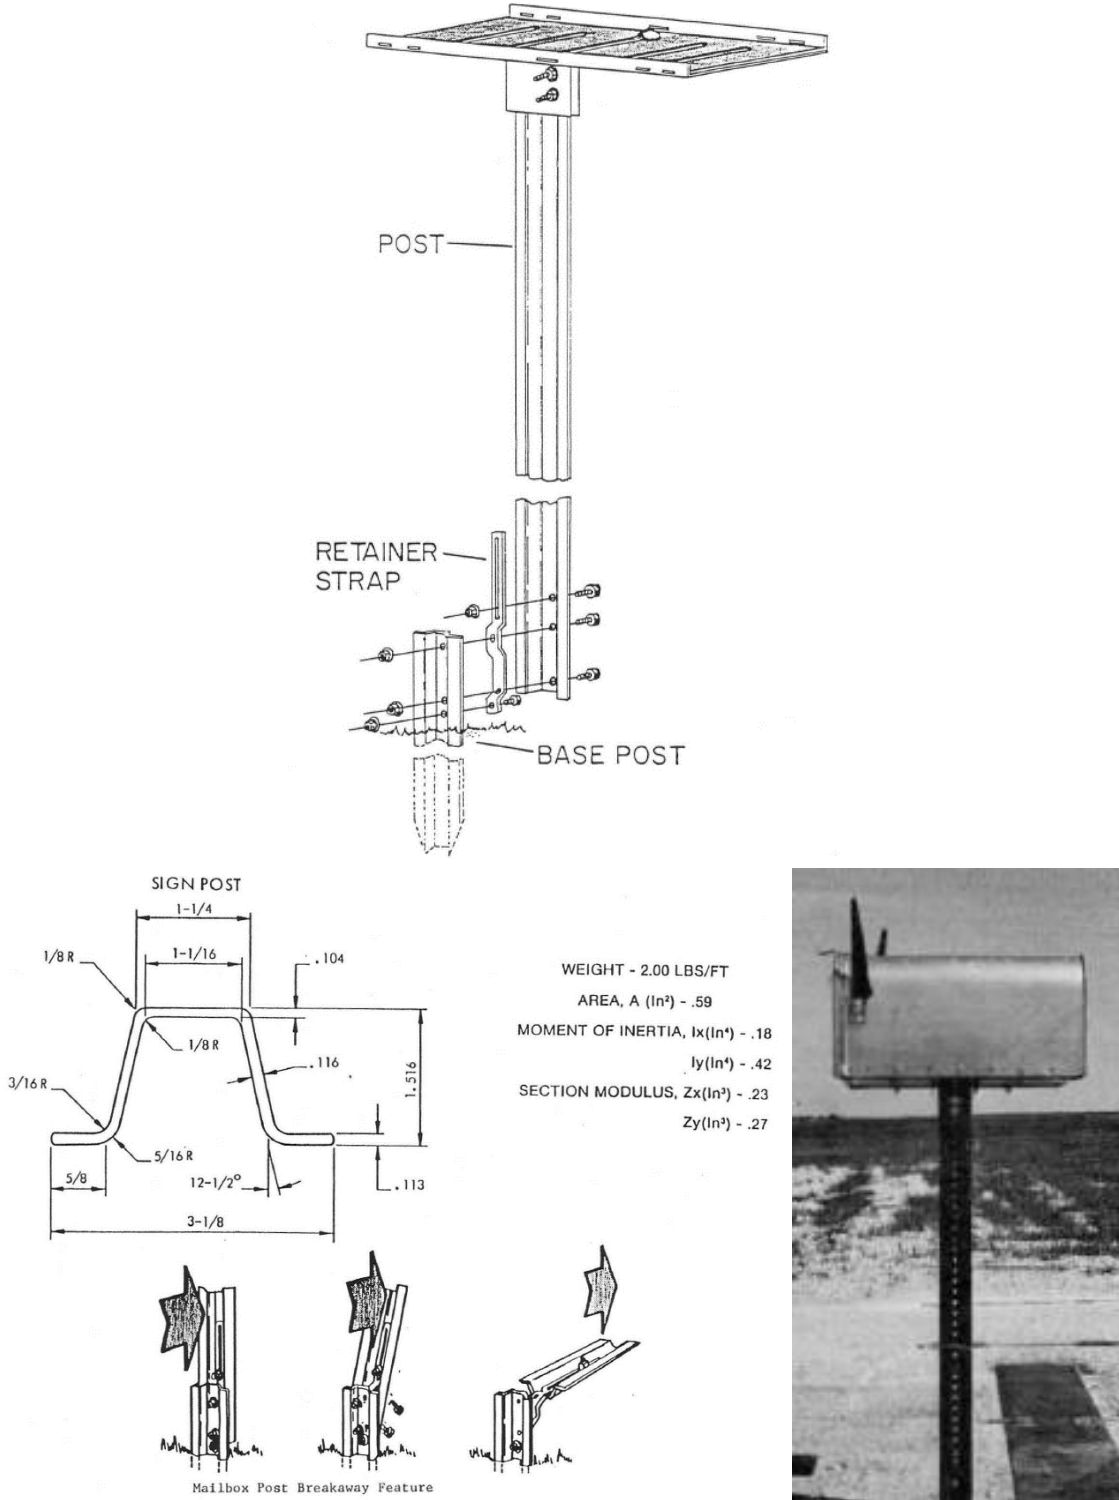
Figure 1. Original NDOT Breakaway Mailbox Support Design

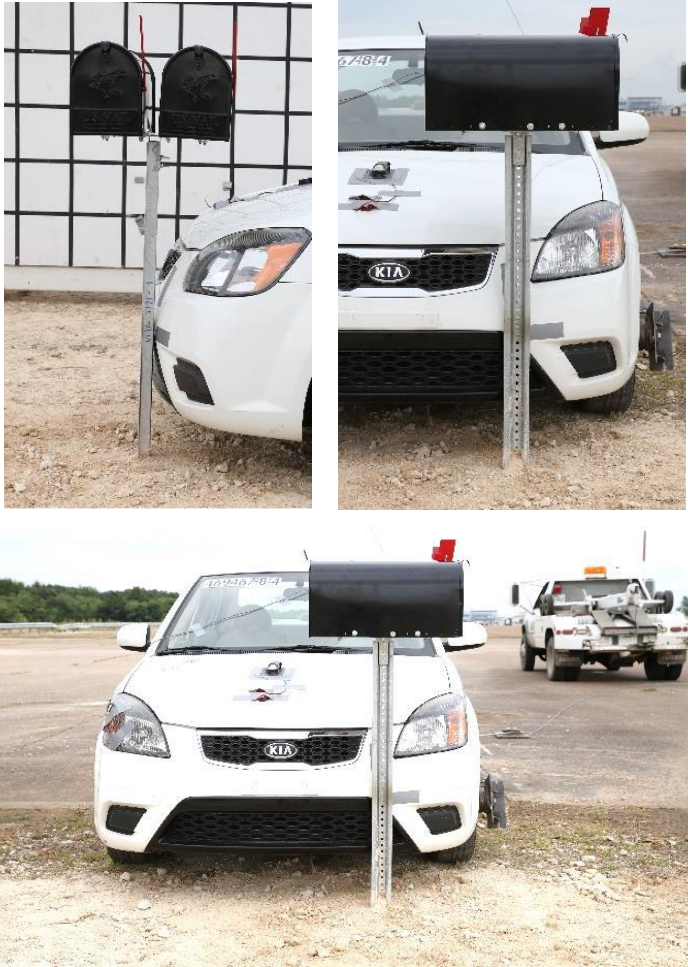
Mail Box	Mailbox Attachment	Mailbox-to-Post Bracket	Support Base	Support Post	Base-to-Post Attachment
<ul style="list-style-type: none"> • Dual Mailbox • Elite No. 1-A mailbox (#E1600B00) • 11 in. tall x 8 ¾ in. wide x 21½ in. deep • Steel • 7 lb (21 lb for mailboxes and bracket) • 42- in. mounting height 	<ul style="list-style-type: none"> • Bracket to Post – two 5/16 – in. diameter SAE Grade 5 bolts • Angle bracket to bracket plate – two 3/8- in. diameter SAE Grade 5 Bolts • Bracket plate to bracket mount and mailbox – four 3/8- in. diameter SAE grade 5 bolts • Extension bracket to bracket mount and mailbox six ¼- in. bolts per unit 	<ul style="list-style-type: none"> • Bracket mount DHT#148939 • Extension bracket DHT#148938 • Bracket plate DHT#3789 • Angle bracket DHT#159490 	<p style="text-align: center;">None</p>	<ul style="list-style-type: none"> • 2 lb/ft steel perforated winged-channel post (DHT #4289) fabricated from ASTM A1011 structural Grade 50 	<p style="text-align: center;">Continuous post with 30½- in. embedment</p>

Figure 2. TxDOT Winged-Channel Mailbox Support - Test No. 469467-8-4

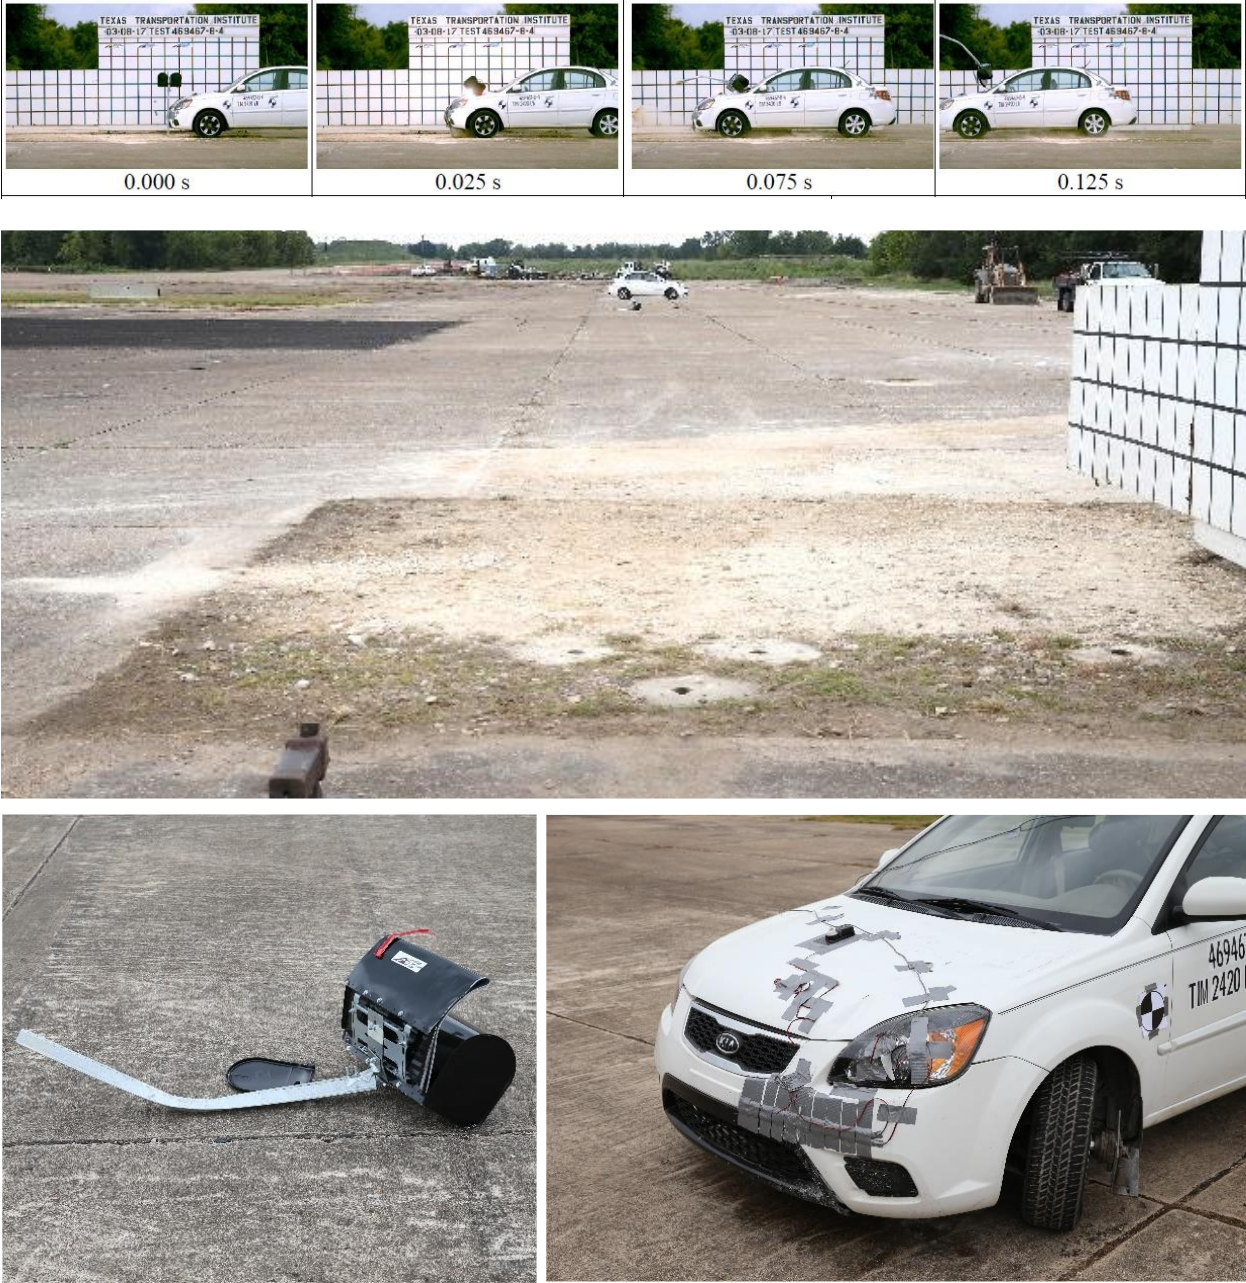
Figure 3. TxDOT Winged-Channel Mailbox Support - Test No. 469467-8-4, Test Results

impacted the mailbox at a speed of 63.3 mph and an angle of 0 degrees. Following initial impact, the support post deformed about the front bumper of the vehicle, which caused the mailbox to be pulled down onto the vehicle's hood. As the vehicle proceeded downstream, the support post fractured near the ground line, and the support post and mailbox were propelled up and over the top of the vehicle. The mailbox remained attached to the support post throughout the impact. The test was deemed acceptable according to the MASH criteria as all occupant risk criteria and occupant compartment deformation and penetration criteria were met during the test. Post test photographs and sequential images of the test are shown in Figure 3. A summary of the relevant test results is shown in Table 1.

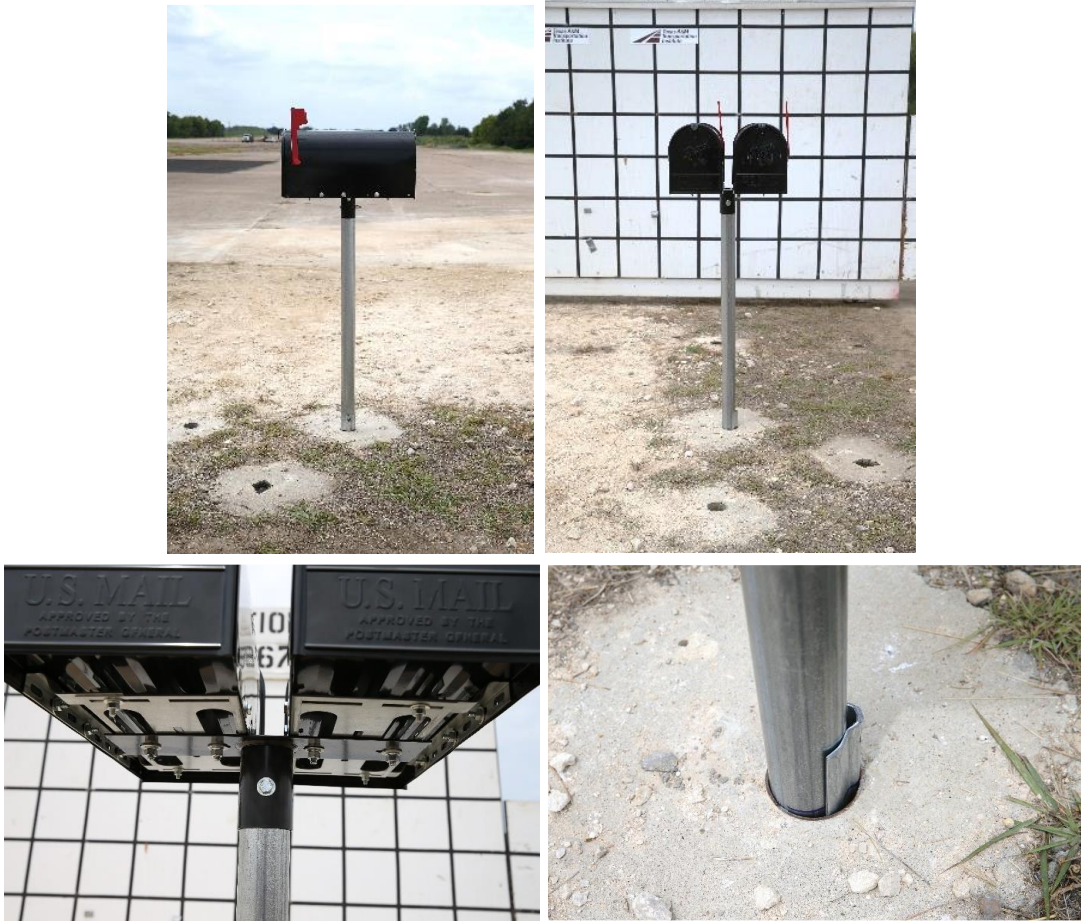
Mail Box	Mailbox Attachment	Mailbox-to-Post Bracket	Support Base	Support Post	Base-to-Post Attachment
<ul style="list-style-type: none"> • Dual Mailbox • Elite No. 1-A mailbox (#E1600B00) • 11 in. tall x 8 ¾ in. wide x 21½ in. deep • Steel • 7 lb (20 lb for mailboxes and bracket) • 42-in. mounting height 	<ul style="list-style-type: none"> • Bracket to Post – two 5/16-in. diameter SAE Grade 5 bolts • Angle bracket to bracket plate – two 3/8-in. diameter SAE Grade 5 Bolts • Bracket plate to bracket mount and mailbox – four 3/8-in. diameter SAE grade 5 bolts • Extension bracket to bracket mount and mailbox six 1/4-in. bolts per unit 	<ul style="list-style-type: none"> • Bracket mount DHT#148939 • Extension bracket DHT#148938 • Collar bracket DHT#162323 	<p>Plastic in reinforced concrete footing (12 in. in diameter x 30 in. deep)</p>	<ul style="list-style-type: none"> • 2 3/8-in. outside diameter 16 gauge thick • ASTM A513 Type5 DOM • 57 in. long • 7.5 lb 	<p>Socketed with locking wedge and 15-in. embedment</p>

Figure 4. TxDOT Double Mailbox System on Thin-Walled Galvanized Tube - Test No. 469467-8-3

TTI conducted MASH TL-3 crash testing on two mailboxes attached to a galvanized thin-wall steel tube support secured inside a 12-gauge galvanized anchor socket embedded in a concrete footing with a curved steel plate wedge, as shown in Figure 4 [5]. Two Elite No. 1-A standard arched-top mailboxes, Gibraltar Industries Model #E1600B00, were attached to the top of the support post. The Elite mailbox had approximate dimensions of 11 in. tall × 8¾ in. wide × 21½ in. deep and weighed 7 lb. Attachment of each mailbox to the post was accomplished using a mailbox bracket (DHT #148939), one extension bracket (DHT #148938), and associated SAE Grade 5 bolts, nuts, and washers. The mailboxes, located 10 in. center to center, were secured plate and collar bracket (DHT #162323) that was attached to the support post using a ¾-in. diameter × 3½-in. long SAE Grade 5 hex bolt, flat and lock washers, and nut.

The two mailboxes were supported on a nominal 2-in. diameter × 16-gauge thick (2⅜-in. outside diameter × 0.065-in. wall thickness) galvanized thin-wall steel tube (DHT #143426) formed from ASTM A513 Type 5 DOM steel tubing. The overall length of the support post was 57 in. The support post was inserted approximately 15 in. into a socket (DHT #143434) and secured with a wedge (DHT #143433) on the impact side. The socket was embedded 27 in. deep and installed flush with the top of a TxDOT Type 2 non-reinforced concrete footer that measured approximately 12 in. in diameter × 30 in. deep.

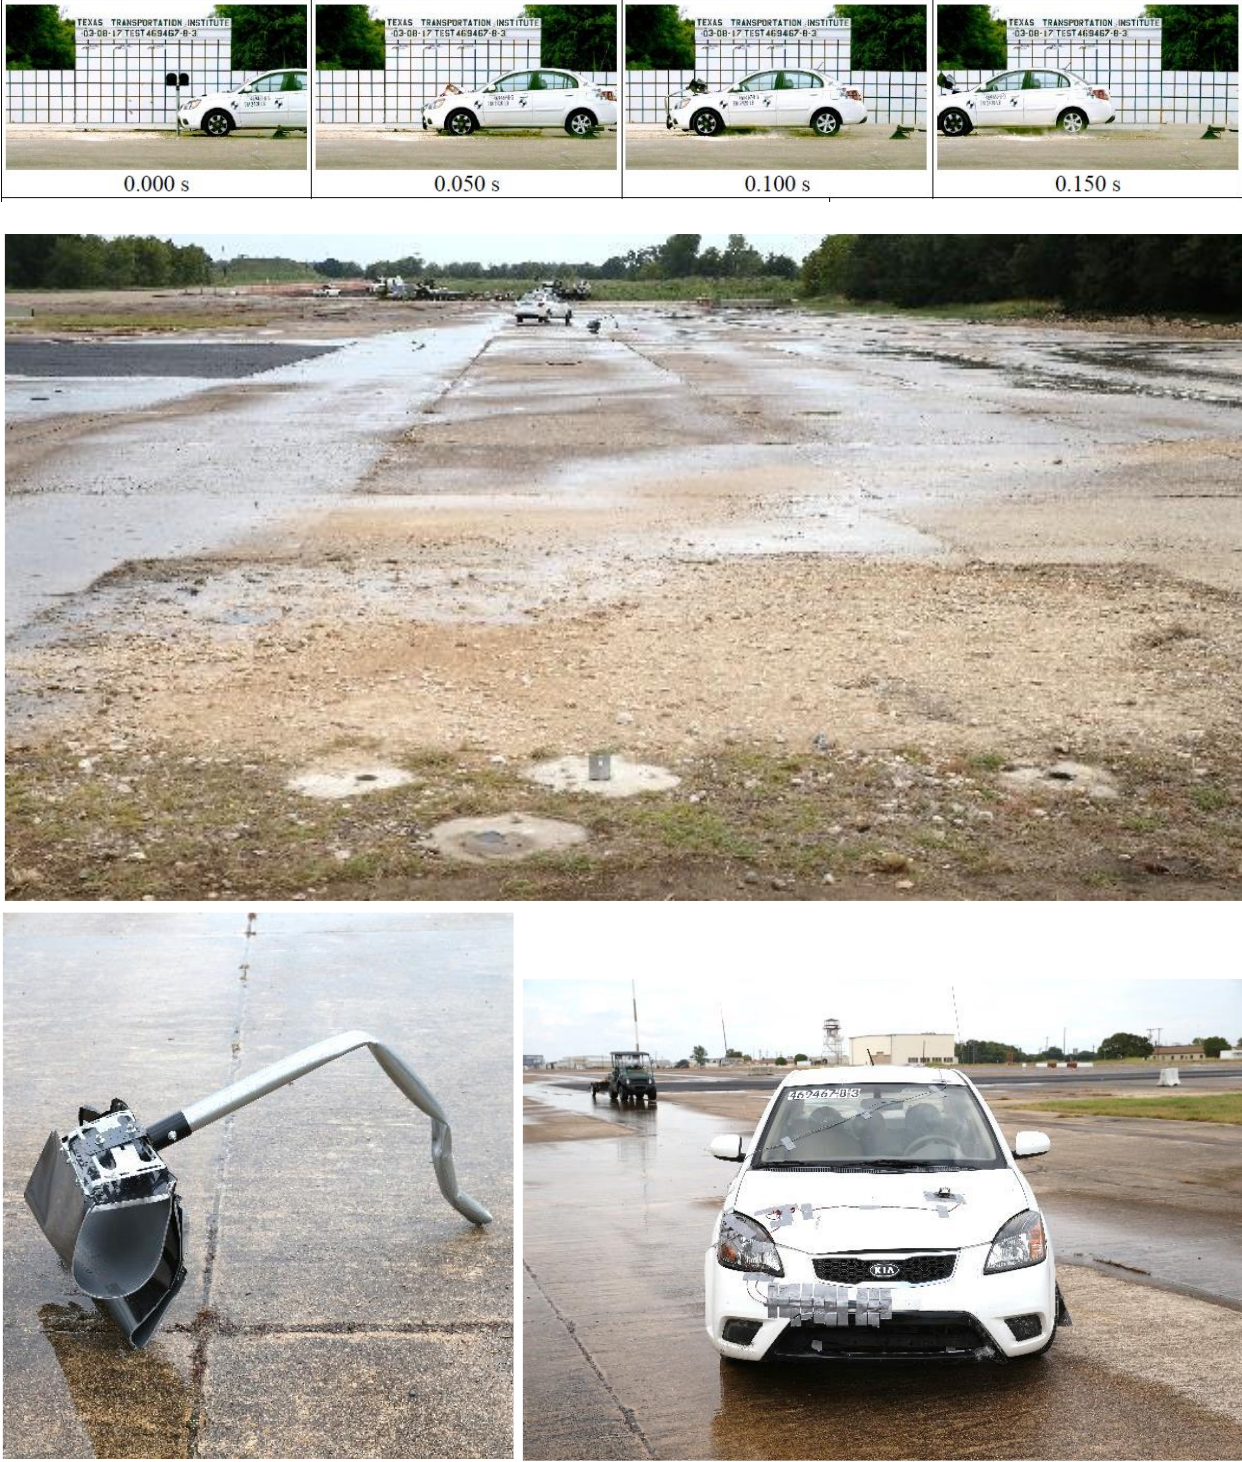
Figure 5. TxDOT Double Mailbox System on Thin-Walled Galvanized Tube - Test No. 469467-8-3, Test Results

The mailbox system was evaluated using MASH test designation no. 3-61, which consisted of a 2,420-lb 1100C small car vehicle impacting the mailbox system at an impact speed of 62 mph and an angle of 0 degrees with a ¼ vehicle offset. In test no. 469467-8-3, the test vehicle impacted the mailbox system at 62.5 mph and an angle of 0 degrees. Following initial impact, the support post deformed about the front bumper of the vehicle, which caused the mailbox to be pulled down onto the vehicle's hood. As the vehicle proceeded downstream, the support post fractured near the ground line, and the support post and mailbox were propelled forward. The mailbox remained attached to the support post throughout the impact. The test was deemed acceptable according to the MASH criteria as all occupant risk criteria and occupant compartment deformation and penetration criteria were met during the test. Post test photo photographs and sequential images of the test are shown in Table 2. A summary of the relevant test results is shown in Figure 5.

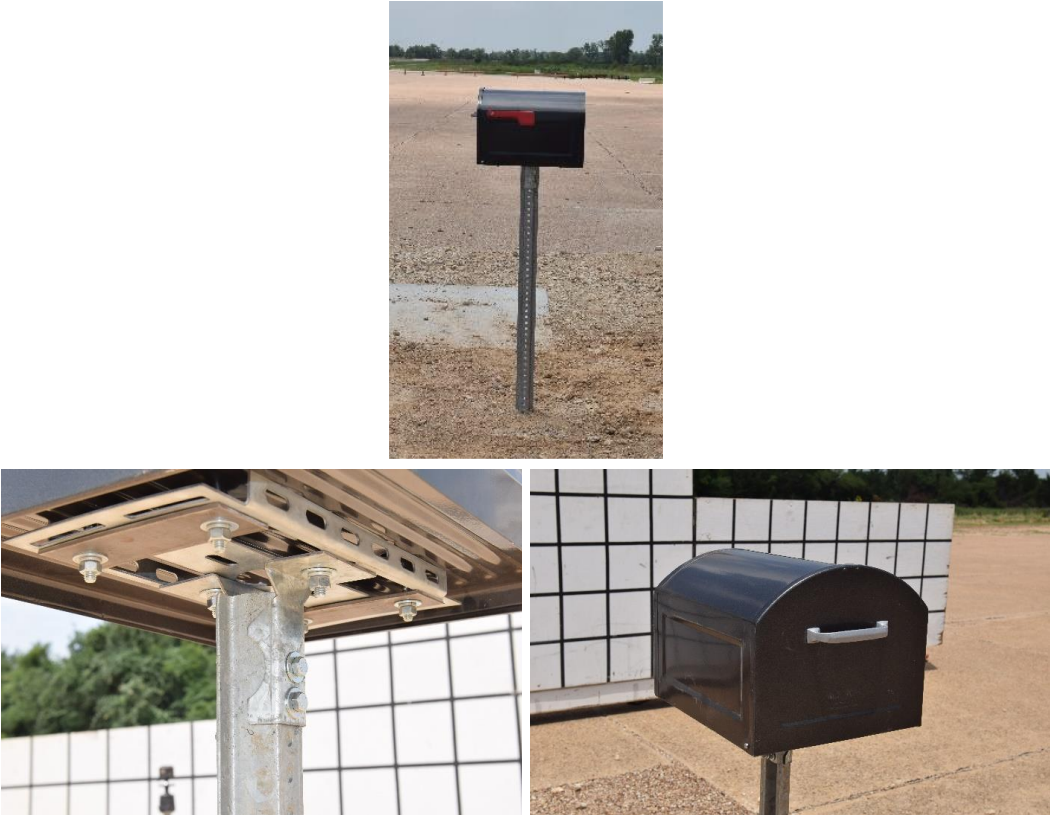
Mail Box	Mailbox Attachment	Mailbox-to-Post Bracket	Support Base	Support Post	Base-to-Post Attachment
<ul style="list-style-type: none"> • Single Mailbox • Architectural Mailboxes© Centennial model #950020B • Steel • 11.8 lb • 42-in. mounting height 	<ul style="list-style-type: none"> • Angle bracket to post – two ⁵/₁₆-in. diameter SAE Grade 5 Bolts • Angle bracket to bracket mount - two ³/₈-in. diameter SAE grade 5 bolts • Bracket mount and mailbox four ⁵/₁₆-in. diameter SAE Grade 5 bolts and plate washers 	<ul style="list-style-type: none"> • Bracket mount DHT# 148939 • Angle bracket DHT# 159489 	<p>none</p>	<ul style="list-style-type: none"> • 2 lb/ft steel perforated U-channel post (DHT #4289) fabricated from ASTM A1011 structural Grade 50 	<p>30-in. embedment</p>

Figure 6. TxDOT Large Mailbox on Type 3 Support - Test No. 469689-1-3

TTI conducted MASH TL-3 crash testing on a single large mailbox mounted on a 2-lb/ft U-channel post, as shown in Figure 6 [6]. A single Architectural Mailboxes® Centennial model #950020B extra-large mailbox was mounted on a 2-lb/ft perforated U-channel post. The mailbox was attached to the post via angle brackets using a model DHT #148939 mailbox bracket. Two steel plate washers measuring 2 in. × 5½ in. × ⅛ in. thick and four 5/16-in. diameter hex bolts secured the bracket assembly to the floor of the mailbox. The post was embedded 30 in. into the soil. The bottom of the mailbox was located 42 in. above grade.

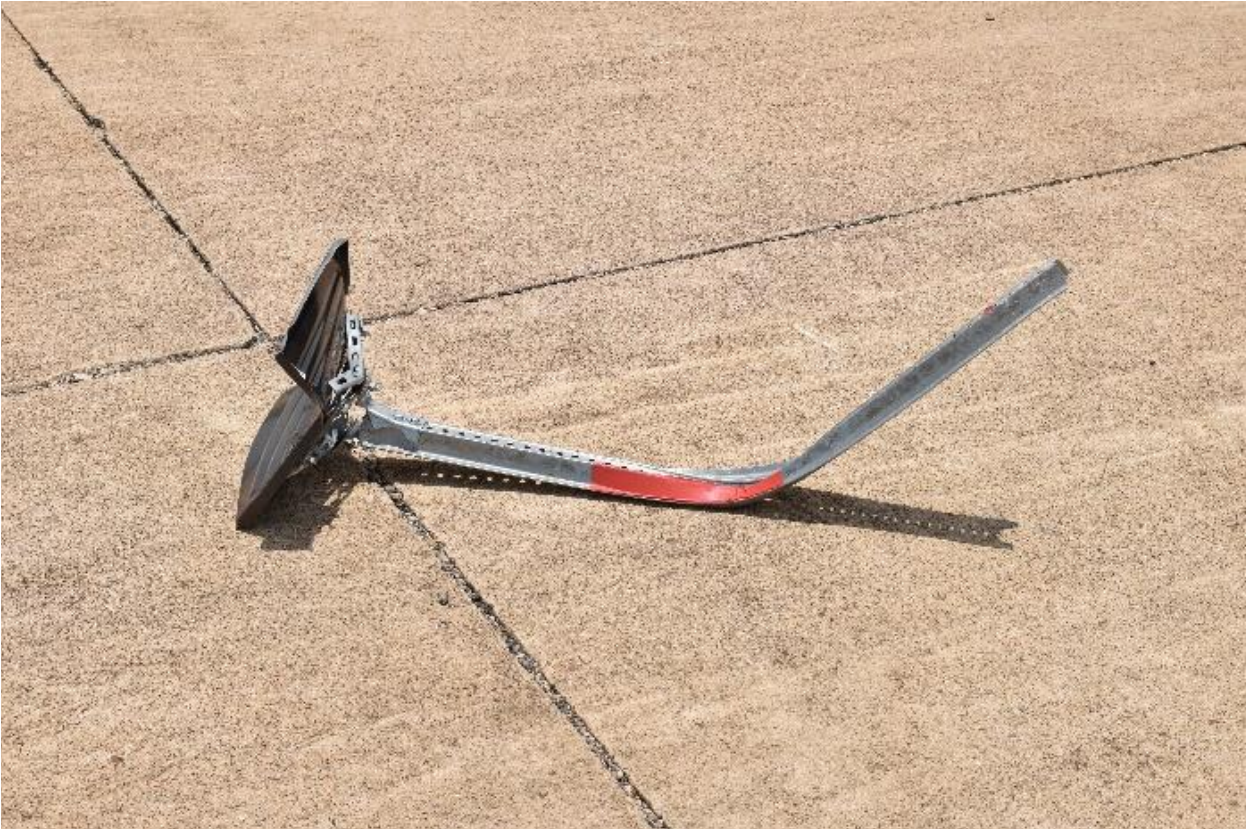
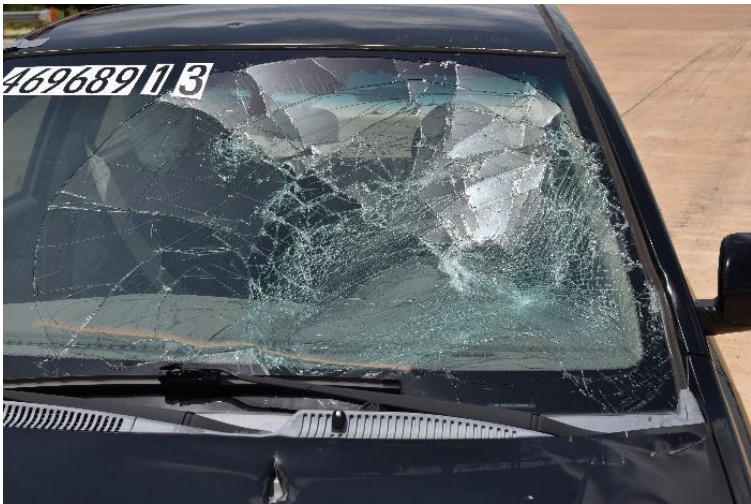
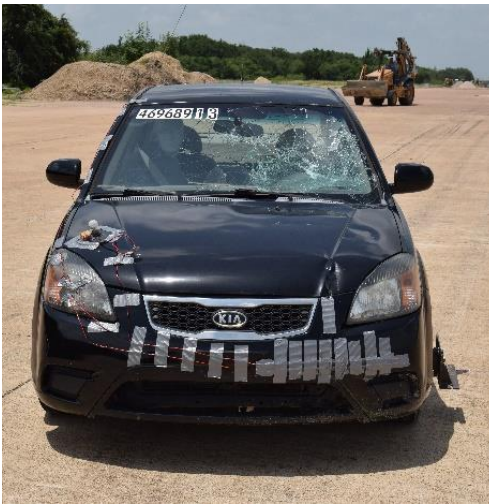
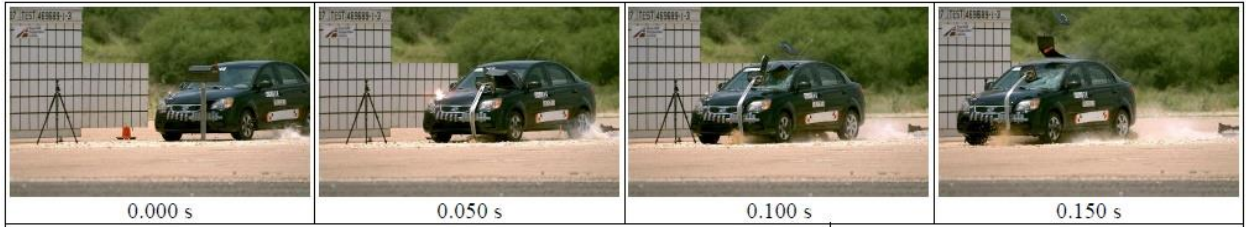
Figure 7. TxDOT Large Mailbox on Type 3 Support - Test No. 469689-1-3, Test Results

The mailbox system was evaluated using MASH test designation no. 3-61, which consisted of a 2,420-lb 1100C small car vehicle impacting the mailbox system at an impact speed of 62 mph and an angle of 0 degrees with a ¼ vehicle offset. In test no. 469689-1-3, the test vehicle impacted the mailbox system at 63.9 mph and an angle of 0 degrees. Following initial impact, the support post of the mailbox deformed about the front bumper of the vehicle which caused the mailbox to be pulled down onto the hood of the vehicle. As the vehicle proceeded downstream, the support post was pulled from the ground. The upper section of the mailbox detached from its base which remained attached to the support post. The detached upper section of the mailbox then impacted the windshield, causing 4.6 in. of deformation to the windshield and creating a tear in the windshield lining. The test was deemed unacceptable according to the MASH criteria due to the windshield damage observed during the test. Post test photographs and sequential images of the test are shown in Figure 7. A summary of the relevant test results is shown in Table 3.

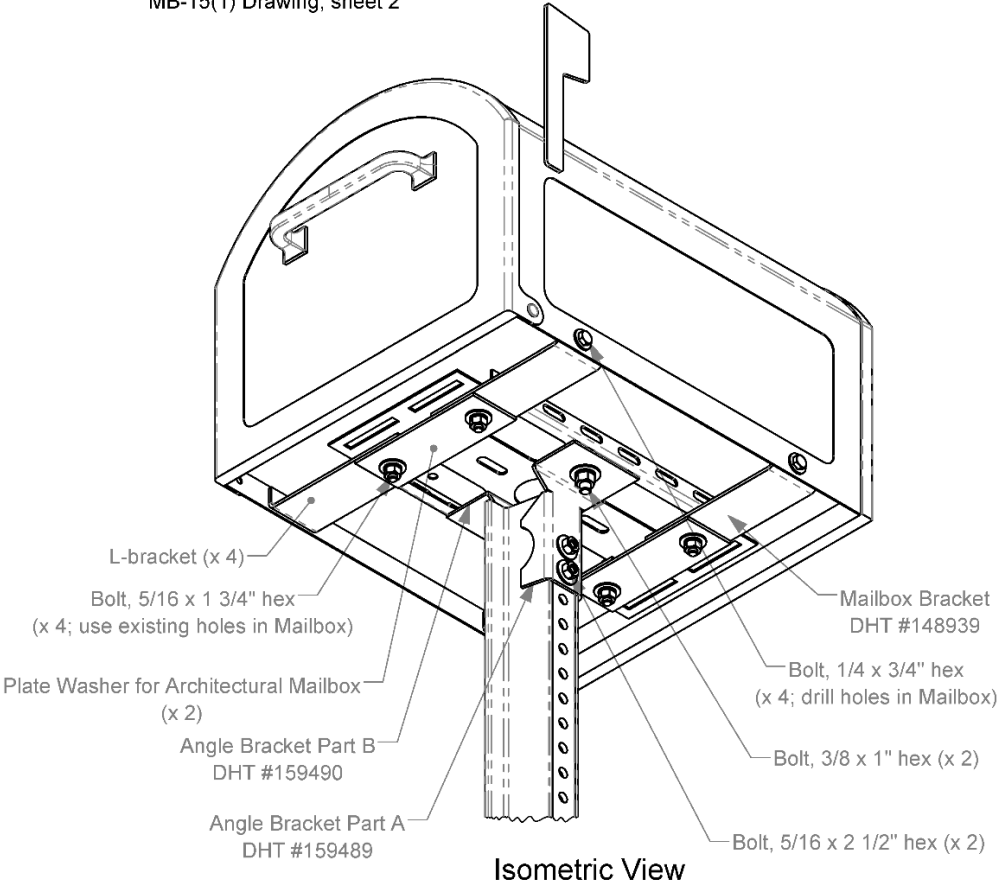
Connection Details

Plate Washer details from TxDOT
MB-15(1) Drawing, sheet 2

Figure 8. TxDOT Large Mailbox on Type 3 Support - Test No. 469689-1-4

Following the failure observed in test no. 469689-1-3, TTI modified the mailbox-to-support post attachment with the addition of four slotted L brackets measuring 2 in. × 6 in. × ⅞ in. × ⅛ in thick. The L-brackets allowed for attachment using four additional ¼-in. diameter hex bolts on the side flanges of the mailbox, as shown in Figure 8. TTI conducted a repeat test using the modified version of the single large mailbox mounted on a 2-lb/ft U-channel post. In test no. 469689-1-4, the test vehicle impacted the mailbox system at 63.9 mph and an angle of 0 degrees. Following initial impact, the support post deformed about the front bumper of the vehicle, which caused the mailbox to be pulled down onto the vehicle’s hood. As the vehicle proceeded downstream, the support post was pulled from the ground. The mailbox remained attached to the

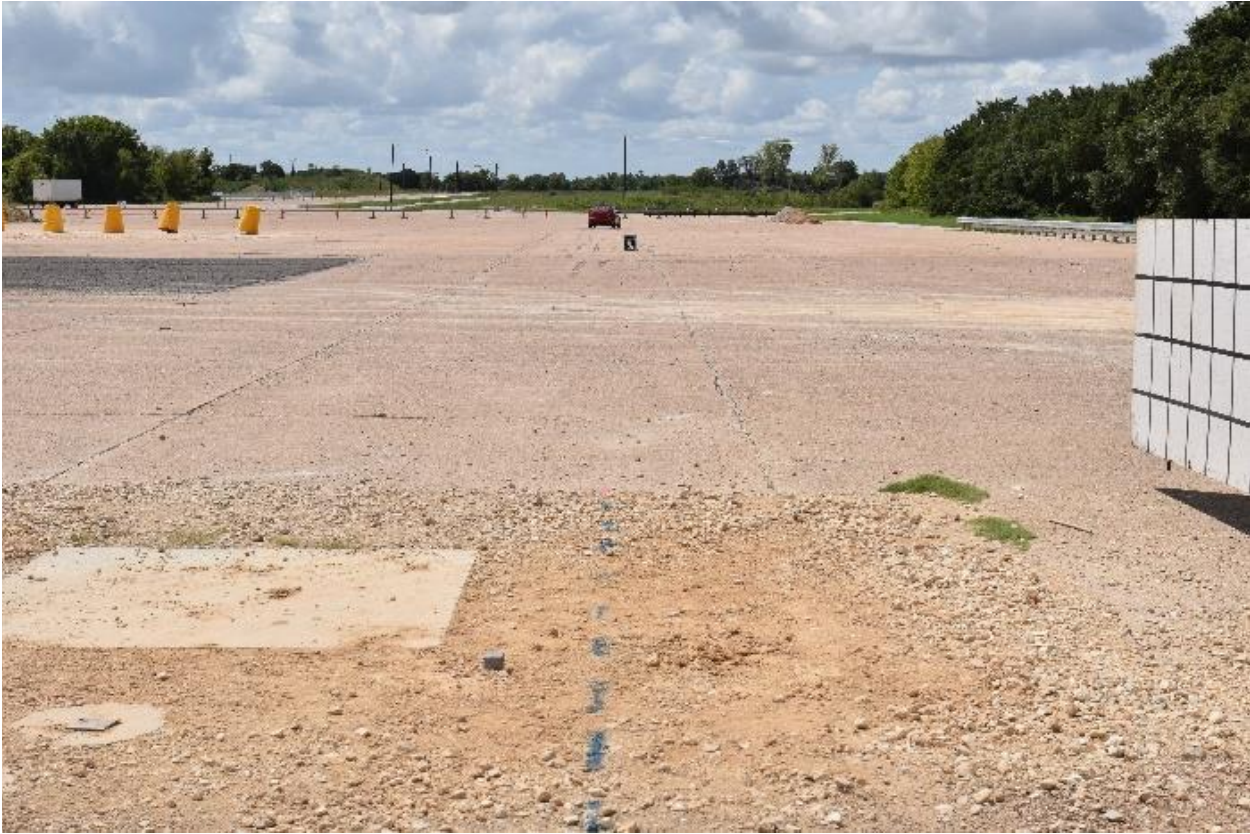
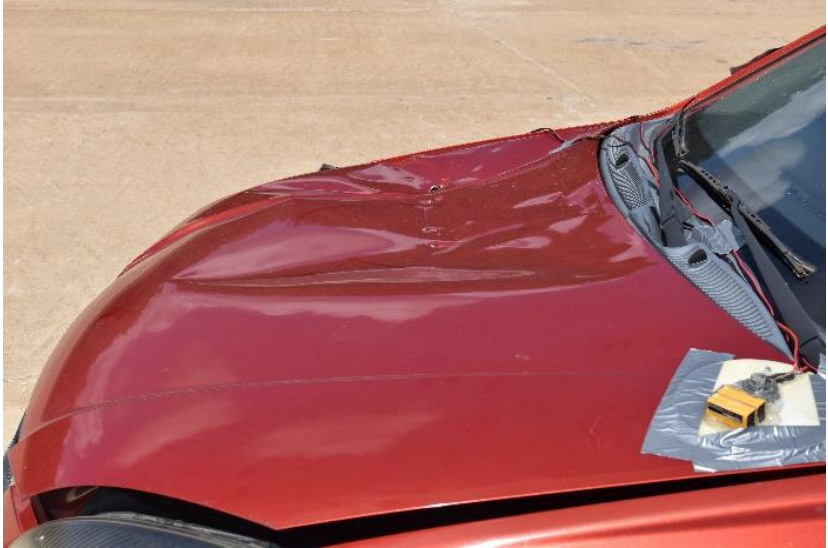
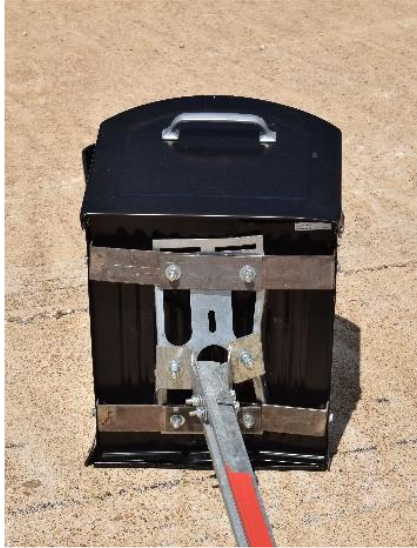
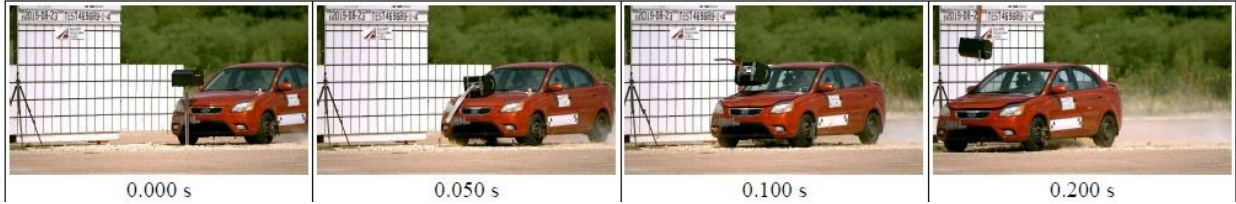
Figure 9. TxDOT Large Mailbox on Type 3 Support - Test No. 469689-1-4, Test Results

support post and was eventually propelled up and over the vehicle. The test was deemed acceptable according to the MASH criteria as all occupant risk criteria and occupant compartment deformation and penetration criteria were met during the test. Post test photographs and sequential images of the test are shown in Figure 9. A summary of the relevant test results is shown in Table 4.

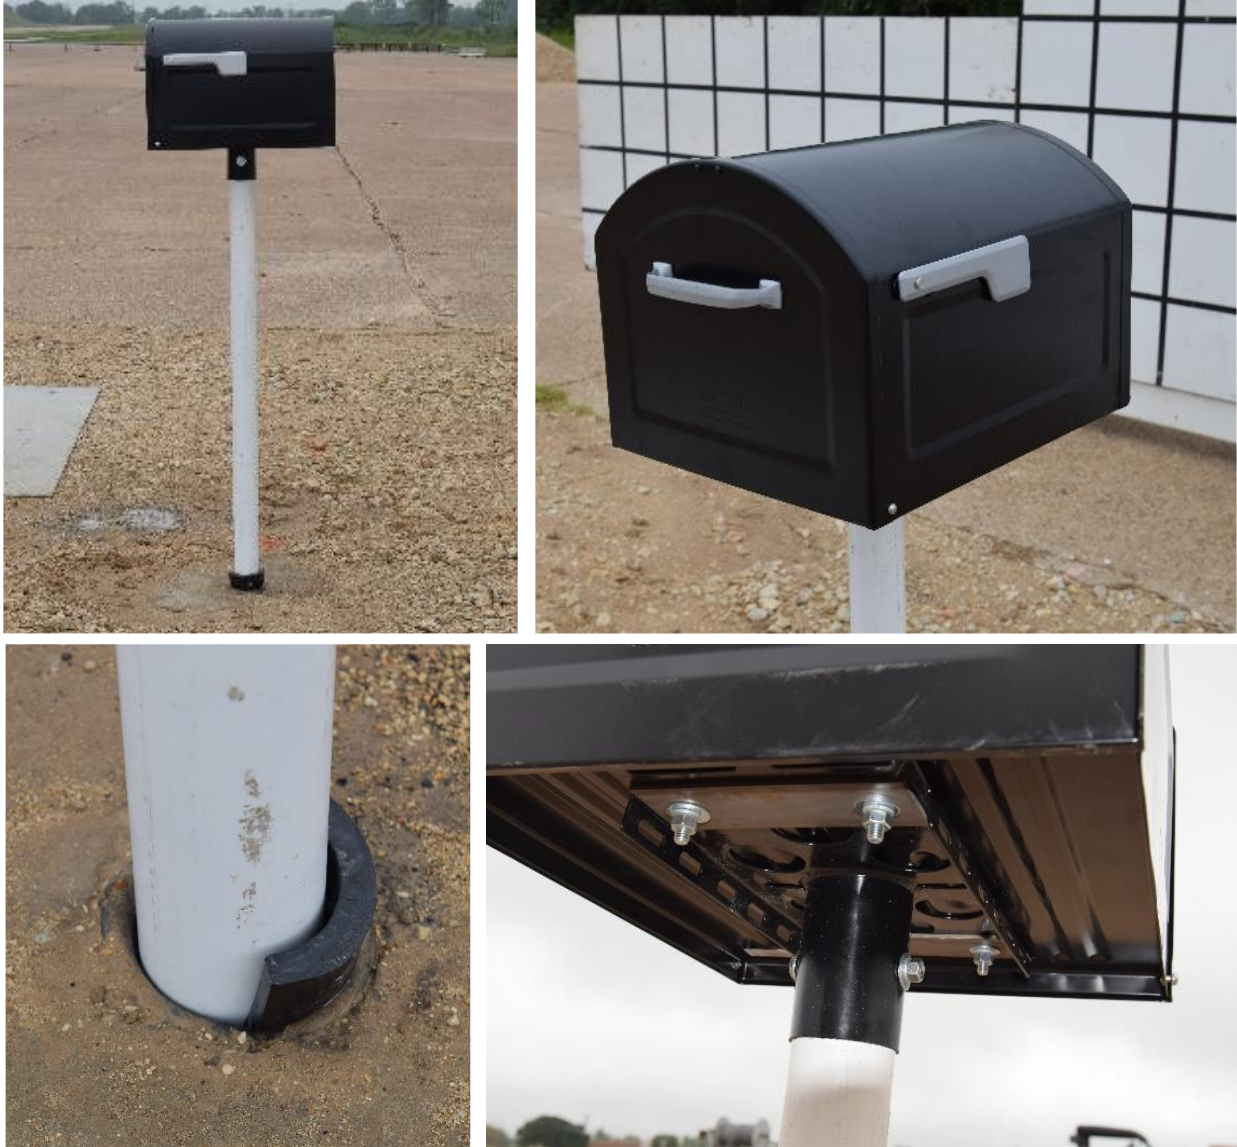
Mail Box	Mailbox Attachment	Mailbox-to-Post Bracket	Support Base	Support Post	Base-to-Post Attachment
<ul style="list-style-type: none"> • Single Mailbox • Architectural Mailboxes© Centennial model #950020B • Steel • 11.8 lb • 42-in. mounting height 	<ul style="list-style-type: none"> • Bracket to post – one 5/16-in. diameter SAE Grade 5 bolts • Bracket mount and mailbox four 5/16-in. diameter SAE Grade 5 bolts 	<ul style="list-style-type: none"> • Bracket mount DHT# 161443 	Plastic socket in reinforced concrete footing (12 in. in diameter x 30 in. deep)	<ul style="list-style-type: none"> • 2 3/8-in. outside diameter x 0.095-in. thick • DHT#162991 • 54.5 in. long 	Socketed with locking wedge and 12.5-in. embedment

Figure 10. TxDOT Large Mailbox on Type 4 Support - Test No. 469689-1-1

TTI conducted MASH TL-3 crash testing of a single large mailbox mounted on a 2-lb/ft u-channel post, as shown in Figure 10 [6]. A single Architectural Mailboxes© Centennial model #950020B extra-large mailbox was mounted on a 2³/₈-in. diameter × 0.095-in. thick steel tube post. The mailbox was attached to the post using a model DHT #161443 mailbox bracket. Two steel plate washers measuring 2 in. × 5½ in. × ¼-in. thick and four ⁵/₁₆-in. diameter hex bolts that secured the bracket assembly to the floor of the mailbox, and a ⁵/₁₆-in. bolt secured the bracket to the post. The post was inserted into a plastic socket and secured with a plastic wedge. This wedge socket was set in a non-reinforced cylindrical concrete foundation measuring 12 in. in diameter × 30 in. deep. The bottom of the mailbox was located 42 in. above grade.

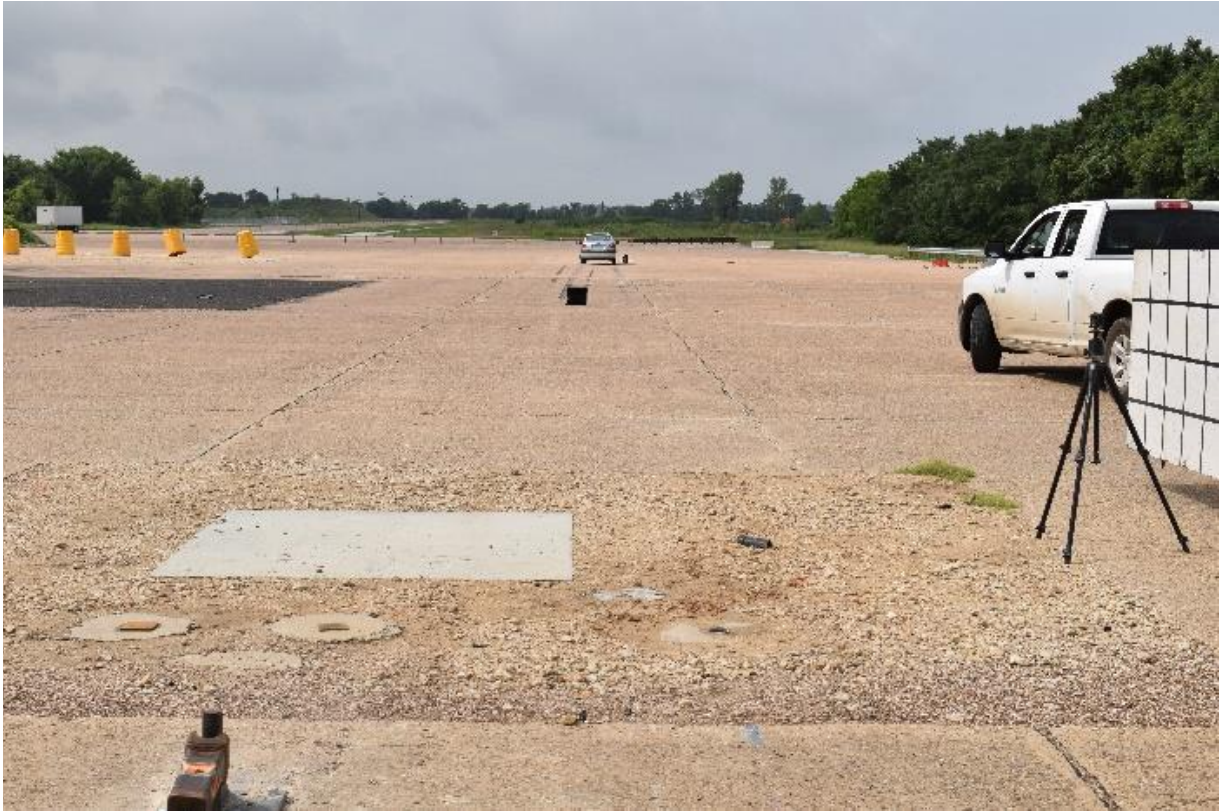
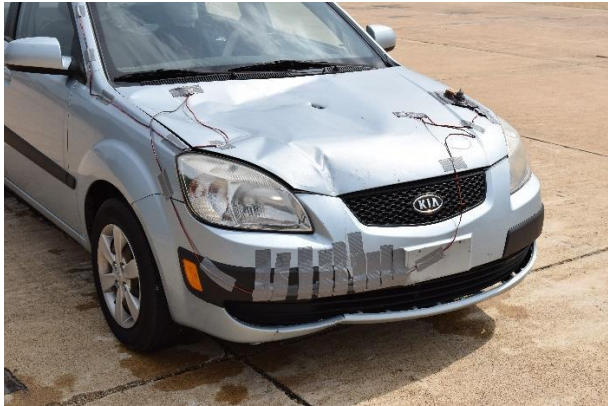
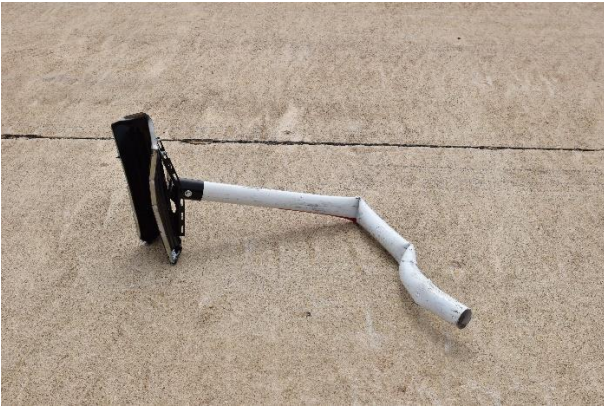
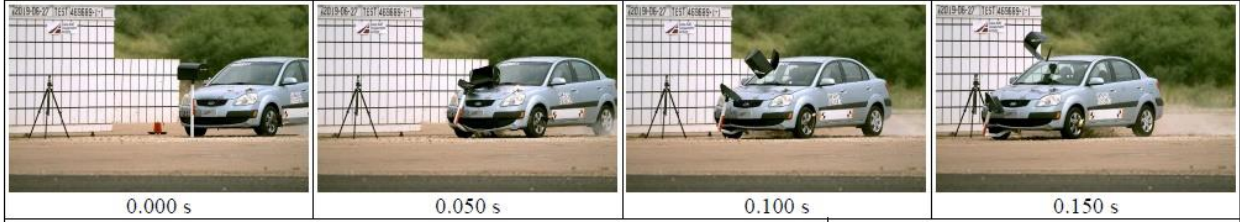
Figure 11. TxDOT Large Mailbox on Type 4 Support - Test No. 469689-1-1, Test Results

The mailbox system was evaluated using MASH test designation no. 3-61, which consisted of a 2,420-lb 1100C small car vehicle impacting the mailbox system at an impact speed of 62 mph and an angle of 0 degrees with a ¼ vehicle offset. In test no. 469689-1-1, the test vehicle impacted the mailbox system at a speed of 63.6 mph and an angle of 0 degrees. Following initial impact, the support post deformed about the front bumper of the vehicle, which caused the mailbox to be pulled down onto the hood of the vehicle. The mailbox detached from the support post after contacting the hood and was propelled up and over the vehicle. As the vehicle proceeded downstream, the support was pulled out of its base at the ground line and pushed in front of the vehicle. The test was deemed acceptable according to the MASH criteria as all occupant risk criteria and occupant compartment deformation and penetration criteria were met during the test. Post test photographs and sequential images of the test are shown in Figure 11. A summary of the relevant test results is shown in Table 5.

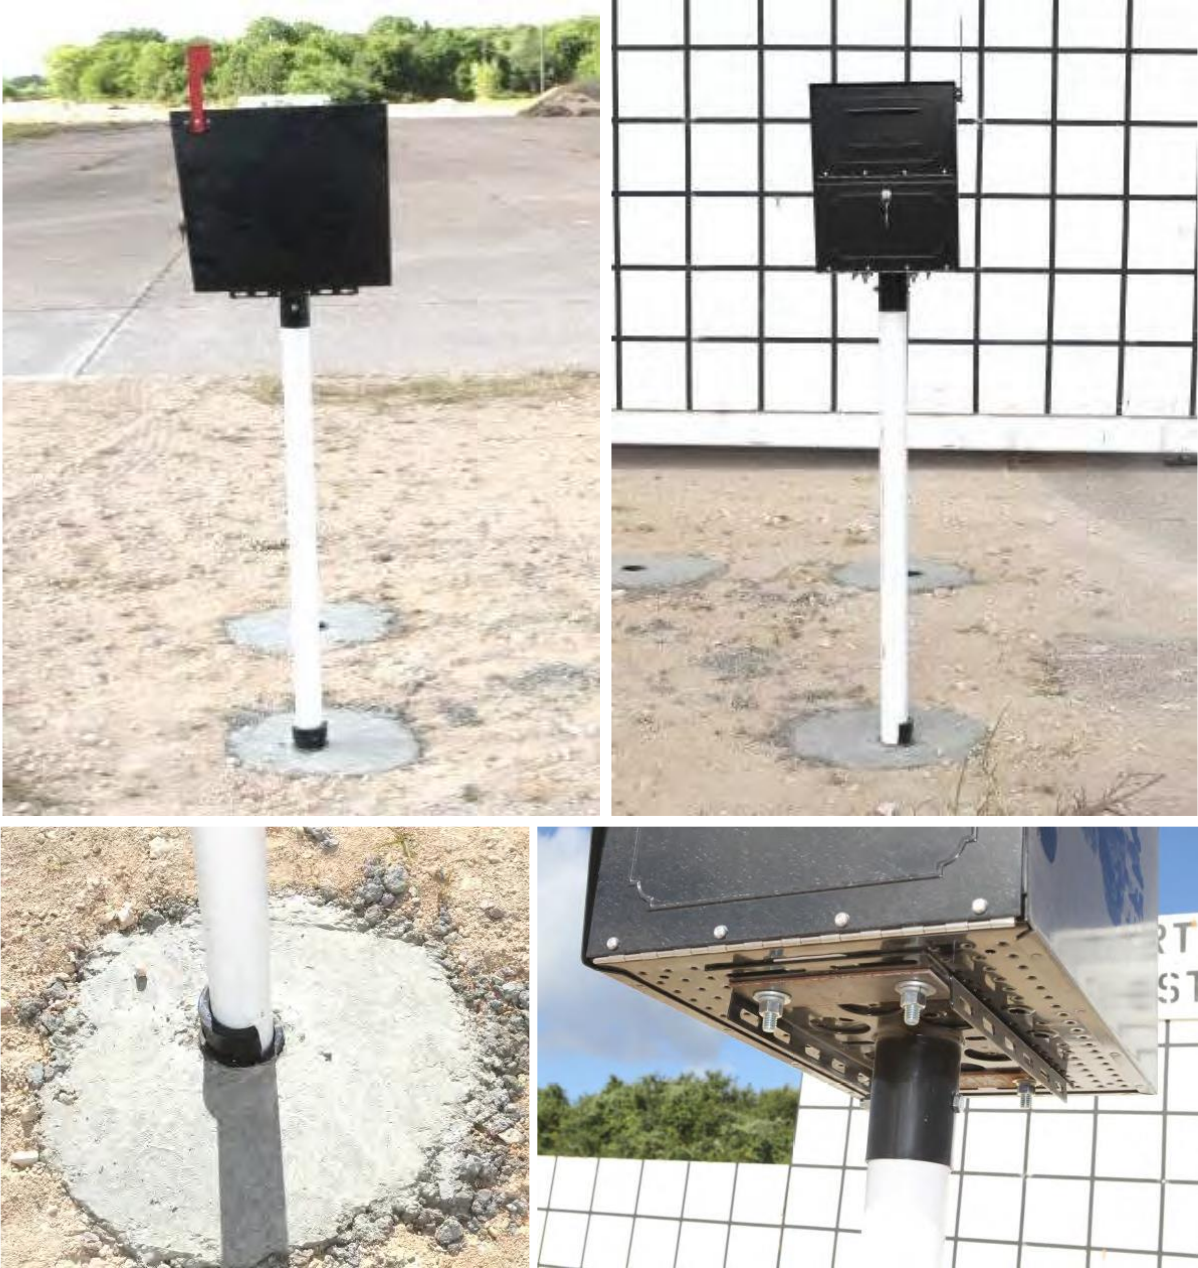
Mail Box	Mailbox Attachment	Mailbox-to-Post Bracket	Support Base	Support Post	Base-to-Post Attachment
<ul style="list-style-type: none"> • Single Mailbox • 15 in. tall x 11½ in. wide x 18 in. deep • 16-gauge and 14-gauge steel • 22.6 lb • 42-in. mounting height 	<ul style="list-style-type: none"> • Four ¾-in. diameter SAE Grade 5 bolts • ½-in. plate washer 	<ul style="list-style-type: none"> • Bracket DHT# 161443 	<ul style="list-style-type: none"> • Plastic socket in reinforced concrete footing (12 in. in diameter x 24 in. deep) 	<ul style="list-style-type: none"> • SHUR-TITE® mailbox post • 2⅝-in. outside diameter x 0.095-in. thick steel tube 	<ul style="list-style-type: none"> • Socketed with locking wedge and 12.5-in. embedment

Figure 12. Locking Architectural Mailbox on Single Mount Post - Test No. 490023-9-1

TTI conducted MASH TL-3 crash testing on a single, locking architectural mailbox mounted on a single 2.375-in. outside diameter (OD) thin-wall steel tube (DHT #162911), which was installed in a plastic socket (DHT #160891) that was embedded in a concrete footing, as shown in Figure 12 [7]. The mailbox tested was an Oasis Jr manufactured by Architectural Mailboxes, LLC. It was fabricated from 16-gauge and 14-gauge galvanized steel and had a black powder-coat finish. The mailbox was 15 in. tall × 11½ in. wide × 18 in. deep and weighed 22.6 lb.

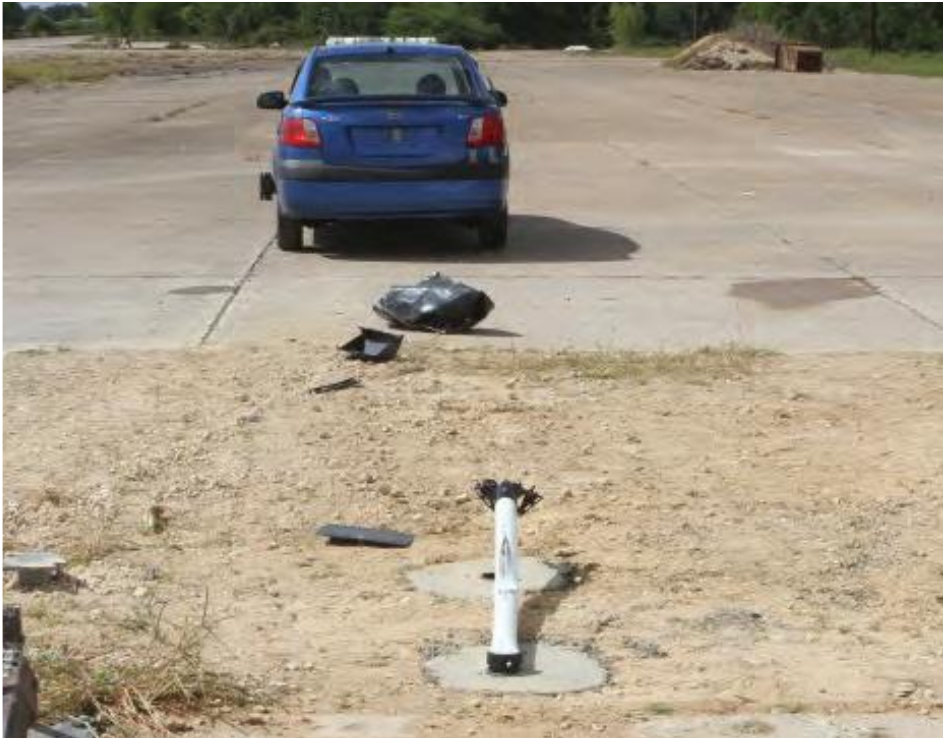
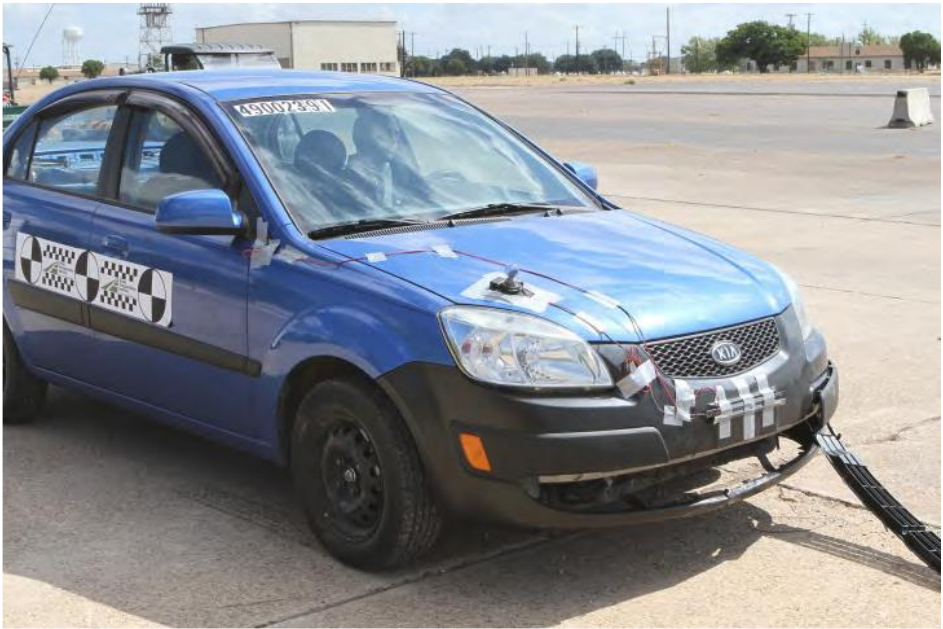
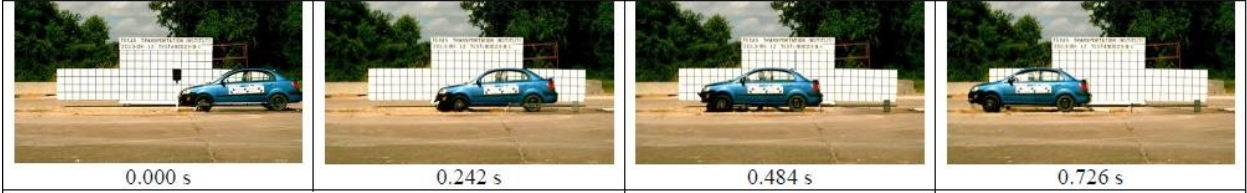
Figure 13. Locking Architectural Mailbox on Single Mount Post - Test No. 490023-9-1, Test Results

The mailbox system was evaluated using MASH test designation no. 3-60 , which consisted of a 2,420-lb 1100C small car vehicle impacting the mailbox system at an impact speed of 19 mph and an angle of 0 degrees with a ¼ vehicle offset; and test designation no. 3-61, which consisted of a 2,420-lb 1100C small car vehicle impacting the mailbox system at an impact speed of 62 mph and an angle of 0 degrees with a ¼ vehicle offset. In test no. 490023-9-1 (test designation no. 3-60), the test vehicle impacted the mailbox system at 19.2 mph and an angle of 0 degrees. Following initial impact, the support post bent downward in front of the vehicle, which allowed the vehicle to override the post and mailbox. The mailbox detached from the support post as the assembly was overridden. The test was deemed acceptable according to the MASH criteria as all occupant risk criteria and occupant compartment deformation and penetration criteria were met during the test. Post test photographs and sequential images of the test are shown in Figure 13. A summary of the relevant test results is shown in Table 6.
