Research Project Number SPR-FY21(010)

CRASHWORTHY PERFORATED SQUARE STEEL TUBE (PSST) MAILBOX SUPPORT – PHASE I

MIDWEST ROADSIDE SAFETY FACILITY

MwRSF Research Report No. TRP-03-473-23

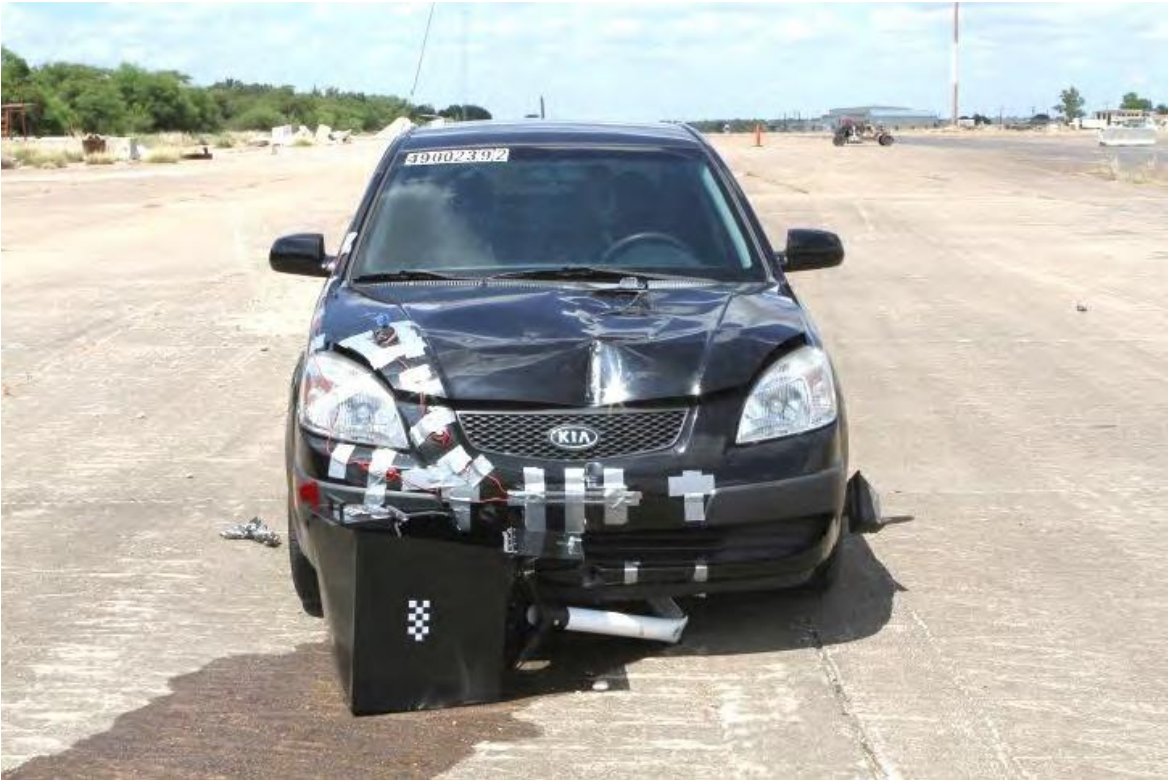
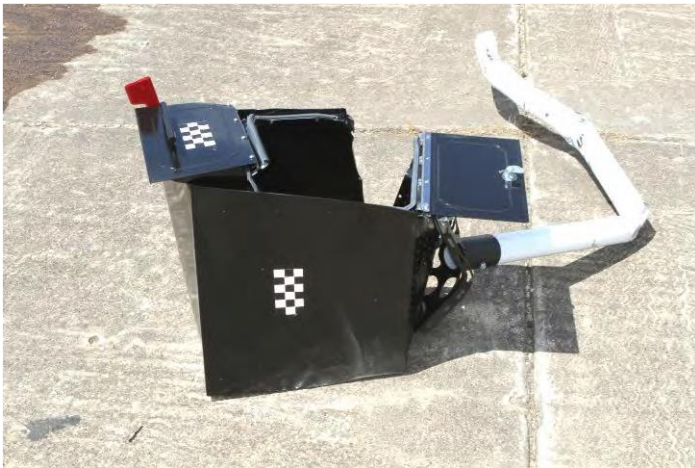
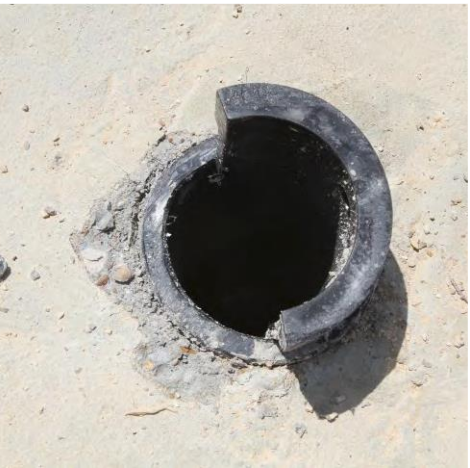
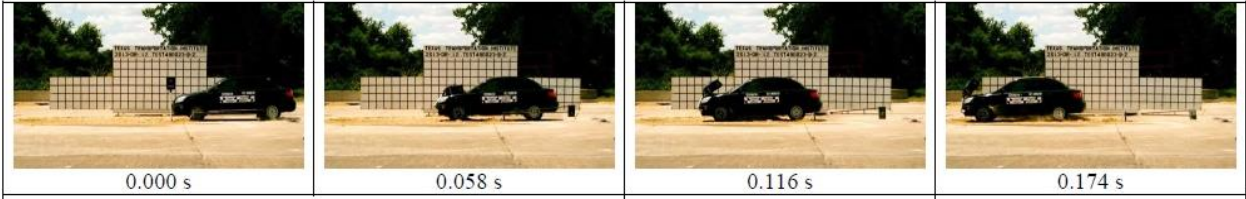
Figure 14. Locking Architectural Mailbox on Single Mount Post - Test No. 490023-9-2, Test Results

In test no. 490023-9-2 (test designation no. 3-61), the test vehicle impacted the mailbox system at 63.8 mph and an angle of 0 degrees. Following initial impact, the support post deformed about the front bumper of the vehicle, which caused the mailbox to be pulled down onto the vehicle's hood. The support post detached from the socket and was propelled downstream. The mailbox remained attached to the support post. The test was deemed acceptable according to the MASH criteria as all occupant risk criteria and occupant compartment deformation and penetration criteria were met during the test. Post test photographs and sequential images of the test are shown in Figure 14. A summary of the relevant test results is shown in Table 7.

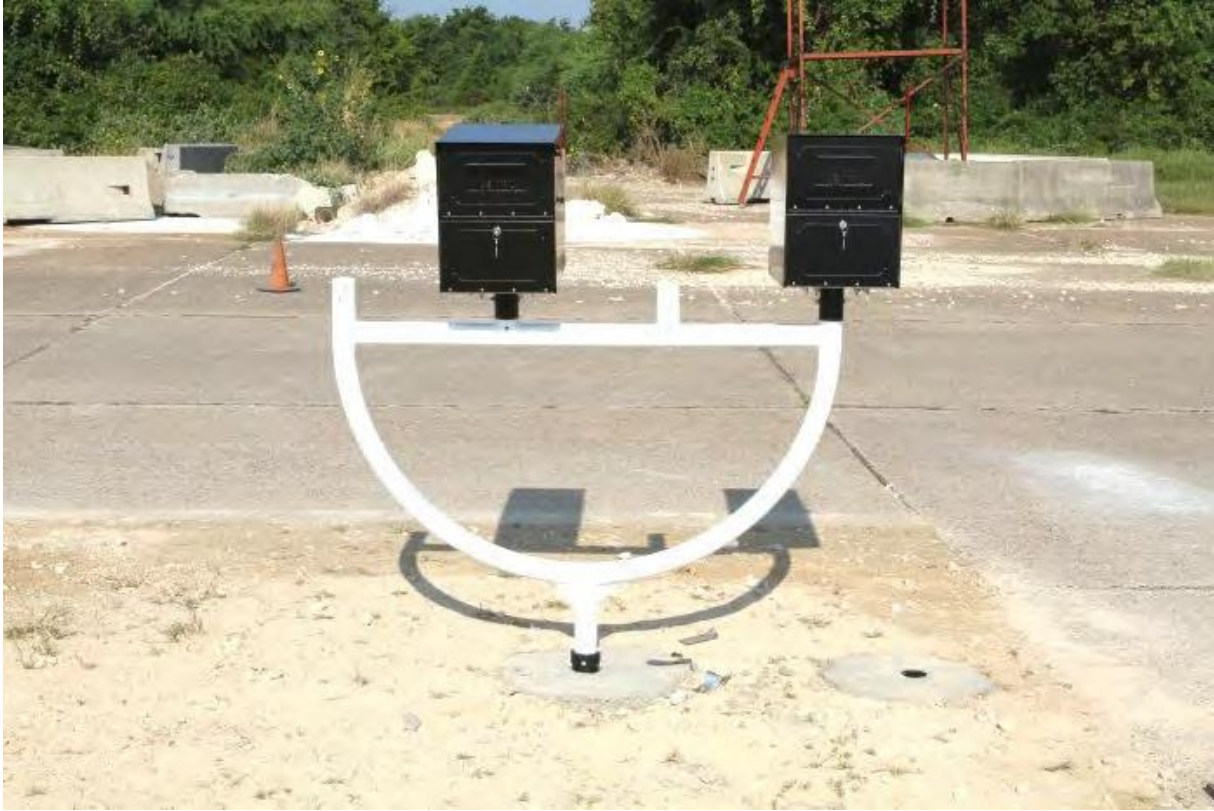
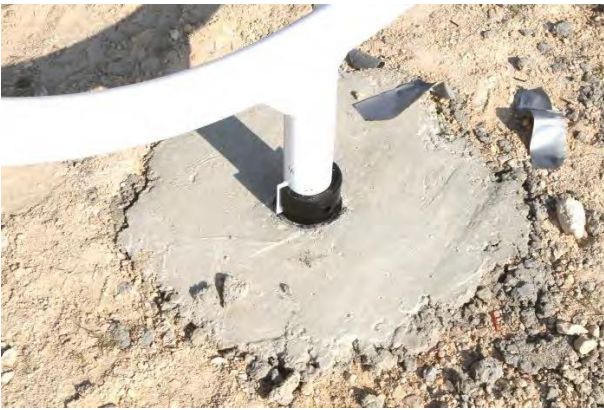
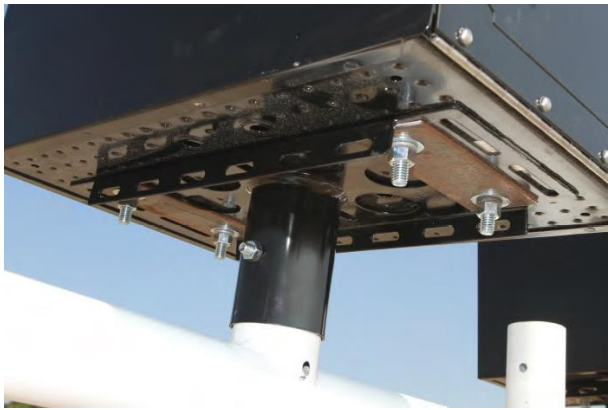
Mail Box	Mailbox Attachment	Mailbox-to-Post Bracket	Support Base	Support Post	Base-to-Post Attachment
<ul style="list-style-type: none"> • Dual Mailbox • 15 in. tall x 11½ in. wide x 18 in. deep • 16-gauge and 14-gauge steel • 22.6 lb each • 42-in. mounting height 	<ul style="list-style-type: none"> • Four ¾-in. diameter SAE Grade 5 bolts • ⅛-in. plate washer 	Bracket DHT# 161443	Plastic socket in reinforced concrete footing (12 in. in diameter x 30 in. deep)	<ul style="list-style-type: none"> • SHUR-TITE® mailbox post • 2⅜-in. outside diameter x 0.065-in. thick steel tube 	Socketed with locking wedge and 13-in. embedment

Figure 15. Locking Architectural Mailbox on Dual Mount Post - Test No. 490023-9-3

TTI conducted MASH TL-3 crash testing of a dual, locking architectural mailbox mounted on a SHUR-TITE® Products multiple mailbox post (DHT #164116) installed in a concrete footing using a plastic socket (DHT #160891) and wedge (DHT #160892), as shown Figure 15 [7]. The mailbox tested was an Oasis Jr. manufactured by Architectural Mailboxes, LLC. It was fabricated from 16-gauge and 14-gauge galvanized steel and had a black powder-coat finish. The mailbox was 15 in. tall × 11½ in. wide × 18 in. deep and weighed 22.6 lb.

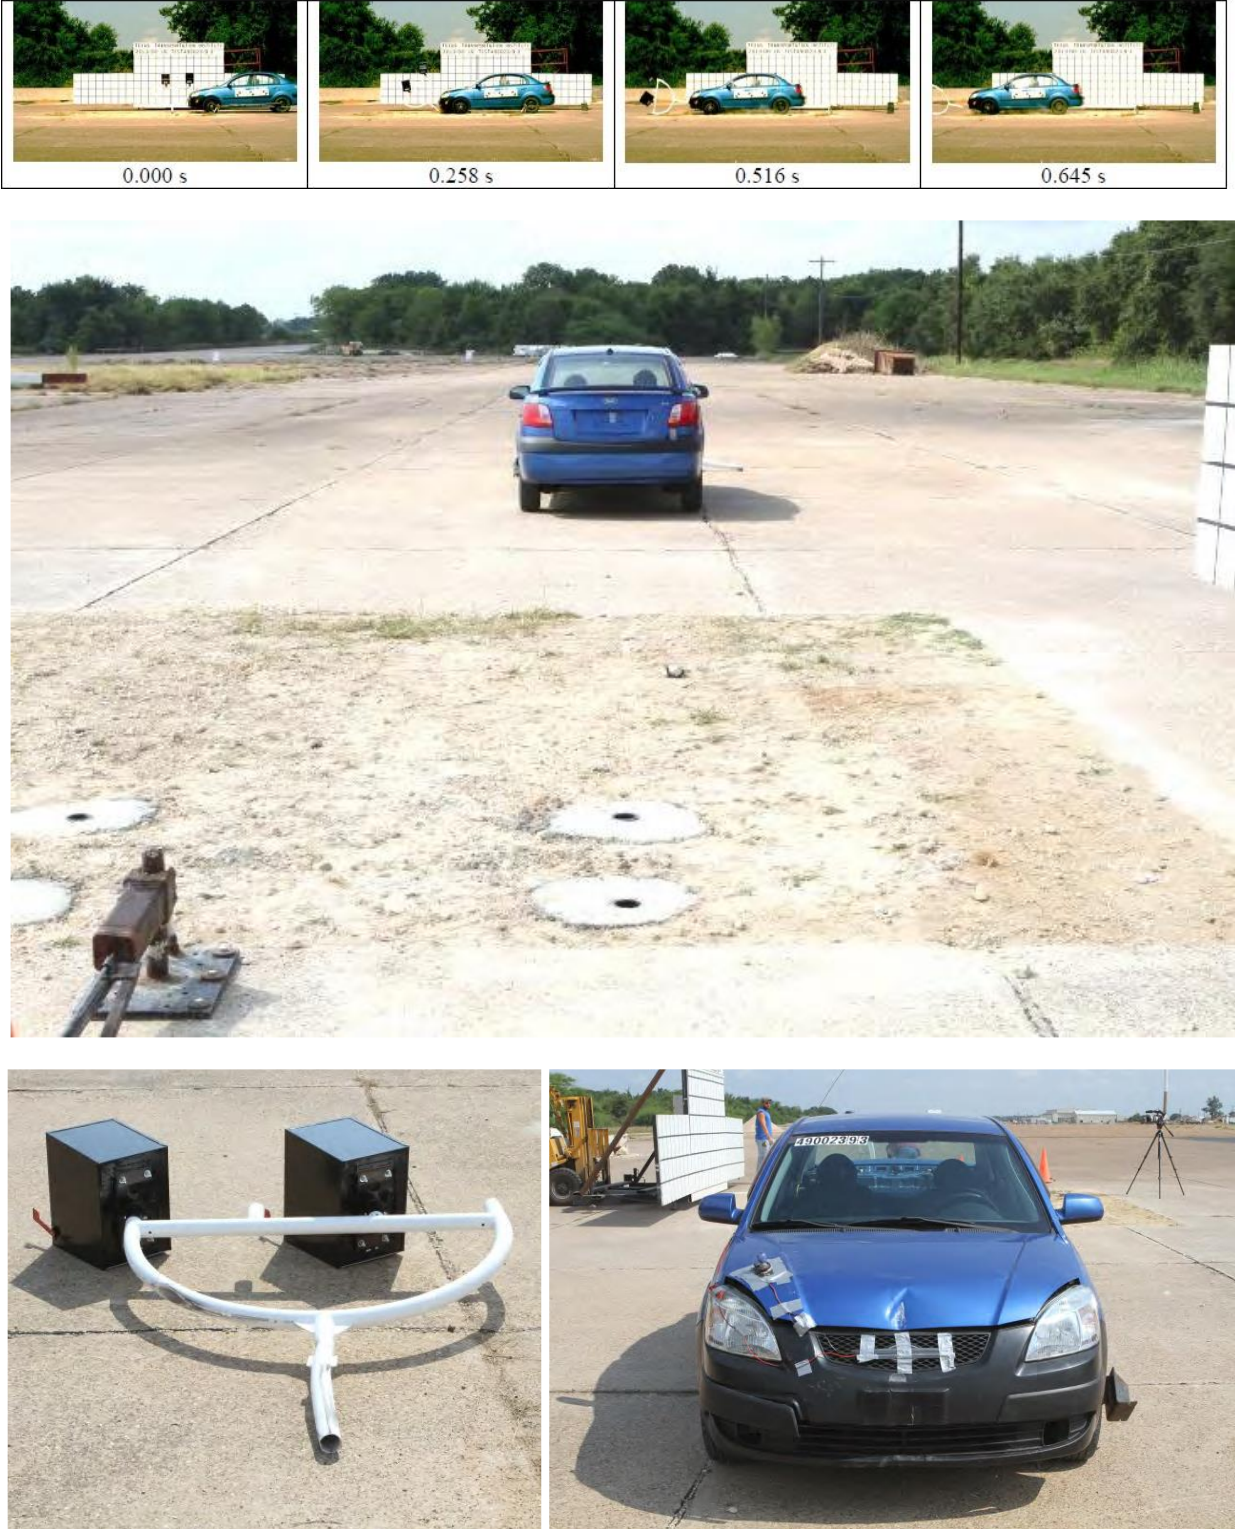
Figure 16. Locking Architectural Mailbox on Dual Mount Post - Test No. 490023-9-3, Test Results

occupant compartment deformation and penetration criteria were met during the test. Post test photographs and sequential images of the test are shown in Figure 16. A summary of the relevant test results is shown in Table 8.

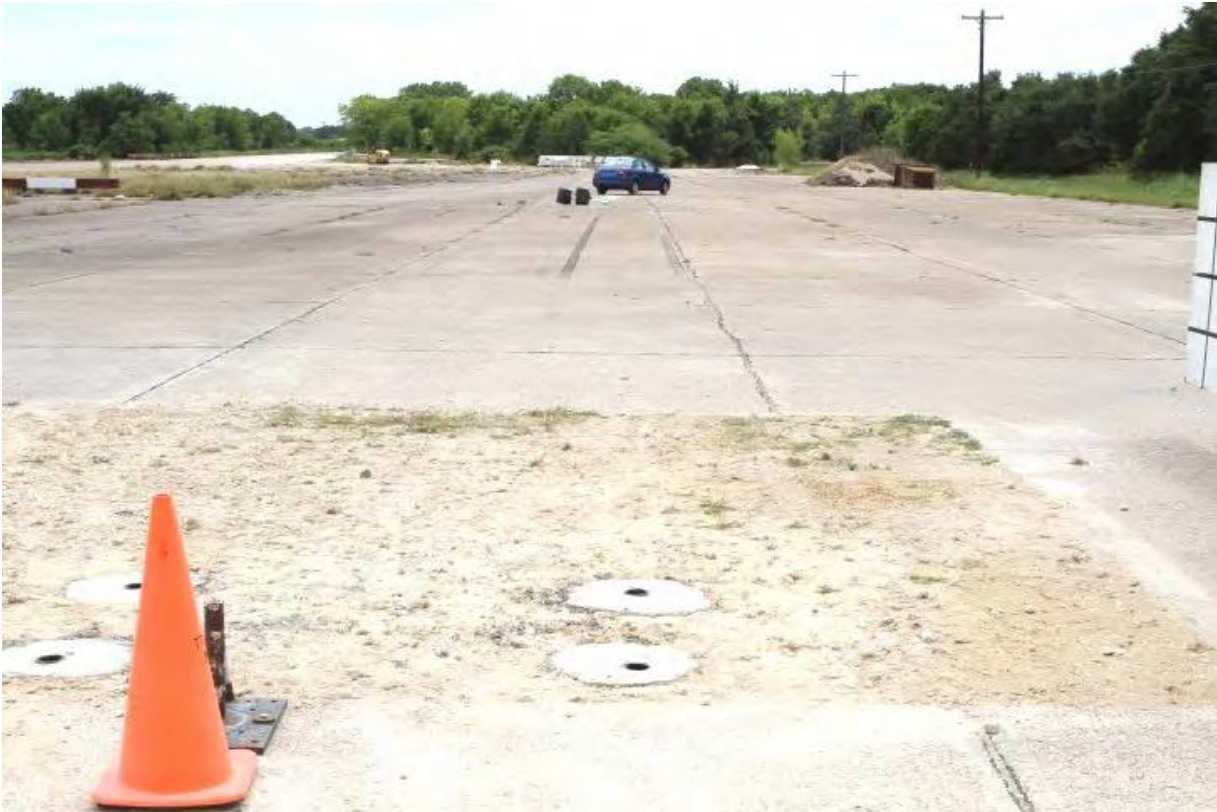
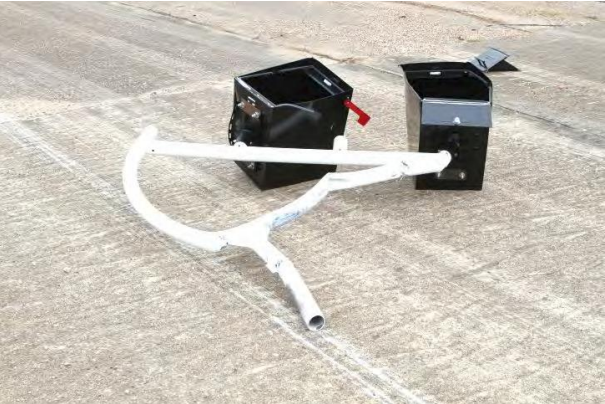
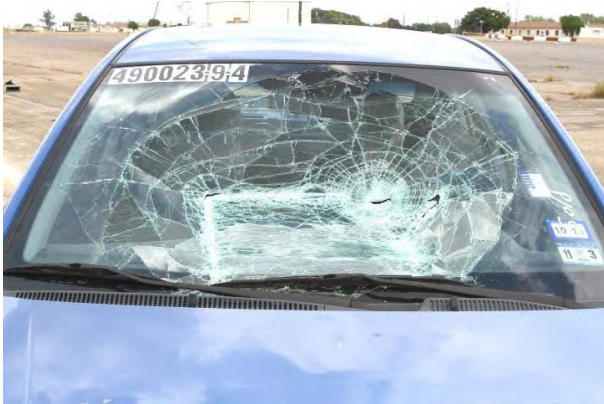
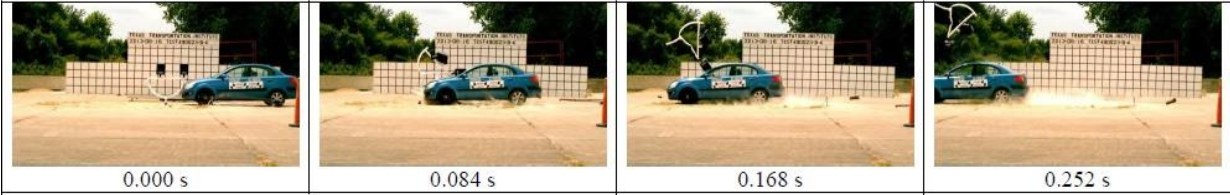
Figure 17. Locking Architectural Mailbox on Dual Mount Post - Test No. 490023-9-4, Test Results

In test no. 490023-9-4 (test designation no. 3-61), the test vehicle impacted the mailbox system at 63.0 mph and an angle of 0 degrees. Following initial impact, the support post deformed and collapsed and the mailboxes rotated toward the vehicle. The support post then pulled out of the socket and moved up on the hood of the vehicle, which allowed the leading mailbox to contact and fracture the windshield. The mailboxes remained attached to the support post. There was 4.5 in. of windshield deformation and penetration of the windshield. The test was deemed unacceptable according to the MASH criteria due to the windshield damage. Post test photographs and sequential images of the test are shown in Figure 17. A summary of the relevant test results is shown in Table 9.

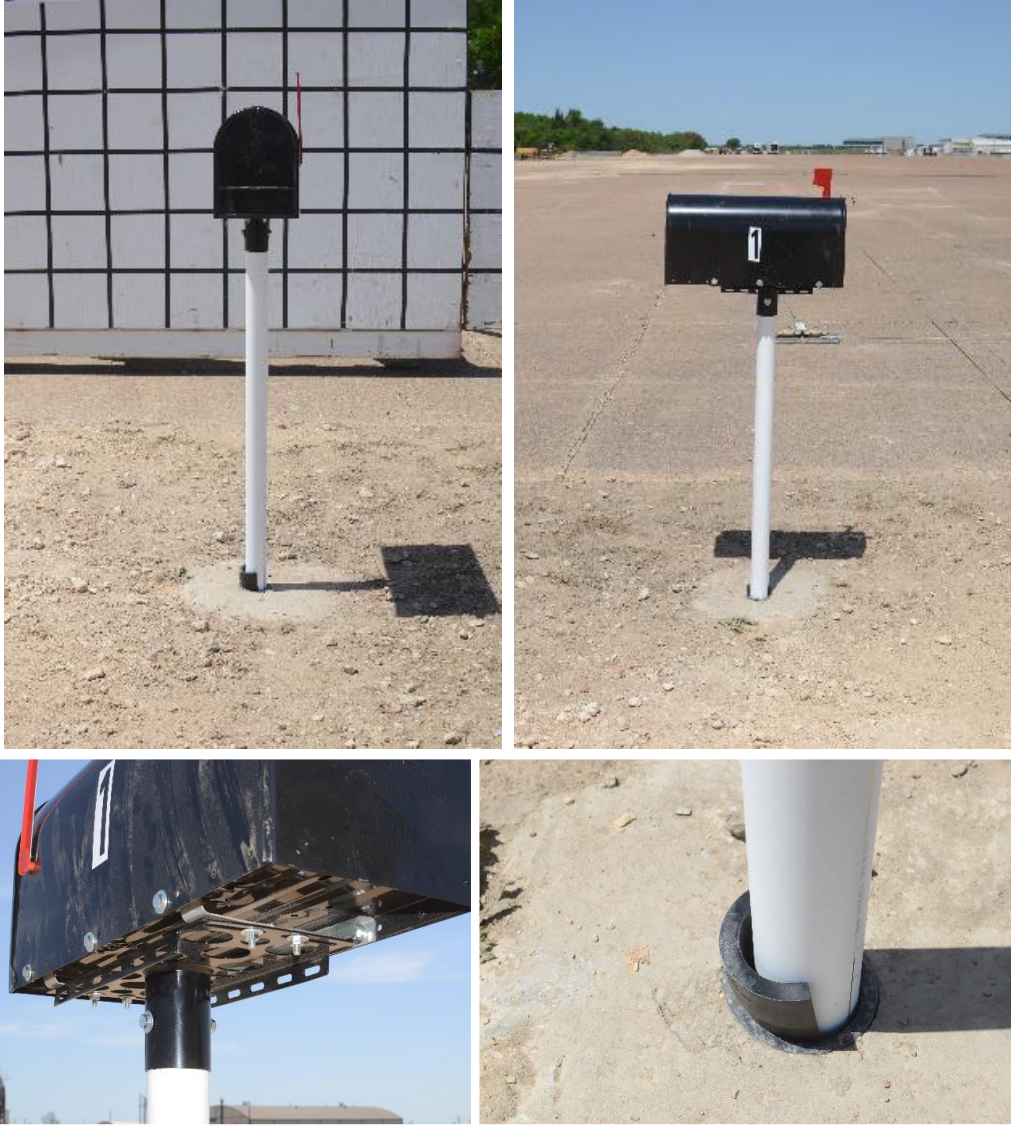
Mail Box	Mailbox Attachment	Mailbox-to-Post Bracket	Support Base	Support Post	Base-to-Post Attachment
<ul style="list-style-type: none"> • Single mailbox • Elite No. 1-a mailbox (#E1600B00) • 11 in. tall x 8¾ in. wide x 21½ in. deep • Steel • 7 lb (10 lb for mailbox and mount) • 42-in. mounting height 	<ul style="list-style-type: none"> • Bracket to post – one 5/16-in. diameter SAE Grade 5 bolts • Bracket plate to mailbox – four ¼-in. diameter SAE Grade 5 bolts • Bracket mount and mailbox – six ¼-in. bolts per unit 	<ul style="list-style-type: none"> • Bracket mount DHT#161443 • Extension bracket DHT#148938 	Plastic socket in reinforced concrete footing (12 in. in diameter x 30 in. deep)	<ul style="list-style-type: none"> • Approximately 2 ¾-in. outside diameter recycled rubber 	Socketed with locking wedge

Figure 18. Single Mailbox with Recycled Rubber Support Post in Type 4 Foundation - Test No. 469468-8-1

TTI conducted MASH TL-3 crash testing of a single mailbox mounted on a recycled rubber post, as shown in Figure 18 [8]. An Elite No. 1-A (Model #E1600B00) standard arched-top medium size mailbox from Solar Group, Inc. was attached to the top of a recycled rubber support post at a height of 42 in. above grade. The mailbox weighed 7 lb and had approximate dimensions of 11 in. tall × 8¾ in. wide × 21½ in. deep. Attachment of the mailbox to the post was accomplished using a mailbox bracket (DHT #161443), two extension brackets (DHT #148938), and associated SAE grade 5 bolts, nuts, and washers. The recycled rubber support post was inserted into a Type 4 foundation socket (DHT #160891) and secured with a tapered semi-circular HDTP wedge (DHT #160892) on the impact side. The foundation socket was installed flush with the surface of a 12-in. diameter × 30-in. deep unreinforced concrete foundation.

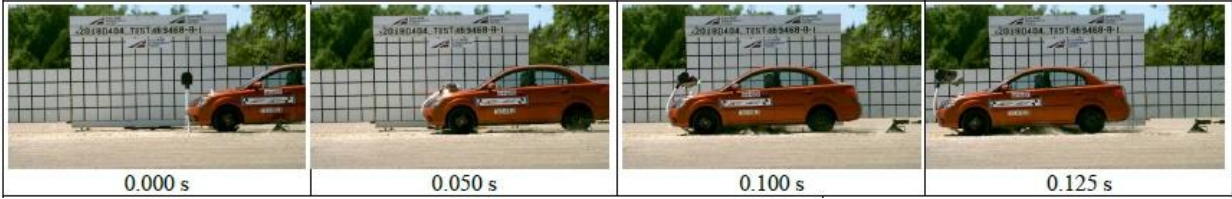
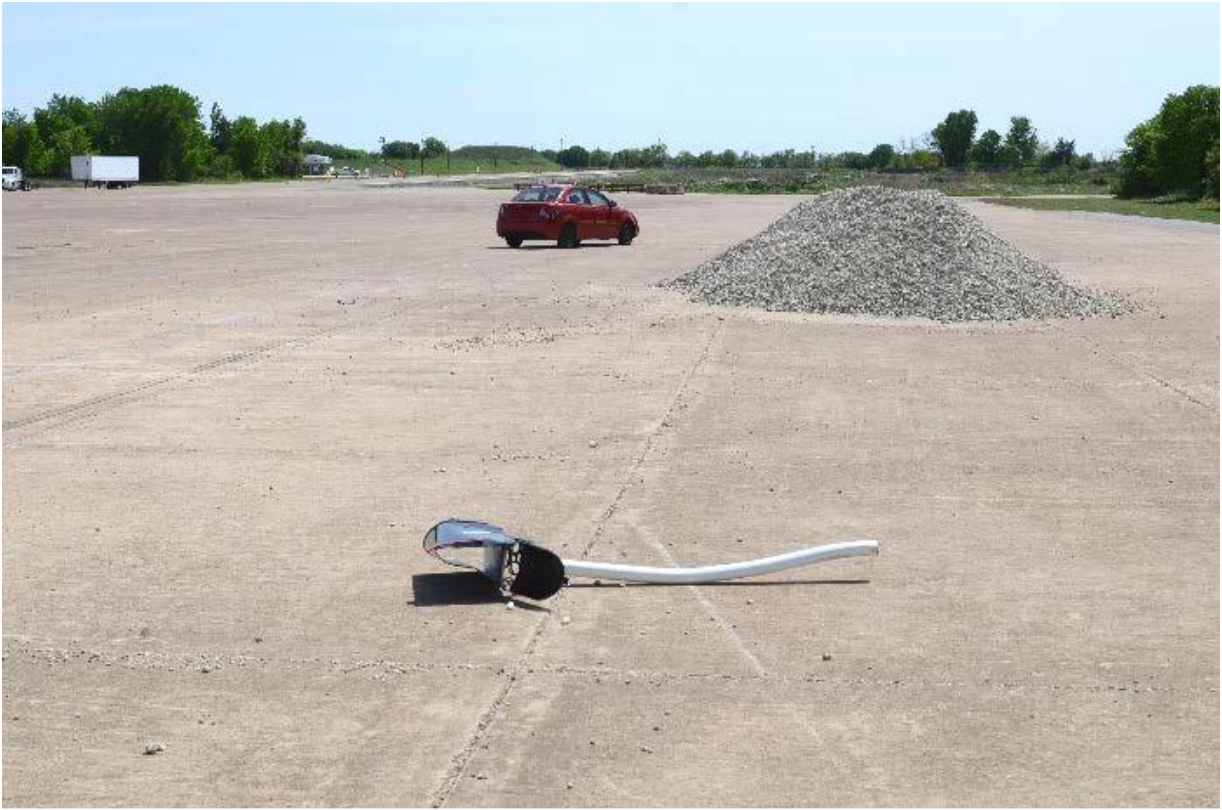
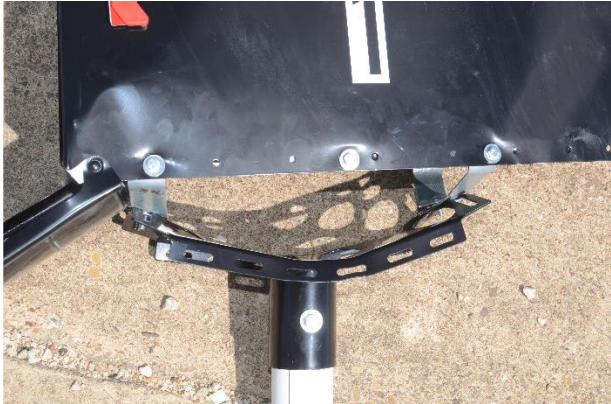
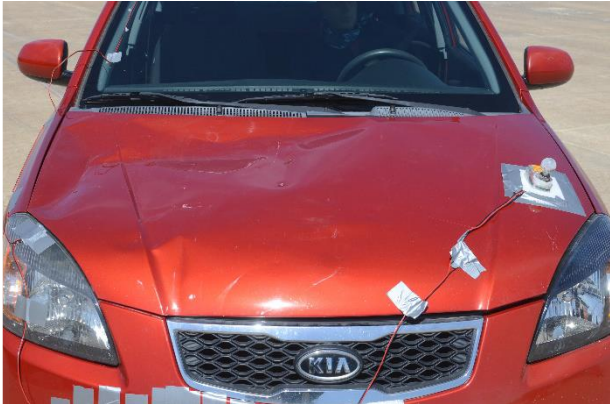
Figure 19. Single Mailbox with Recycled Rubber Support Post in Type 4 Foundation - Test No. 469468-8-1, Test Results

The mailbox system was evaluated using MASH test designation no. 3-61, which consisted of a 2,420-lb 1100C small car vehicle impacting the mailbox system at an impact speed of 62 mph and an angle of 0 degrees with a ¼ vehicle offset. In test no. 469468-8-1, the test vehicle impacted the mailbox system at 63.8 mph and an angle of 0 degrees. Following initial impact, the mailbox support post deformed about the front bumper of the vehicle which caused the mailbox to be pulled down onto the vehicle's hood. As the vehicle proceeded downstream, the support post was pulled from the socket. The upper section of the mailbox remained attached to the support, and the test article was propelled in front of the vehicle. The test was deemed acceptable according to the MASH criteria as all occupant risk criteria and occupant compartment deformation and penetration criteria were met during the test. Post test photographs and sequential images of the test are shown in Figure 19. A summary of the relevant test results is shown in Table 10.

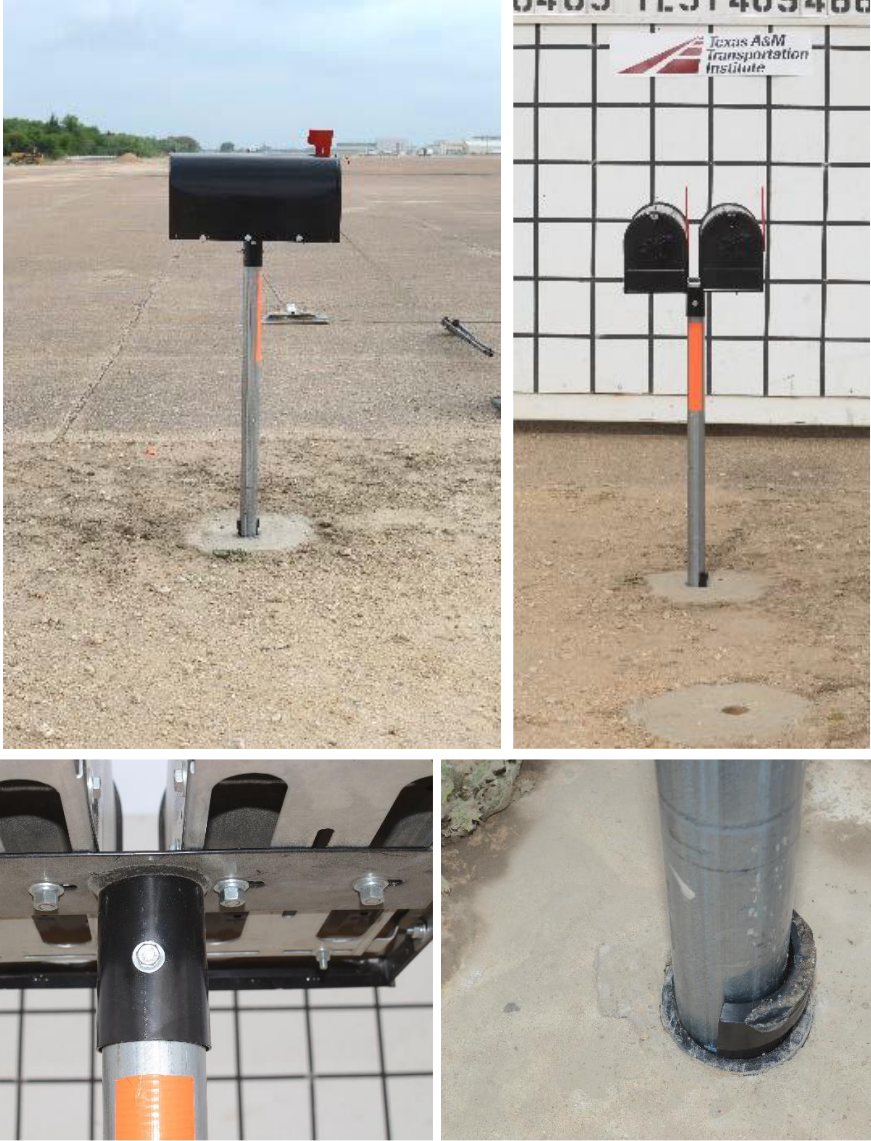
Figure 20. Double Mailbox with Thin-Wall Galvanized Support Post in Type 4 Foundation - Test No. 469468-8-2

TTI conducted MASH TL-3 crash testing of a dual mailbox mounted on a thin wall steel support post, as shown in Figure 20 [8]. Two Elite No. 1-A (Model #E1600B00) standard arched-top medium size mailboxes from Solar Group, Inc. were attached to the top of a galvanized, thin-wall steel support post at a height of 42 in. above grade. The mailboxes weighed 7 lb and had approximate dimensions of 11 in. tall × 8¾ in. wide × 21½ in. deep. A mailbox bracket (DHT #161443) and extension bracket (DHT #148938) were attached to the bottom of each mailbox using SAE grade 5 bolts, nuts, and washers. Attachment of the Elite mailboxes to the post was accomplished using a bracket (DHT #162323) that consisted of a horizontal steel plate and tubular socket. The mailboxes were bolted to the horizontal plate at a center-to-center spacing of 10 in. The bracket socket was then placed over the end of the support post and secured using a ⅜-in. diameter × 3½-in. long SAE grade 5 hex bolt, flat and lock washers, and nut. The galvanized steel support post (DHT #143426) was fabricated from 2-in. nominal 16-gauge (2⅜-in. outside diameter × 0.109-in. wall thickness) thin wall ASTM A513 Type 5 DOM steel tubing. The support post, which had a length of 57 in., was inserted into a Type 4 foundation socket (DHT #160891) and secured with a tapered semi-circular HDTP wedge (DHT #160892) on the impact side. The foundation socket was installed flush with the surface of a 12-in. diameter × 30-in. deep unreinforced concrete foundation.

Mail Box	Mailbox Attachment	Mailbox-to-Post Bracket	Support Base	Support Post	Base-to-Post Attachment
<ul style="list-style-type: none"> • Dual mailbox • Elite No. 1-a mailbox (#E1600B00) • 11 in. tall x 8¾ in. wide x 21½ in. deep • Steel • 7 lb (20 lb for both mailboxes and bracket) • 42-in. mounting height 	<ul style="list-style-type: none"> • Collar bracket to post – one ¾-in. diameter SAE Grade 5 bolt • Extension bracket to bracket mount and mailbox – four ¾-in. diameter SAE Grade 5 bolts • Extension bracket to bracket mount and mailbox – eight ¼-in. bolts per unit 	<ul style="list-style-type: none"> • Bracket mount DHT#161443 • Extension bracket DHT#148938 • Collar bracket DHT#162323 	Plastic socket in reinforced concrete footing (12 in. in diameter x 30 in. deep)	<ul style="list-style-type: none"> • 2¾-in. outside diameter 16 gauge thick • ASTM A513 type 5 DOM • 57 in. long • 7.5 lb 	Socketed with locking wedge and 15-in. embedment

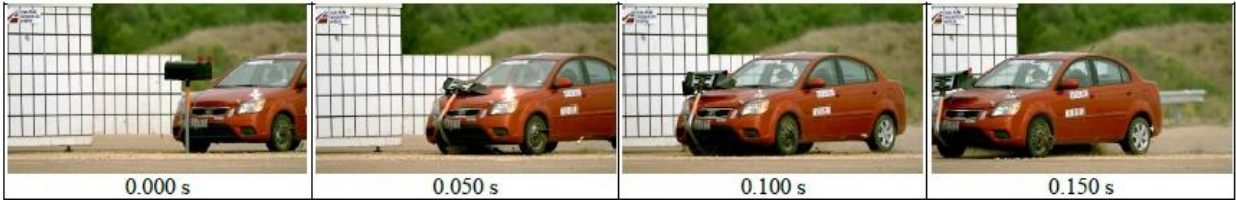
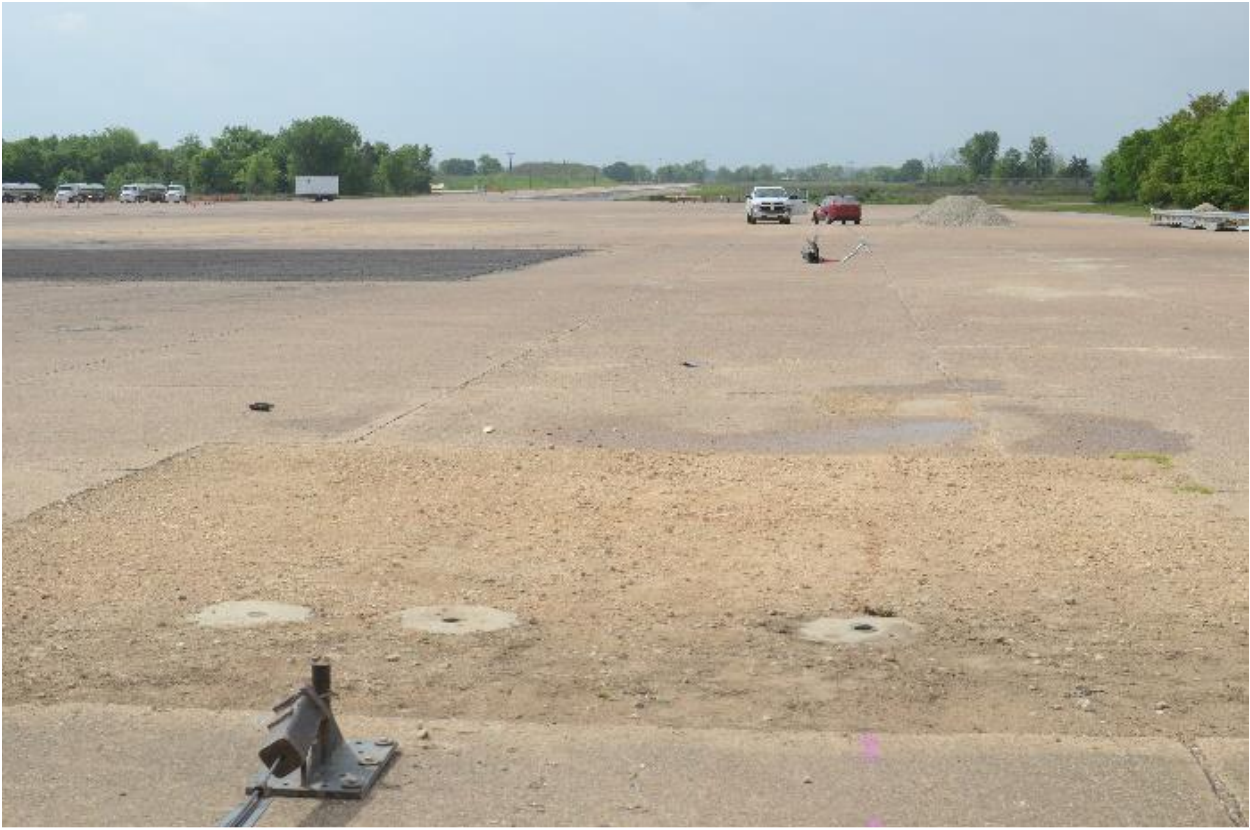
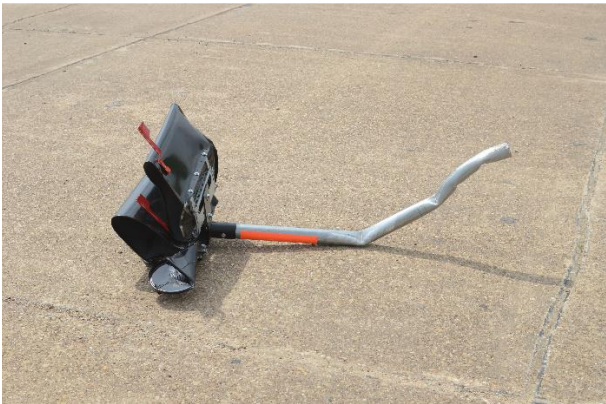
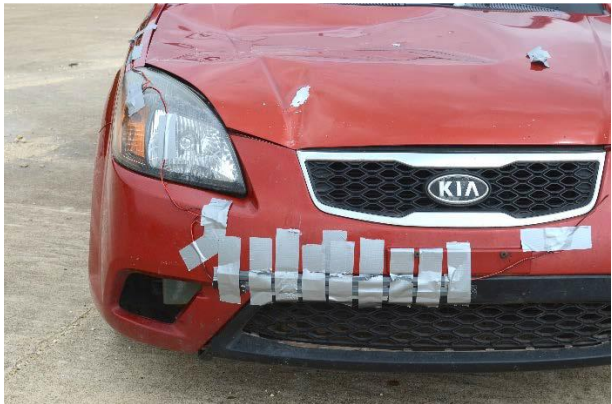
Figure 21. Double Mailbox with Thin-Wall Galvanized Support Post in Type 4 Foundation - Test No. 469468-8-2, Test Results

The mailbox system was evaluated using MASH test designation no. 3-61, which consisted of a 2,420-lb 1100C small car vehicle impacting the mailbox system at an impact speed of 62 mph and an angle of 0 degrees with a ¼ vehicle offset. In test no. 469468-8-2, the test vehicle impacted the mailbox system at 63.3 mph and an angle of 0 degrees. Following initial impact, the mailbox support post deformed about the front bumper of the vehicle which caused the mailbox to be pulled down onto the vehicle's hood. As the vehicle proceeded downstream, the support post was pulled from the socket. The upper section of the mailbox remained attached to the support, and the test article was propelled in front of the vehicle. The test was deemed acceptable according to the MASH criteria as all occupant risk criteria and occupant compartment deformation and penetration criteria were met during the test. Post test photographs and sequential images of the test are shown in Figure 21. A summary of the relevant test results is shown in Table 11.

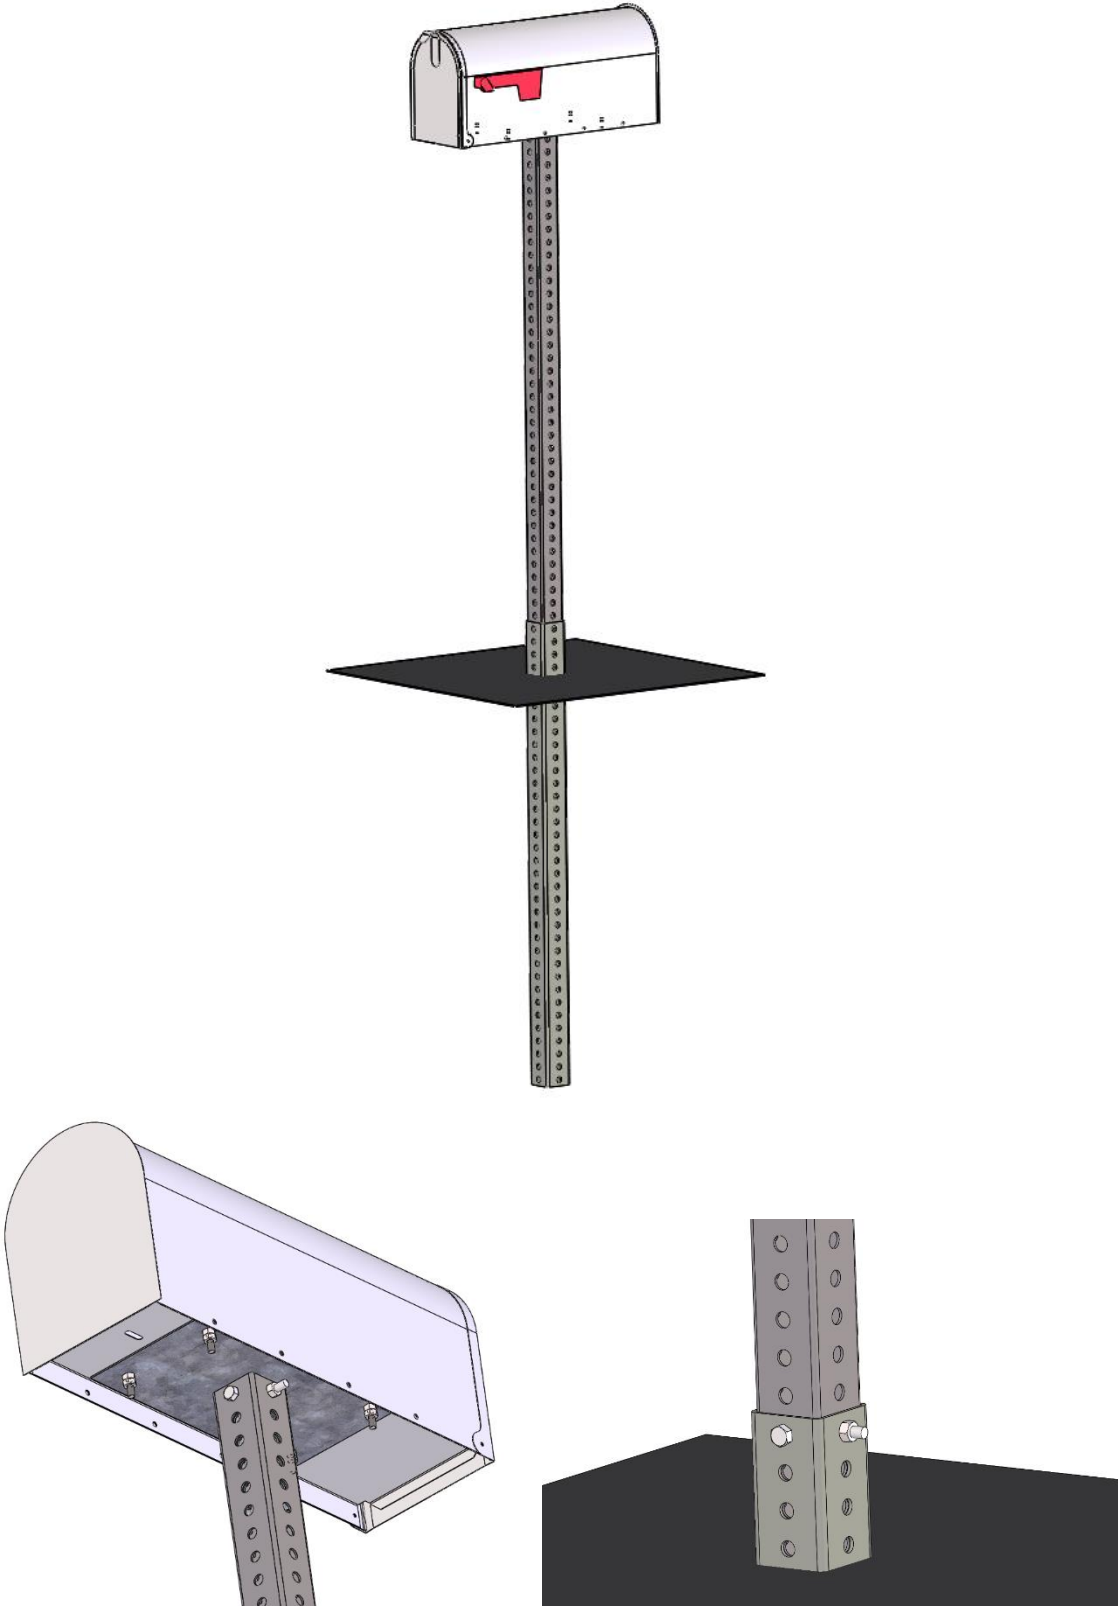
Figure 22. NDOT Original PSST Mailbox Support Design Concept

At the onset of the research effort, NDOT supplied a proposed mailbox mount to MwRSF for consideration as a starting point for the design process, as shown in Figure 22. The NDOT mailbox design consisted of a 2-in. × 14-gauge PSST support post inserted in a 2¼-in. × 12-gauge PSST embedded stub. The stub section of the mailbox support was 36 in. long and extended 4 in. above grade. The PSST support post was inserted 6 in. into the lower stub. Both the support post and embedded stub were made of ASTM A1011 Grade 50 steel. A mailbox mount was created by welding a 1/16-in. thick ASTM A36 plate to a 1¾-in. × 14-gauge PSST stub inserted 5 in. into the top of the PSST support post. The support post was connected to the embedded stub and mounting plate stub with 5/16-in. diameter corner bolts. Four ¼-in. diameter Phillips round head bolts were used to attach the mounting plate to the base of the mailbox.

Comparison of this design to previously tested mailbox systems and existing mailboxes led the researchers to note that there may be design modifications to the proposed mailbox support. First, it was noted that the mounting plate may need to be modified to accept mounting bolts from a wider variety of mailbox types. Second, it was noted that the mailbox mount currently used a PSST stub at the base of the mounting plate which could make fabrication difficult. PSST currently is only readily available in galvanized form. As such, welding a tube to the base plate could be difficult due to toxicity and weld issues associated with welding galvanized steel. Finally, the previous testing of mailbox supports suggested that the strength of the connection between the mailbox mount and mailbox was critical to retaining the mailbox to the support and the overall safety performance of the mailbox support. As such, it was noted that increasing the size, grade, or number of attachment bolts may need to be considered depending on the mass of the mailbox used with the support.

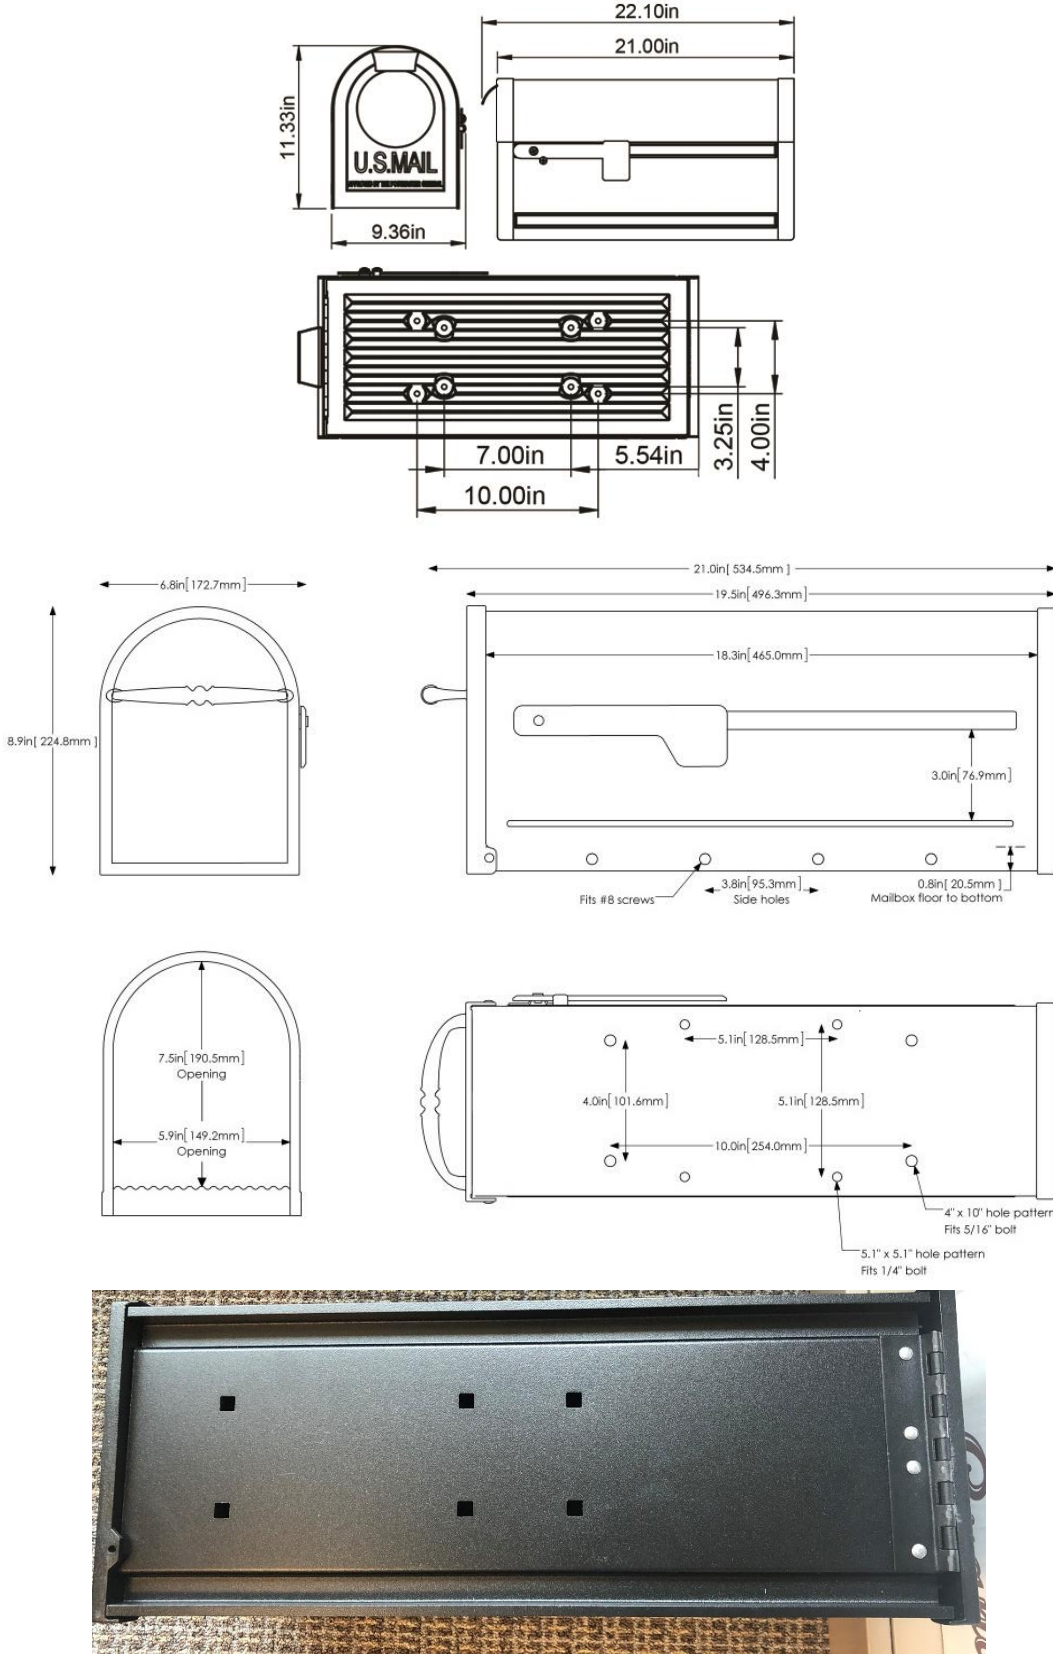
Figure 23. Various Mailbox Mounting Configurations

Because the mailbox support was to be based on PSST, MwRSF noted to NDOT that PSST manufacturers have a variety of prefabricated PSST mounts that could potentially be used to attach the support post to the mailbox mounting bracket. Additionally, there were several commercially available mailbox mounting brackets available for single or dual mailbox mounts. Thus, MwRSF and NDOT discussed the use of the commercially available components in the design. NDOT indicated that they preferred simple, non-proprietary mounting hardware if possible. Thus, they wished to retain a simple plate type mailbox mount with that could be fabricated easily for the mailbox support.

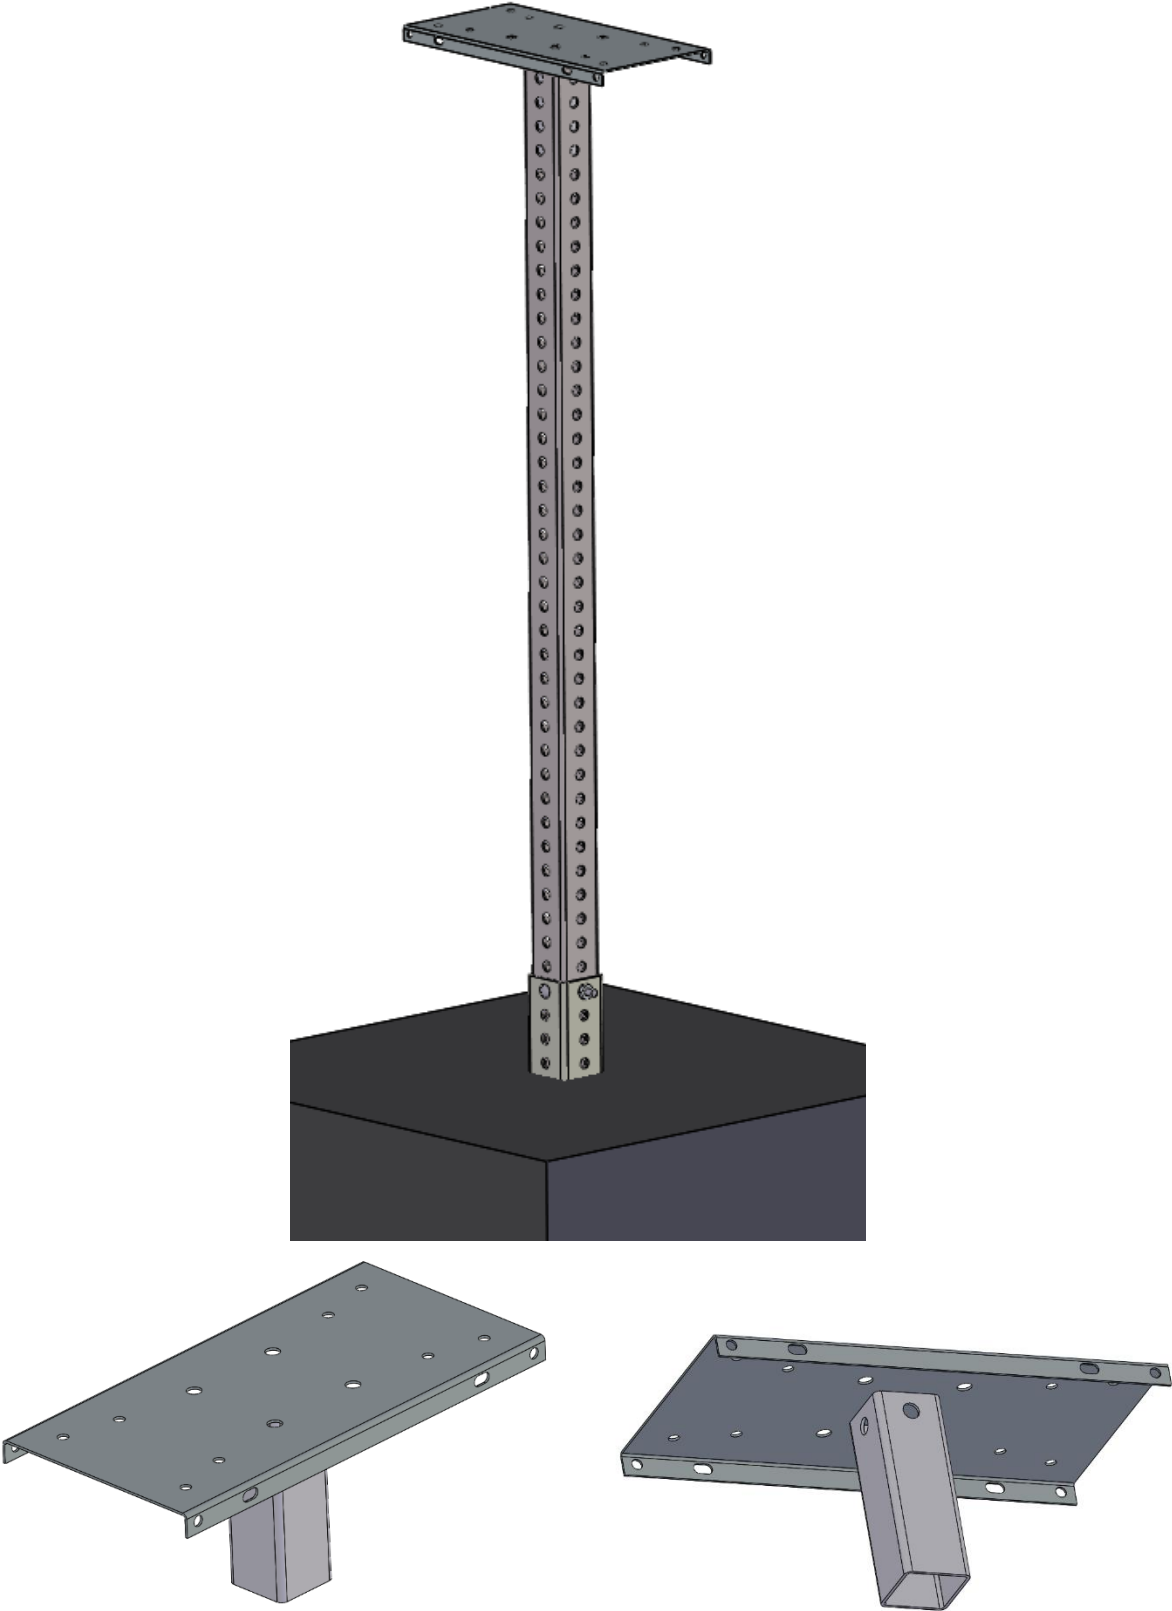
Figure 24. Single Mailbox Support Concept

A single mailbox mount concept was developed based on the previously-described original design concept from NDOT and information gleaned from the literature review, as shown in Figure 24. The support post and embedded stub remained unchanged from the original NDOT concept and consisted of a 2-in. \times 14-gauge PSST and a $2\frac{1}{4}$ -in. \times 12-gauge PSST, respectively. The stub was 36 in. long and embedded 32 in. into the ground. The support post was socketed 6 in. inside the stub and was connected to the stub with a $\frac{5}{16}$ -in. diameter corner bolt. The mailbox mount was modified from the original NDOT design. The mounting plate was fabricated from 14-gauge ASTM 1011 Grade 50 steel. The shape of the mounting plate was modified to add bent flanges on the side and additional mounting holes. These modifications were made to allow for attachment of the wide variety of base-mounted and side flange-mounted mailboxes that could potentially be used with the mailbox support. The mounting plate was welded to a $2\frac{1}{2}$ -in. \times $2\frac{1}{2}$ -in. \times $\frac{3}{16}$ -in. steel tube that socketed over the support post and was held in place by a $\frac{5}{16}$ -in. diameter corner bolt. Both Grade 2 and Grade 5 mailbox attachment hardware were considered for the single mailbox support concept.

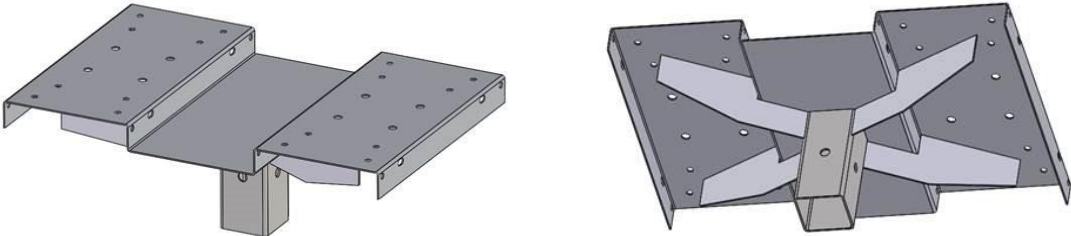
Figure 25. Non-Proprietary Dual Mailbox Support Bracket Concept No. 1

NDOT requested that the researchers develop a dual mailbox support concept based on the single mailbox support. The dual mailbox support concepts used the same stub and support post as the single mailbox support concept but modified the mailbox mounting bracket to accommodate two mailboxes. Two modified mounting bracket concepts were developed based on the extension of the single mounting bracket to a dual mailbox configuration. The first concept consisted of a single bent plate that had two mailbox mounting sections with a flat section of plate between them, as shown in Figure 25. A tube socket was welded beneath the midspan of the plate for attachment to the support post, and gussets were welded beneath the plate to support the cantilevered weight of the mailboxes and reinforce the mounting bracket. The second dual mailbox mounting bracket concept is shown in Figure 26. This concept uses a gusseted flat plate welded to the tube socket. Separate mounting bracket parts could then be bolted to the plate to accommodate dual mailboxes.
