Research Project Number SPR-FY21(010)

CRASHWORTHY PERFORATED SQUARE STEEL TUBE (PSST) MAILBOX SUPPORT – PHASE I

MIDWEST ROADSIDE SAFETY FACILITY

MwRSF Research Report No. TRP-03-473-23

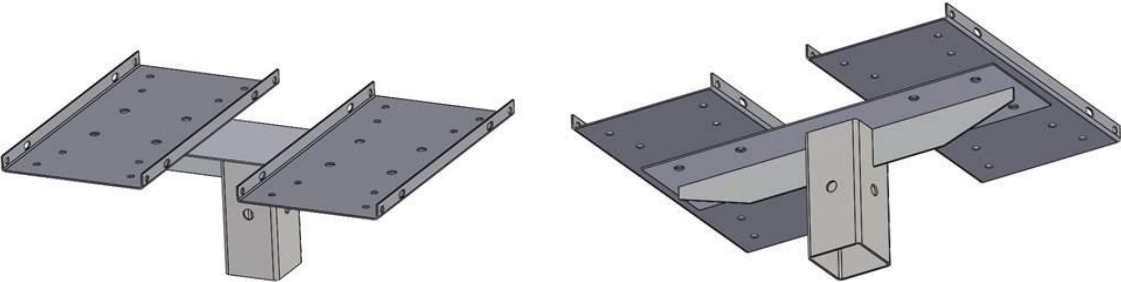
Figure 26. Non-Proprietary Dual Mailbox Support Bracket Concept No. 2

NDOT requested that the researchers develop a dual mailbox support concept based on the single mailbox support. The dual mailbox support concepts used the same stub and support post as the single mailbox support concept but modified the mailbox mounting bracket to accommodate two mailboxes. Two modified mounting bracket concepts were developed based on the extension of the single mounting bracket to a dual mailbox configuration. The first concept consisted of a single bent plate that had two mailbox mounting sections with a flat section of plate between them, as shown in Figure 25. A tube socket was welded beneath the midspan of the plate for attachment to the support post, and gussets were welded beneath the plate to support the cantilevered weight of the mailboxes and reinforce the mounting bracket. The second dual mailbox mounting bracket concept is shown in Figure 26. This concept uses a gusseted flat plate welded to the tube socket. Separate mounting bracket parts could then be bolted to the plate to accommodate dual mailboxes.

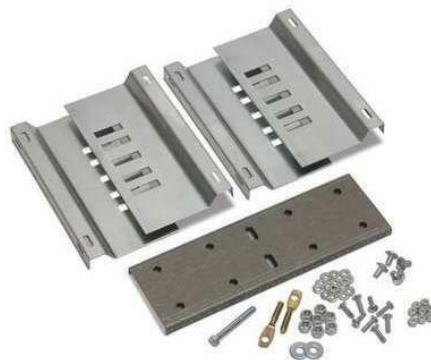
Figure 27. TAPCO Dual Mailbox Mounting Kit

NDOT had previously used the TAPCO dual mailbox mount kit (Part no. 034-00045) and requested that MwRSF adopt that mailbox mount to the proposed PSST support, as shown in Figure 27. The TAPCO mount was intended for use with a circular, 2-in. diameter tube post manufactured by TAPCO. The kit contains a pair of two-piece, adjustable, 16-gauge mounting brackets and a 14-gauge flat plate bracket. The mount used $\frac{5}{16}$ -in. diameter spade bolts to connect the support to the flat plate bracket. The adjustable mailbox brackets were bolted to the flat plate bracket with $\frac{5}{16}$ -in. truss head machine screws. The adjustable mailbox brackets facilitated attachment of mailboxes through the lower flange of the mailbox with #10 machine screws.

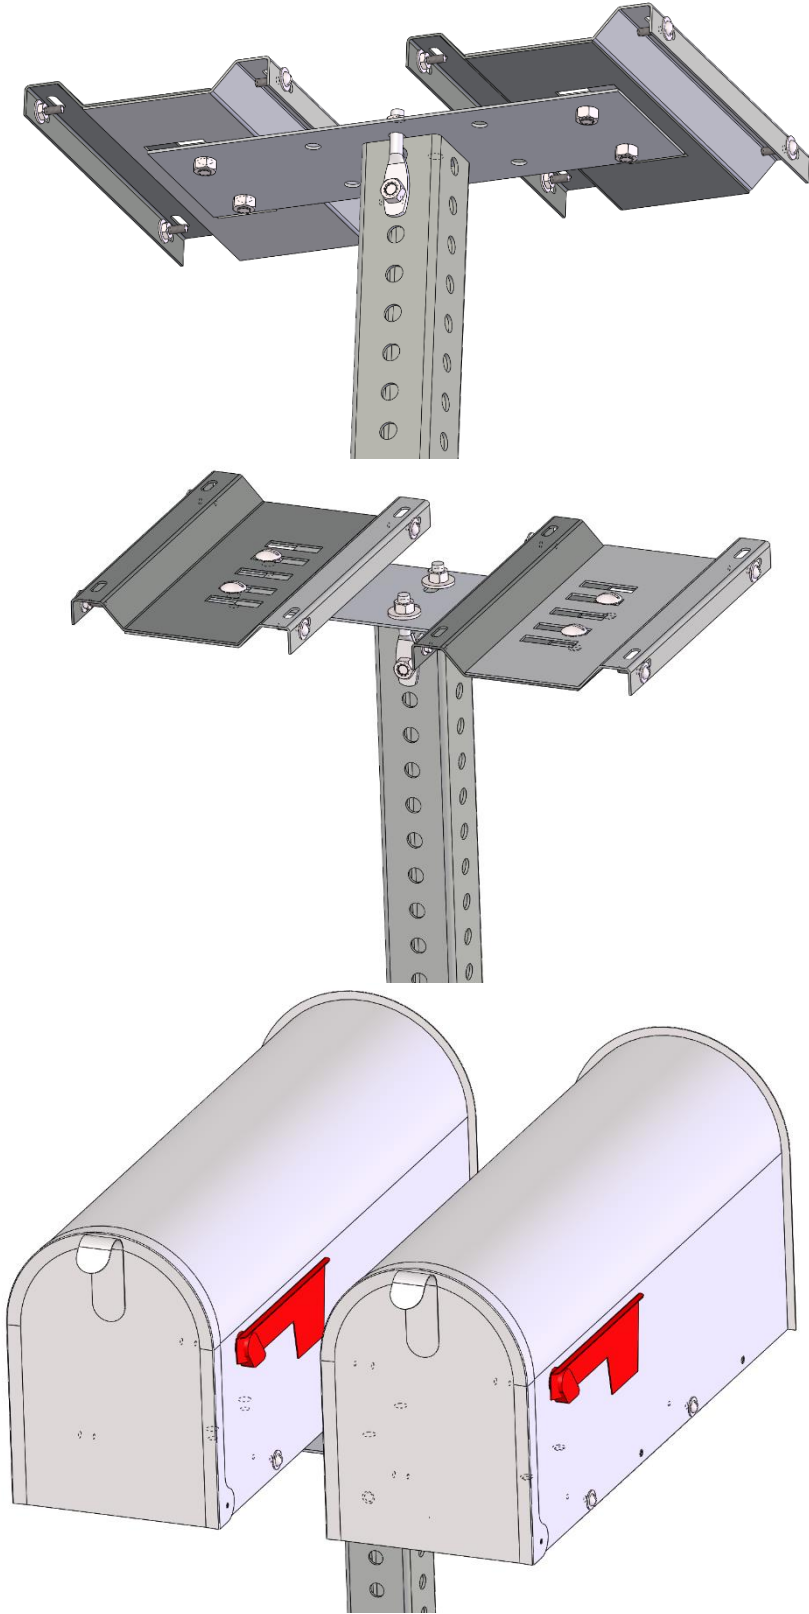
Figure 28. Modified TAPCO Dual Mailbox Mount for PSST Mailbox Support

The TAPCO mount only required minor modifications for use with the PSST support. The mailbox weight for the dual support was limited to 3 to 5-lb mailboxes. This reduced concerns for mailbox detachment and ensured that commercially available mailboxes would have side flanges compatible with the mounting bracket. The $\frac{5}{16}$ -in. diameter spade bolts were compatible for attachment to the 2-in. square PSST support post through the use of a $\frac{5}{16}$ -in. diameter hex bolt supplied with the kit. As such, the supplied TAPCO mounting hardware was used for attachment of the spade bolts to the PSST and attachment of the flat plate bracket to the adjustable mailbox brackets. The mounting bolts for attachment of the mailbox to the mounting brackets were upgraded to $\frac{1}{4}$ -in. diameter SAE Grade 5 hardware to mitigate concerns for mailbox detachment. The modified TAPCO dual mailbox mount on the PSST support is shown schematically in Figure 28.

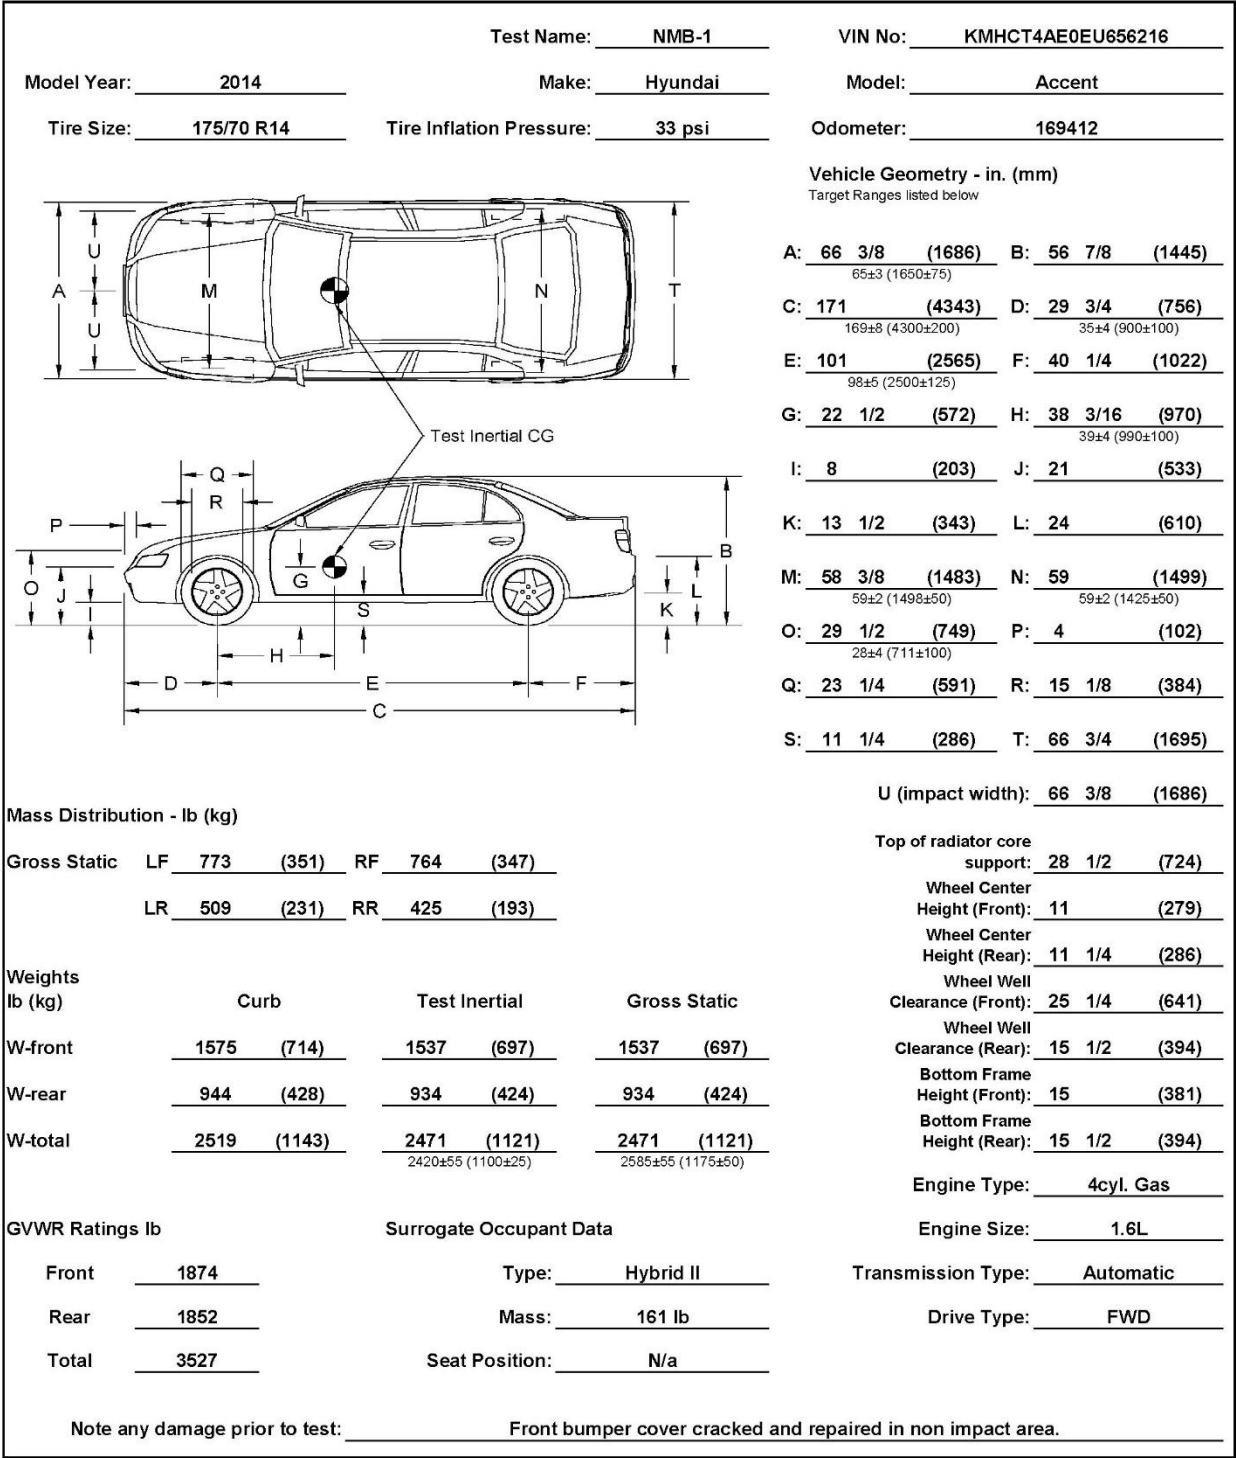
Figure 30. Vehicle Dimensions, Test No. NMB-1

The longitudinal component of the center of gravity (c.g.) was determined using the measured axle weights the vertical component of the c.g. for the 1100C vehicle was determined utilizing a procedure published by SAE [14]. The final c.g. location is shown in Figure 30.

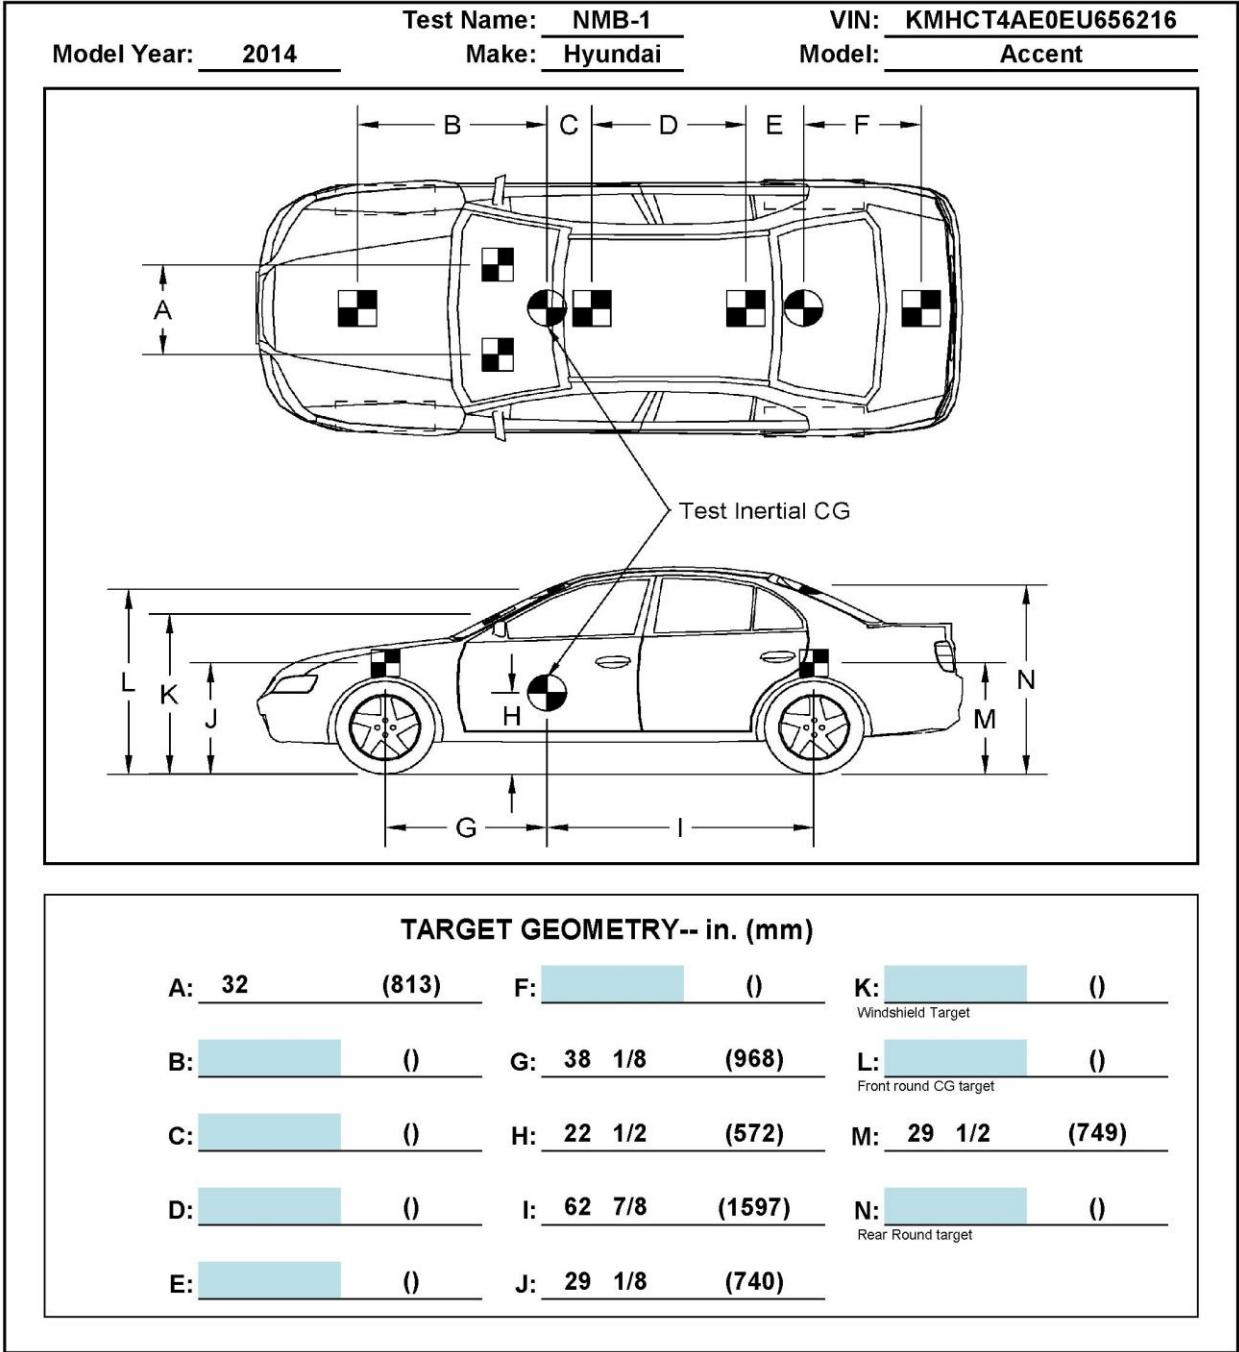
Figure 31. Target Geometry, Test No. NMB-1

Ballast information and data used to calculate the location of the c.g. are shown in Appendix C. Square, black-and-white checkered targets were placed on the vehicle for reference, as shown in Figure 31, to serve as a reference in the high-speed digital video and aid in the video analysis. Round, checkered targets were placed at the c.g. on the left-side door, the right-side door, and the roof of the vehicle.

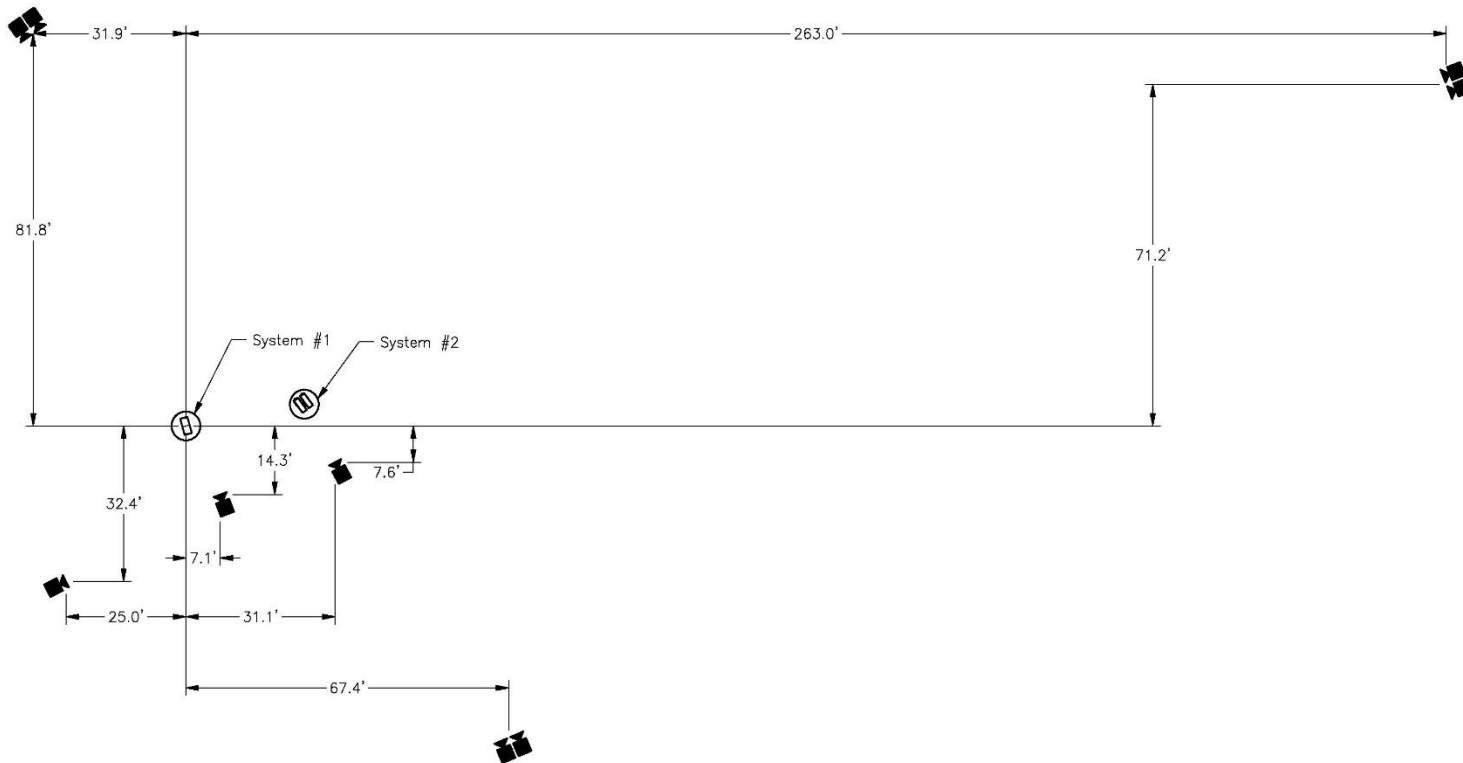
Figure 32. Camera Locations, Speeds, and Lens Settings, Test No. NMB-1

Three AOS high-speed digital video cameras, two GoPro digital video cameras, and four Panasonic digital video cameras were utilized to film test no. NMB-1. Camera details, camera operating speeds, lens information, and a schematic of the camera locations relative to the system are shown in Figure 32.

No.	Type	Operating Speed (frames/sec)	Lens	Lens Setting
AOS-5	AOS X-PRI Gigabit	500	100 mm	
AOS-11	AOS Vitcam CTM	500	17-50 at 35	
AOS-12	AOS Vitcam CTM	500	24-135 at 35	
GP-23	GoPro Hero 7	120		
GP-24	GoPro Hero 7	120		
PAN-2	Panasonic HC-V770	120		
PAN-4	Panasonic HC-V770	120		
PAN-5	Panasonic HC-V770	120		
PAN-6	Panasonic HC-V770	120

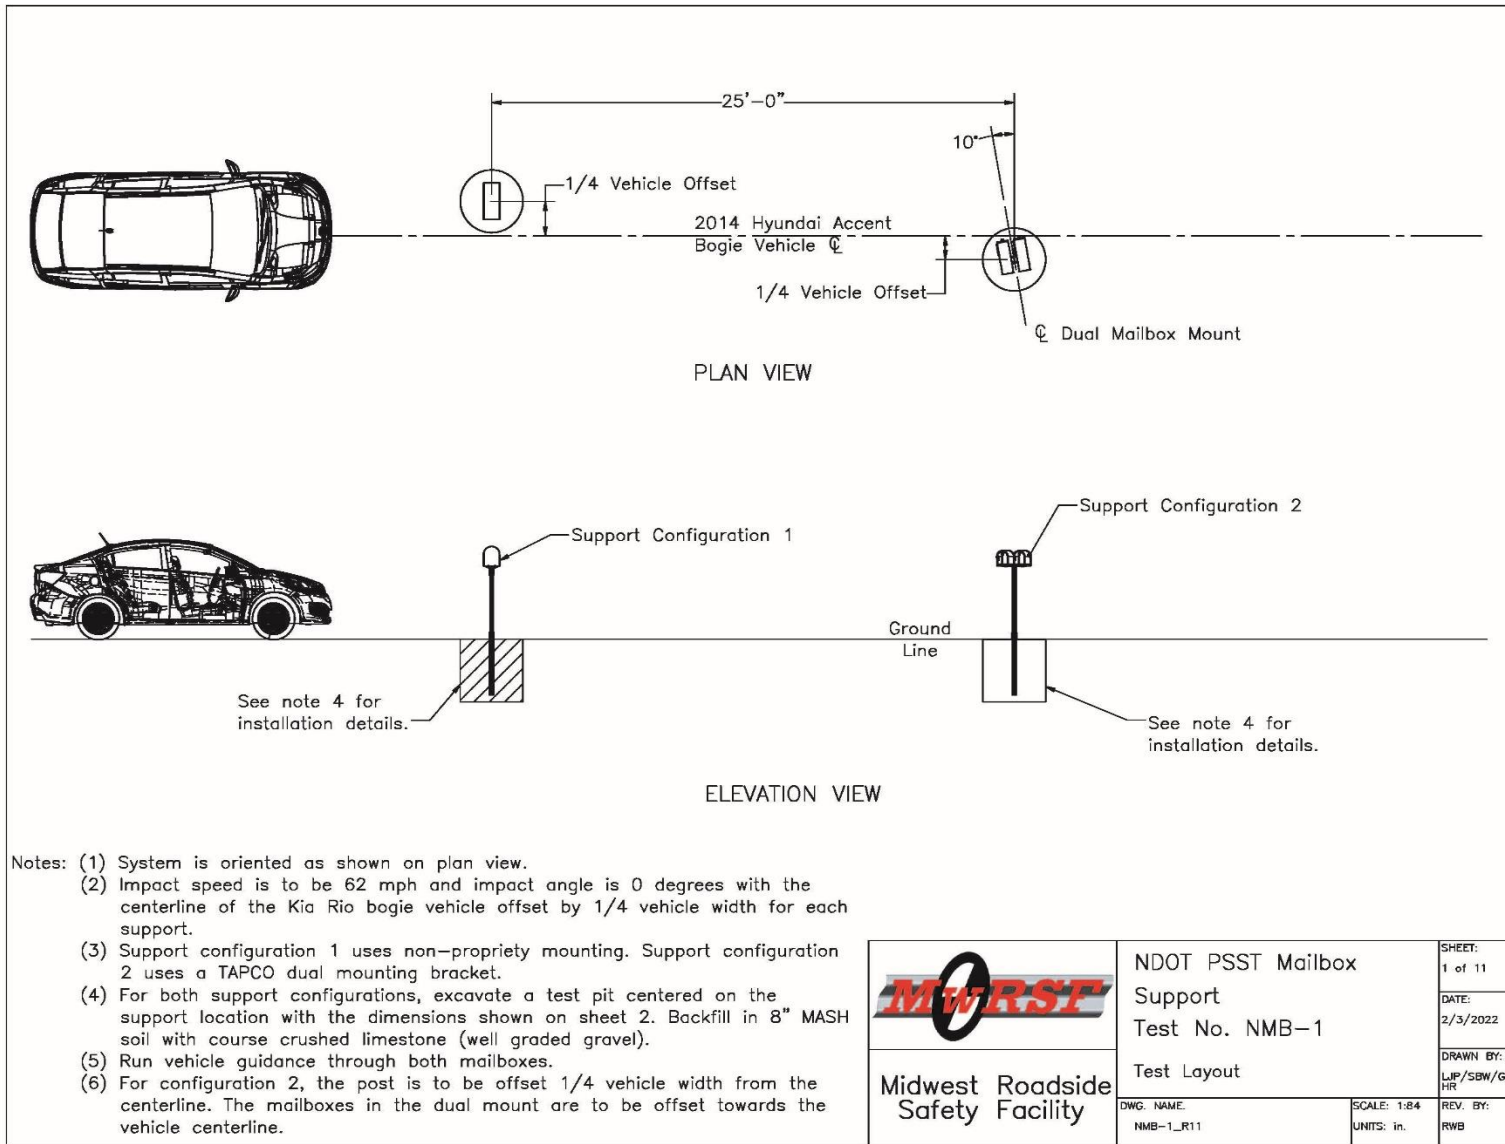
Figure 33. Test Installation Layout, Test No. NMB-1

Both mailbox supports were imbedded 32 in. into a compacted, coarse, crushed limestone material, alternatively classified as well-graded gravel by the Unified Soil Classification System that met American Association of State Highway and Transportation Officials (AASHTO) standard soil designation M147 Grade B. The second mailbox was placed 25 feet downstream and with an offset equal to one half the vehicle's width from the first mailbox, as shown in Figure 33.

The single and dual PSST mailbox supports impacted in the dynamic component testing with a surrogate, non-compliant MASH 1100C vehicle are shown in Figures 33 through 43. Photographs of the test installation are shown in Figures 44 through 46. Material specifications, mill certifications, and certificates of conformity for the system materials are shown in Appendix B

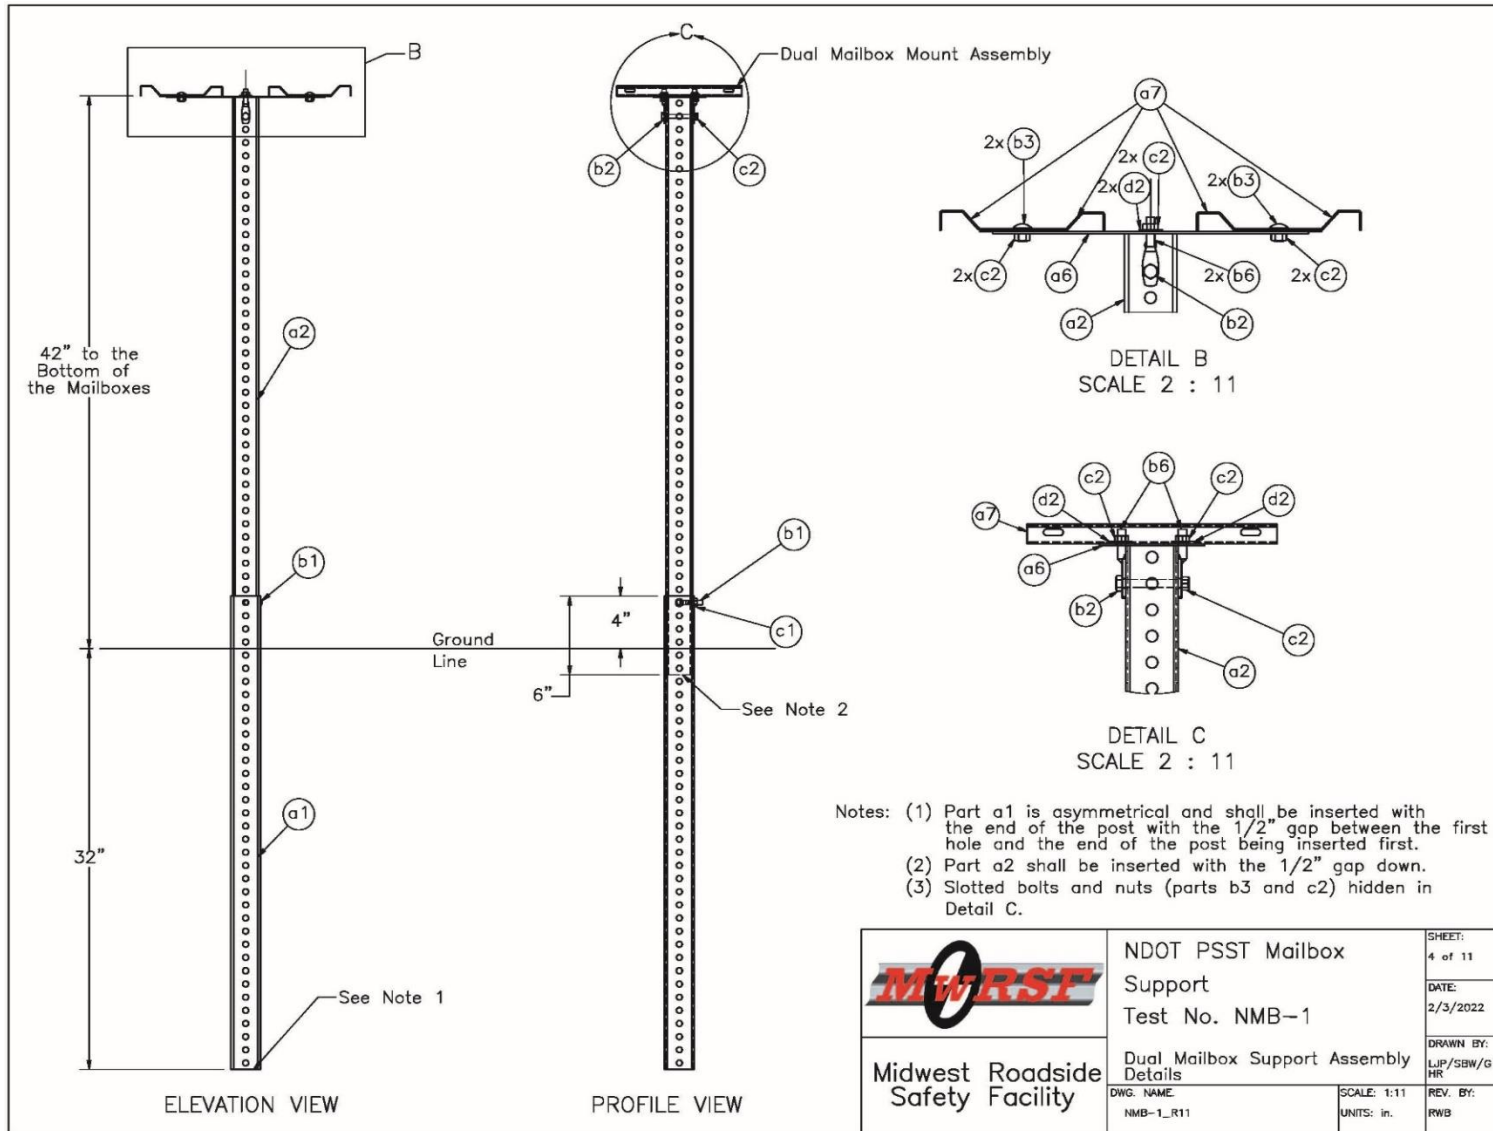
Figure 36. Dual Mailbox Support Assembly Details, Test No. NMB-1

The dual mailbox support used the same stub and support post as the single mailbox support concept but modified the mailbox mounting bracket to accommodate two mailboxes. A TAPCO dual mailbox mount kit (Part no. 034-00045) was used to mount the dual mailboxes to the support post. The kit contained a pair of two-piece, adjustable, 16-gauge mounting brackets and a 14-gauge flat plate bracket. The TAPCO mounting kit supplied 5/16-in. diameter spade bolts and a 5/16-in. diameter hex bolt that were compatible for attachment of the flat plate bracket to the 2-in. square PSST support post. The adjustable mailbox brackets were bolted to the flat plate bracket with 5/16-in. truss head machine screws. The mounting bolts for attachment of the mailbox to the mounting brackets were upgraded to ¼-in. diameter SAE Grade 5 hardware to mitigate concerns for mailbox detachment. A Gibraltar Elite Post Mount Mailbox (Model #E1100B00) made from galvanized steel was attached to each mailbox mounting bracket. The mailbox weight was 4.6 lb.

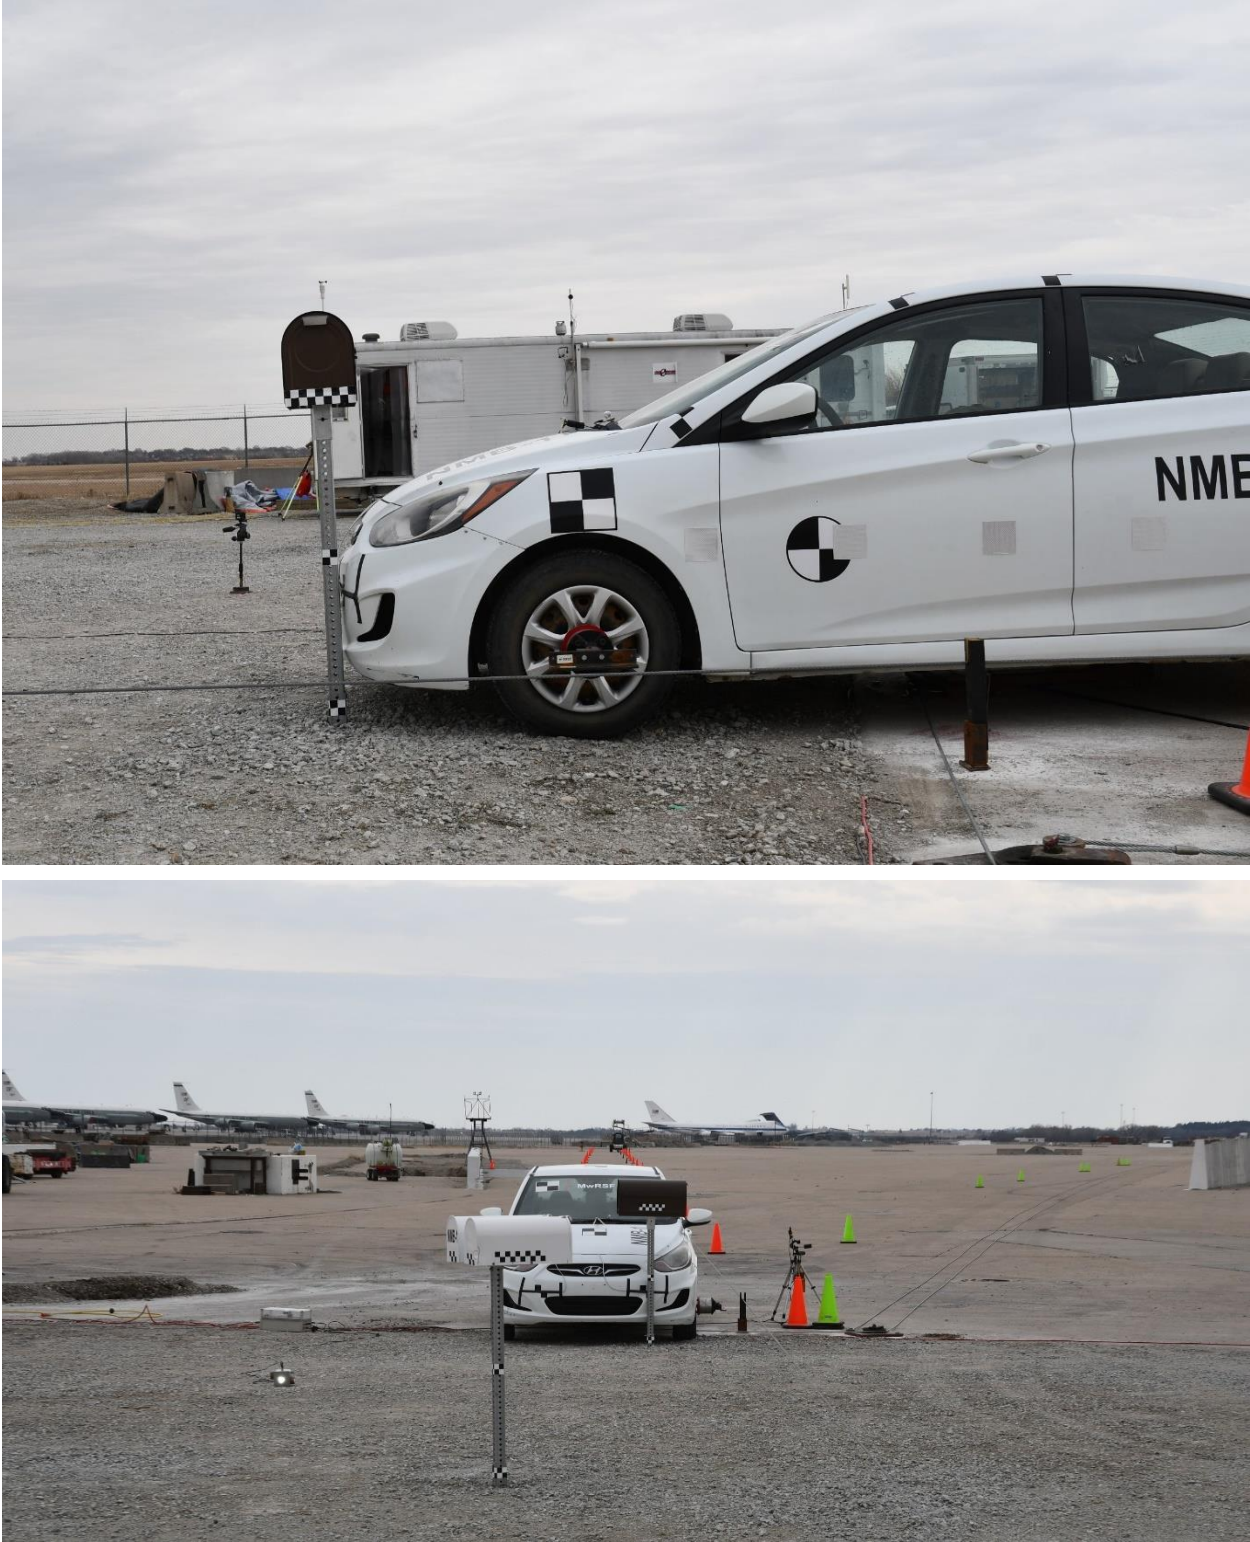
Figure 47. Target Impact Location, Test No. NMB-1

Test no. NMB-1 was conducted as a dynamic component test to explore the performance of two prototype PSST mailbox supports. The test was conducted using a surrogate, non-compliant, MASH 1100C vehicle that impacted two mailbox supports in a single vehicle pass. The first mailbox support impact (single mailbox support) was identified as test no. NMB-1A, and the second mailbox support impact (dual mailbox support) was identified as test no. NMB-1B. The two mailbox supports were offset longitudinally by 25 ft and were offset laterally to allow impact on opposing quarter points of the test vehicle, as shown in Figure 47.

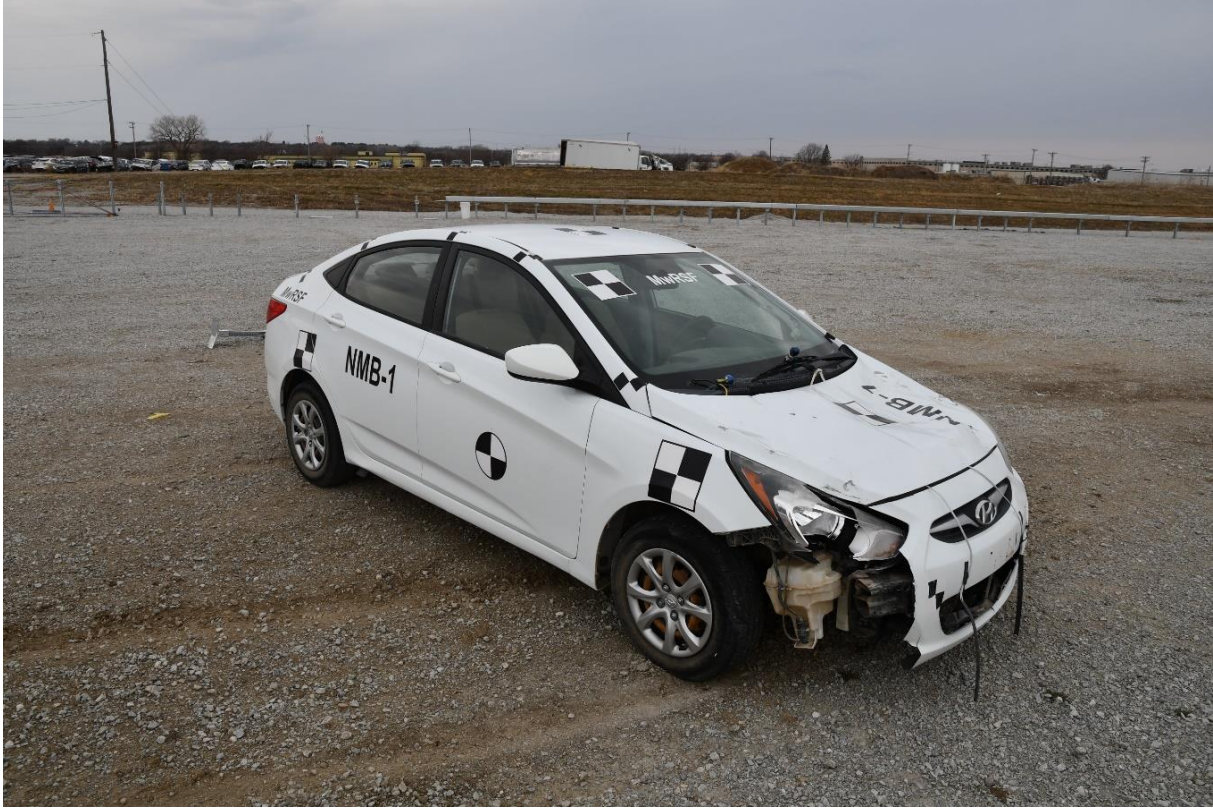
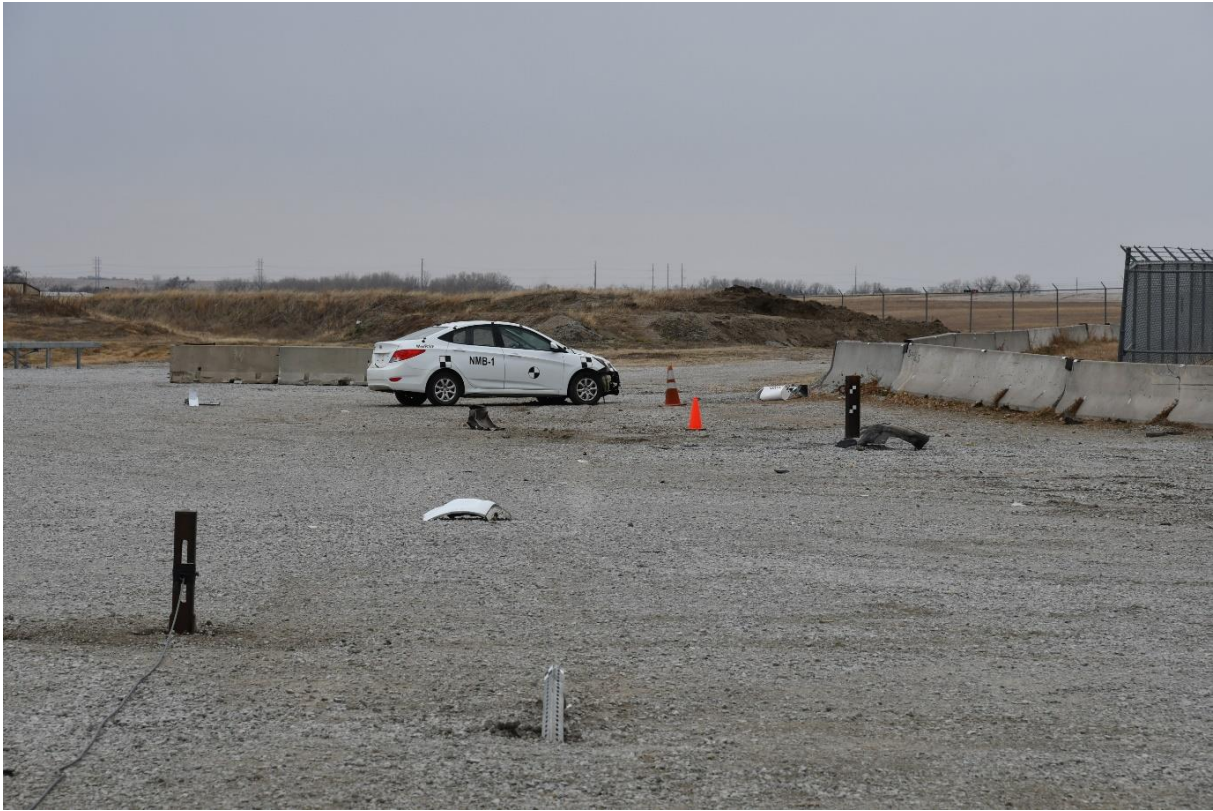
Figure 51. Vehicle Final Position and Trajectory Marks, Test No. NMB-1

A detailed description of the sequential impact events is contained in Tables 15 and 16. Sequential photographs are shown in Figures 48 through 50. The vehicle trajectory and final position are shown in Figure 51.

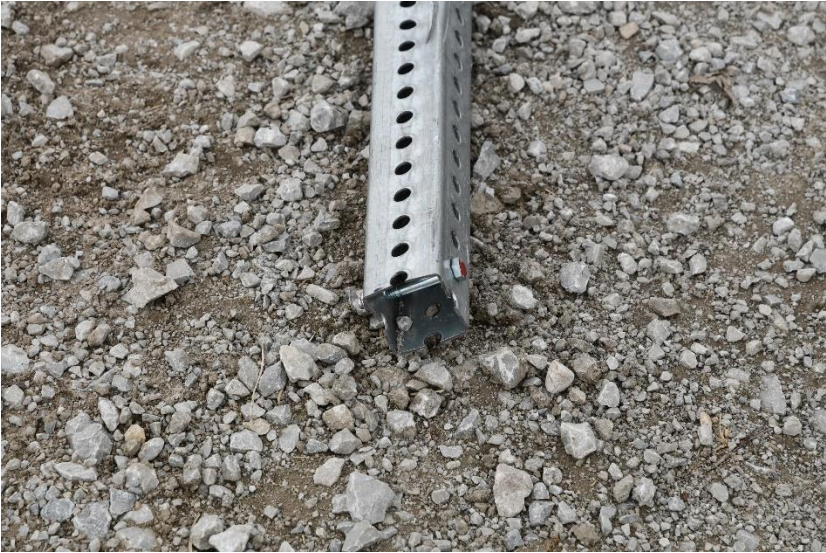
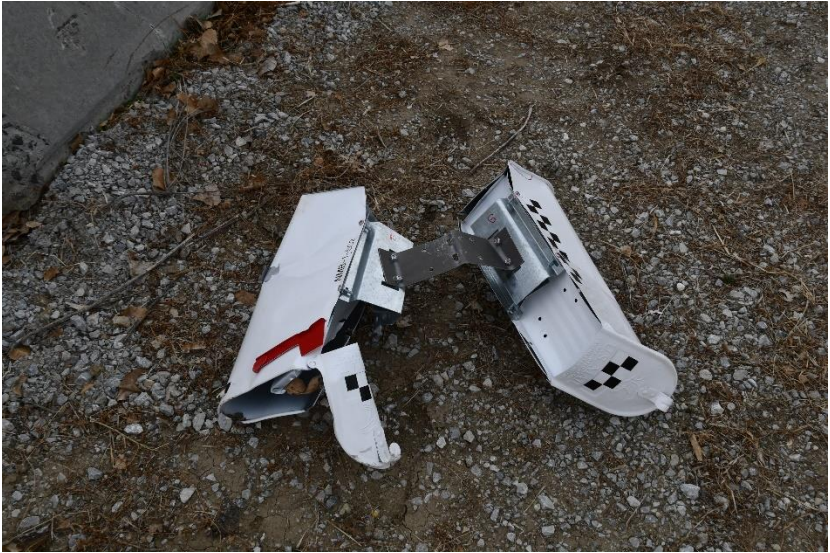
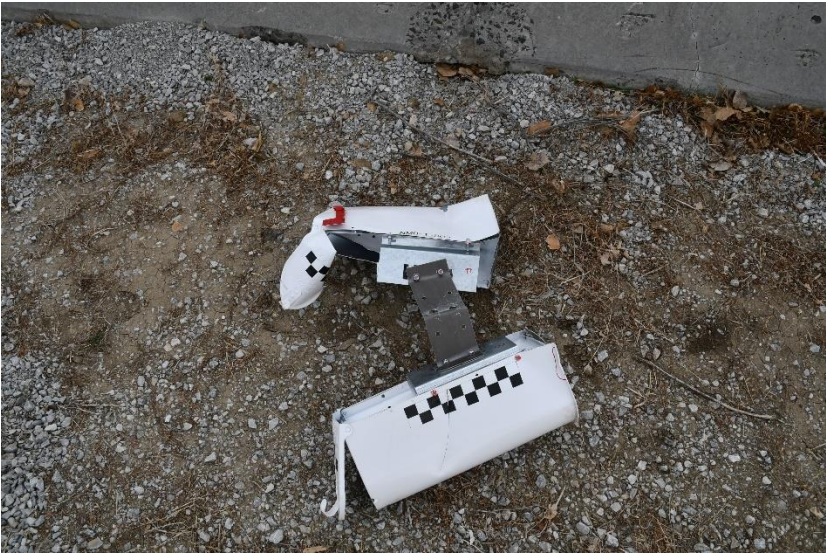
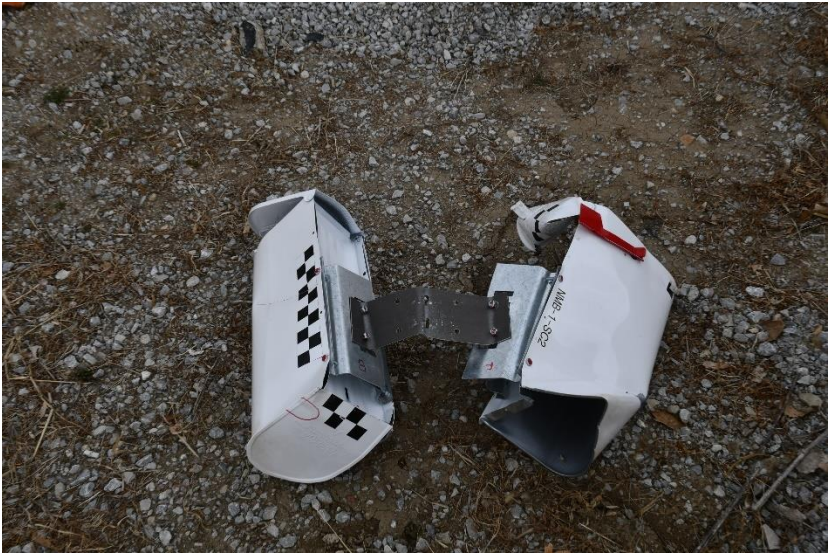
Figure 55. System Damage, Test No. NMB-1B

Damage to System B, the dual mailbox support, was extensive, as shown in Figures 54 and 55. The embedded stub of the mailbox support was displaced several inches through the soil and was bent near the groundline. The mailbox support post remained connected to the embedded stub and the corner bolt connecting the stub and support post remained intact. The mailbox support post was kinked and bent at a location midway along its length and was partially fractured where it was inserted into the stub. The dual mailboxes in System B were completely detached from the support post due to fracture of both spade bolts connecting the support post to the TAPCO mounting bracket. Both mailboxes remained attached to the TAPCO mounting bracket. The flat plate portion of the bracket and the adjustable brackets remained attached to each other and the mailboxes, but the mounting bracket hardware was deformed during impact. The mailbox nearest to the vehicle at impact was severely deformed. The rear mailbox was deformed as well, but the extent of the deformation was significantly less. All mailbox attachment bolts were intact and remained attached.

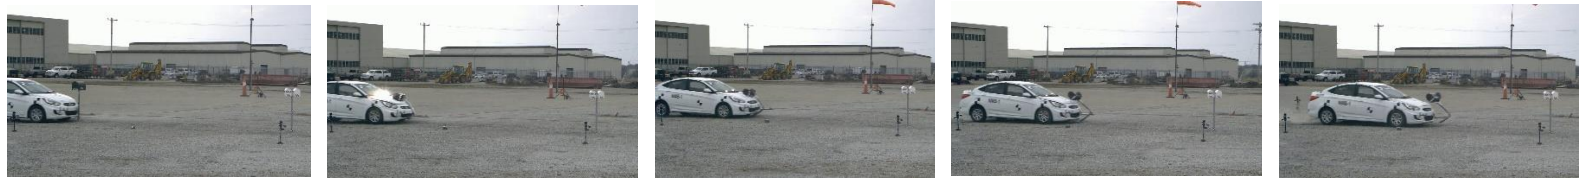
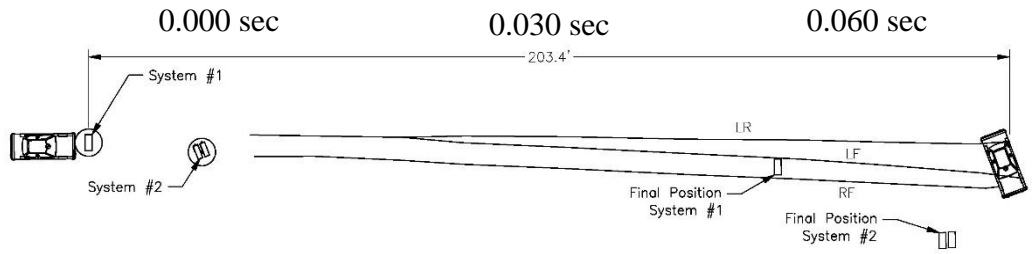
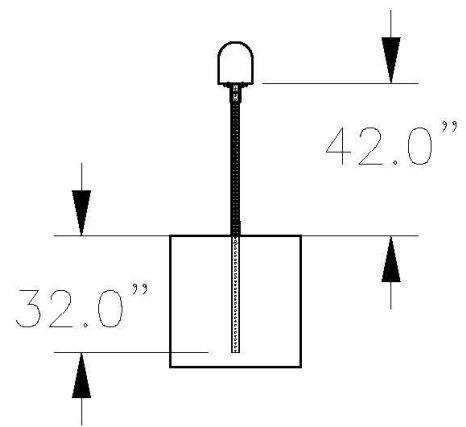
Figure 57. Summary of Test Results and Sequential Photographs, Test No. NMB-1A

- Test AgencyMwRSF
- Test Number.....NMB-1A
- Date.....03/21/2022
- MASH 2016 Test Designation No..... 3-61 (Non-Compliant)
- Test Article..... PSST Single Mailbox Support

- Vehicle Make /Model..... 2014 Hyundai Accent
 - Curb.....2,519 lb
 - Test Inertial.....2,471 lb
 - Gross Static.....2,471 lb
- Impact Conditions
 - Speed63.7 mph

- Angle0 deg.
 - Impact Location.....Left ¼ Point of Front Bumper
- Impact Severity/Kinetic Energy 335.2 kip-ft > 286.1 kip-ft MASH limit
- Exit Conditions

- Speed.....61.2 mph
 - Angle-1.47 deg.
- Vehicle Stability.....Satisfactory
- Vehicle Stopping DistanceN/A
- Vehicle Damage..... Minimal
 - VDS [15]N/A
 - CDC [16]N/A

- Test Article DamageExtensive
- Transducer Data

Evaluation Criteria		Transducer		MASH 2016 Limits
		SLICE-1 (primary)	SLICE-2	
OIV ft/s	Longitudinal	-3.69	-3.63	±40
	Lateral	0.46	0.52	±40
ORA g's	Longitudinal	N/A	N/A	±20.49
	Lateral	N/A	N/A	±20.49
Maximum Angular Displacement deg.	Roll	1.05	1.30	±75
	Pitch	-0.64	-0.90	±75
	Yaw	-1.47	-1.58	not required
THIV – ft/s		0	0	not required
PHD – g's		N/A	N/A	not required
ASI		0.20	0.26	not required

The analysis of the test results for test no. NMB-1 showed that both the prototype single and dual mailbox systems had the potential to meet MASH TL-3. A summary of the test results and sequential photographs are shown in Figures 57 and 58.

In test no. NMB-1A, detached elements, fragments, or other debris from the test article did not penetrate or show potential for penetrating the occupant compartment, or present an undue hazard to other traffic, pedestrians, or work-zone personnel. Deformations of, or intrusions into, the occupant compartment that could have caused serious injury were not observed, but it should be noted that formal occupant compartment measurements were not recorded. Vehicle roll, pitch, and yaw angular displacements were deemed acceptable because they did not adversely influence occupant risk nor cause rollover. Occupant risk values were within the MASH limits. Therefore, test no. NMB-1A indicated that the performance of the PSST single mailbox support had the potential to be acceptable according to the MASH safety performance criteria for test designation no. 3-61.

In test no. NMB-1A, the 2,471-lb small car impacted the single mailbox support at a speed of 63.7 mph and an angle of 0 degrees with a ¼ offset toward the left side of the vehicle. The PSST mailbox support wrapped around the front of the vehicle and released near the ground line. The mailbox was retained on the support while it was in contact with the vehicle. Vehicle damage was minimal and no contact or damage to the vehicle windshield was noted. Occupant risk measures were all within suggested MASH limits.

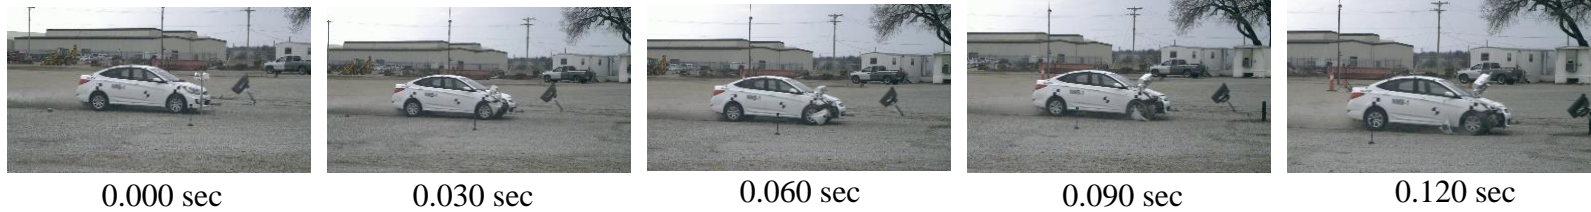
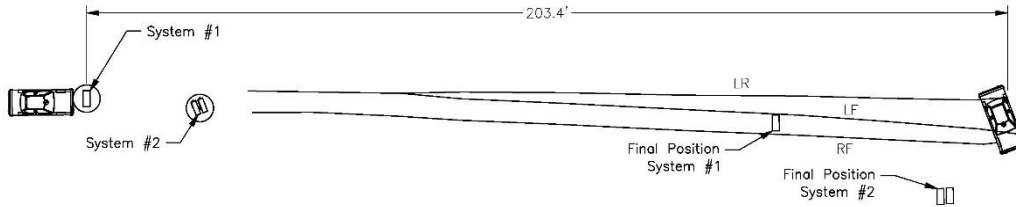
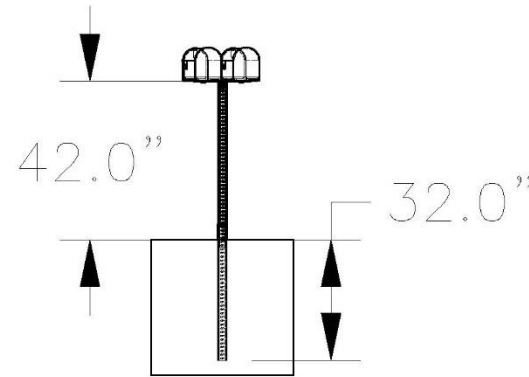
- Test AgencyMwRSF
- Test Number.....NMB-1B
- Date.....03/21/2022
- MASH 2016 Test Designation No..... 3-61 (Non-Compliant)
- Test Article.....PSST Dual Mailbox Support

- Key Component – PSST Support
 - Stub2¼-in. × 12-gauge PSST
 - Mast.....2-in. × 14-gauge PSST
 - Height to Bottom of Mailbox.....42 in.
- Key Component – Mailbox

- Vehicle Make /Model..... 2014 Hyundai Accent
 - Curb.....2,519 lb
 - Test Inertial.....2,471 lb
 - Gross Static.....2,471 lb
- Impact Conditions
 - Speed61.1 mph

- Angle10 deg.
 - Impact Location.....Right ¼ Point of Front Bumper
- Impact Severity/Kinetic Energy308.4 kip-ft > 286.1 kip-ft MASH limit
- Exit Conditions

- Speed59.0 mph
 - Angle4.6 deg.
- Vehicle Stability.....Satisfactory
- Vehicle Stopping DistanceN/A
- Vehicle Damage.....Minimal
 - VDS [15]N/A
 - CDC [16].....N/A

- Test Article DamageExtensive
- Transducer Data

In test no. NMB-1B, detached elements, fragments, or other debris from the test article did not penetrate or show potential for penetrating the occupant compartment, or present an undue hazard to other traffic, pedestrians, or work-zone personnel. Deformations of, or intrusions into, the occupant compartment that could have caused serious injury were not observed, but it should be noted that formal occupant compartment measurements were not recorded. Vehicle roll, pitch, and yaw angular displacements were deemed acceptable because they did not adversely influence occupant risk nor cause rollover. Occupant risk values were within the MASH limits. Therefore, test no. NMB-1B indicated that the performance of the PSST dual mailbox support had the potential to be acceptable according to the MASH safety performance criteria for test designation no. 3-61.

PSST support post wrapped around the front of the vehicle which pulled the mailbox down toward the hood. The PSST did not separate from the embedded stub in this impact, but partial fracture of the PSST post was noted near the stub socket. The impact released the mailboxes and TAPCO mounting bracket from the PSST, and the mailbox and mounting bracket were propelled up and to the side of the 1100C vehicle with little to no relative velocity toward the windshield. No contact with the windshield or deformation or penetration of the occupant compartment were observed due to contact with the mailbox, and occupant risk measures were all within suggested MASH limits.

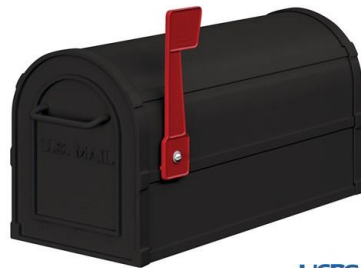
1. Salisbury Heavy Duty Rural Mailbox

- a. <https://www.mailboxes.com/heavy-duty-rural-mailbox-beige/>
- b. 7.5" W x 9.5" H x 20.5" D
- c. 15 lb – 20 lb depending on options
- d. Aluminum

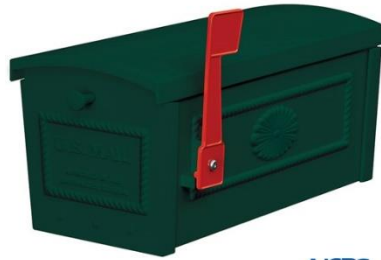
2. Salisbury Townhouse Mailbox - Post Style

- a. <https://www.mailboxes.com/townhouse-mailbox-post-style/>
- b. 8.5" W x 8.75" H x 21" D
- c. 25 lb
- d. Aluminum

e. All Aluminum Construction

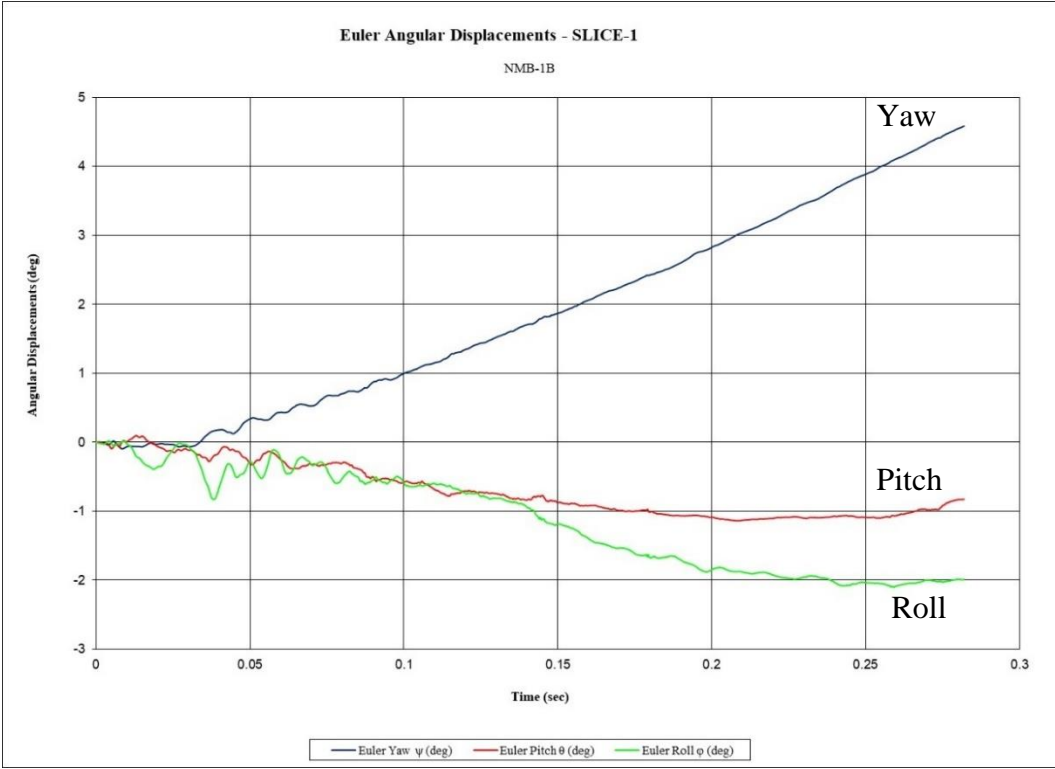
Figure D-23. Vehicle Angular Displacements (SLICE-1), Test No. NMB-1B

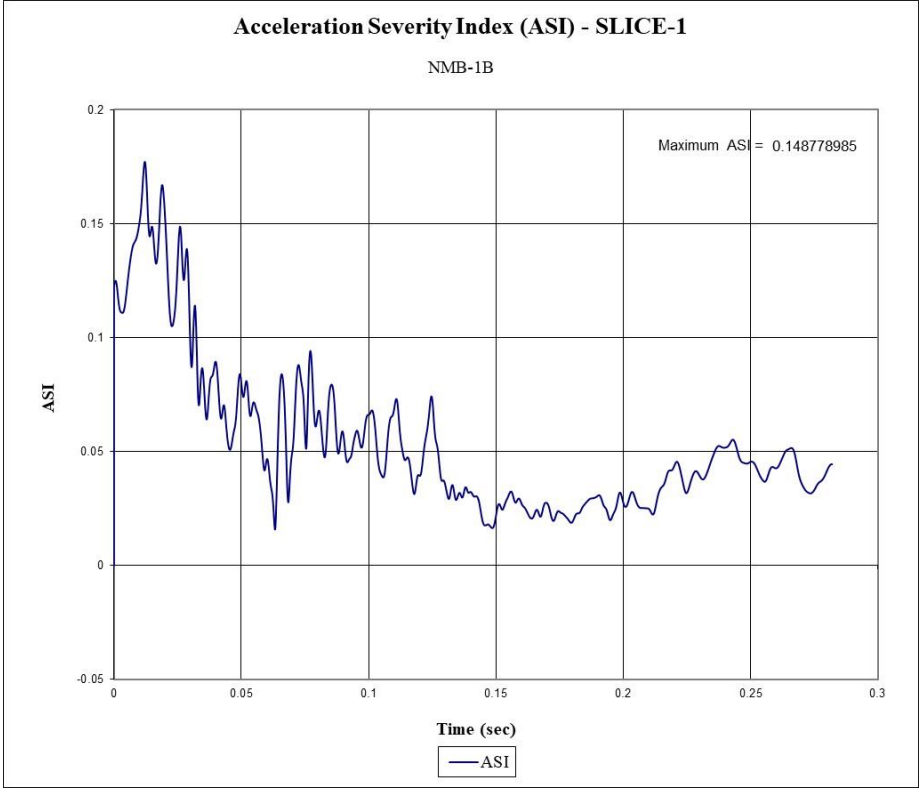
Figure D-24. Acceleration Severity Index (SLICE-1), Test No. NMB-1B
