Research Project Number SPR-FY21(010)

CRASHWORTHY PERFORATED SQUARE STEEL TUBE (PSST) MAILBOX SUPPORT – PHASE I

MIDWEST ROADSIDE SAFETY FACILITY

MwRSF Research Report No. TRP-03-473-23

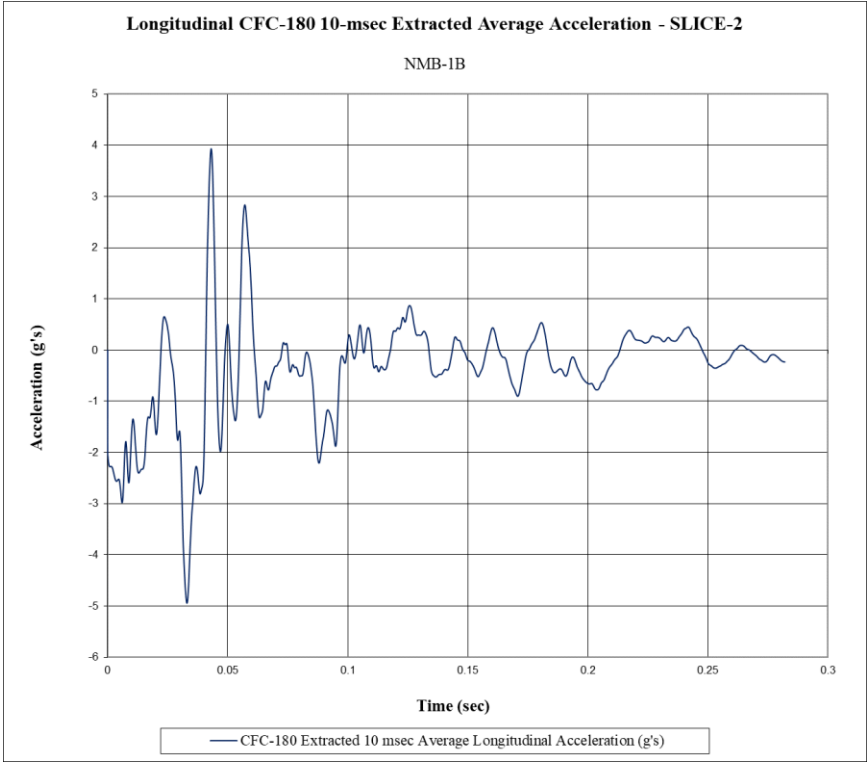
Figure D-25. 10-ms Average Longitudinal Deceleration (SLICE-2), Test No. NMB-1B

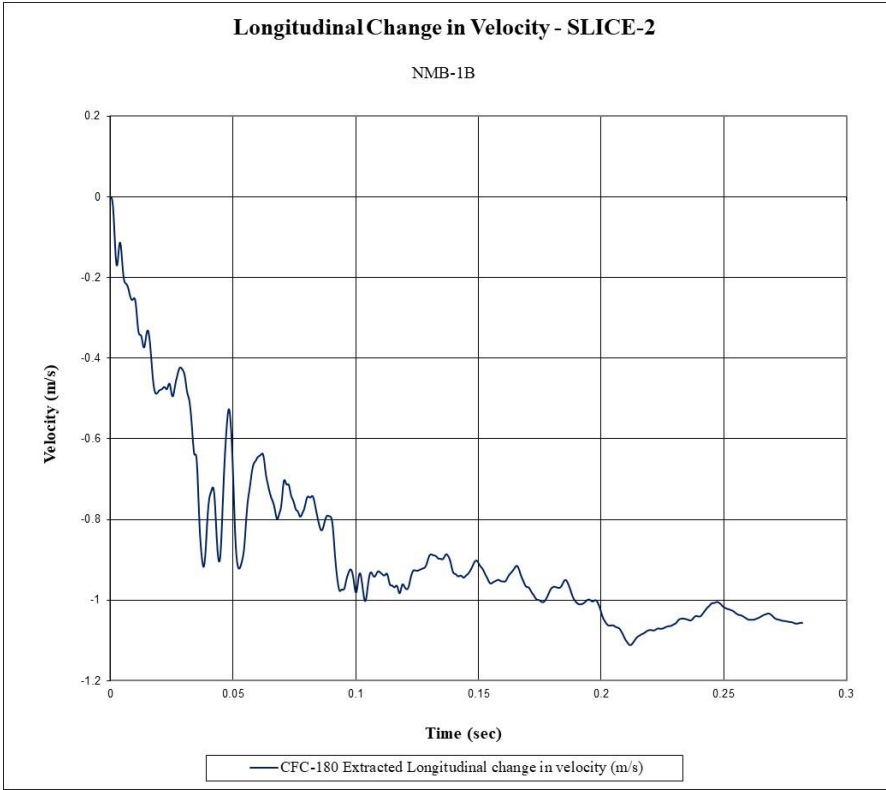
Figure D-26. Longitudinal Occupant Impact Velocity (SLICE-2), Test No. NMB-1B

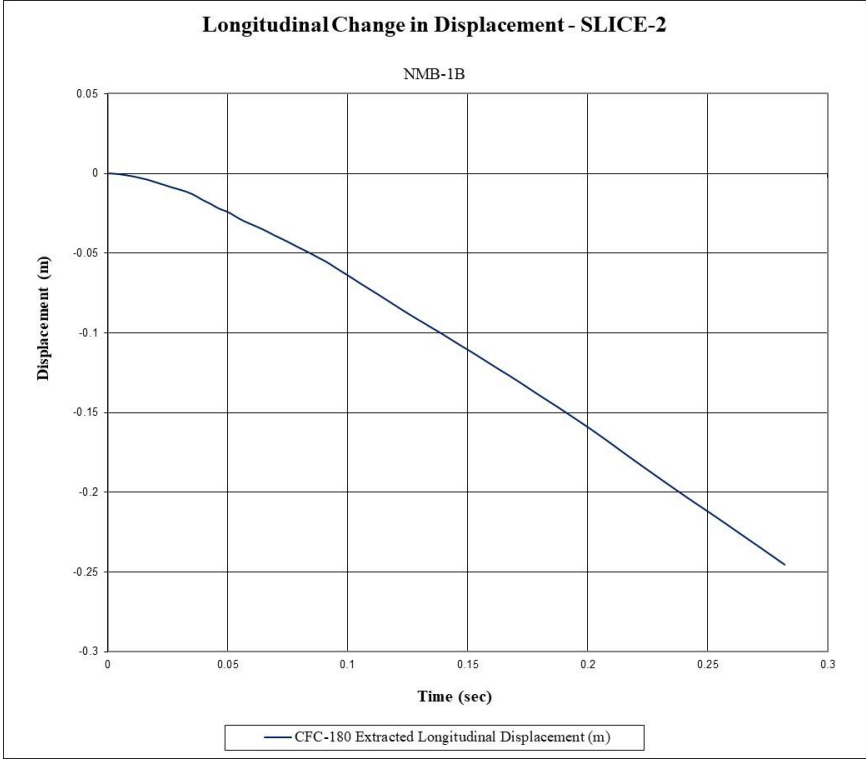
Figure D-27. Longitudinal Occupant Displacement (SLICE-2), Test No. NMB-1B

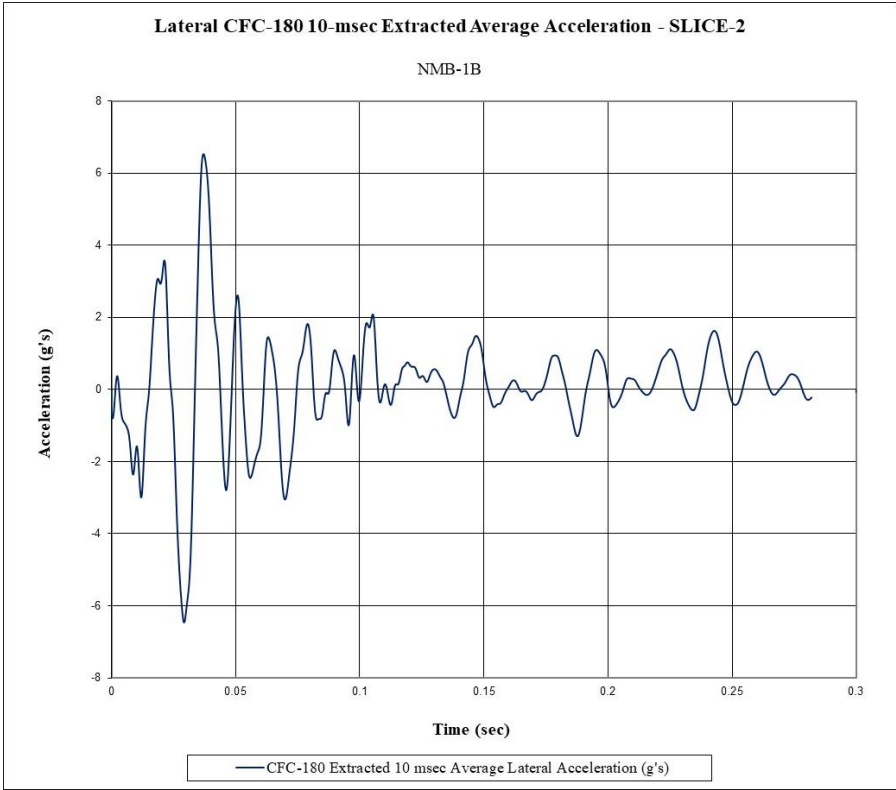
Figure D-28. 10-ms Average Lateral Deceleration (SLICE-2), Test No. NMB-1B

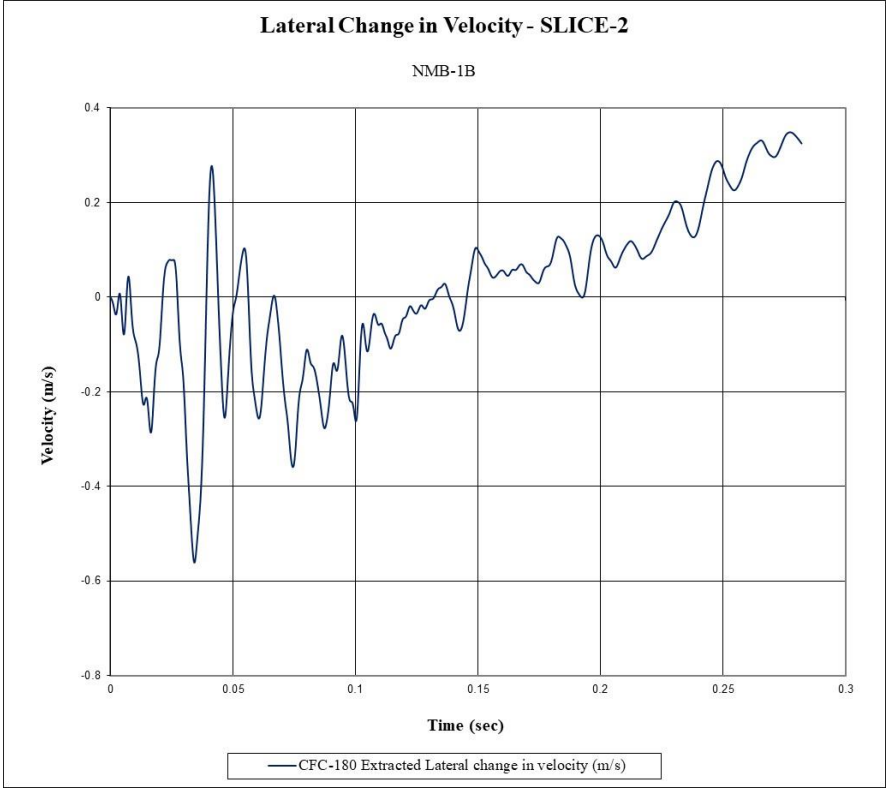
Figure D-29. Lateral Occupant Impact Velocity (SLICE-2), Test No. NMB-1B

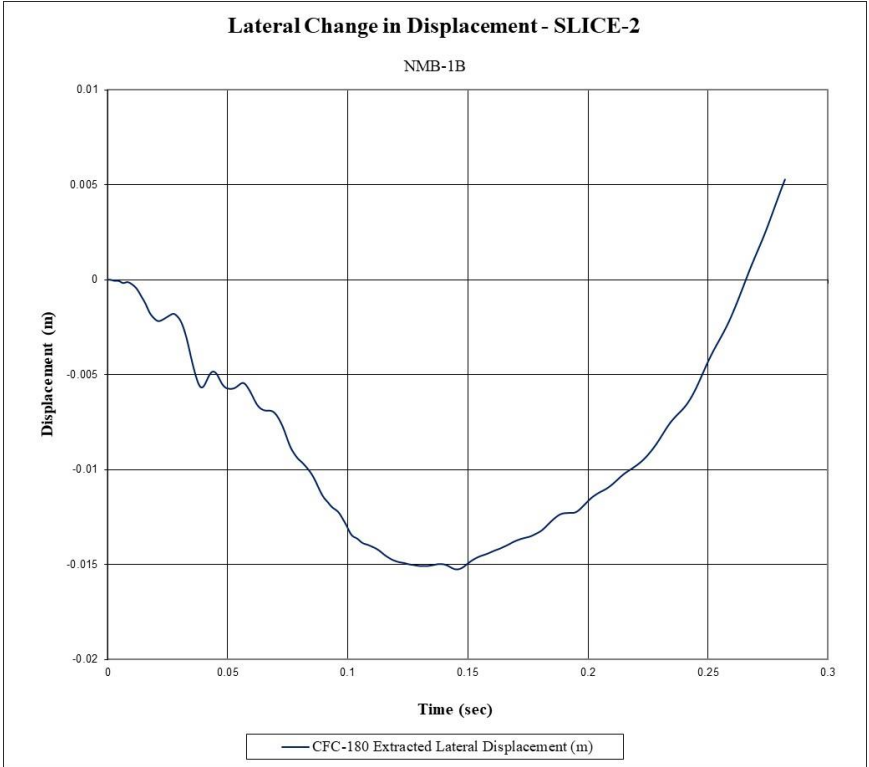
Figure D-30. Lateral Occupant Displacement (SLICE-2), Test No. NMB-1B

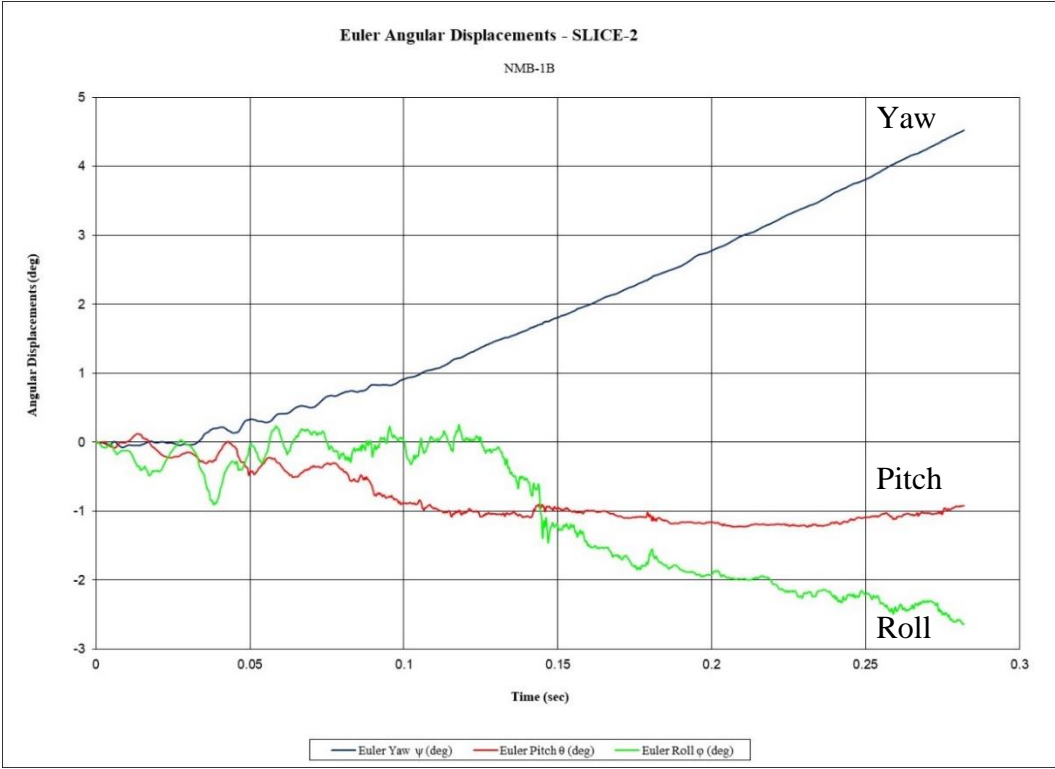
Figure D-31. Vehicle Angular Displacements (SLICE-2), Test No. NMB-1B

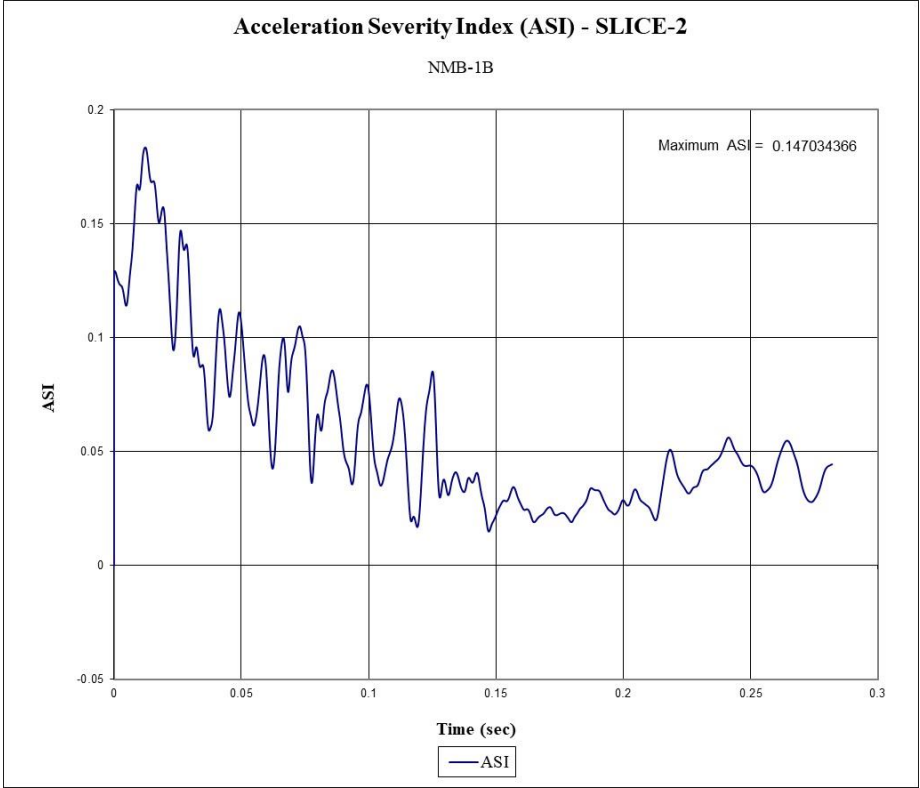
Figure D-32. Acceleration Severity Index (SLICE-2), Test No. NMB-1B
